## ***Bluff Cabin Trail: Assessment & Prescription***

## Assessment

### ***Prescription***

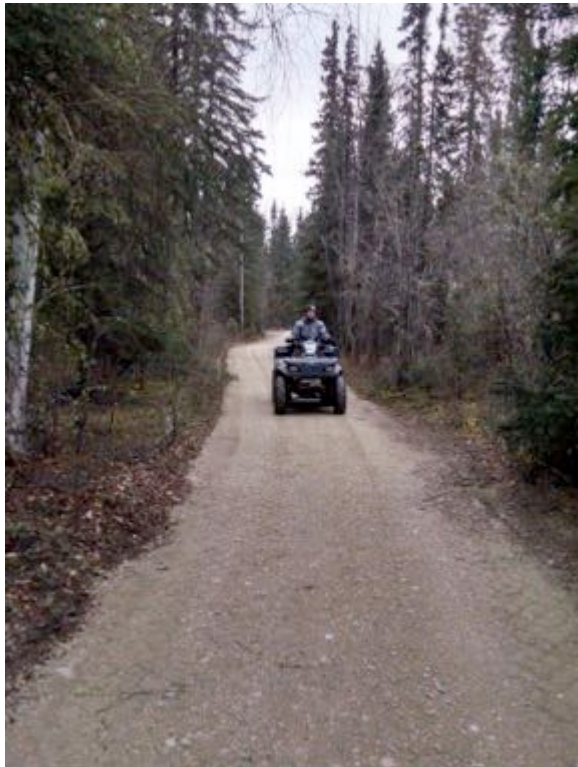
**A-B (1).** Segment restored w/ gravel fill & cap.

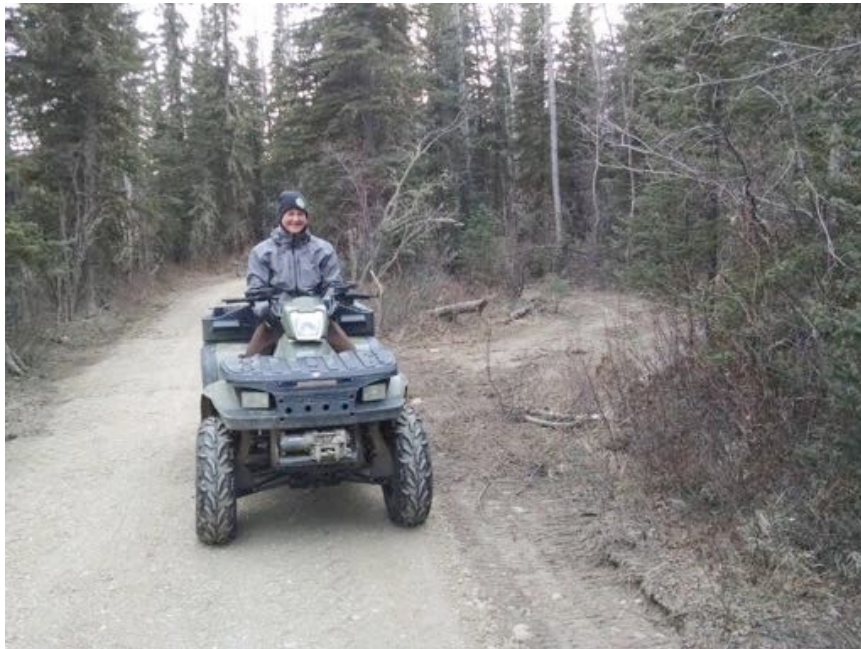
**A-B (2).** Segment restored w/ gravel fill & cap.

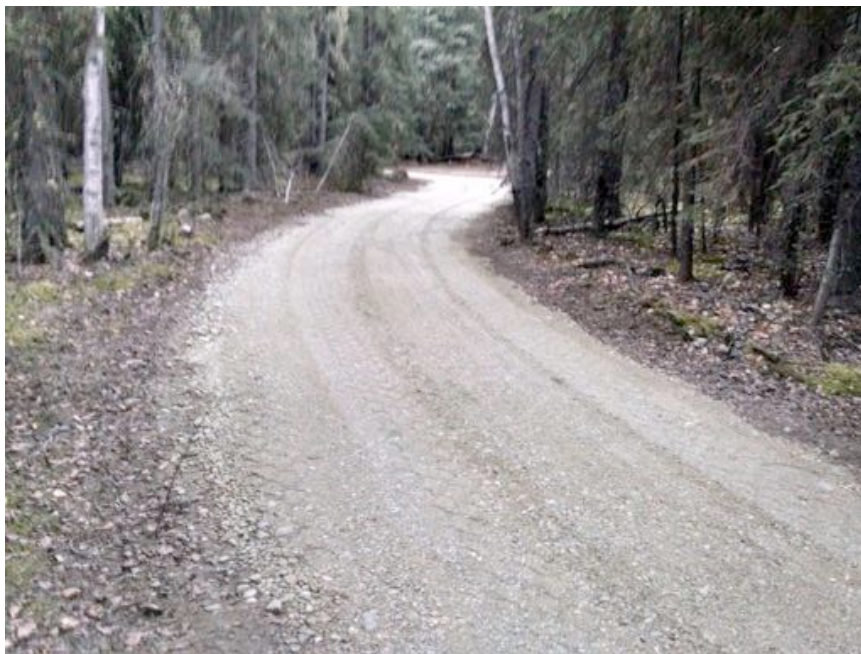
**A-B (3).** Segment restored w/ gravel fill & cap.

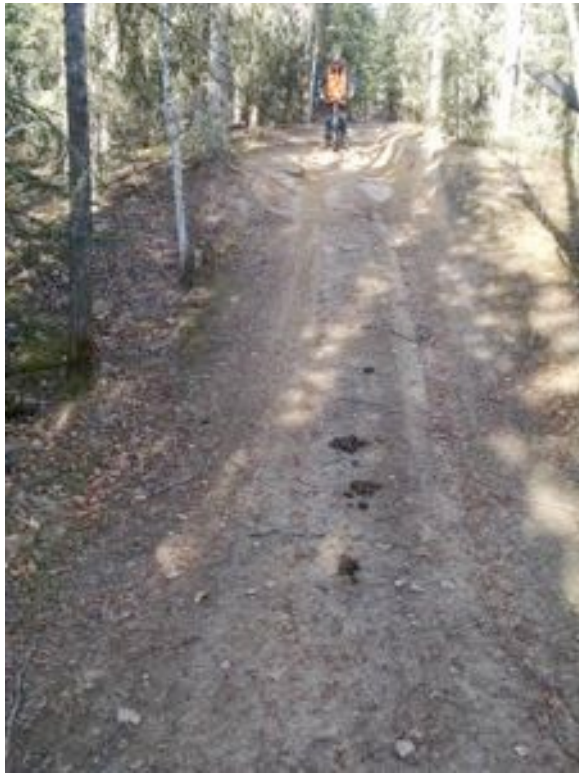
Bluff Cabin Lakes Segment: At the junction (B), this section has a 24-25% fall-line alignment; after the junction, from point D to point E, the trail is acceptable, but will require limited attention to berms and drains, and maintenance is likely to increase in the future as use increases. At point F, un-maintainable fall-line segment over an underlying seep, showing severe erosion and braiding. At point G, un-maintainable segment, showing severe erosion and braiding. Portions of the trail adjacent to both lakes are in adequate condition.

**B-D.** Entrenched, w/ 24-25% fall-line alignment.

Bluff Cabin Lakes Segment: Trail at points B-D requires realignment, w/ 25' radius sweep turns at 10-12% grades (0.2 miles); original alignment needs to be physically closed. Trail to points D-E, remove berms and install drains at low points in the trail. Trail after point E needs to be abandoned. A new trail constructed north on Bluff Cabin Ridge, from point I to the northern lake (H, ~1.2 miles), with a spur down to southern lake at point J (~0.2 miles).

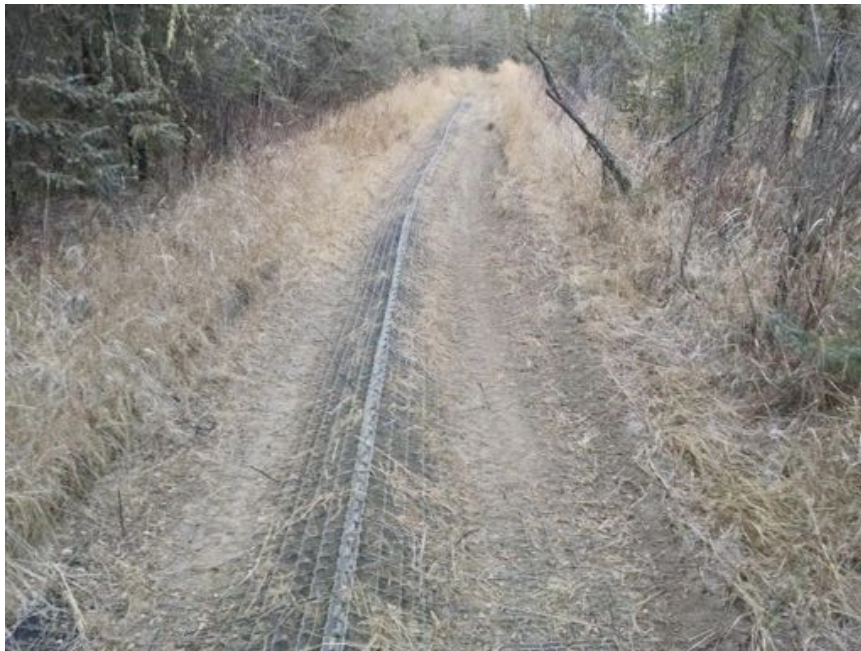
Bluff Cabin Slough Segment (B-C): Geoblock has not been installed correctly: ruts were not leveled prior to installation, panels are seamed rather than inter-locked, lack of weatherproof plywood backing plates at connections, zip-ties have not been clipped (screw fastening into the backing plates, rather than zip-ties would have reduced the flexing of the geoblock). Trail segment is deeply rutted and entrenched and un-maintainable to ~500yds of terminus.

**B-C (1).** Geoblock installation.

Bluff Cabin Slough Segment (B-C, as depicted in the above map): Abandon this segment and create realignment, from point E to point C (~1.1 miles). Consider salvaging geoblock for future use.

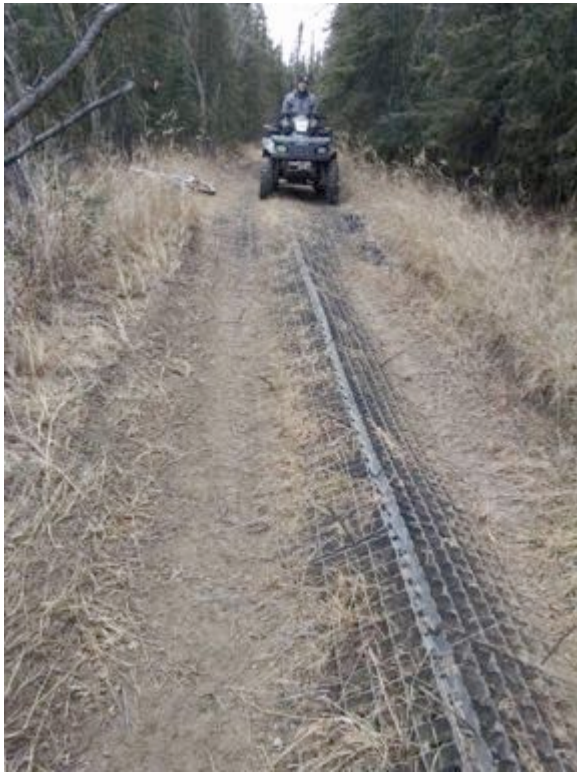
**B-C (2).** Geoblock installation.

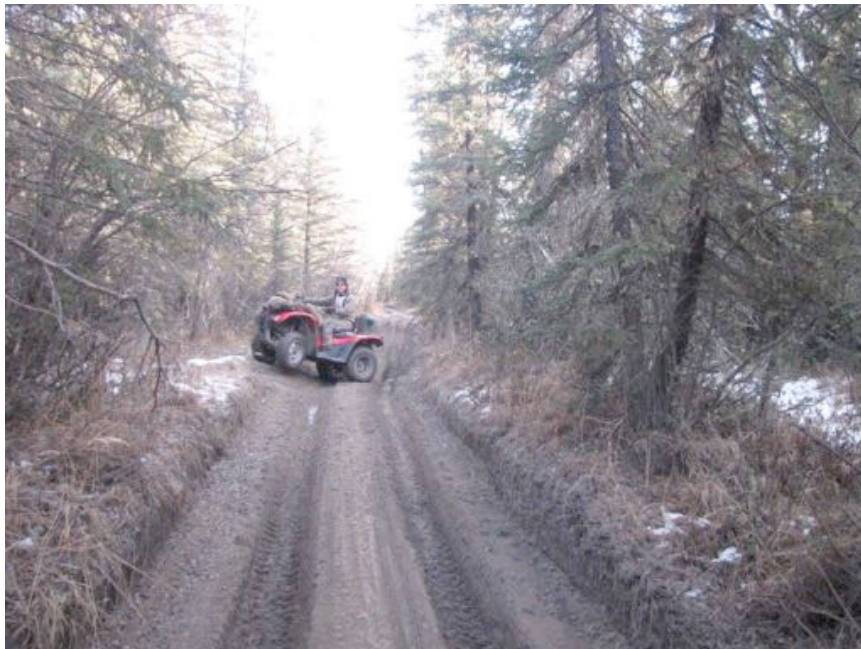
**B-C (3).** Entrenchment & rutting. (*Credit: ADF&G, Brandy Baker*)

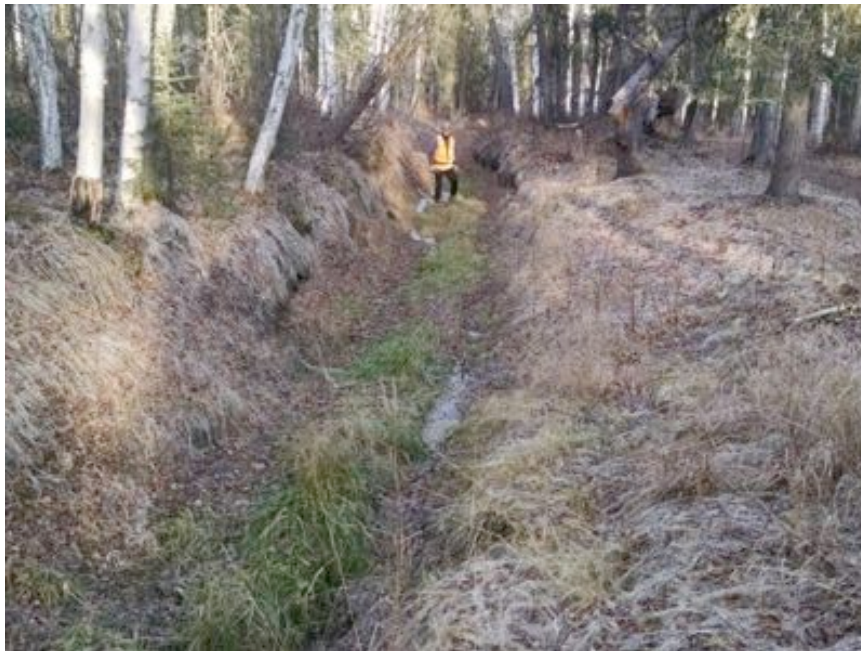
**F.** Un-maintainable, fall-line segment, showing severe entrenchment, erosion and braiding.

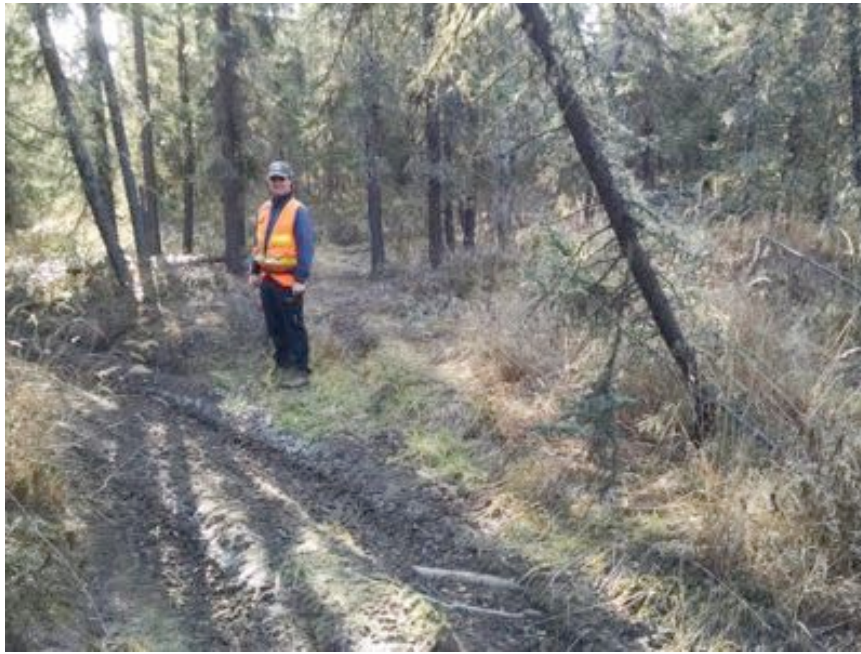
**G.** Un-maintainable segment, showing severe erosion and braiding.
