**Hazardous Material Survey Report  
Snowden Roof Replacement  
ACS #C-18-0001**

**FINAL REPORT**

January 2018

Stantec Project No.: 2046068501.1

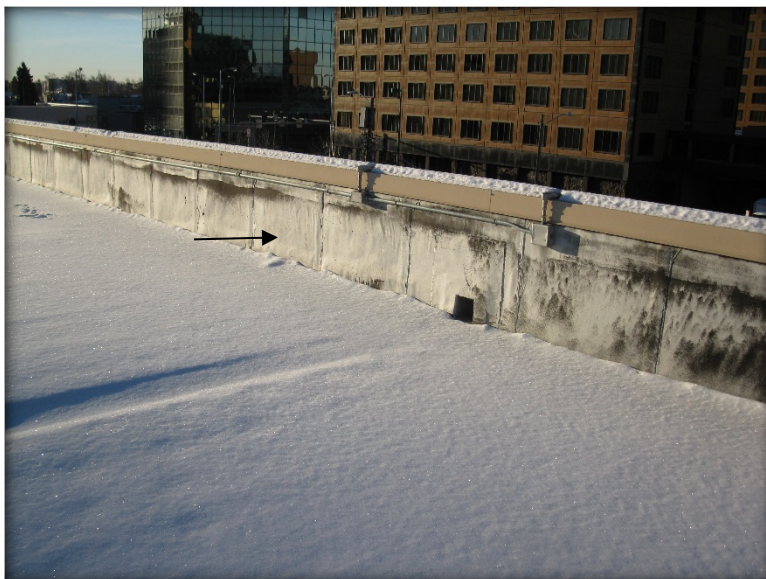
### **1.4.1 Silver Seal Roof Coating**

A silver seal coating, which has been applied to the roof surface and parapet walls, tested positive for ACM with a 5 percent concentration of chrysotile. The coating is also located on roof-top mechanical equipment ducting and curb construction. The material appears to be in good condition and is still adhered to the roof surface.

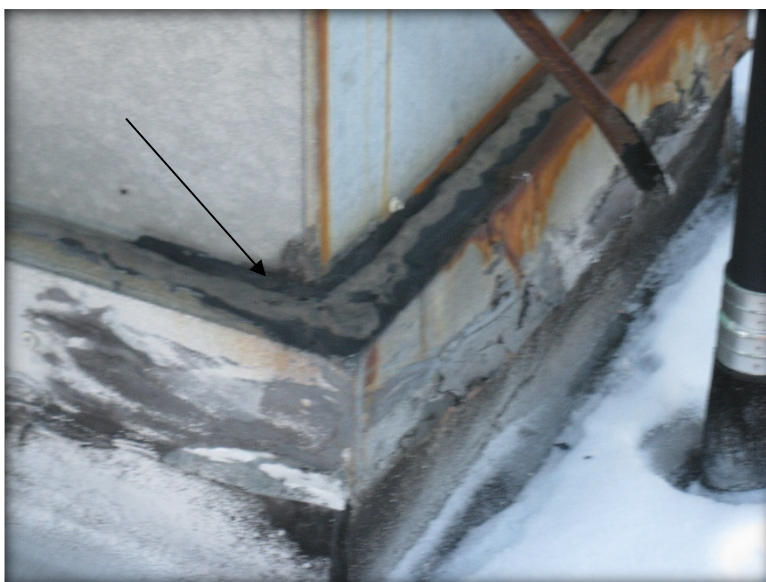
### **1.4.2 Mastic at Roof Curbing**

Black mastic located at rooftop unit bases and curbs tested positive for ACM designation with an 8 percent concentration of chrysotile. The sample of mastic was taken from a mechanical curb on Roof 4b; however, similar material also appears to be present at curbing and equipment flashings on Roof 4a. The material is non-friable and in good condition overall.

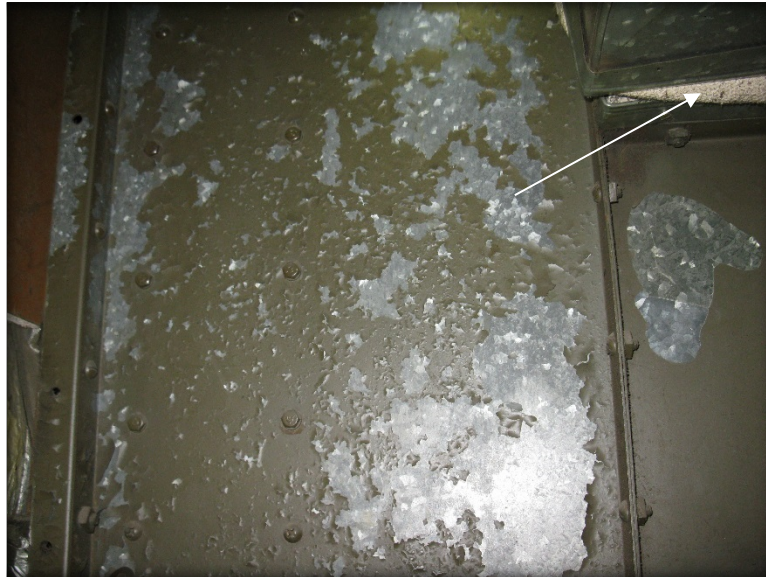
### **1.4.3 Duct Cloth**

Cloth membrane material located in the penthouse at duct flexible connection points associated with the ventilation unit and its corresponding ducting tested positive for ACM with a reported concentration of 95 percent chrysotile. Two connection points with this material in place were observed during the survey. The observed material is friable and found to be intact and in good condition in the areas that were accessible.

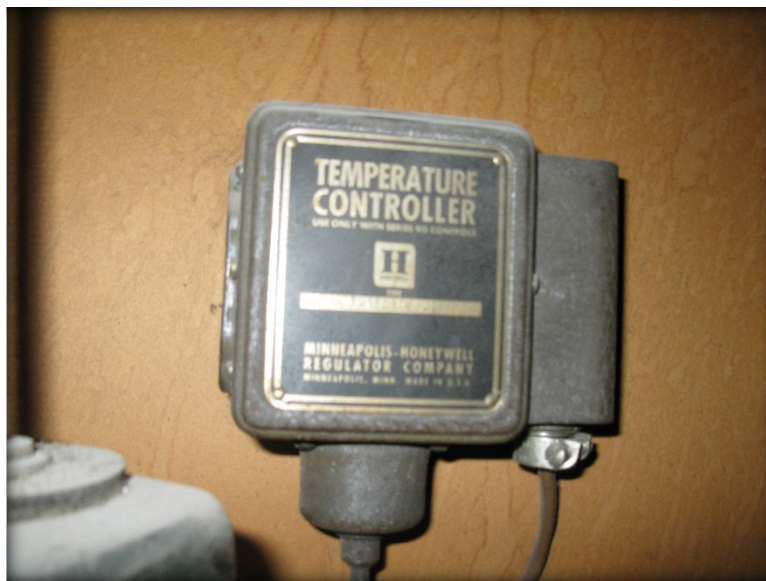
A cursory review of the work area at the Snowden Administration Building revealed a temperature control device within the penthouse that is suspected of containing a mercury bulb.

When discarded in the trash, mercury-containing lamps, thermostats, etc., can break, allowing some of the mercury content to be released. This can lead to the release of elemental mercury into the environment and subsequent contamination of groundwater and the food chain. The EPA developed the Universal Waste Standard in attempt to reduce the hazardous waste management and recycle burden for smaller entities, providing an environment that promotes collection and recycling.
