RE: Project Name: Statewide Roof Replacement Design & Contract
Services
Project Number: 20-19-02
Project Location: Statewide
RFP Opening Date and Time: September 27, 2018 @ 2:00 PM local time

Addendum # TWO (2)

ROOF INVESTIGATION REPORT
WILDWOOD CORRECTIONAL CENTER
BUILDING 8 ROOF REPLACEMENT

Kenai, Alaska

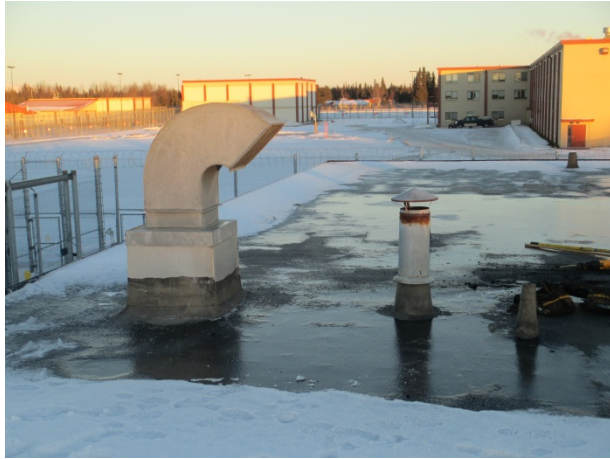
Photo 1: **Wildwood Bldg 8 Main Roof - Mechanical Penetrations**

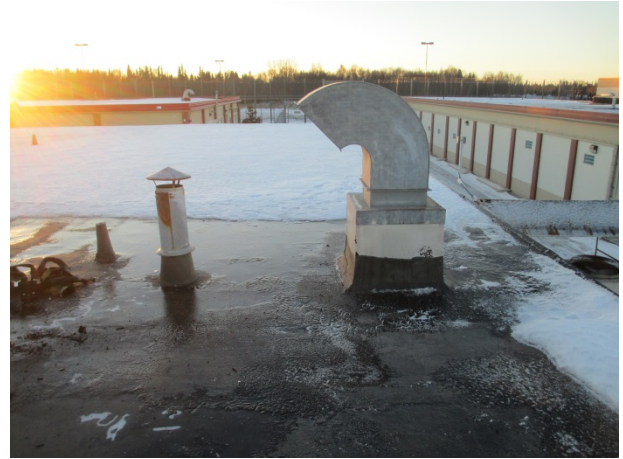
Photo 2: **Wildwood Bldg 8 Main Roof - Mechanical Penetrations**

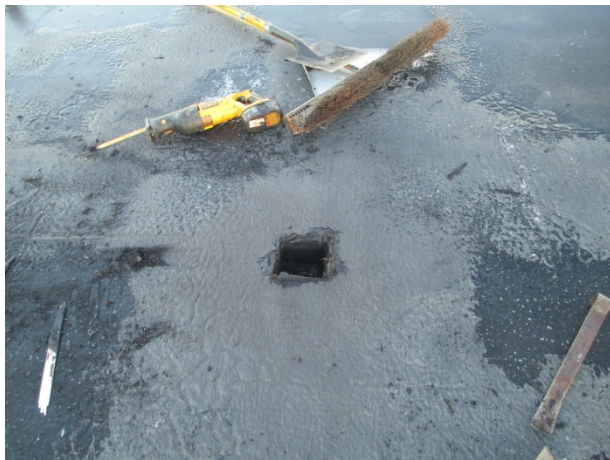
- BUR Assembly, multiple plies, up to 1-1/2" thick in areas
- 2" cork insulation
- BUR Vapor retarder
- 6" concrete roof deck

Photo 3: **Wildwood Bldg 8 Main Roof - Core Cut #1**

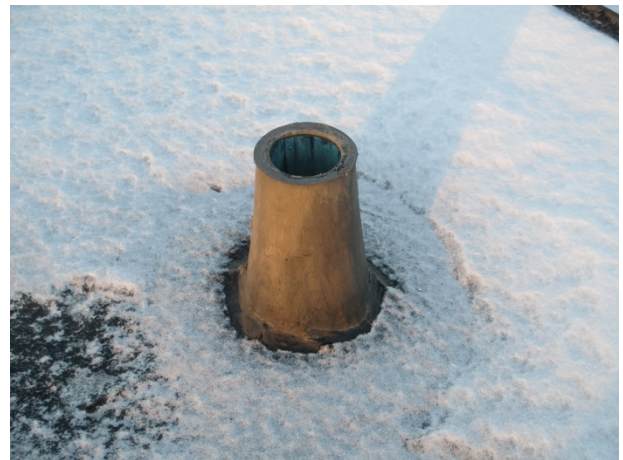
Photo 4: **Wildwood Bldg 8 Main Roof - Typical VTR Penetration**

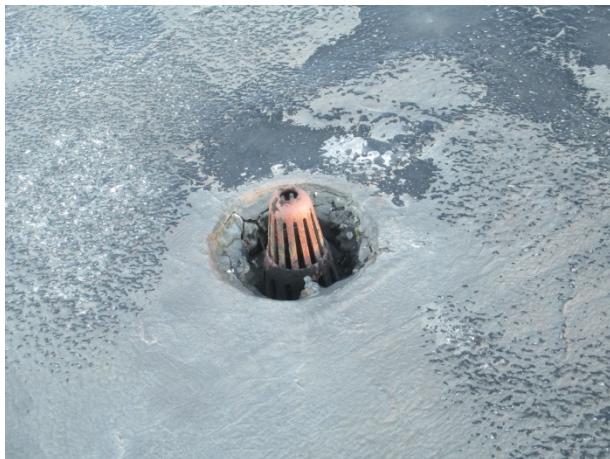
The Building 8 Roof A is drained internally. This means the roof drains are approximately located mid span of the structure. The concrete roof deck is flat and there are no tapers or crickets in the insulation to direct water toward the drains. There are two primary roof drains, however, there are no overflow drains or scuppers, which are now required by code.

Photo 5: **Wildwood Bldg 8 Main Roof - Typical Roof Drain**

Having either overflow roof drains or scuppers is now required by code and will need to be added during this roof replacement project. Due to design load constraints, overflow scuppers will be problematic, as they require the roof to hold more water than overflow roof drains would. This weight difference will exceed the live load capacity of the roof, therefore, overflow roof drains will be pursued, one for each of the two primary roof drains.

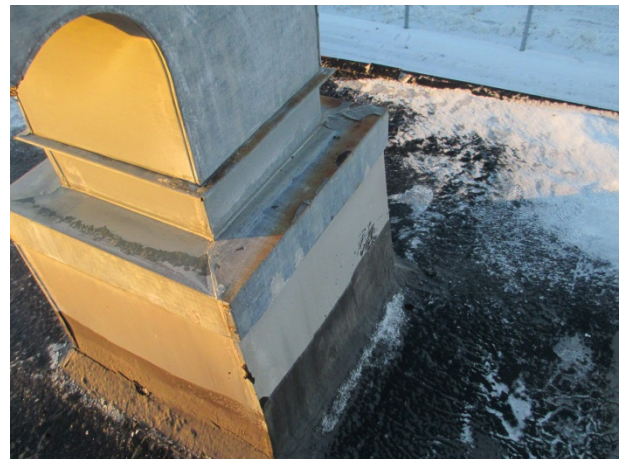
Photo 6: **Wildwood Bldg 8 Main Roof - Mech Penetration & Curb from Boiler Room Below to be Removed**

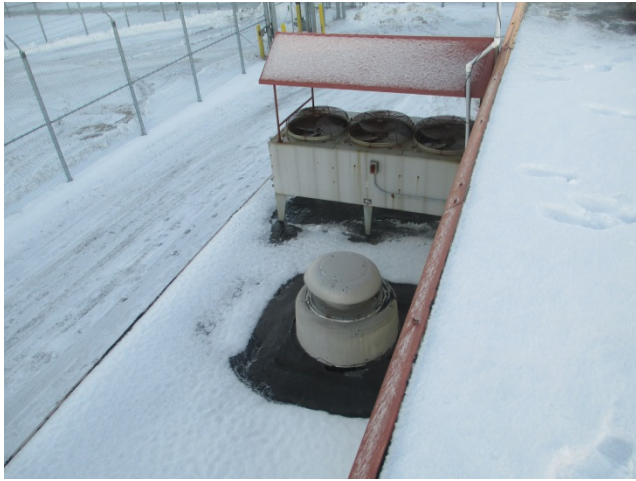
Photo 7: **Wildwood Bldg 8 Roof B Below – Mechanical Ventilator & Condenser Unit to be Removed**

- 4) Climbed up to the Mechanical Room located on the back of the main building. Observed an existing condenser unit and ventilator that are to be demolished. Condenser unit may be removed by in-house workforce, while the ventilator will be removed under this contract. Observed Rain Proof Roofing cutting the existing BUR assembly for Core Cut #2. Noted the 3" fiberboard was extremely wet. Took photos of the Core Cut and mechanical equipment. Bagged and identified the core sample for analysis. All roof deck penetrations that are removed will be framed-in prior to re-roofing. Discussed ideas for a new roof system installed onto the Mechanical Room roof. The leading candidate is a shed type roof with shingles. Will discuss with Structural Dept on the necessary design.

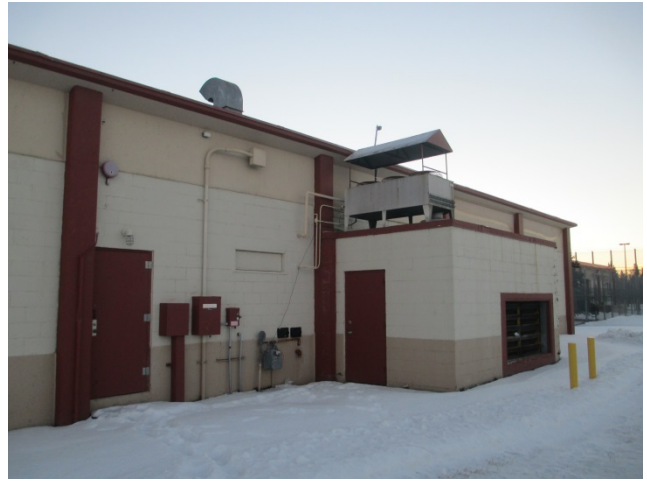
Photo 8: **Wildwood Bldg 8 – Roof B @ Mechanical Room**

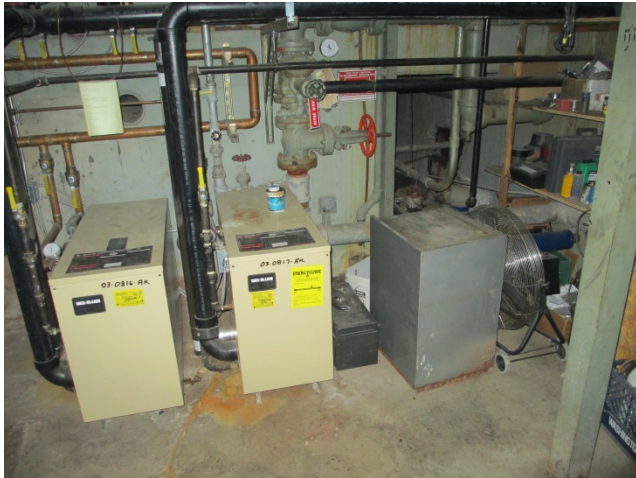
Photo 9: **Wildwood Bldg 8 – Existing Boilers to Remain Intact**

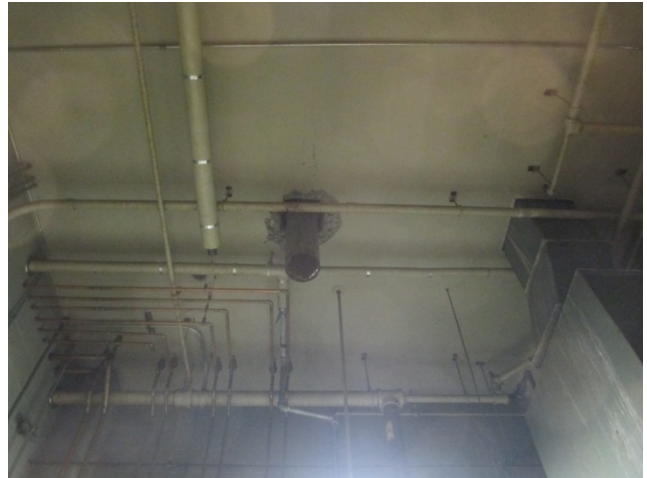
Photo 10: **Wildwood Bldg 8 – Old Boiler Stack Penetration to be Removed & Framed-in**

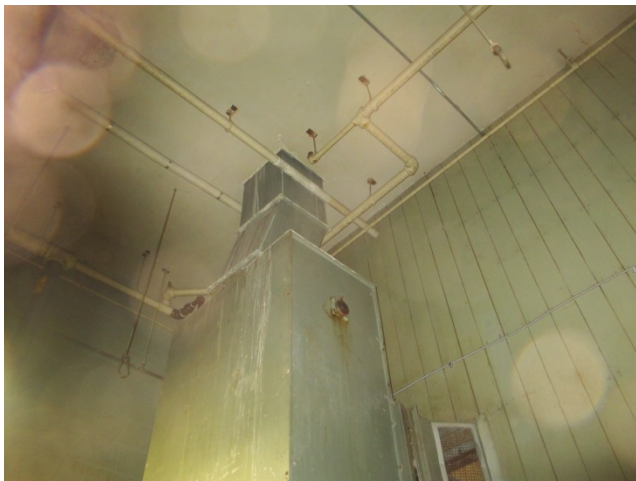
Photo 11: **Wildwood Bldg 8 – Old Mechanical Duct Penetration to be Removed & Framed-in**

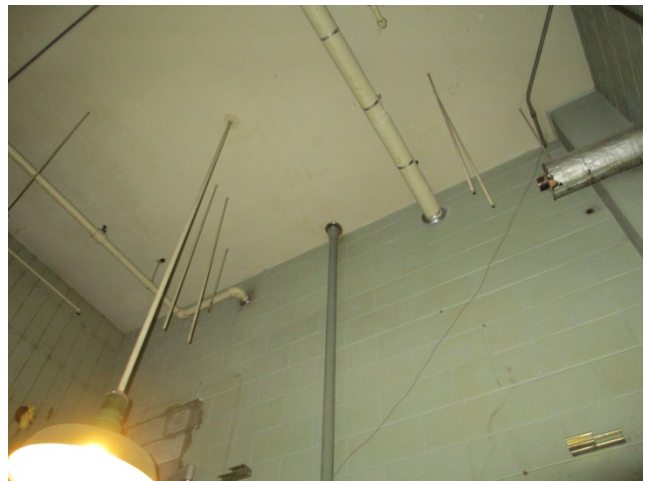
Photo 12: **Wildwood Bldg 8 – Typical VTR Penetration to Remain (Sizes Vary)**

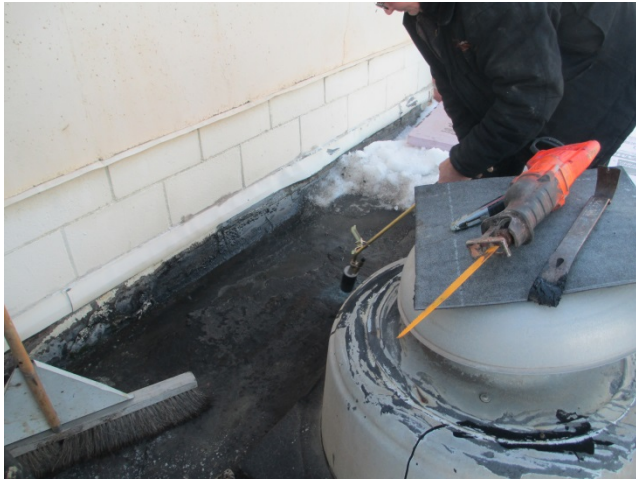
Photo 13: Wildwood Bldg 8 – Roof B @ Mechanical Room Core Cut #2 Prep w/ Ventilator to be Removed

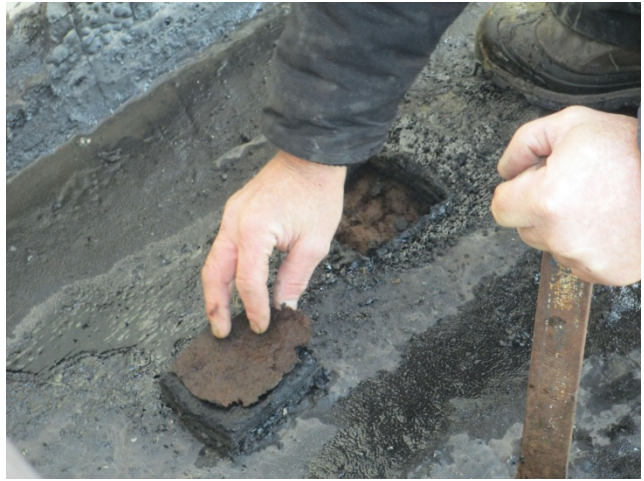
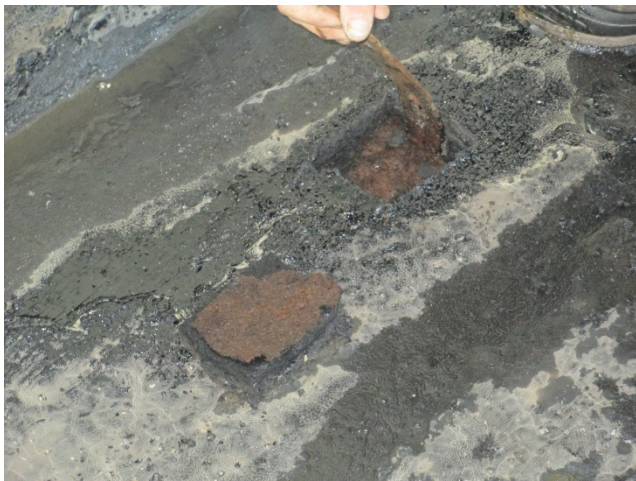
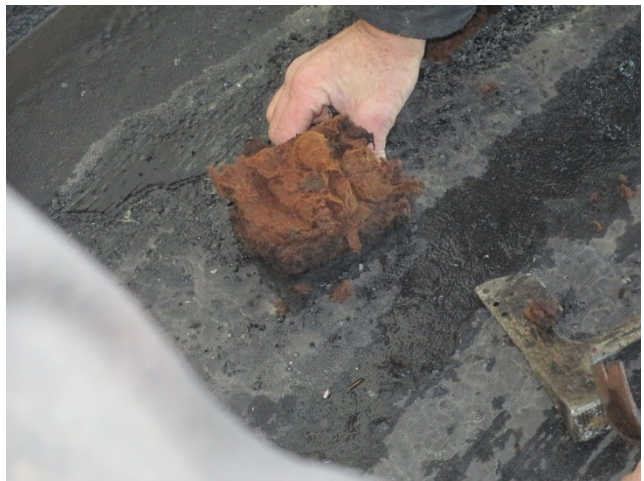
Photo 14: Wildwood Bldg 8 – Roof B @ Mechanical Room Core Cut #2 Disassembly

Photo 15: Wildwood Bldg 8 – Roof B @ Mechanical Room Core Cut #2 Disassembly

Photo 16: Wildwood Bldg 8 – Roof B @ Mechanical Room Core Cut #2 Disassembly

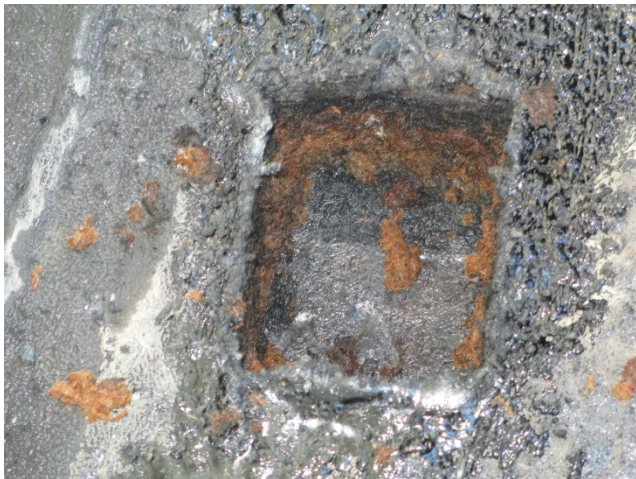
Photo 17: Wildwood Bldg 8 – Roof B @ Mechanical Room Core Cut #2 With Deck Exposed

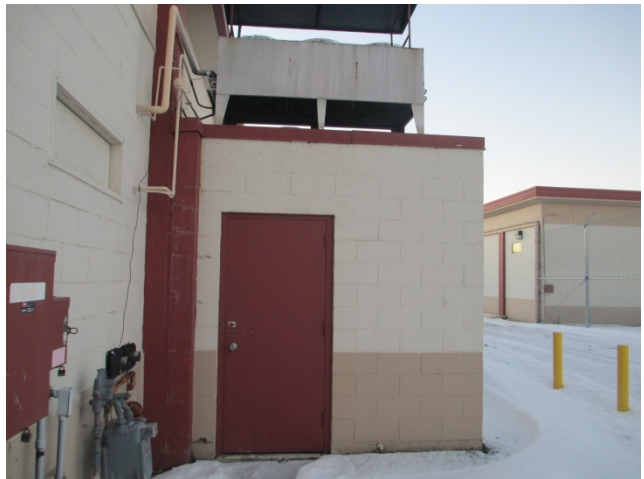
Photo 18: Wildwood Bldg 8 – Mechanical Room Entrance w/ Condenser Above to be Removed

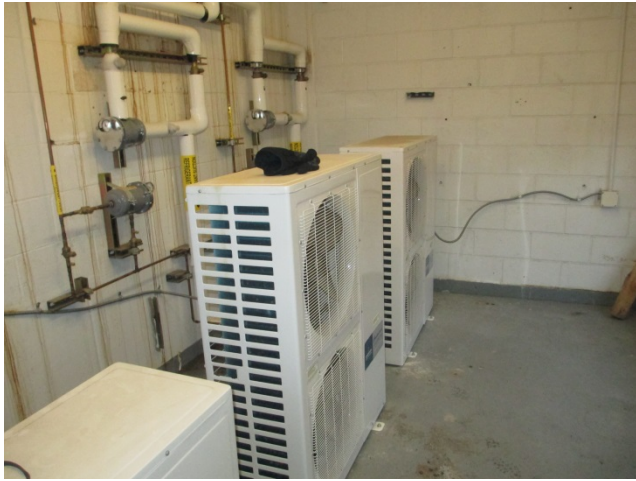
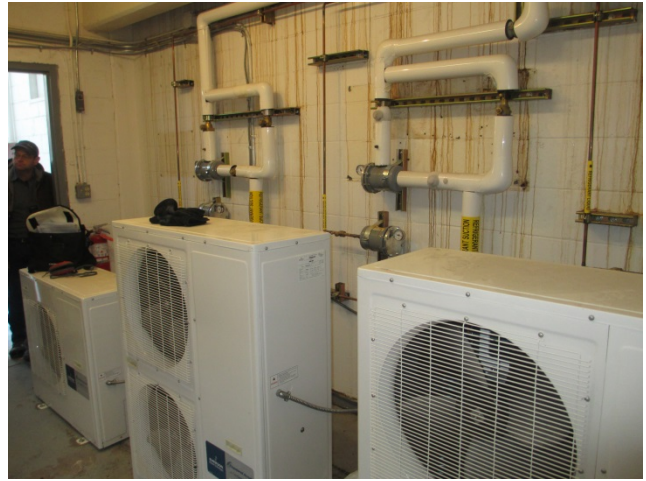
Photo 19: **Wildwood Bldg 8 – Mechanical Room Equipment to Remain Intact**

Photo 20: **Wildwood Bldg 8 – Mechanical Room Equipment to Remain Intact**

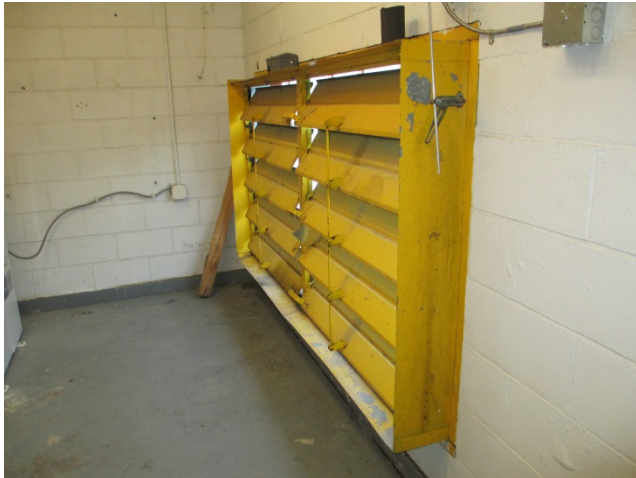
Photo 21: **Wildwood Bldg 8 – Mechanical Room Louver Assembly to Remain Intact**

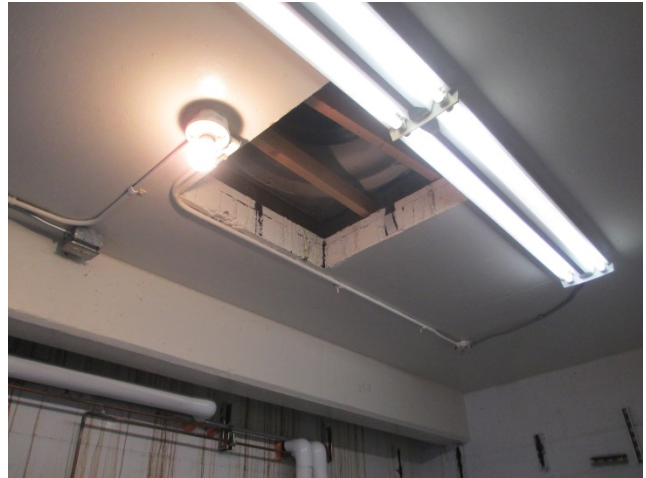
Photo 22: **Wildwood Bldg 8 – Mechanical Room w/ Access Hole to Ventilator to be Removed**

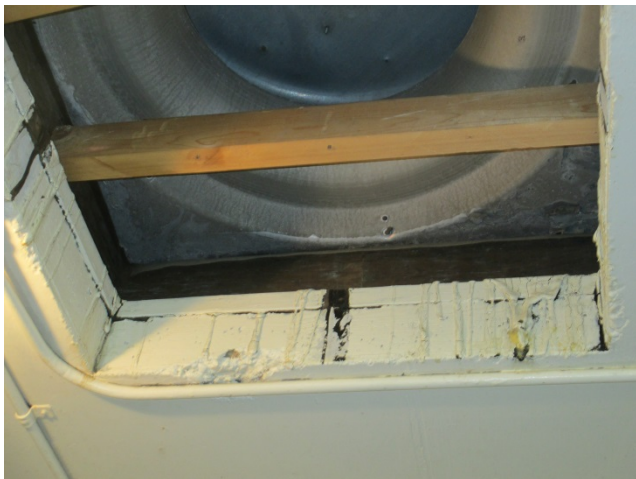
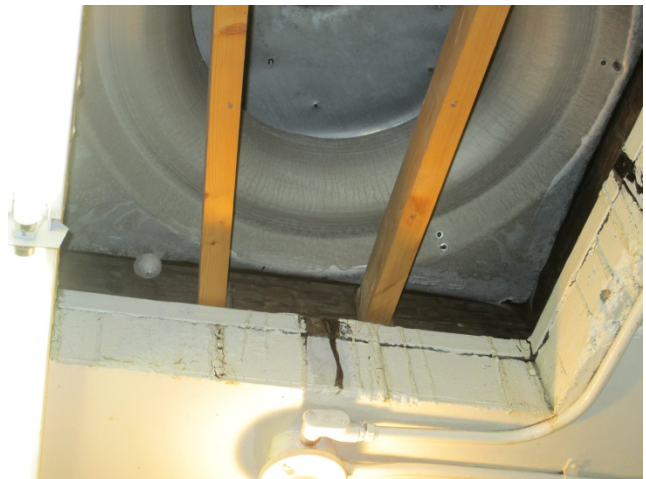
Photo 23: **Wildwood Bldg 8 – Access Hole to Ventilator to be Framed-in**

Photo 24: **Wildwood Bldg 8 – Access Hole to Ventilator to be Framed-in**

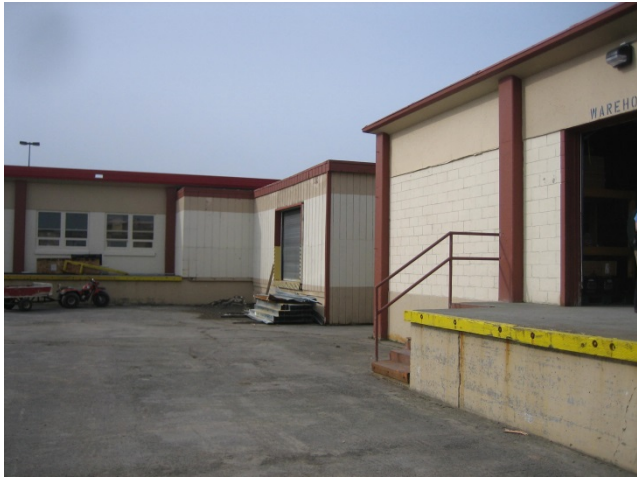
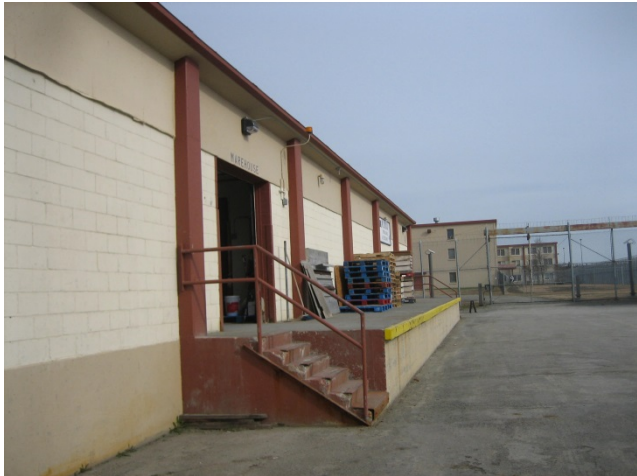
A loading dock runs the entire length of the east side of Building 8. The DOC desires a canopy over the garage door and exterior stairs at the south end of the loading dock that would protect the distance from the face of the building to a trailer being unloaded. Due to main vehicle entry gate limitations, the tallest reasonable size trailer to be designed around would be 11 feet above the loading dock.

Photo 25: **Wildwood Bldg 8 – Location of Proposed Canopy @ South End of Loading Dock**

Photo 27: **Wildwood Bldg 8 – Location of Proposed Canopy @ South End of Loading Dock**

A schematic design has been developed using steel columns and beams braced back to the face of the building. The canopy can be drained internally, and then tied back inside the building to the existing rain leaders, or scuppered to a downspout that would discharge at the face of the loading dock.

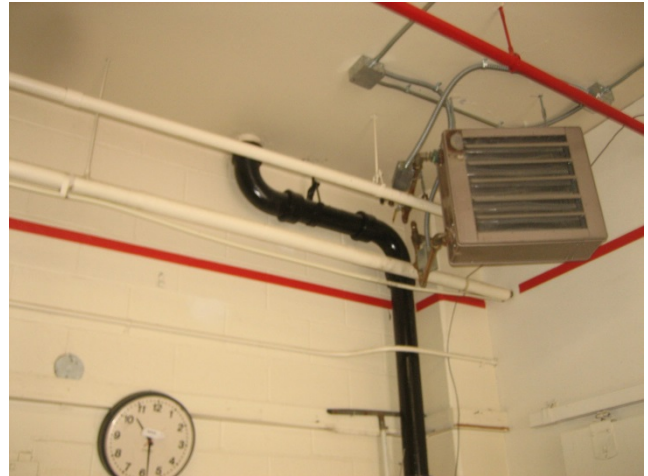
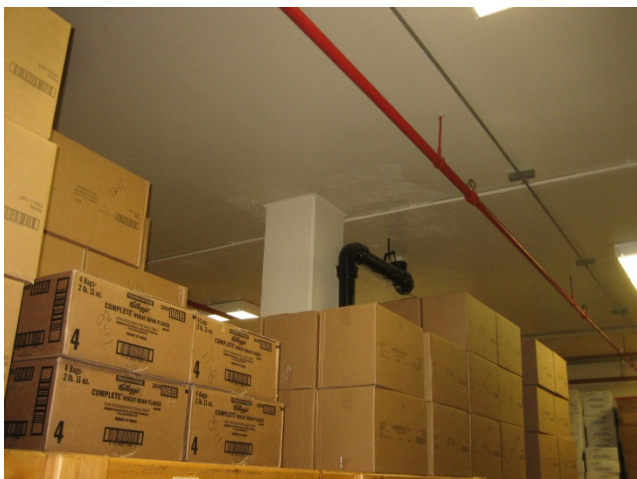
~~The internal rain leaders and conductors appear to have been replaced relatively recently, as they are constructed of ABS.~~ Each of the two rain leaders elbow toward the nearest internal building column and then elbow again down to run through the floor slab. Per the as-builts, the ceiling system is composed of cement asbestos board.

Photo 28: **Wildwood Bldg 8 – View of Existing Roof Drain**

Photo 29: **Wildwood Bldg 8 – View of Existing Roof Drain**

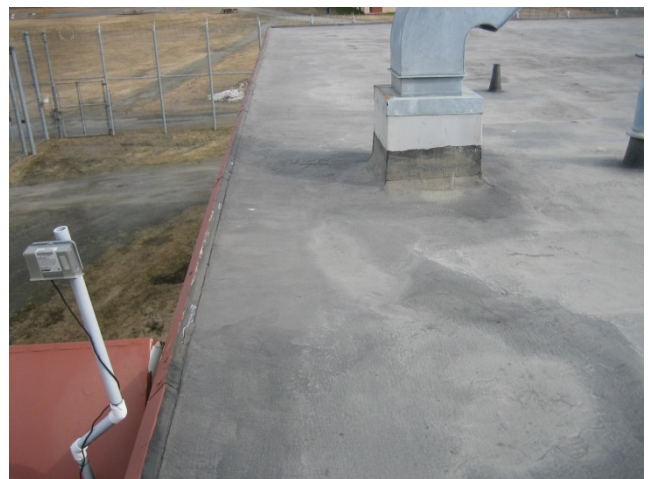
Photo 30: **Wildwood Bldg 8 – View of Existing Enstar Gas Co. Remote Sensor to be Moved by Others**
