HAZARDOUS BUILDING MATERIAL SURVEY REPORT

**4106 MENDENHALL BOULEVARD
JUNEAU, ALASKA**

OCTOBER 26, 2018

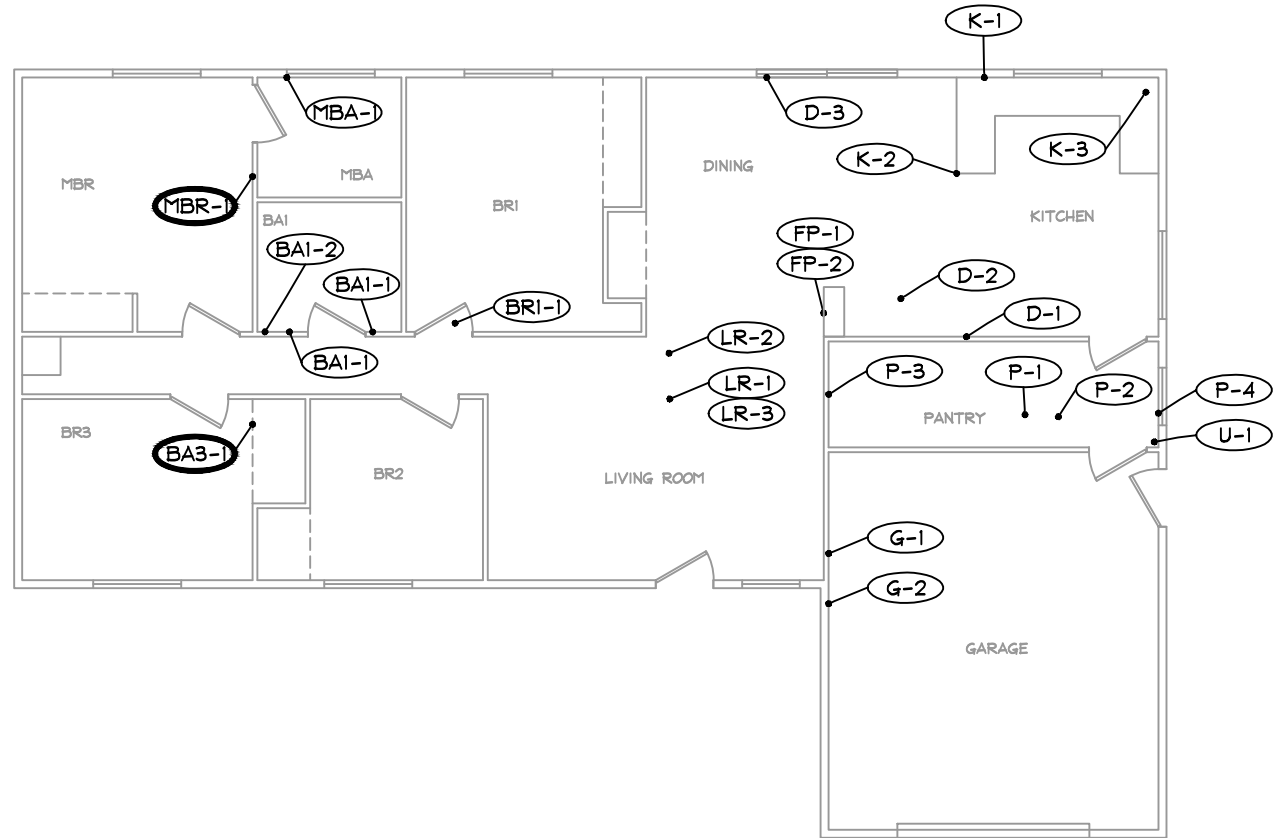
FIGURE
 3

Asbestos Results Data		
Surveyed by Nortech : October 2018		
Sample ID	Substrate	Asbestos
G-1	Drywall	ND
G-1	Joint Compound	ND
G-2	Plaster	ND
P-1	Tile	ND
P-1	Mastic	ND
P-2	Vinyl	ND
P-3	Drywall	ND
P-3	Joint Compound	ND
P-4	Vinyl	ND
U-1	Cove Base	ND
U-1	Mastic	ND
K-1	Joint Compound	ND
K-2	Formica	ND
K-2	Mastic	ND
K-3	Texture	ND
D-1	Mastic	ND
D-2	Vinyl	ND
D-3	Tape	ND
LR-1	Drywall	ND
LR-2	Joint Compound	ND
LR-2	Drywall	ND
LR-3	Joint Compound	ND
FP-1	Ceramic Tile	ND
FP-1	Mortar	ND
FP-1	Slate	ND
FP-2	Adhesive	ND
BA1-1	Drywall	ND
BA1-1	Joint Compound	ND
BA1-1	Texture	ND
BA1-2	Mastic	ND
BA1-3	Mastic	ND
BA1-3	Bead Board	ND
BR1-1	Carpet	ND
BR1-1	Pad	ND
BA3-1	Tile	3%
BA3-1	Mastic	ND
MBA-1	Mastic	ND
MBA-1	Bead Board	ND
MBR-1	Tile	4%
MBR-1	Mastic	ND
R-1	Black Patch	ND
R-2	Green Shingle	ND
R-3	Tar	ND
R-3	Brown Shingle	ND
R-# = Roof Sample		
ND = None Detected

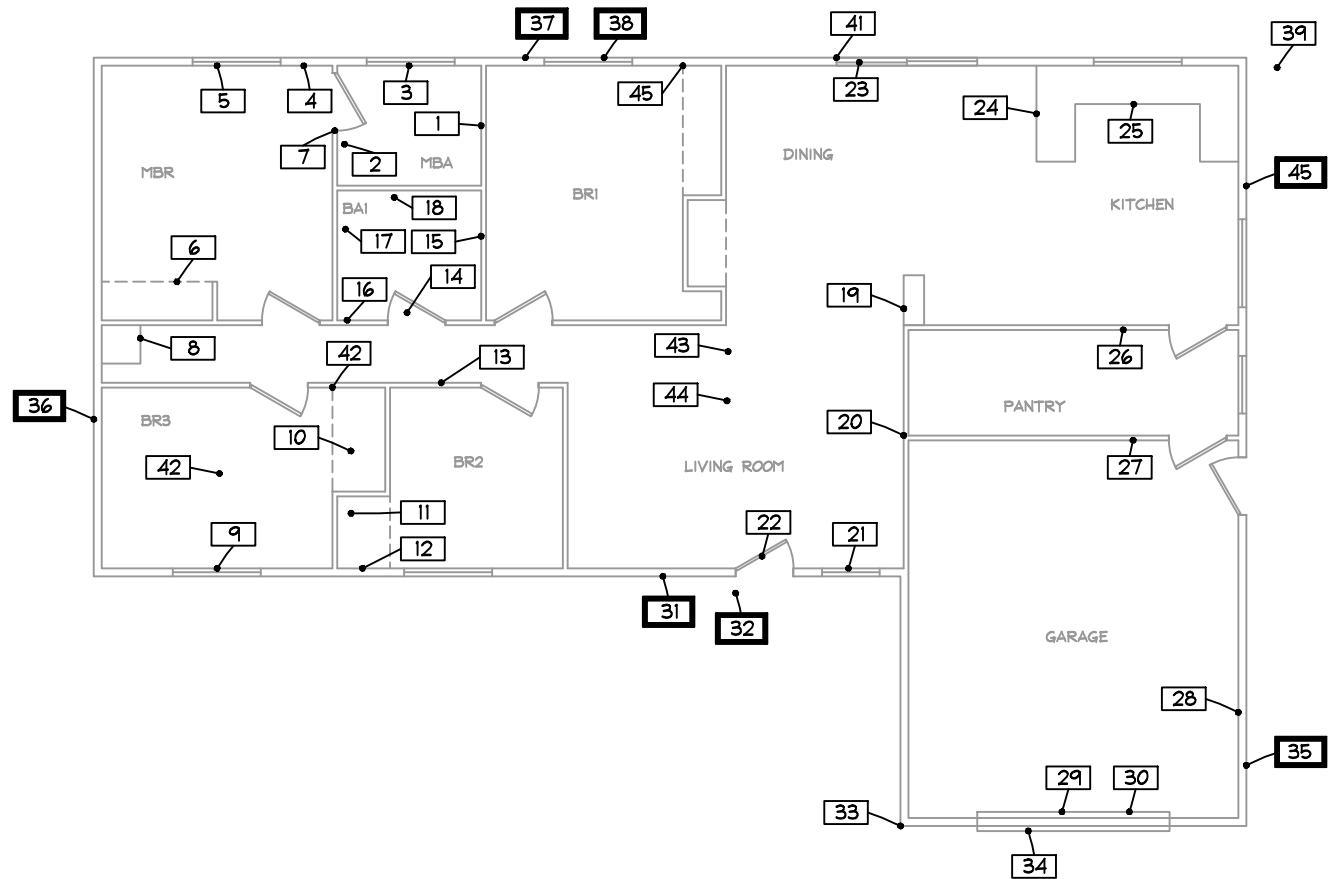
Lead Result Data		
Surveyed by Nortech : October 2018		
Sample ID	Description	Lead
1	Wall	0.0
2	Floor	0.0
3	Window Frame	0.0
4	Wall	0.1
5	Window Frame	0.9
6	Closet Door	0.0
7	Door Frame	0.0
8	Wall	0.0
9	Window Frame	0.0
10	Shelving	0.0
11	Shelving	0.0
12	Wall	0.0
13	Wall	0.0
14	Floor	0.01
15	Bead Board	0.0
16	Baseboard	0.0
17	Shower	0.68
18	Under Sink Wall	0.12
19	Tiles	0.0
20	Baseboard	0.08
21	Wall Paneling	0.0
22	Door	0.0
23	Door	0.0
24	Counter	0.0
25	Under Sink Tile	0.0
26	Cabinet	0.0
27	Wall	0.0
28	Shelving	0.0
29	Door	0.0
30	Door Joints	0.0
31	Exterior Wall	3.9
32	Under Roof	2.9
33	Exterior Trim	0.5
34	Exterior Door	0.0
35	Exterior Wall	2.8
36	Exterior Wall	3.7
37	Exterior Wall	2.4
38	Exterior Window Trim	1.3
39	Exterior Fencing	0.0
41	Exterior Door Frame	0.0
42	Ceiling	0.0
43	Ceiling	0.0
44	Ceiling	0.0
45	Exterior Wall	1.6

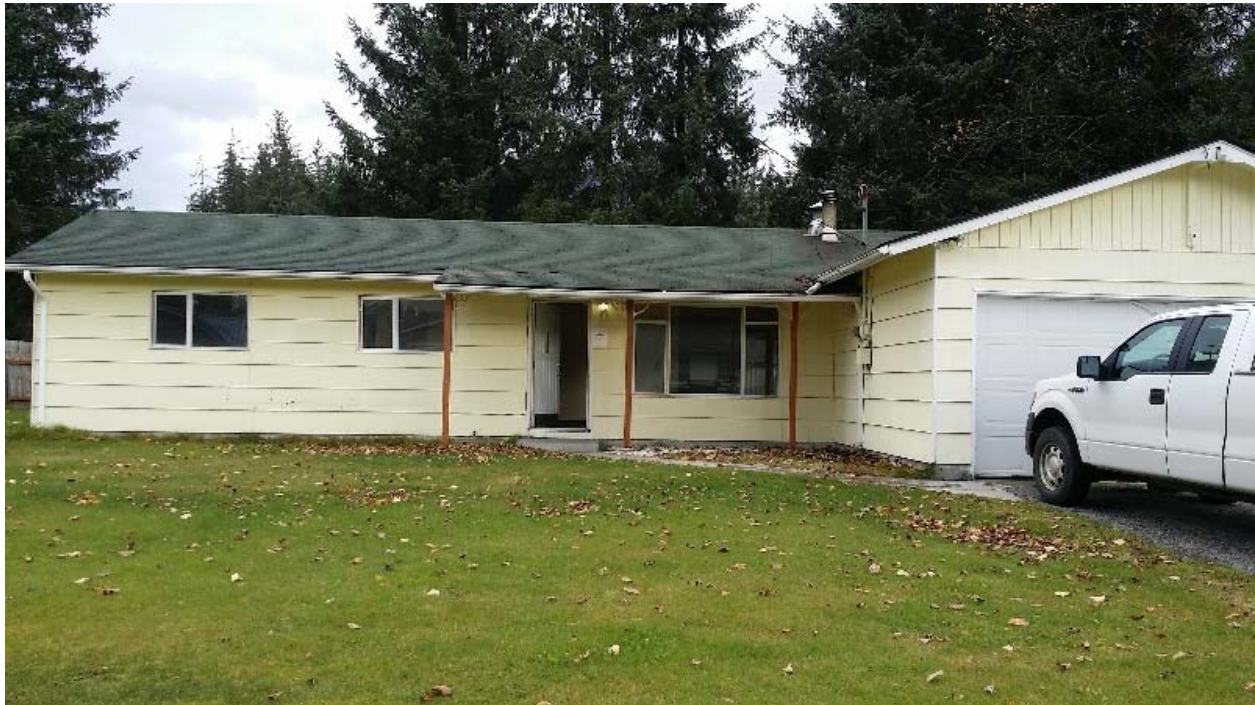
Photo 1: Lead-based paint was identified on the exterior of the house in the main exterior color (yellow), the white-trim, and a section of purple-brown paint.

- Demolition workers should be advised of the presence of lead paint on the building's exterior
- Due to the limited nature of lead containing materials on Site, a hazardous materials contractor is not needed to remove tiles or paint containing lead above HUD Standards

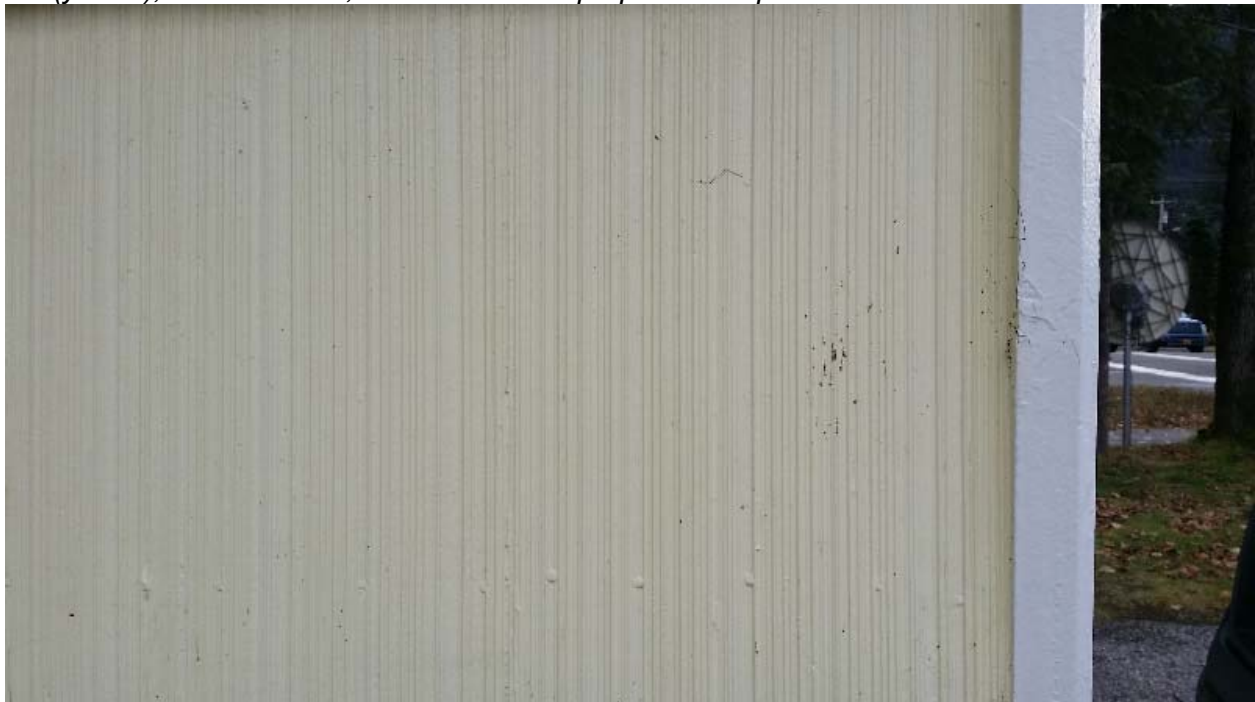
Photo 2: The yellow exterior paint had a lead concentration of 3.9 ppm, and the white trim had a lead concentration of 2.9.

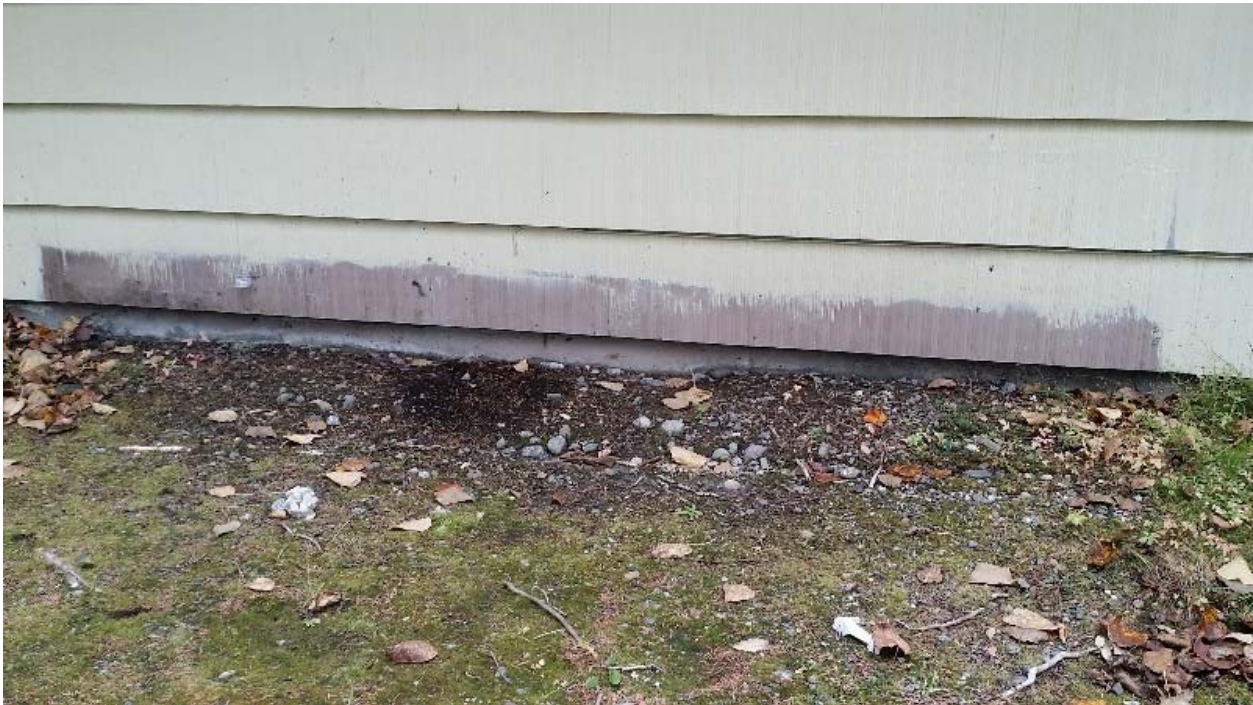
Photo 3: The area of purple-brown paint with a lead concentration of 1.6 is located near the sliding back door.

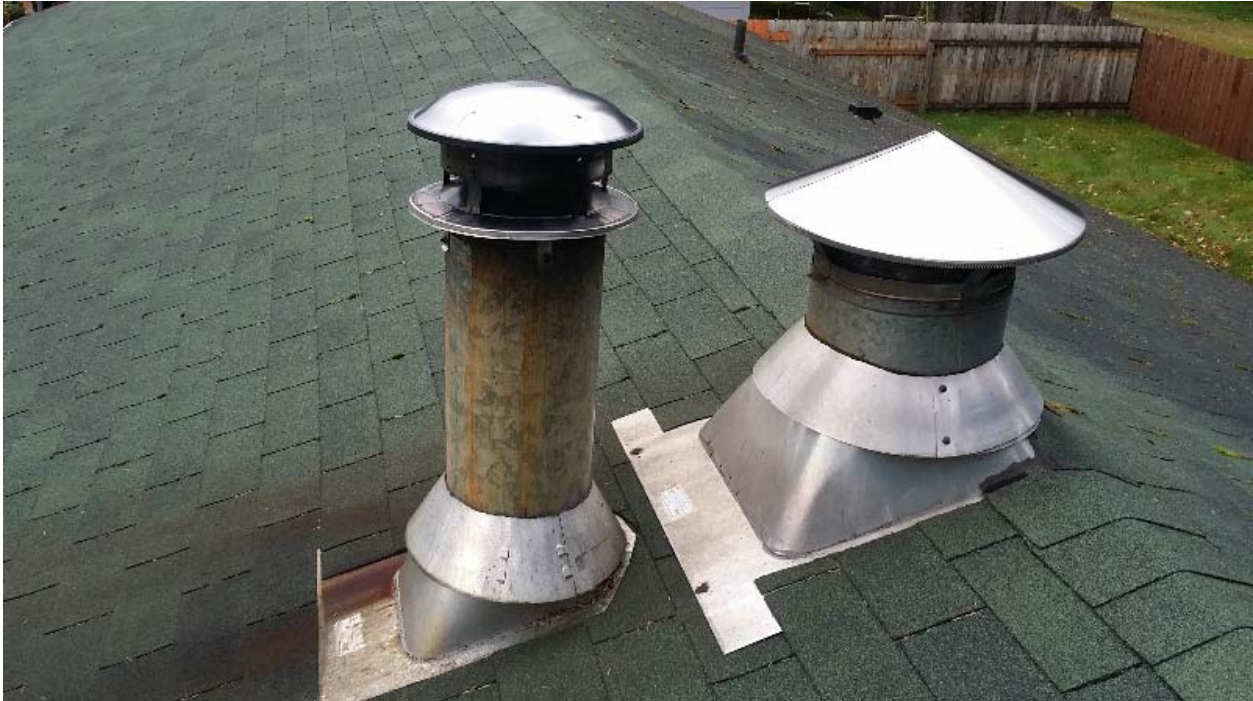
Photo 4: Both chimney pipes had plaques identifying them as asbestos-containing pipes and are considered Non-Friable Category II ACM.

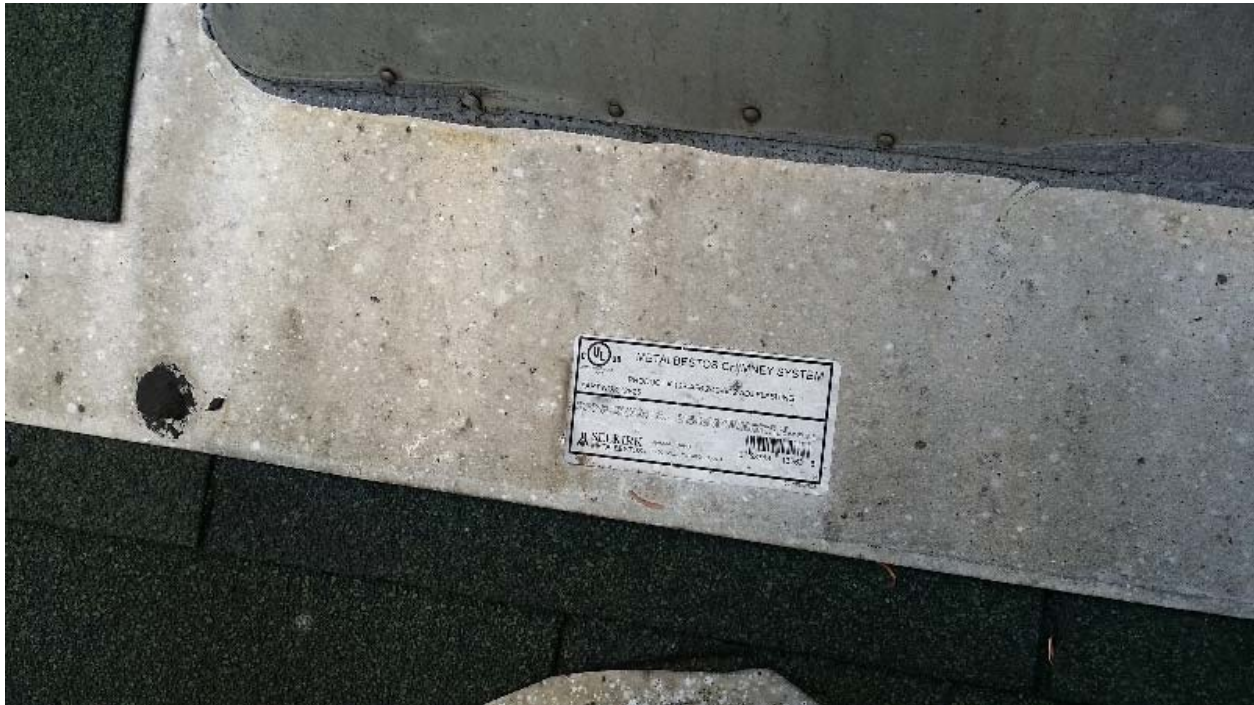
Photo 5: NORTECH did not collect a sample of the chimney pipe segments as both chimneys contain labels indicating they contain asbestos.

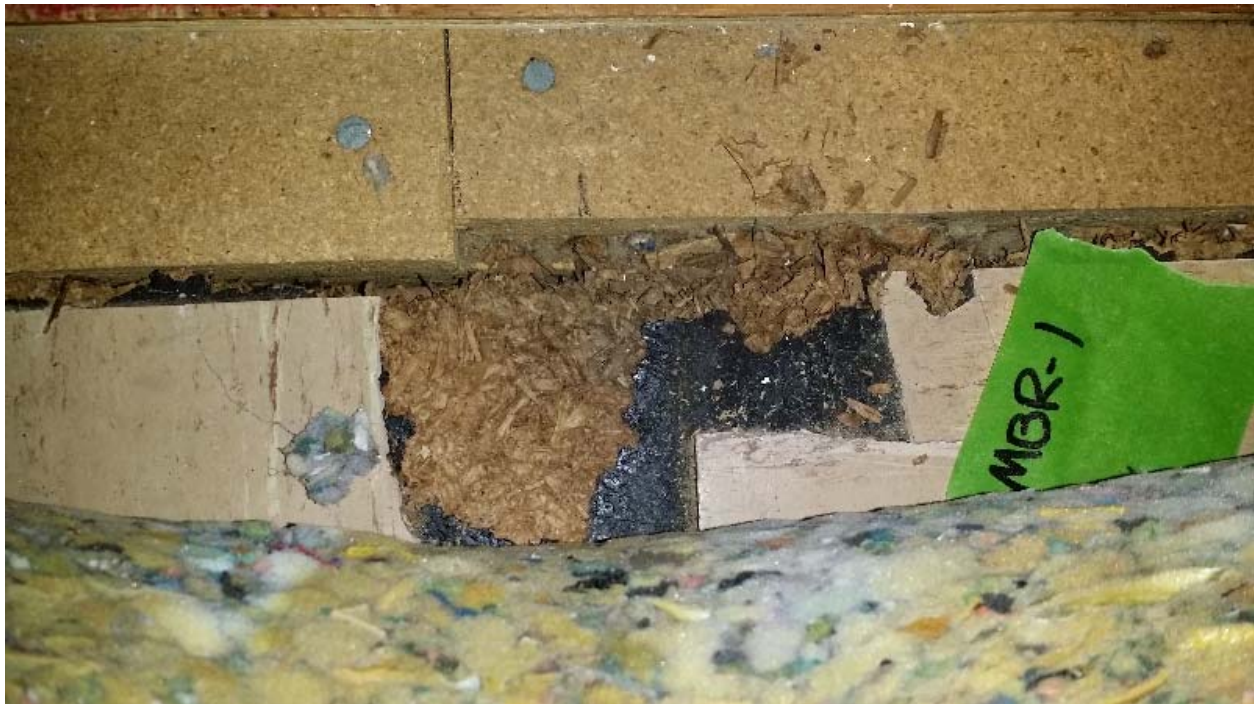
Photo 6: The light brown vinyl flooring under the carpet in the Master Bedroom contained 4% Chrysotile asbestos.

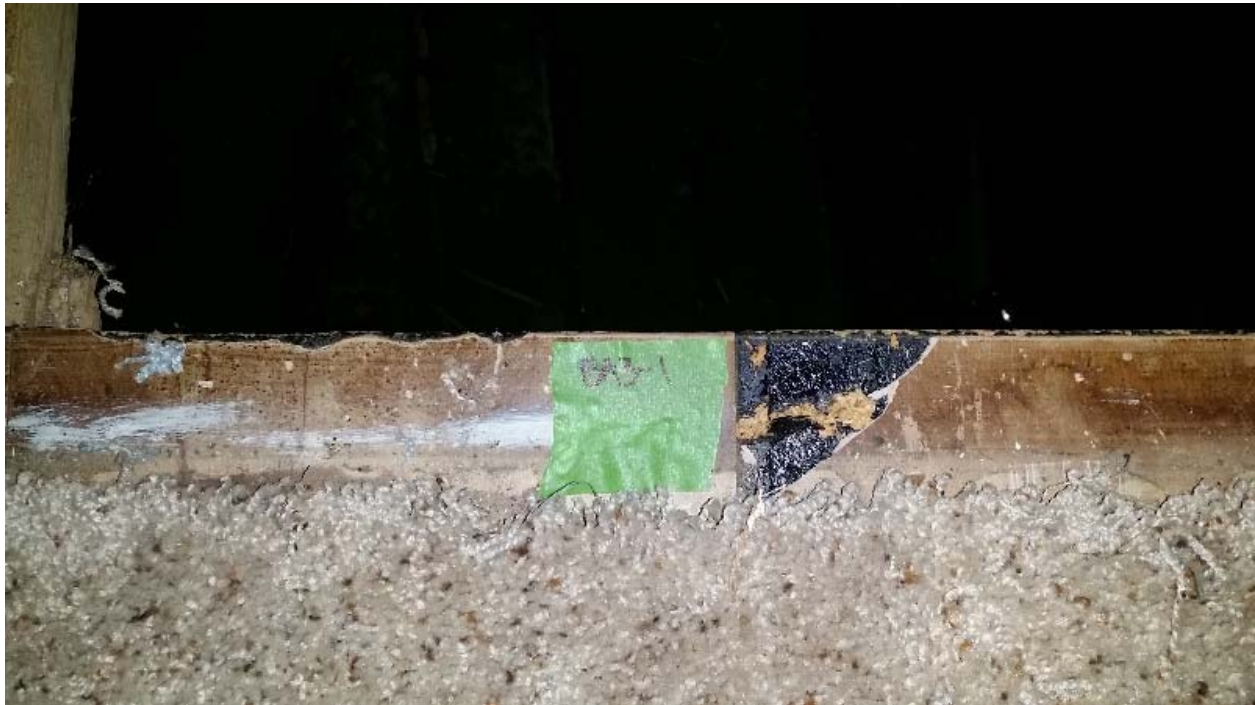
Photo 7: The dark brown vinyl flooring under the carpet in Bedroom 3 contained 3% Chrysotile asbestos.

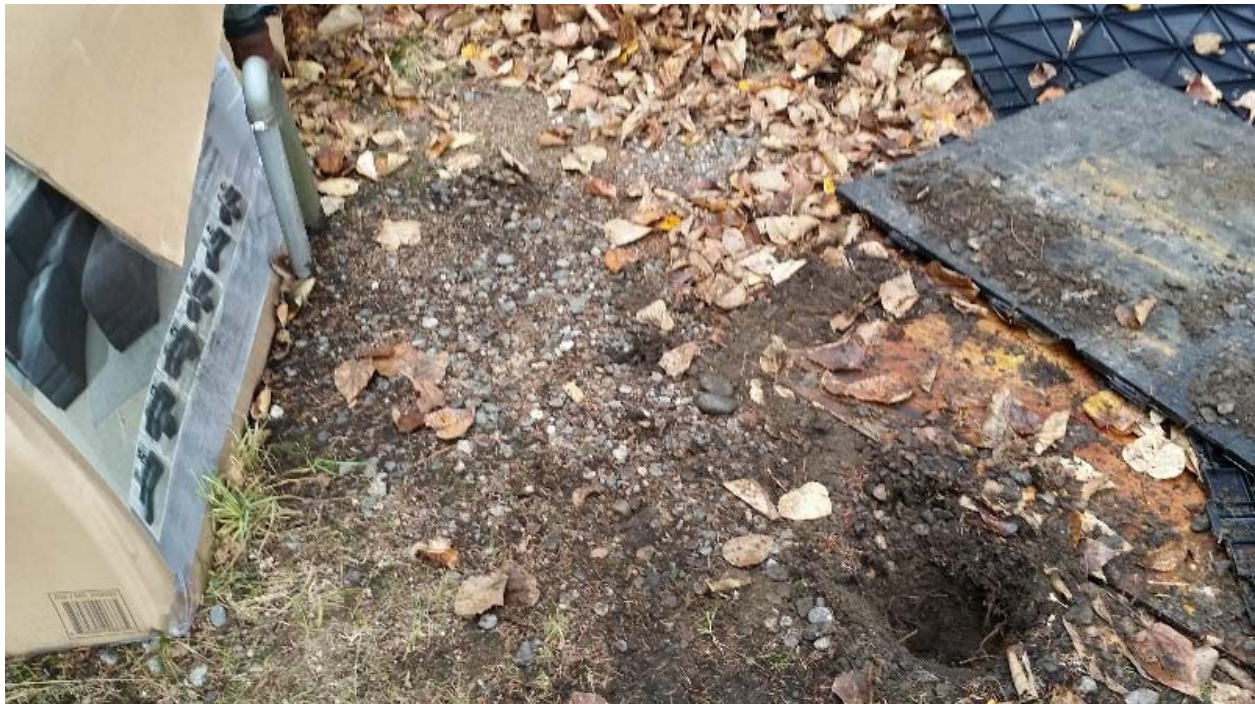
NORTECH noted an underground storage tank (UST) was present on the eastern side of the residence (Photo 8, Appendix 2). Mr. Michael Schular (ADOT&PF) indicated the UST contained fuel at the time of the survey, but the remaining fuel would be pumped from the tank as soon as possible. **NORTECH** did not observe evidence that the tank or associated piping was leaking, and no signs of previous leaks within the boiler room were observed. Indications that a slight overfill of the tank had occurred in the past (elevated field screening readings on surface soils near the fill tank that diminished with depth), but an assessment of the UST was not within the scope of the project and therefore was not conducted.

- An UST is located on the eastern side of the residence
 - The tank's condition is unknown
 - No visible signs of leaking from the tank or associated piping was observed
 - An assessment of the UST was beyond the scope of the project

Photo 8: NORTECH noted a UST was present on the eastern side of the residence.

Mr. Schular also indicated the UST would be removed prior to planned ADOT&PF road construction activities. **NORTECH** recommends looking for signs of previous or ongoing leaks from the UST during tank excavation activities (stained soils, soils that smell of diesel, visible holes in the UST).

- ADOT&PF has plans to remove the UST prior to road construction activities
 - The tank should be pumped of any remaining fuel
 - Tank piping should be drained and removed
 - Tank should be excavated
 - If evidence of a leak (fuel odor, sheen on water) is found, the leak should be reported immediately to the Alaska Department of Environmental Conservation
 - If this occurs, an environmental contractor should oversee the remaining tank excavation and remediation activities
