**Alaska Department of Environmental Conservation  
Village Safe Water Program  
Proposal Form**

Proj No.....: VSW-MTM-2019-37  
Project Title.....: Design Services  
City.....: Metlakatla, Alaska

**Request for Statement of Qualifications**  
**VSW-MTM-2019-37**

## *DISINFECTION BYPRODUCT REDUCTION AND PIPE CORROSION*

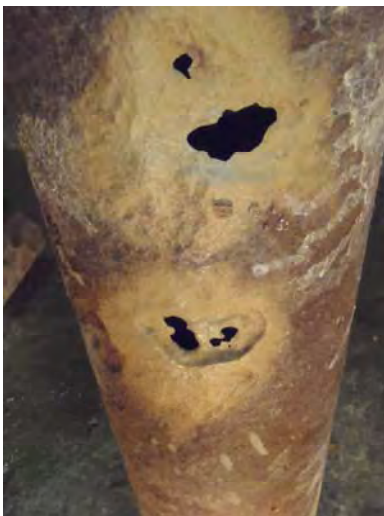
External examinations revealed significant and extensive corrosion along the bottom of pipe. While the top of pipe was always found to be in fair to good condition, the bottom of pipe was found to have isolated and large scale pitting prevalent throughout. In many instances this pitting was observed to be 6 inches to 12 inches in diameter with through-hole penetrations located in the deepest valleys. Discussion with the Public Works crew indicated that the majority of through-hole penetrations were found to be where the pipe was in direct contact with muskeg or other organic material. This information, coupled with the overwhelming extent of the bottom side external corrosion was determined to be the primary corrosion mechanism resulting in the previous failures.

**Figure 1** – Extensive metal loss and through-hole penetrations evident on the bottom exterior of a previously removed section of Trailer Court water distribution DIP.

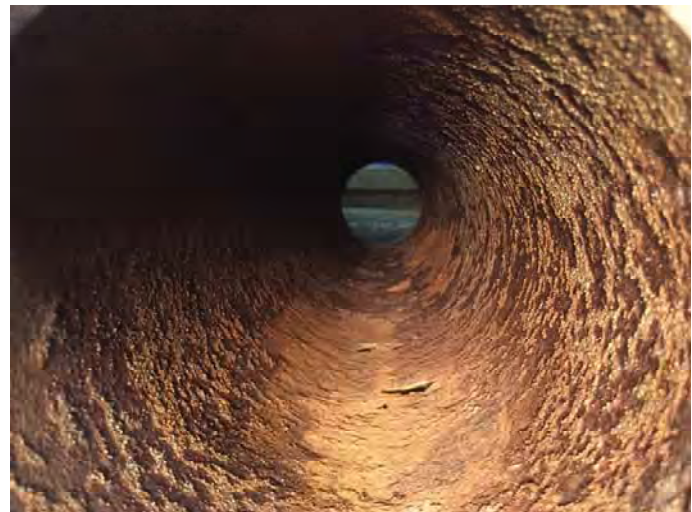
**Figure 2** – Typical internal pipe surface exhibiting only minor interior metal loss, light pitting and externally produced through-hole penetrations.

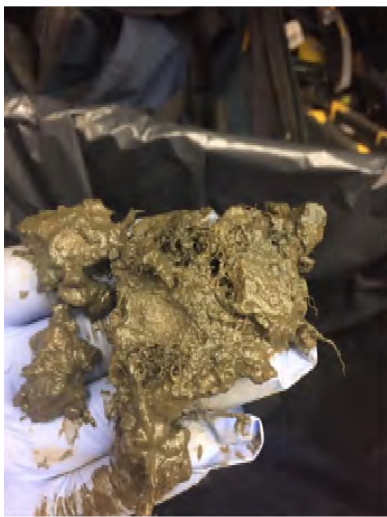
Flowing groundwater and wood cribbing were also encountered at this location. Groundwater was encountered at the top-of-pipe depth (3.5 feet below grade). Wood cribbing was removed and the piping examined for possible corrosion at the contact point.

**Figure 3** – Typical organic material collected from around the pipe at Dig Site #2.

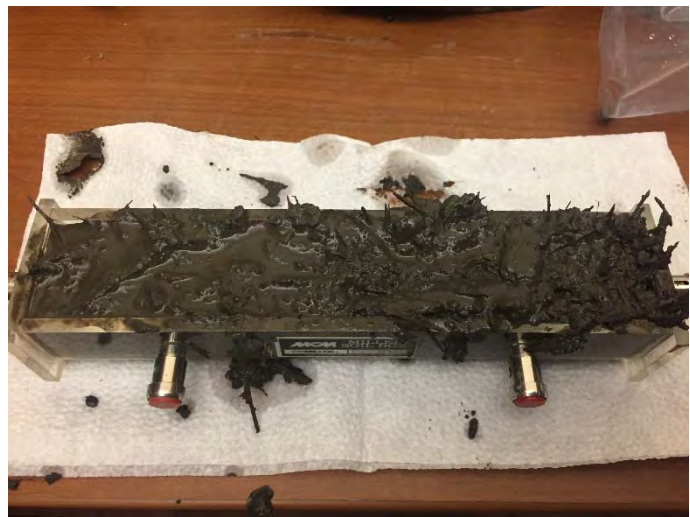
**Figure 4** – Typical backfill material collected from Dig Site #3 featuring heavy quantities of wood debris and organic material.

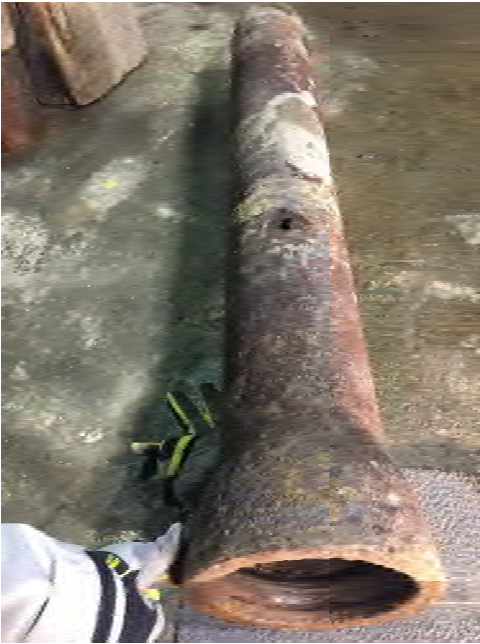
PHOTO B1: 1/26/17 – Previously removed section of New Trailer Court Area piping (bell & spigot joint) exhibiting external bottom-of-pipe pitting and associated through-hole corrosion.

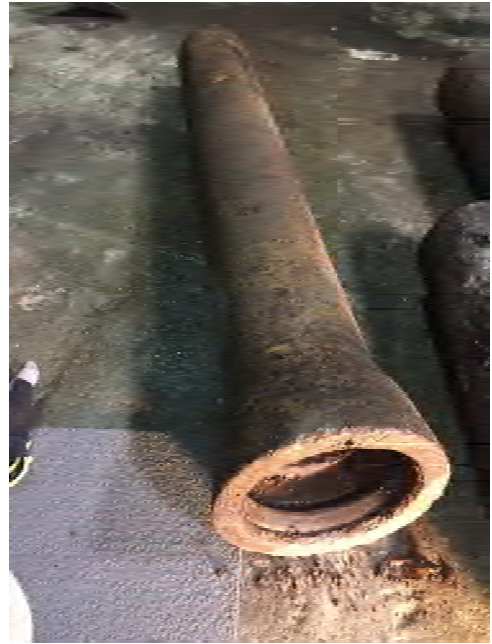
PHOTO B2: 1/26/17 – Previously removed bell & spigot pipe segment showing generally good top-of-pipe condition.

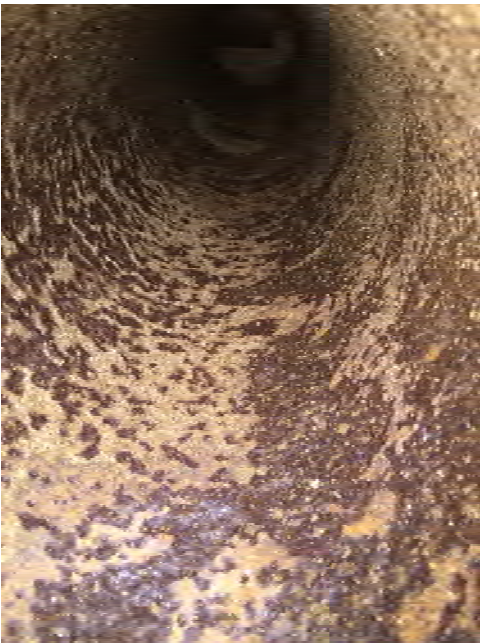
PHOTO B3: 1/26/17 – Typical internal condition of replaced piping segment exhibiting only minor wall loss and surface corrosion with random locations of light pitting (10 to 20 mils).

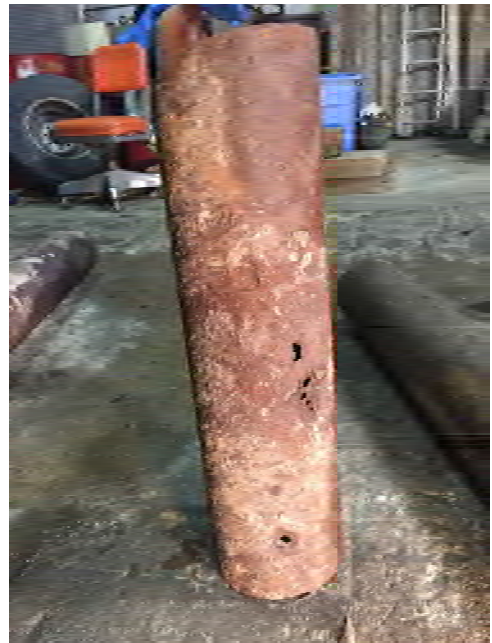
PHOTO B4: 9/13/15 – Another segment of previously removed Trailer Court piping from a separate repair area. Photo shows extensive bottom-side (external) wall loss and through-hole penetrations.

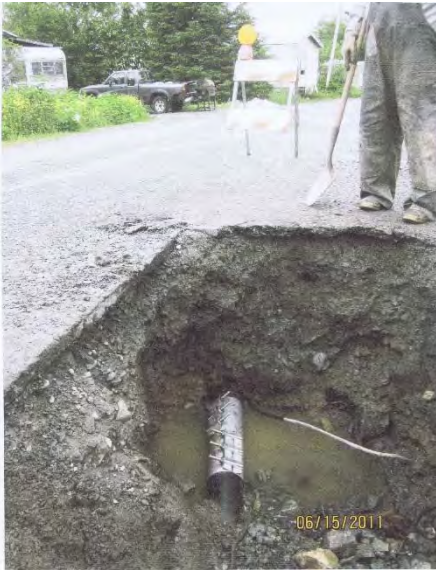
PHOTO B5: Photo of insitu pipe segment prior to 2011 removal/replacement. Organic matter and debris evident around pipe. (Photo provided by Metlakatla Public Works Department.)

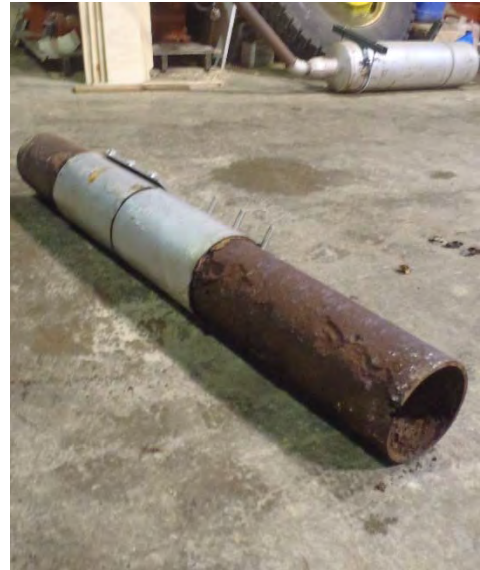
PHOTO B6: 1/26/17 – Same segment of pipe examined after previous removal (see Photo B5). Heavy external pitting and wall loss (bottom-of-pipe) noted prior to removing clamps.

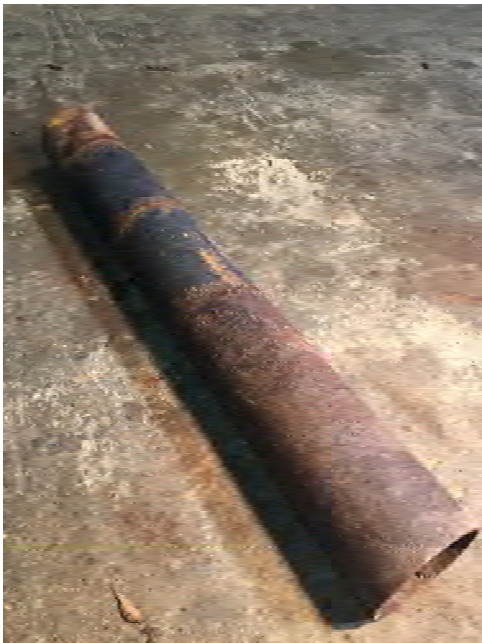
PHOTO B7: 1/26/17 – Previously removed double-clamp segment after removal of clamps. Top-of-pipe in relative good condition.

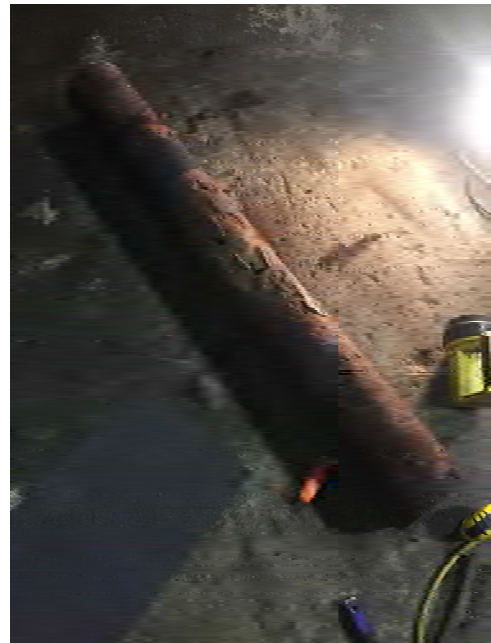
PHOTO B8: 1/26/17 – Bottom-of-pipe view of previously removed double-clamp pipe segment. Extensive external corrosion and through-hole penetrations evident beneath former clamp area.

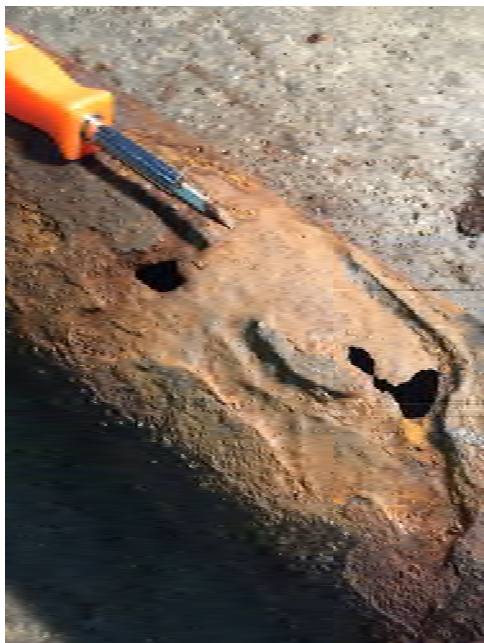
PHOTO B9: 1/26/17 – Close-up of previously removed double-clamp segment showing extensive external corrosion and failed factory asphaltic coating.

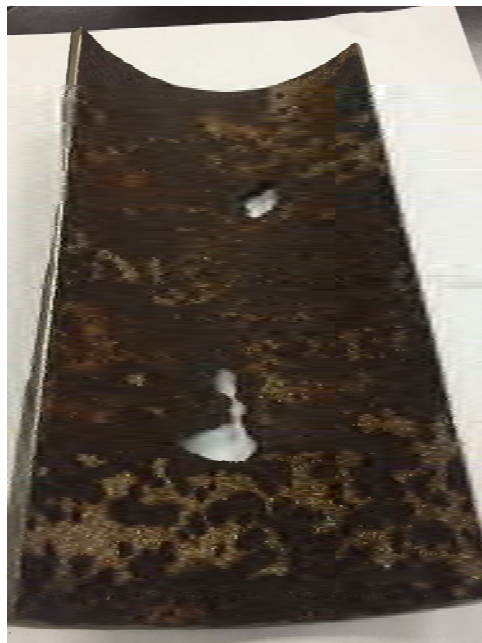
PHOTO B10: 2/4/17 – Coupon cut-out of previously removed double-clamp pipe segment showing relative good condition of internal pipe surface with only minor wall loss noted.

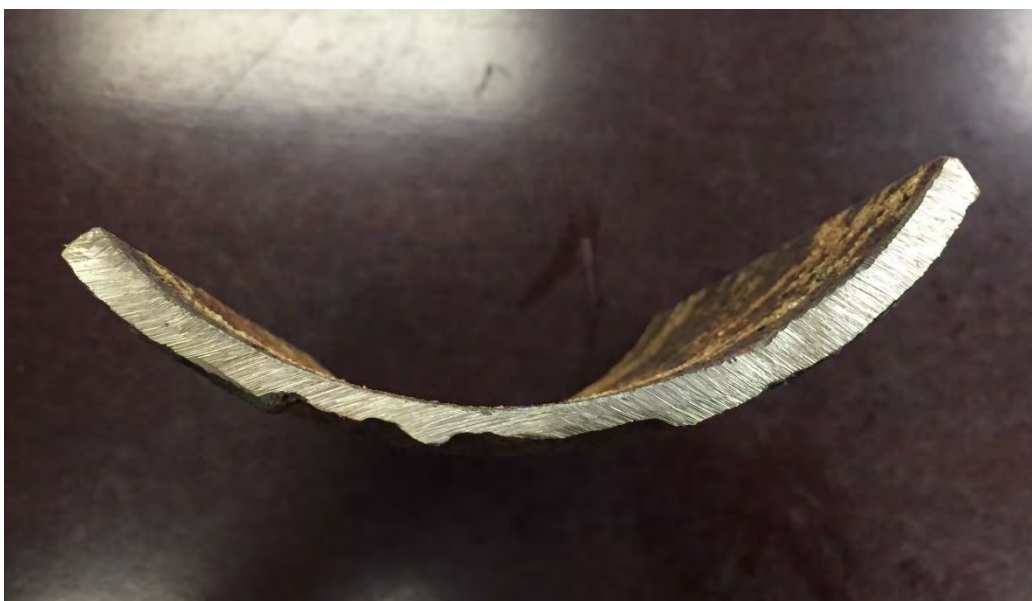
PHOTO B11: 2/4/17 – End view of double-clamp pipe segment coupon cut-out showing heavy external wall loss with relatively little internal loss.

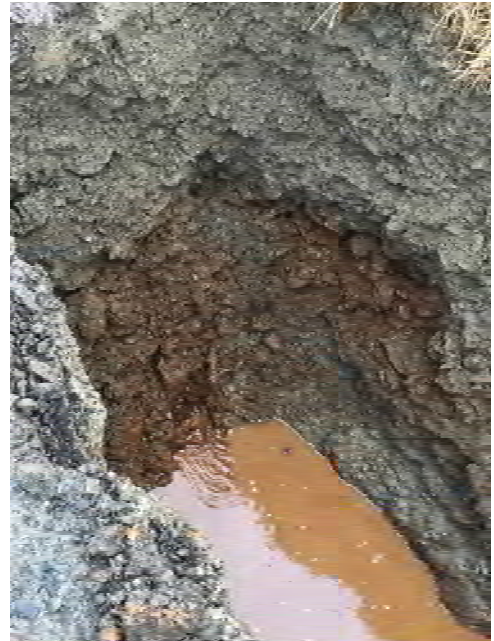
PHOTO B13: 1/26/17 – Dig Site #1 flowing water encountered at the approximate 4' depth.

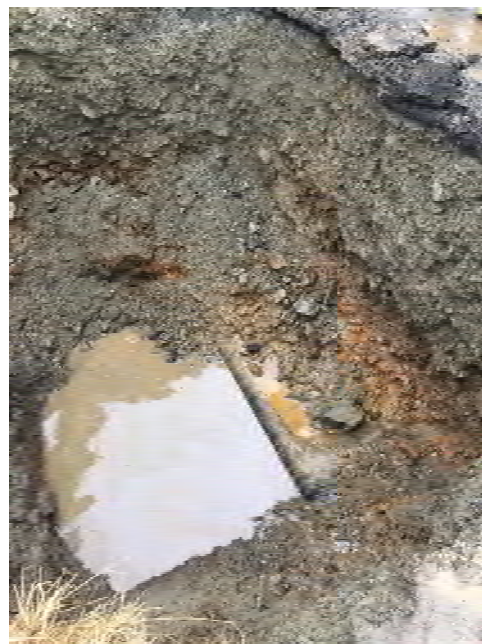
PHOTO B14: 1/26/17 – Dig Site #1 pipe exposure showing surrounding soil conditions with portions of clay and organic matter evident at pipe depth (~5.5' below grade).

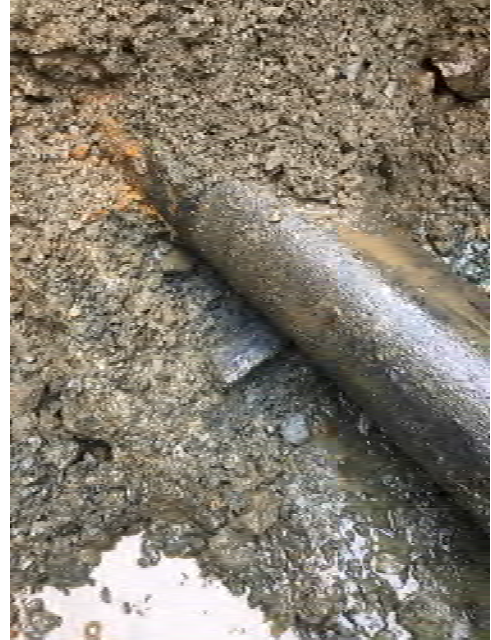
PHOTO B16: 1/27/17 – Pipe exposure at Dig Site #2 showing wood support cribbing beneath pipe and corrosion staining leaching through asphaltic coating at dig limit.

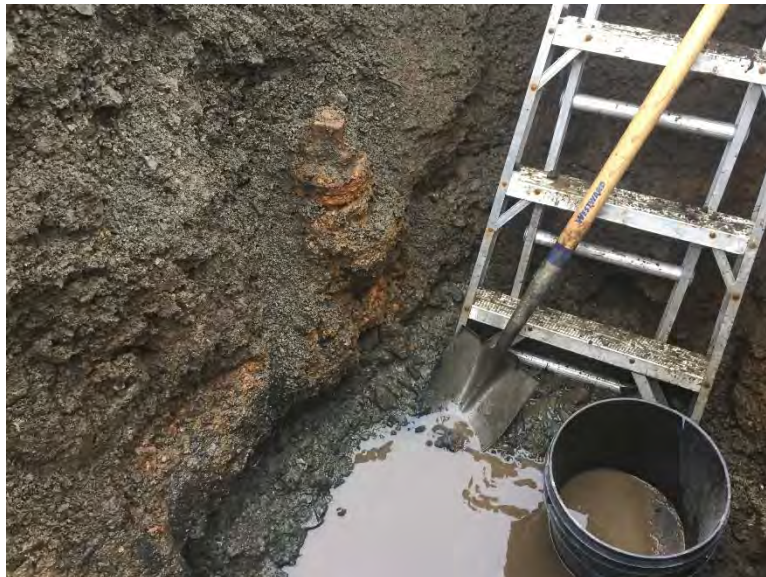
PHOTO B17: 1/26/17 – Previously unknown shut-off valve (functional) encountered at the Dig Site #2 location. Corrosion staining, moderate organic material and possible MIC bacteria residue present around pipe.

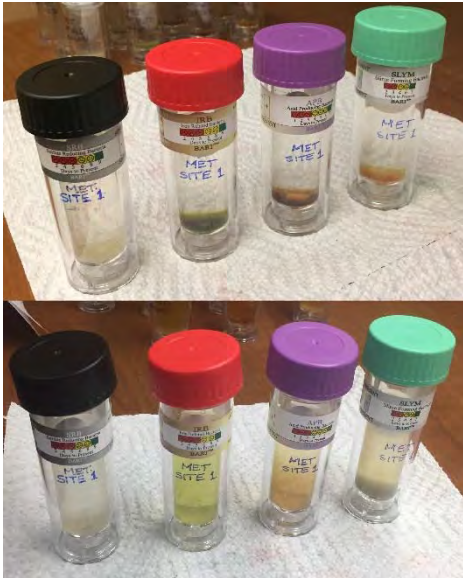
PHOTO B21: 2/21/17 – Dig Site #1 BART water sample comparison showing activation conditions (top) and 6-day incubation conditions (bottom). Sample test positive for corrosion causing iron reducing bacteria (IRB), acid producing bacteria (APB) and slime producing bacteria.

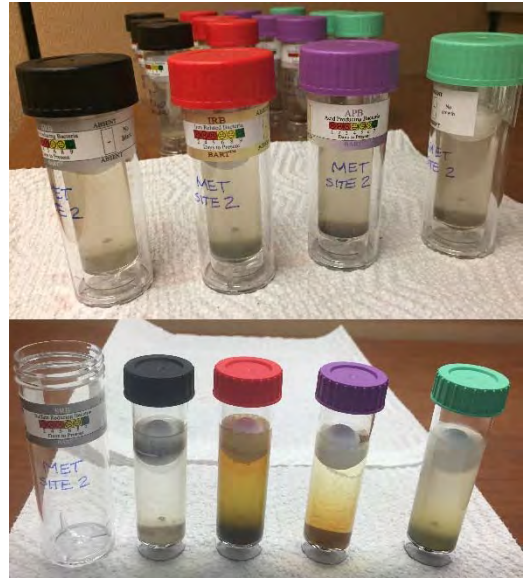
PHOTO B22: 2/21/17 – Dig Site #2 BART water sample comparison showing activation conditions (top) and 6-day incubation conditions (bottom). Sample tests positive for corrosion causing sulfate reducing bacteria (SRB), IRB, APB and slime producing bacteria.

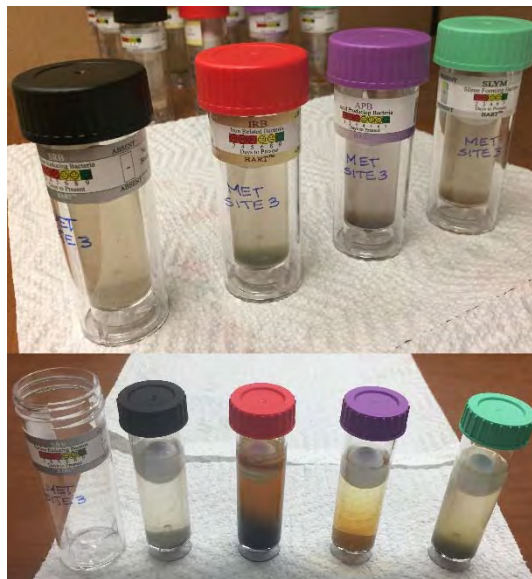
PHOTO B22: 2/21/17 – Dig Site #3 BART water sample comparison showing activation conditions (top) and 6-day incubation conditions (bottom). Sample tests positive for corrosion causing SRB, IRB, APB and slime producing bacteria.
