ADDENDUM #2
TO THE INVITATION FOR BIDS
For
Kodiak Courthouse: Interior Renovations
PROJECT #C-19-0001

ALASKA COURT SYSTEM
KODIAK COURTHOUSE INTERIOR RENOVATIONS
PROJECT C-19-001
KODIAK, ALASKA

Asbestos: Findings and Recommendations

SITE PHOTOS

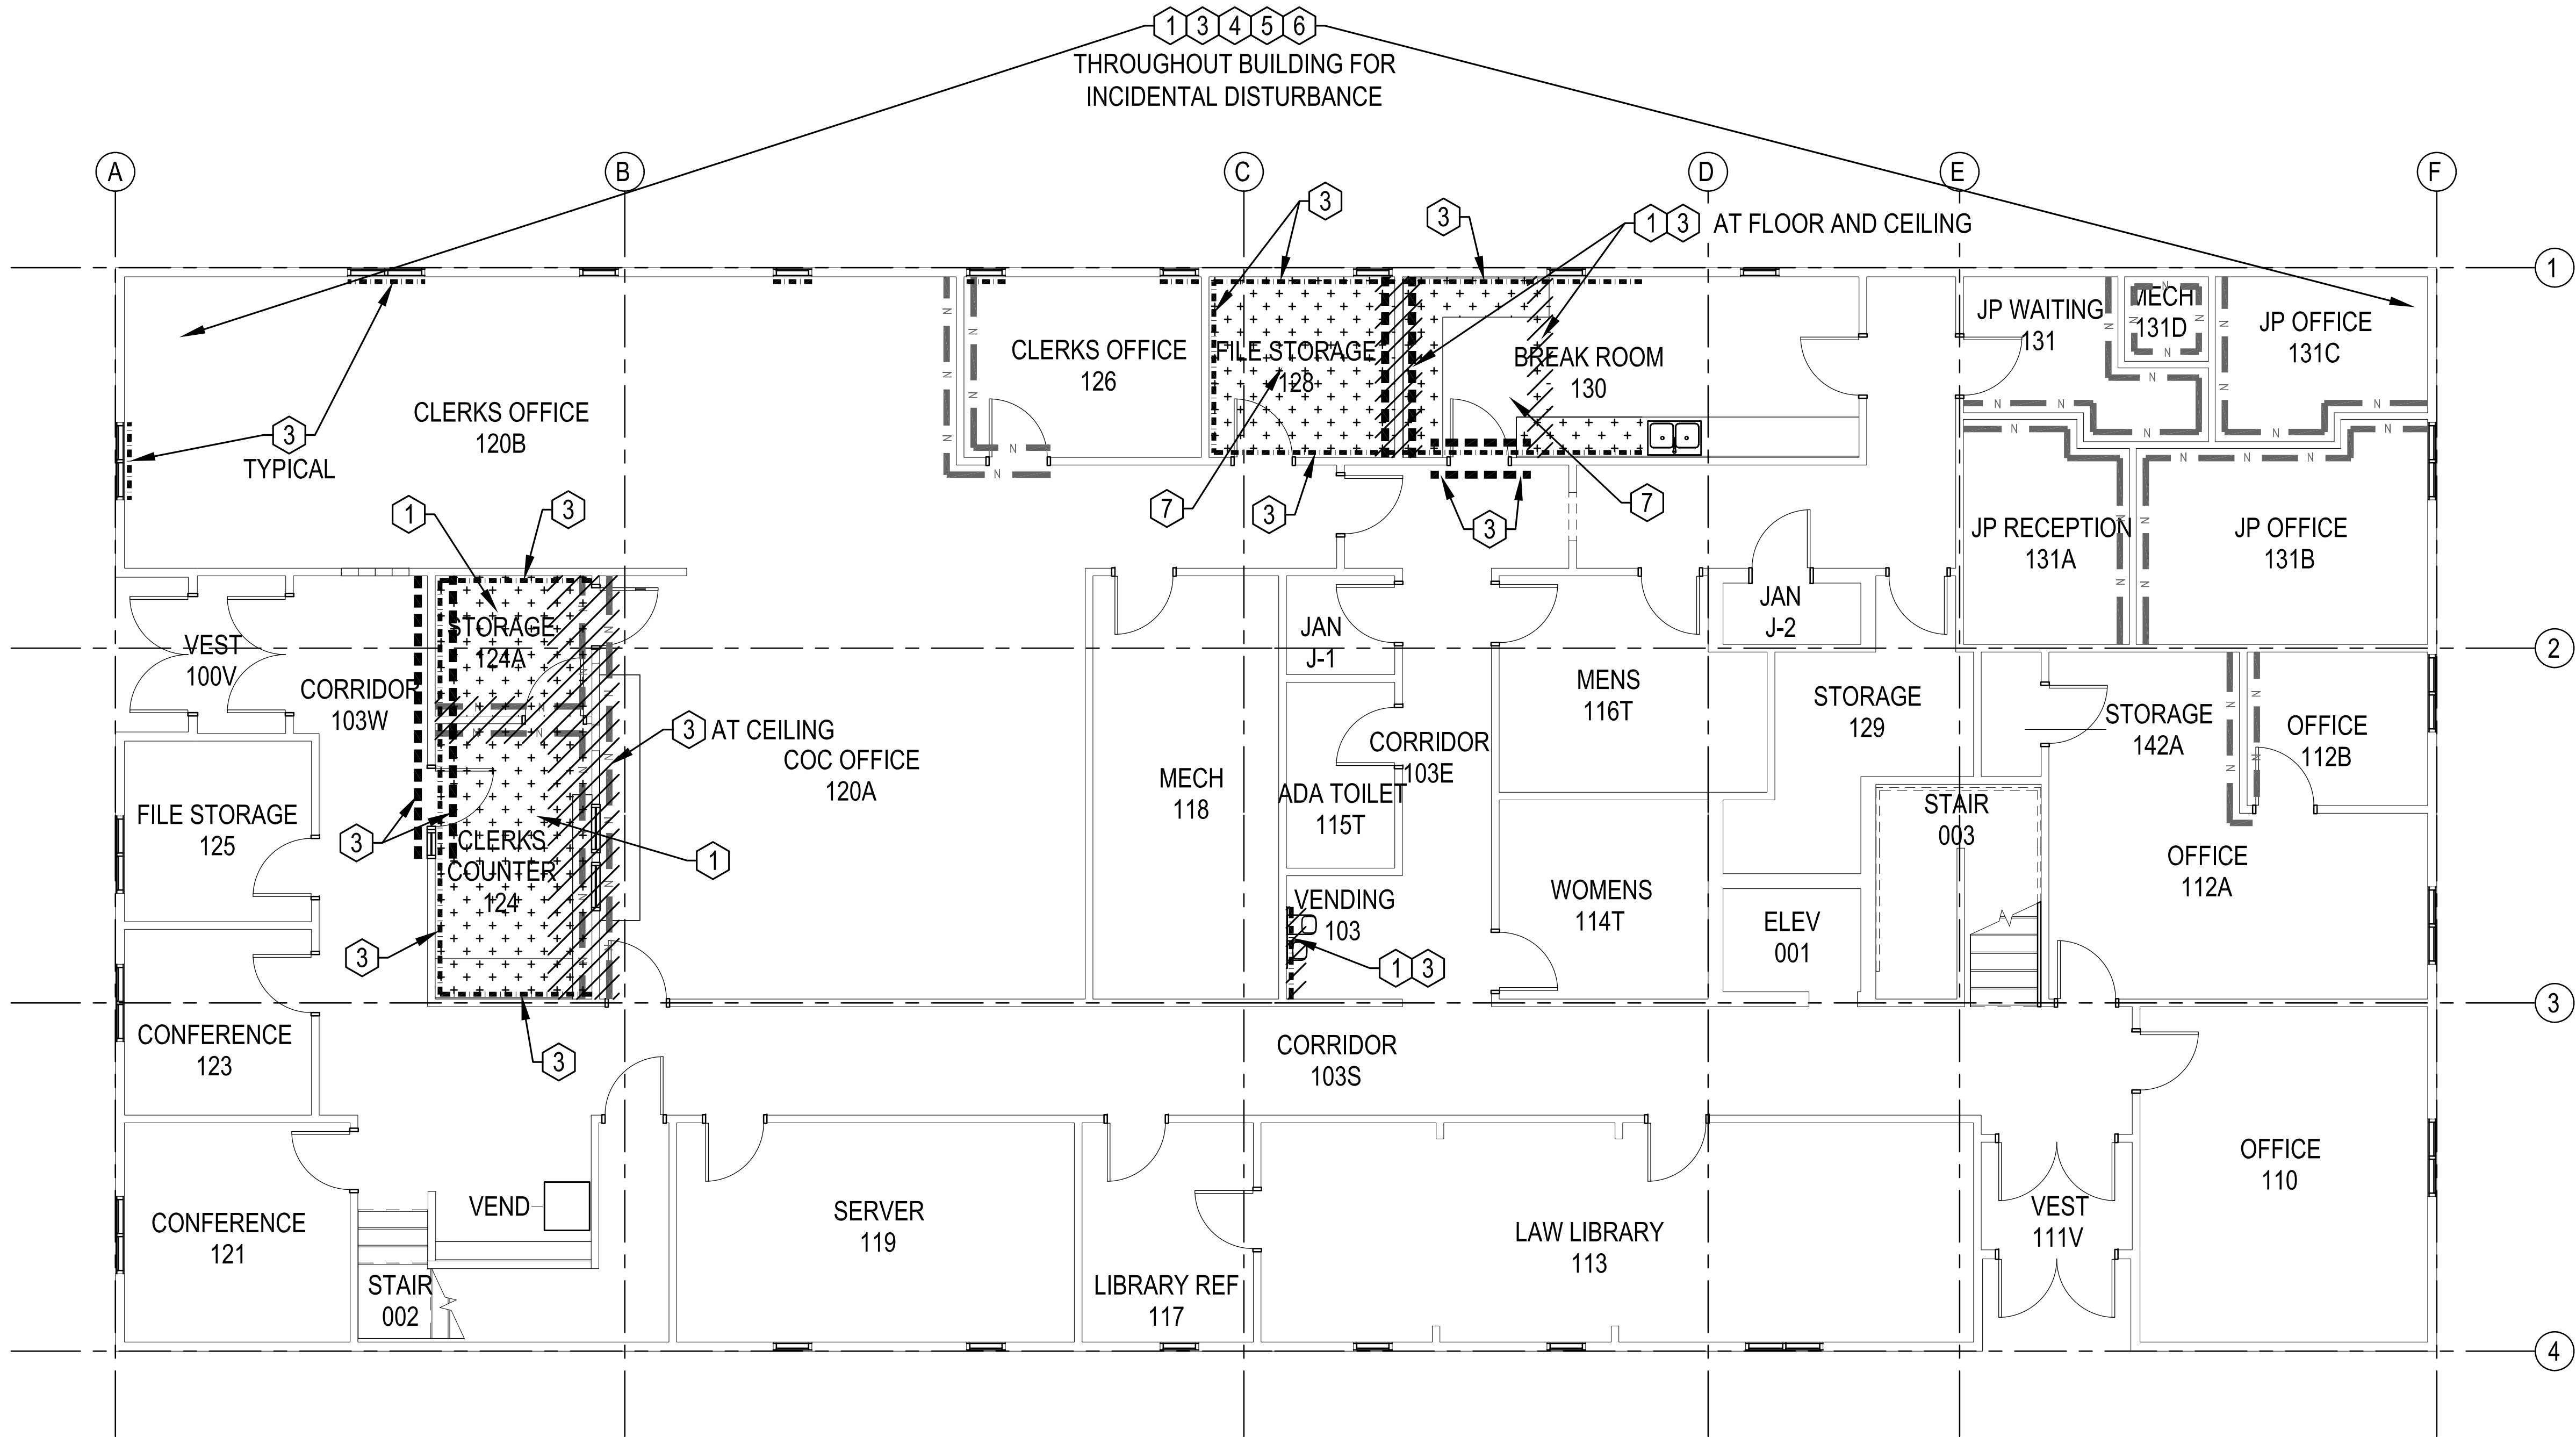
1 HAZARDS ABATEMENT - FIRST FLOOR
H101 FULL SIZE: 3'10" = 1'-0" HALF SIZE: 3'32" = 1'-0"

- 550* SQUARE FEET OF GYPSUM WALL BOARD WALLS WITH ASBESTOS-CONTAINING JOINT COMPOUND, SKIM COAT AND QUESTIONED "ASBESTOS-CONTAINING" COVE BASE MASTIC TO BE REMOVED.
- 150* SQUARE FOOT ALLOWANCE OF GYPSUM WALL BOARD CEILINGS WITH ASBESTOS-CONTAINING JOINT COMPOUND, SKIM COAT TO BE REMOVED.
- 95\$ LINEAR FEET OF QUESTIONED "ASBESTOS-CONTAINING" COVE BASE MASTIC TO BE REMOVED, ALONG WITH ANY LOOSE ASBESTOS-CONTAINING JOINT COMPOUND, AND SKIM COAT. WALL TO BE CLEANED AND PREPARED SO THAT NO FURTHER DISTURBANCE OF ASBESTOS-CONTAINING MATERIALS IS NEEDED TO INSTALL NEW COVE BASE OR OTHER WORK.
- 4 EACH FIXTURES WITH ASSUMED PCB-CONTAINING BALLASTS AND 8 MERCURY-CONTAINING LAMPS TO BE REMOVED.
- 2 EACH FIXTURES WITH ASSUMED PCB-CONTAINING BALLASTS AND 4 MERCURY-CONTAINING LAMPS TO BE RELOCATED.

- ② REMOVE RAISED WOOD FLOOR ASSEMBLY, AND REMOVE VINYL ASBESTOS TILE AND ALL LOOSE ASBESTOS-CONTAINING MASTIC FROM WOOD FLOOR DECK. INSTALL NEW UNDERLAYMENT OVER EXISTING ASBESTOS-CONTAINING WOOD FLOOR DECK, OF THICKNESS TO MATCH UNDERLAYMENT ADDED BY PREVIOUS PROJECTS OVER ASBESTOS MASTIC IN THE COURTROOMS AND ADJACENT AREAS. COORDINATE INCIDENTAL PENETRATIONS OF VARIOUS ASBESTOS-CONTAINING FLOORING LAYERS WITH OTHER TRADES. BECAUSE NO SPECIFIC SURVEY HAS BEEN DONE FOR THIS PROJECT, THE QUANTITIES SHOWN ARE ASSUMED TO INCLUDE BOTH VINYL ASBESTOS TILE OVER ASBESTOS-CONTAINING MASTIC, AND ASBESTOS-CONTAINING MASTIC THAT HAS CONTAMINATED WOOD FLOORING MEMBERS, ETC.

- ③ WITH THE EXCEPTION OF WALLS OR CEILINGS ADDED AT A LATER DATE, THE MAJORITY OF THE WALLS AND CEILINGS OF THE BUILDING HAVE ASBESTOS-CONTAINING JOINT COMPOUND AND ASBESTOS-CONTAINING SKIM COAT, ALONG WITH QUESTIONED "ASBESTOS-CONTAINING" COVE BASE MASTIC AND SOME AREAS OF CEILINGS HAVING QUESTIONED "ASBESTOS-CONTAINING" CEILING TILE MASTICS. REFER TO LEGEND, DEPICTION OF AREAS SCHEDULED FOR DIFFERENT WORK. WALLS AND CEILINGS TO BE REMOVED OR DISTURBED AS NECESSARY TO COMPLETE THE WORK. APPLY BRIDGING ENCAPSULANT TO CUT AND BROKEN EDGES. ONLY MAJOR PORTIONS OF WORK SHOWN, REFER TO ADDITIVE ALTERNATES, AND COORDINATE EXACT EXTENT OF WORK WITH OTHER TRADES. SEE GENERAL NOTE 9. SEE NOTES AT QUANTITIES FOR REQUIRED WORK IF MASTICS CONTAIN ASBESTOS.

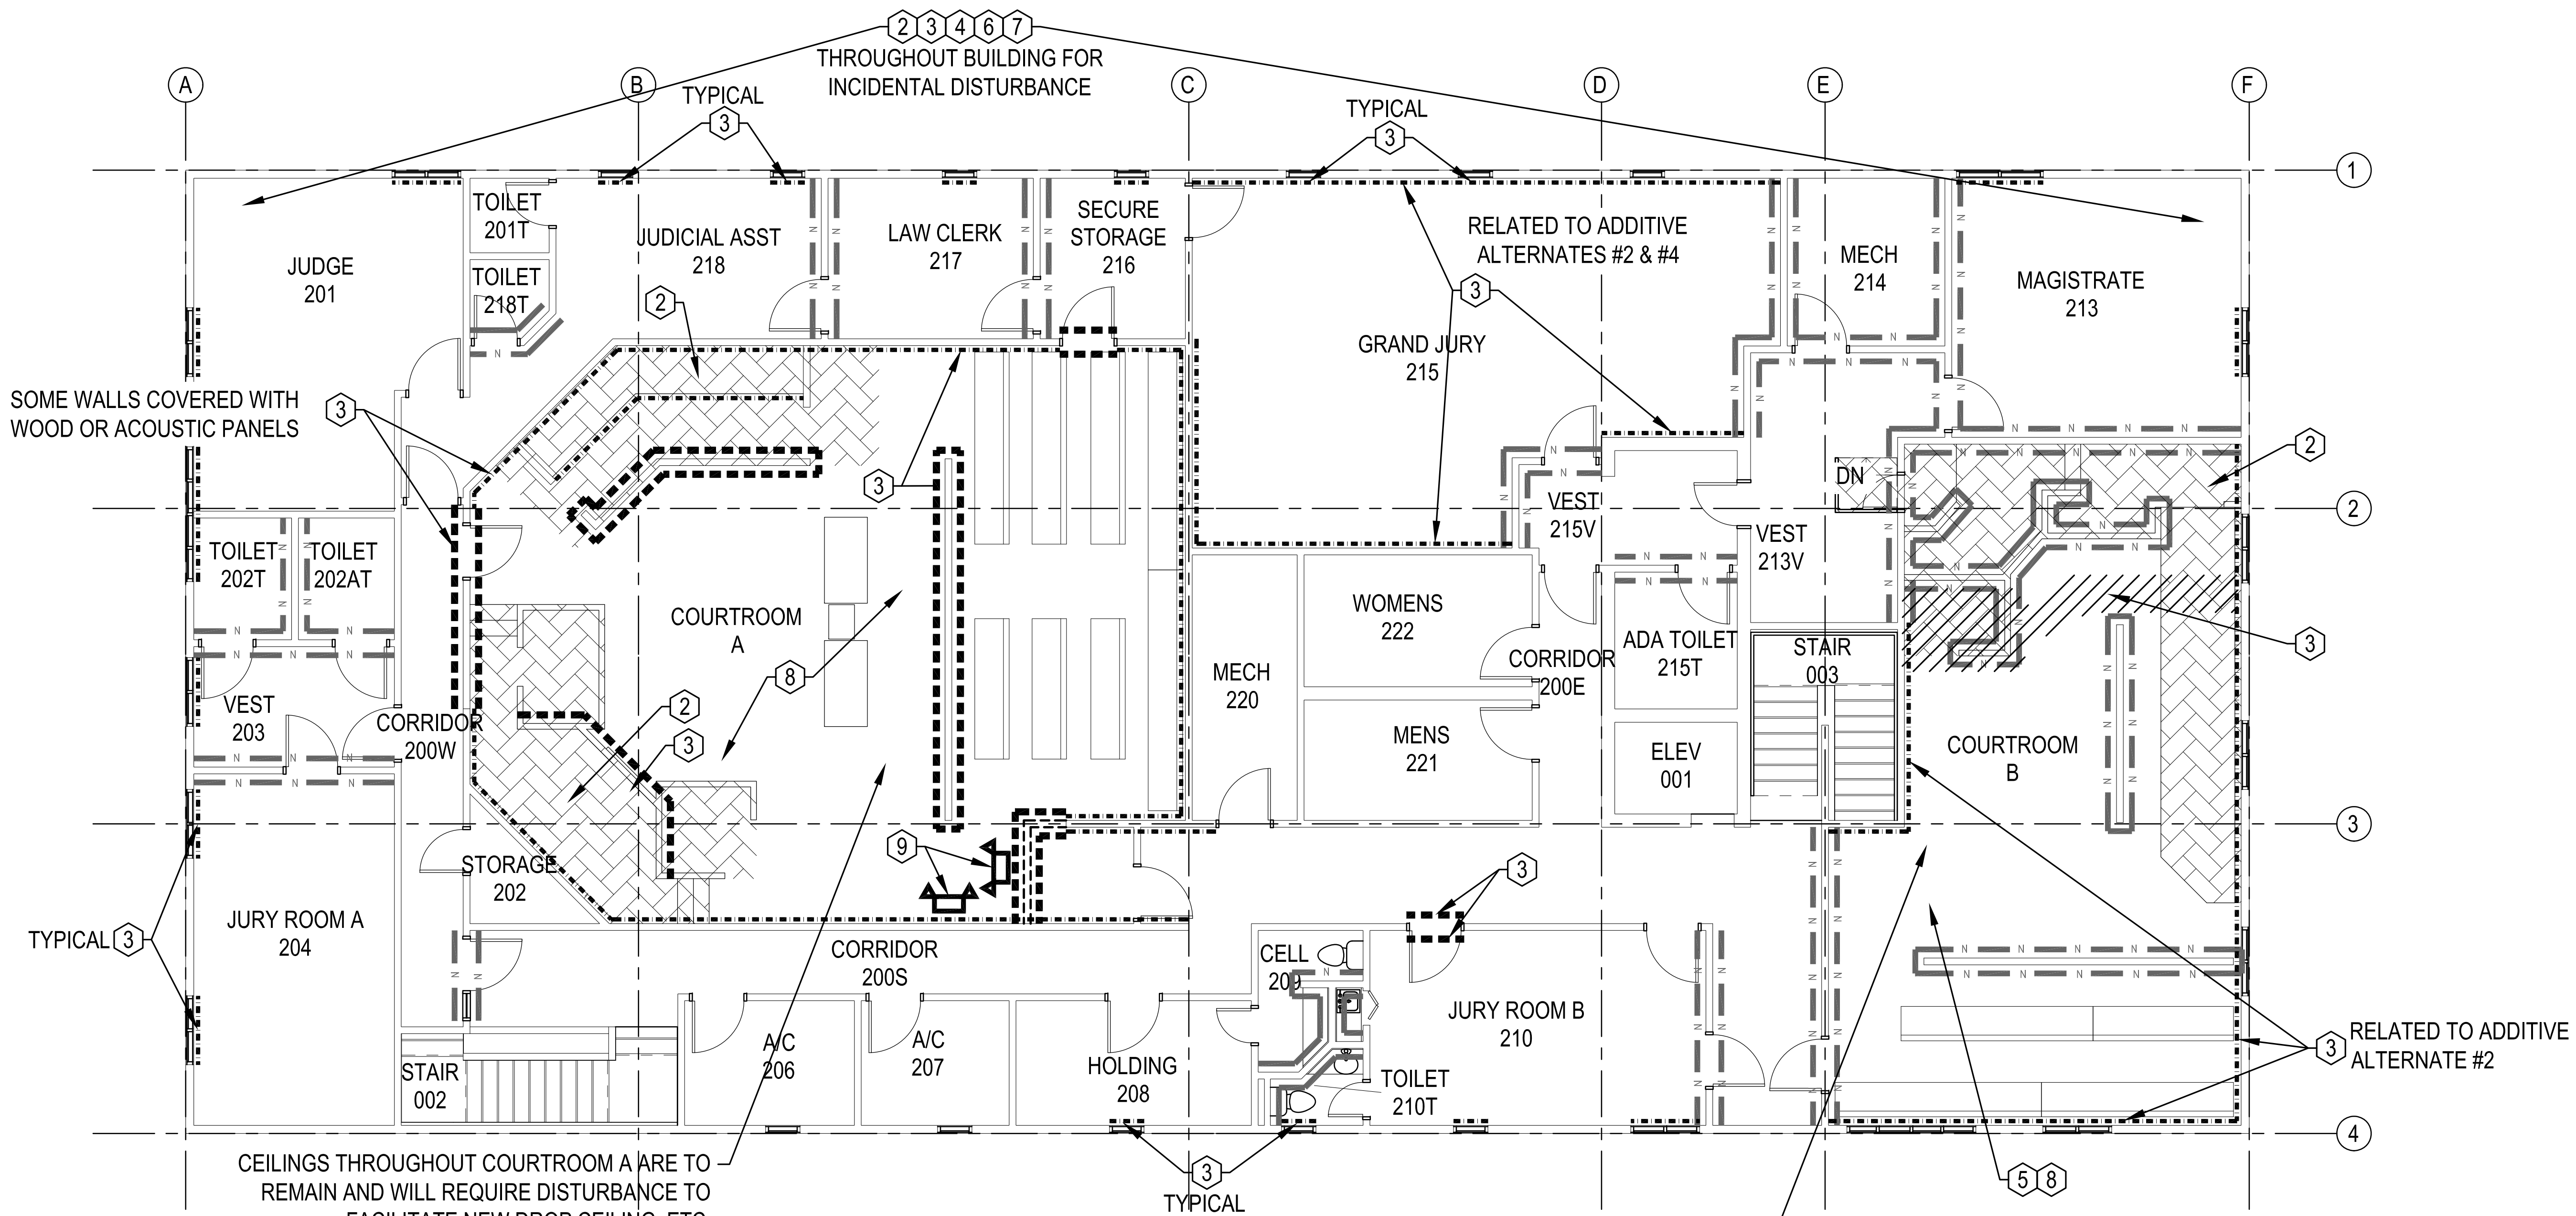
HAZARDS ABATEMENT - SECOND FLOOR

- 50* SQUARE FOOT ALLOWANCE OF GYPSUM WALL BOARD CEILINGS WITH ASBESTOS-CONTAINING JOINT COMPOUND AND SKIM COAT TO BE REMOVED.
- 380\$ LINEAR FEET OF QUESTIONED "ASBESTOS-CONTAINING" COVE BASE MASTIC TO BE REMOVED, AND ANY LOOSE ASBESTOS-CONTAINING JOINT COMPOUND, AND SKIM COAT. WALL TO BE CLEANED AND PREPARED SO THAT NO FURTHER DISTURBANCE OF ASBESTOS-CONTAINING MATERIALS IS NEEDED TO INSTALL NEW COVE BASE OR OTHER WORK.

LOWERED SOFFIT PORTION OF CEILING IS NEWER AND DOES NOT CONTAIN ASBESTOS, BUT CEILING ABOVE AND IN REMAINDER OF COURTROOM ARE ASSUMED TO CONTAIN ASBESTOS

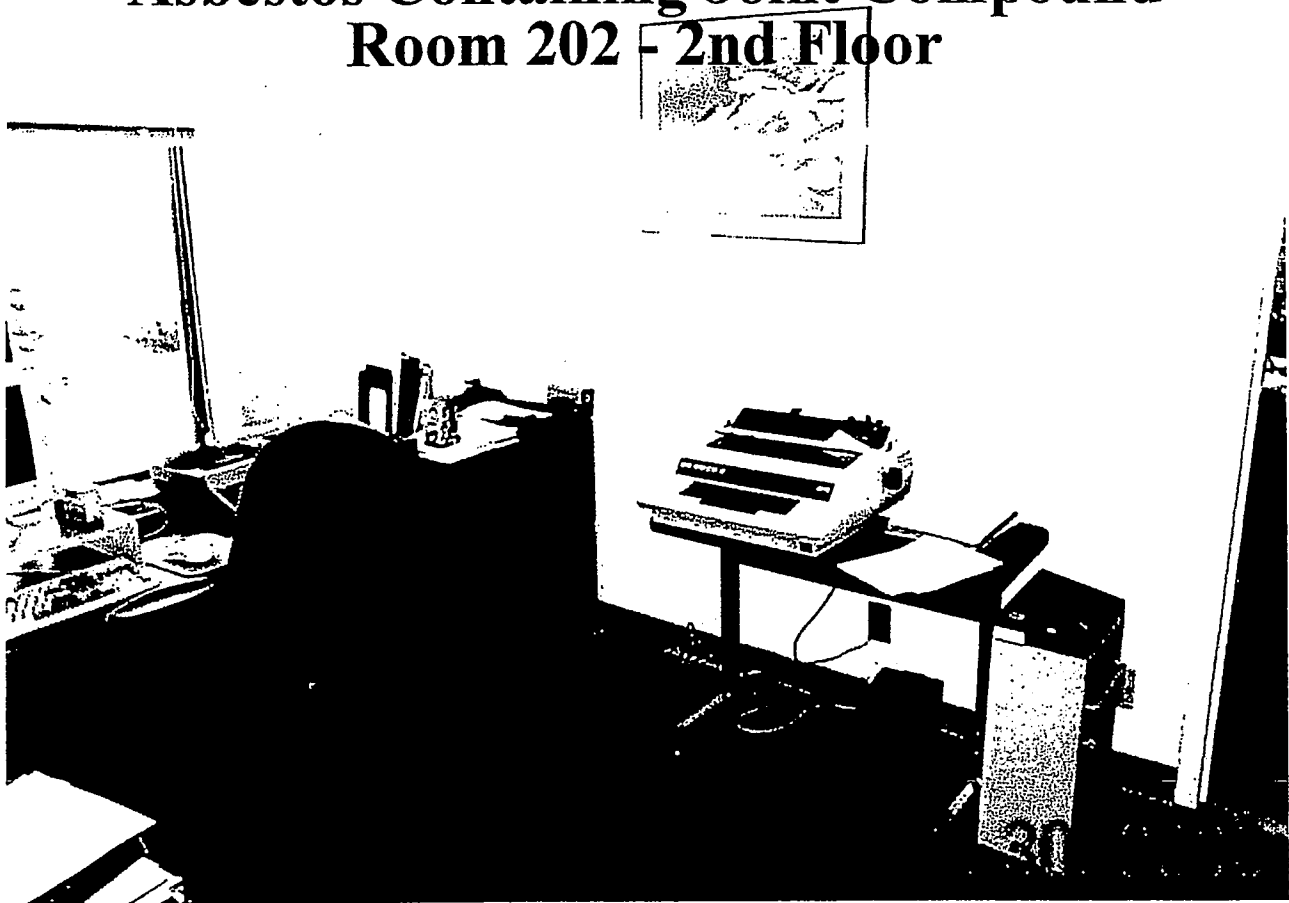
**Asbestos Containing Joint Compound
Room 202 - 2nd Floor**

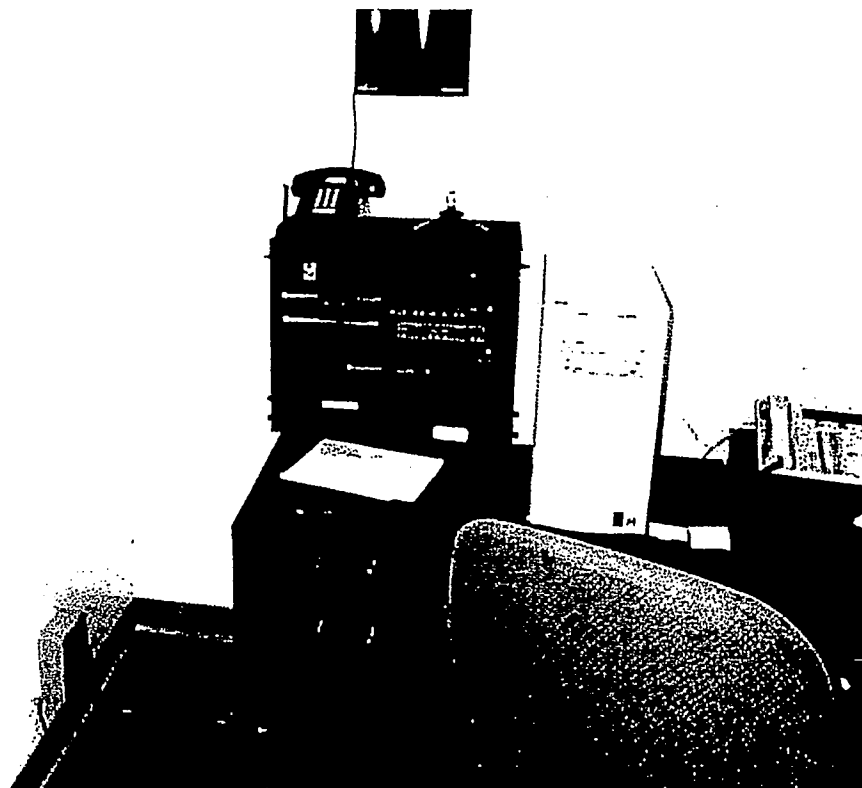
**Asbestos Containing Joint Compound & Gypsum Wall Board Skim Coat
NE Corner of Grand Jury Room - 1st Floor**

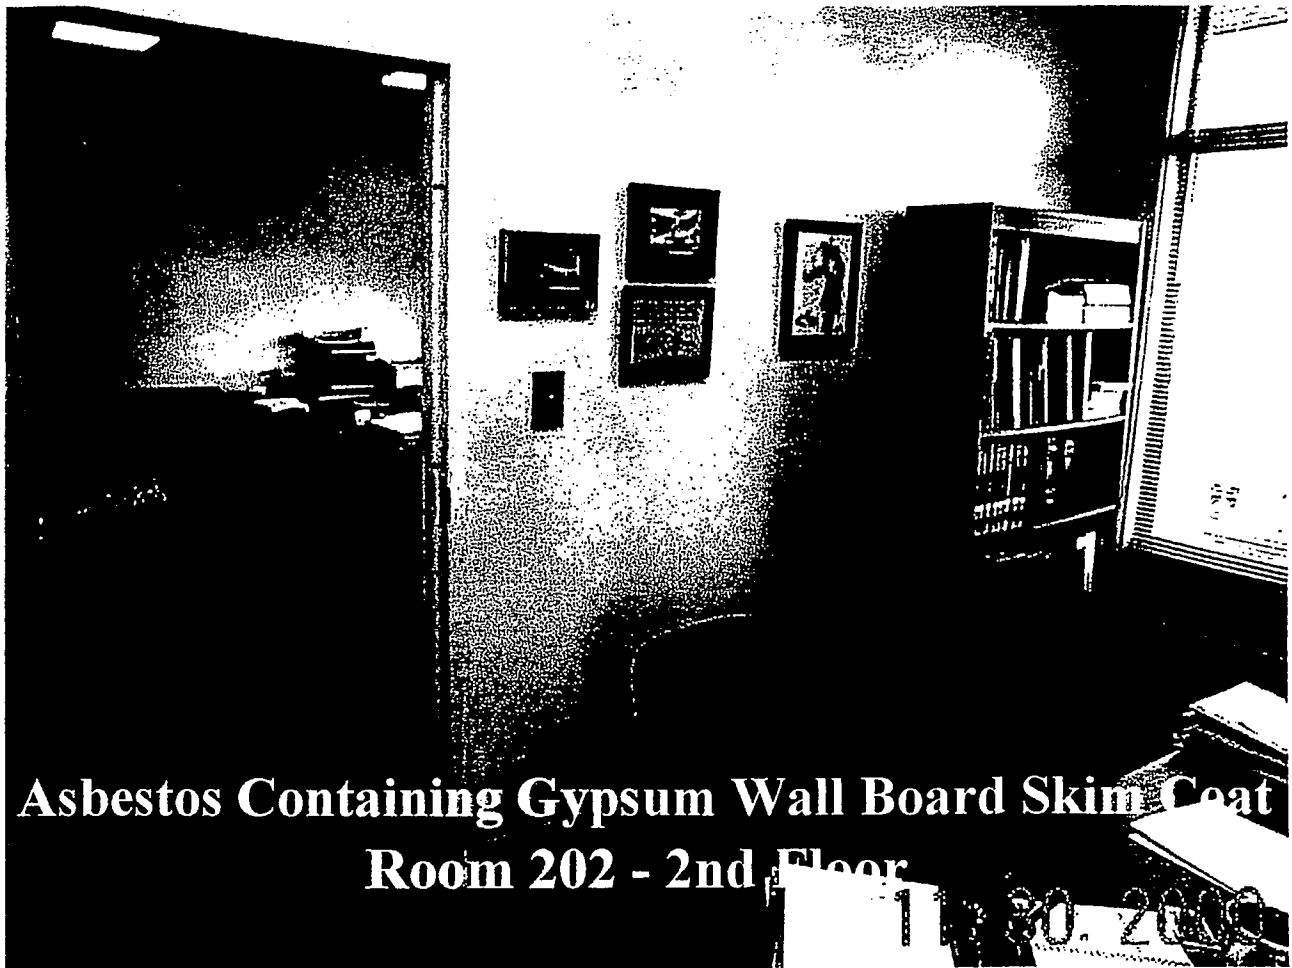
Asbestos Containing Gypsum Wall Board Skin Coat
Room 202 - 2nd Floor

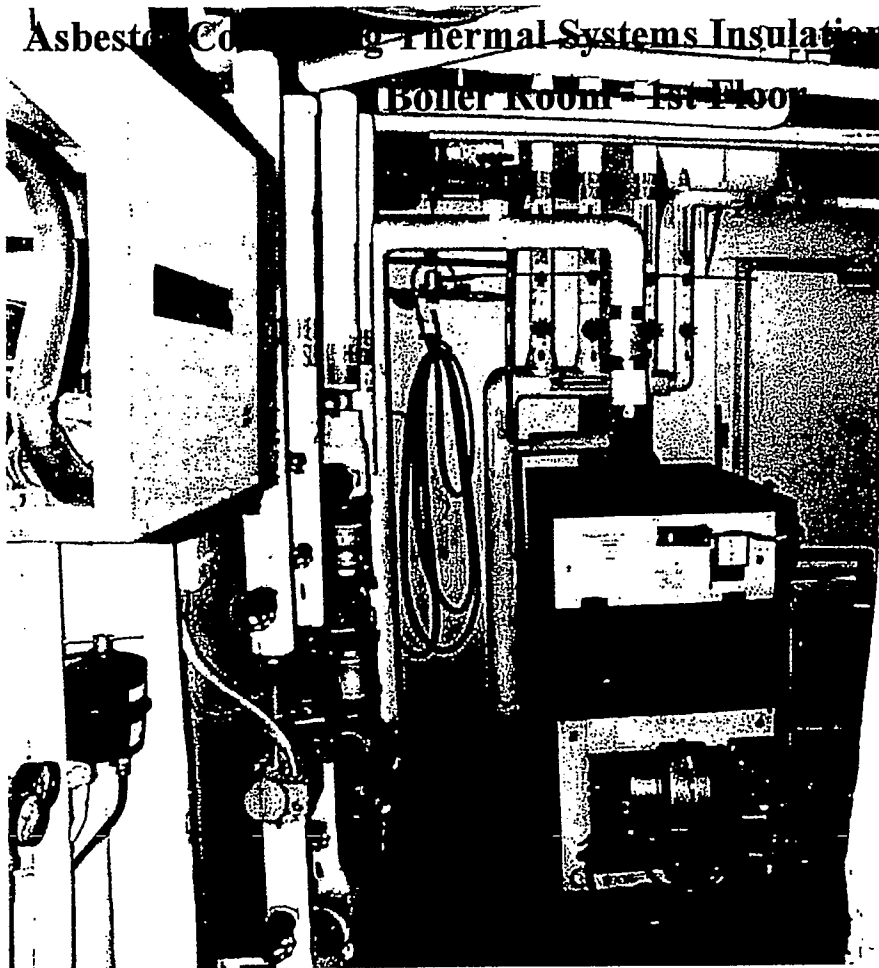
Although the majority of this material was typically found to be in good condition there were areas where cementitious insulation was significantly damaged and should be abated or repaired immediately to minimize the risk of exposure. All cementitious insulation on piping elbows, tees, and pipe hangers throughout the building should be assumed to contain asbestos. Any disturbance of the material should only be performed by state certified asbestos abatement personnel.

Asbestos Containing Thermal Systems Insulation on Associated Piping
Boiler Room - 1st Floor

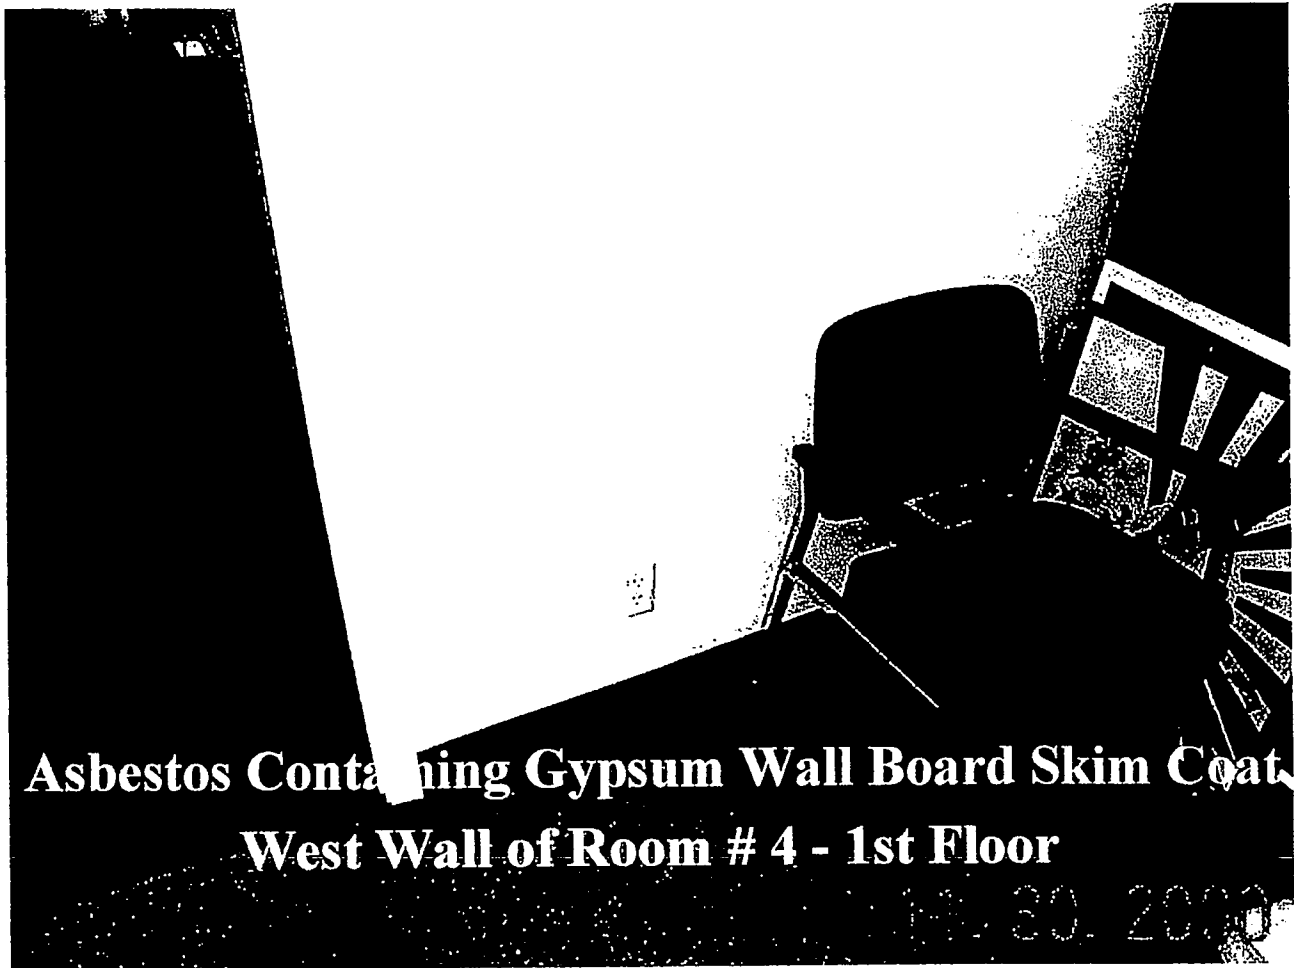
Asbestos Containing Gypsum Wall Board Skim Coat
West Wall of Room # 4 - 1st Floor

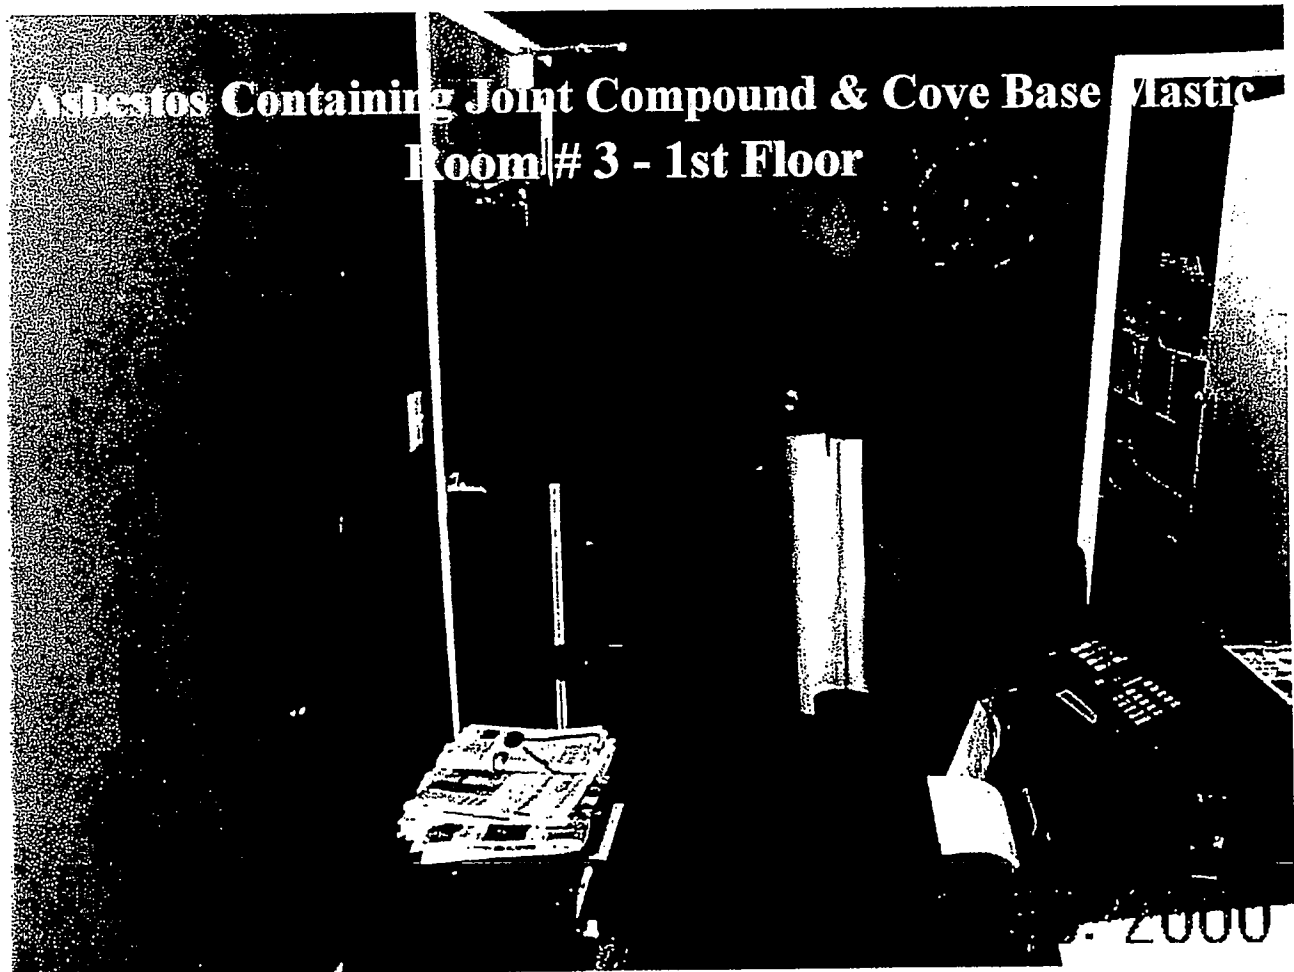
Asbestos Containing Joint Compound & Cove Base Mastic
Room # 3 - 1st Floor
