Attachment A
FVF Chenega Condition Report

2018 - 2019 FLEET CONDITION SURVEY

FVF CHENEGA

PREPARED FOR
ALASKA MARINE HIGHWAY SYSTEM

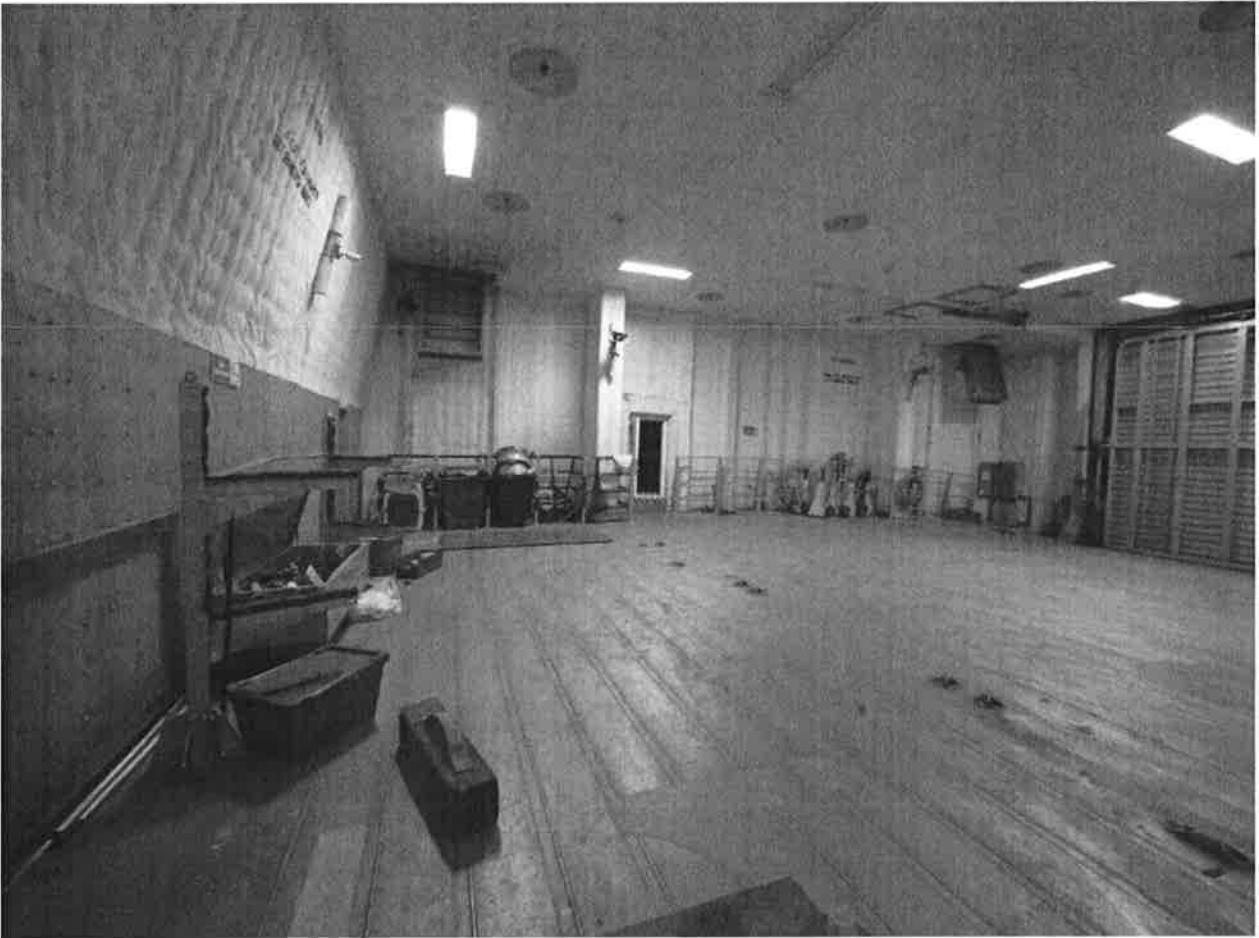
The vehicle deck bulkheads and overhead are entirely covered by insulation (Figure 1). There is no evidence of corrosion or cracking.

Figure 1 Vehicle deck view looking forward towards side door; insulation visible at sides and overhead

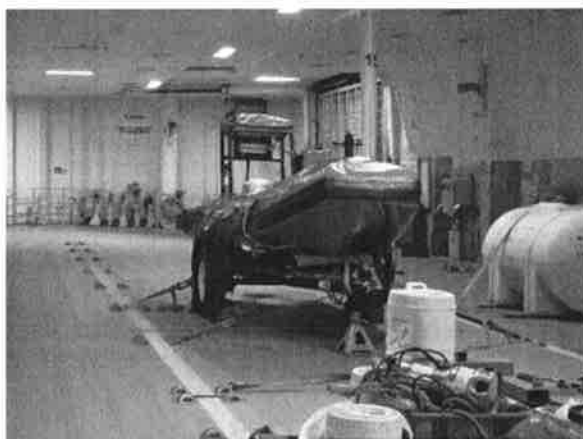
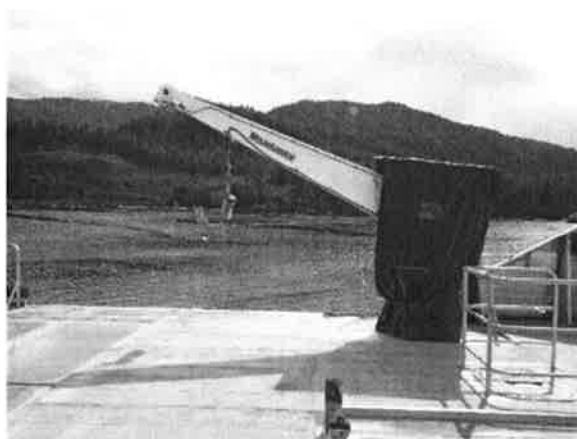
The rescue boat is currently secured on the Vehicle Deck, and the davit is installed on the House Top. Both are in good condition (Figure 2).

Figure 2 Rescue boat secured on Vehicle Deck; davit installed on House Top

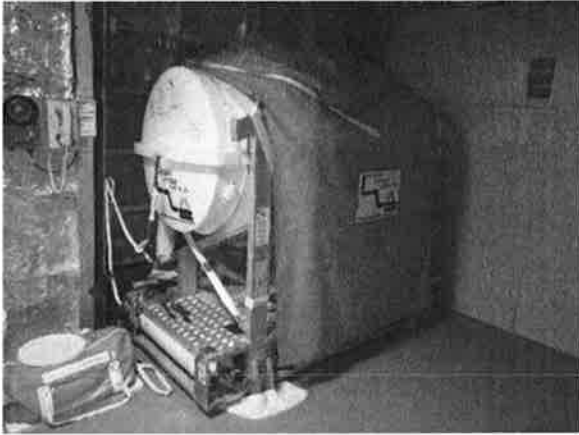
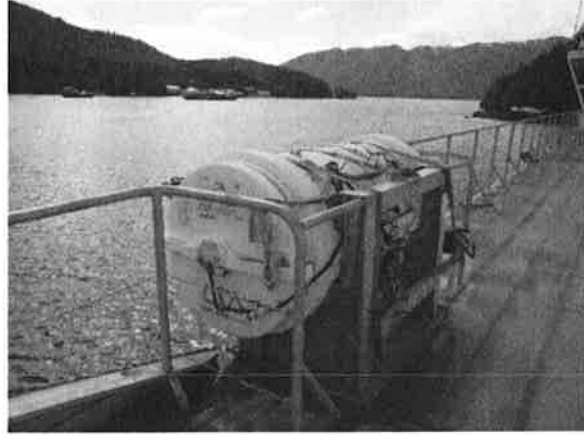
Figure 3 (Left) Slide/Life Raft unit in Starboard MES; (Right) Life Raft unit on House Top, Port

The MES equipment is manufactured and serviced by Liferaft Systems Australia. The equipment is in excellent condition.

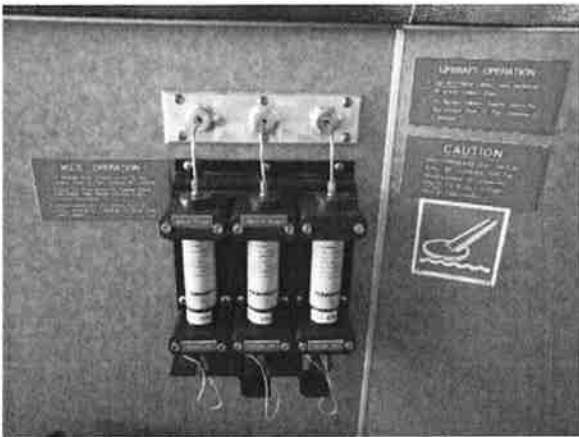
Figure 4 Remote deploying of MES, in Pilothouse

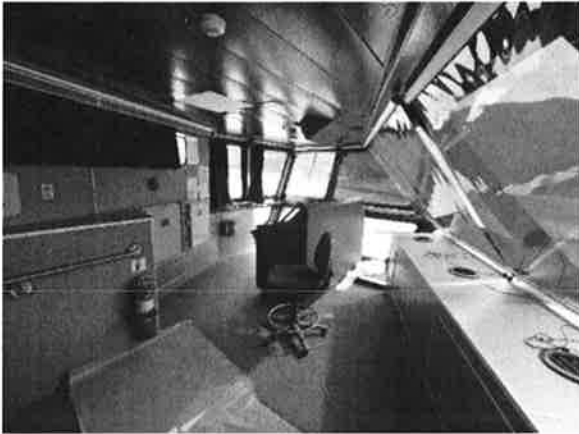
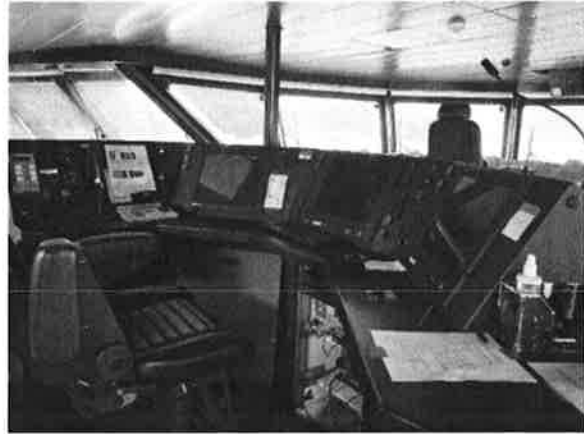
The Pilothouse is generally in excellent condition (Figure 5).

Figure 5 Pilothouse on Bridge Deck

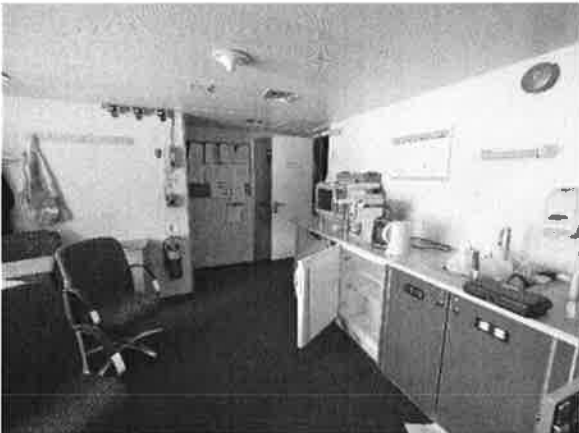
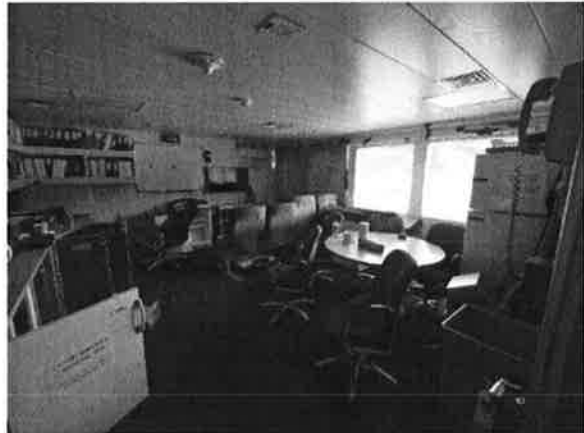
The Crew Day Room is in good condition. Appliances should be cleaned and polished as applicable. Stains, wear, and deformation are evident on the carpet; it should be cleaned or replaced (Figure 6).

Figure 6 Crew Day Room on Bridge Deck

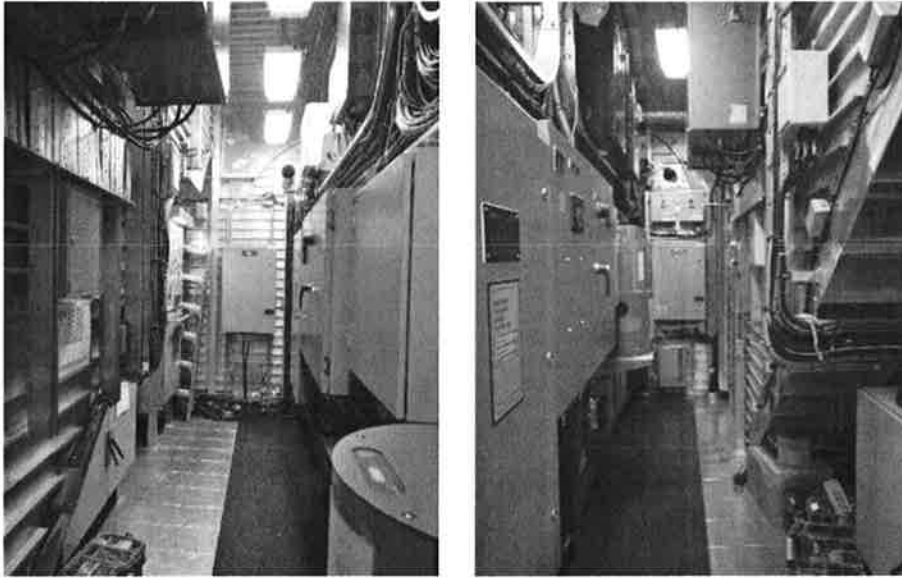
The Bridge Electrical Room is in excellent condition (Figure 7).

Figure 7 Bridge Electrical Room on Bridge Deck

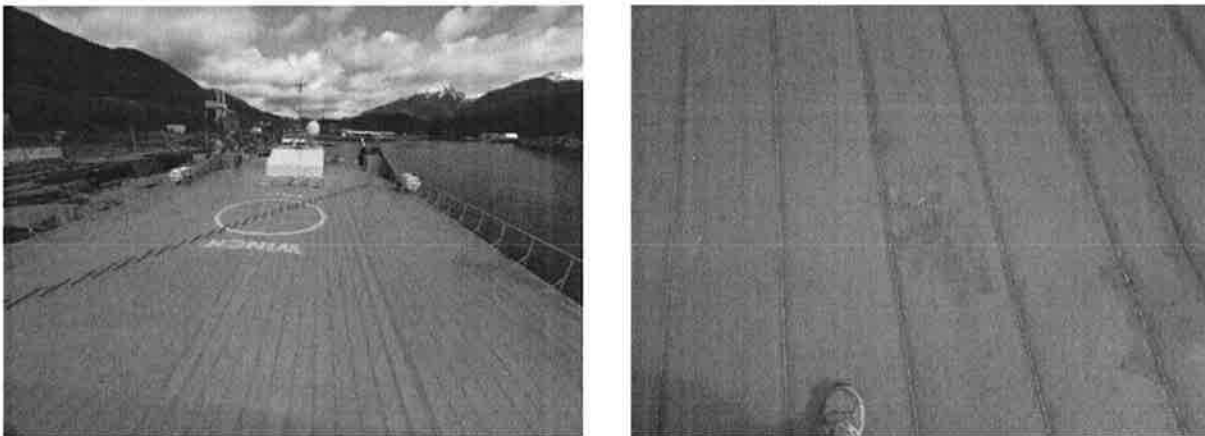
The House Top is in good condition. Small regions of repair are evident in some areas (Figure 8).

Figure 8 House Top (left) with repair evident (right) on Bridge Deck

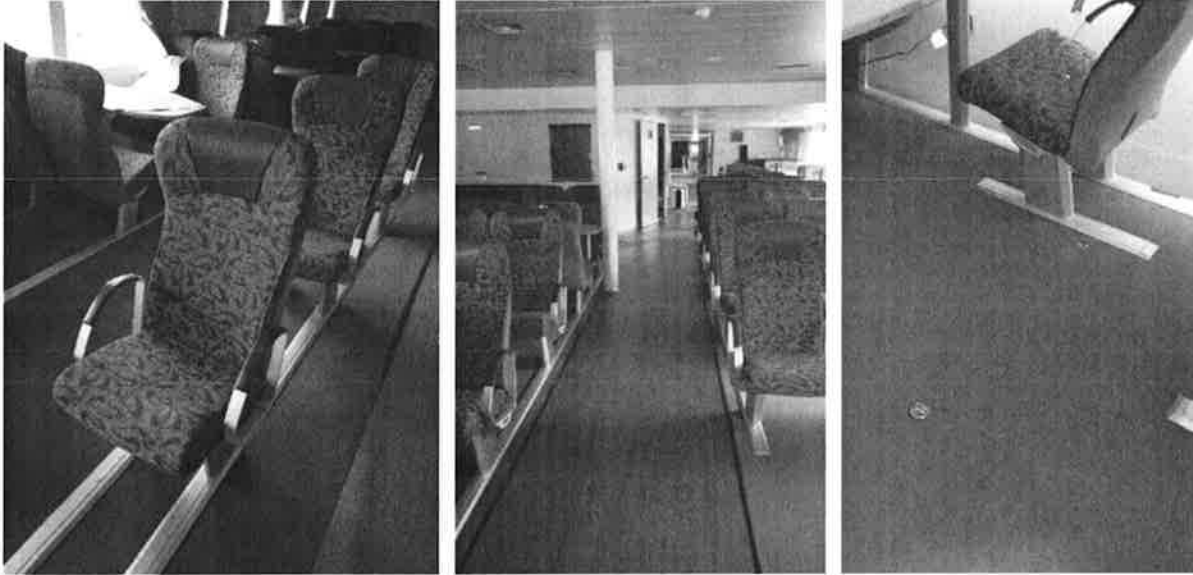
The Forward Observation Lounge is in excellent condition. In 2014, the carpeting and faux wood flooring were recommended to be replaced. Both deck covering types were replaced and are now in excellent condition. The armrest pads and seat cushions were also recommended for replacement in 2014. The replacement seats are in excellent condition (Figure 9).

Figure 9 Replacement seats (left), replacement faux wood flooring (middle), and replacement carpet (right) in Forward Observation Lounge

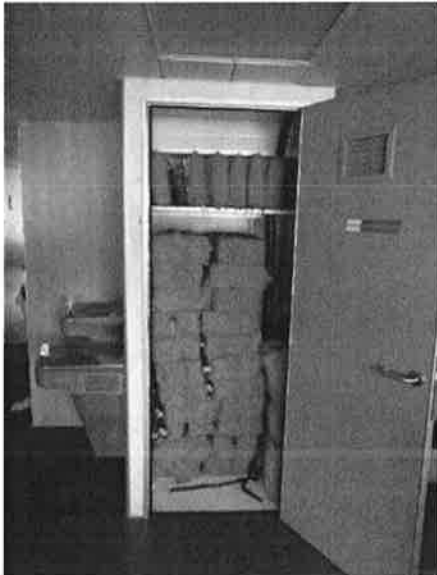
The lifejacket locker is in excellent condition (Figure 10).

Figure 10 Lifejacket locker on Passenger Deck

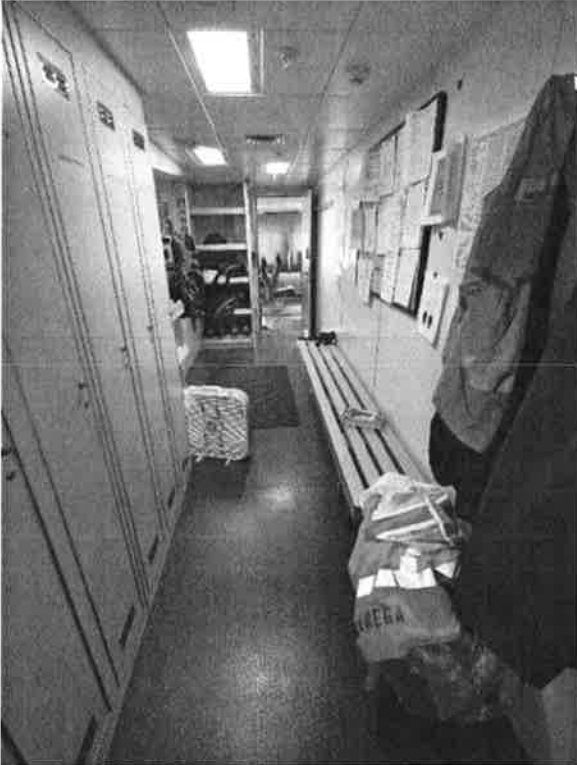
The Crew Locker Room is in excellent condition (Figure 11).

Figure 11 Crew Locker on Passenger Deck

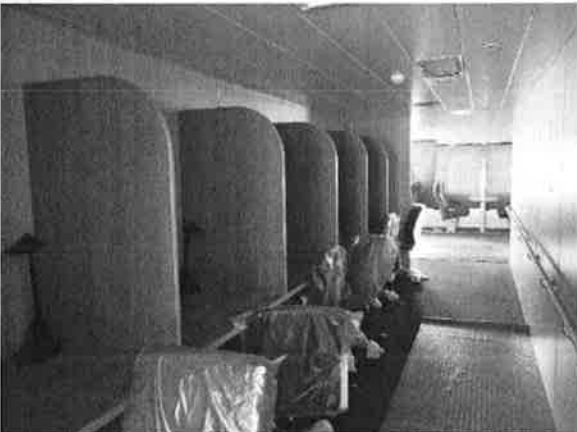
The Quiet Work Area is in excellent condition (Figure 12). During the survey on the *Fairweather*, the crew noted that this space receives minimal use due to lack of outlets for purposes such as charging phones and plugging in laptops. It is recommended to add more outlets to this space.

Figure 12 Quiet Work Area on Passenger Deck

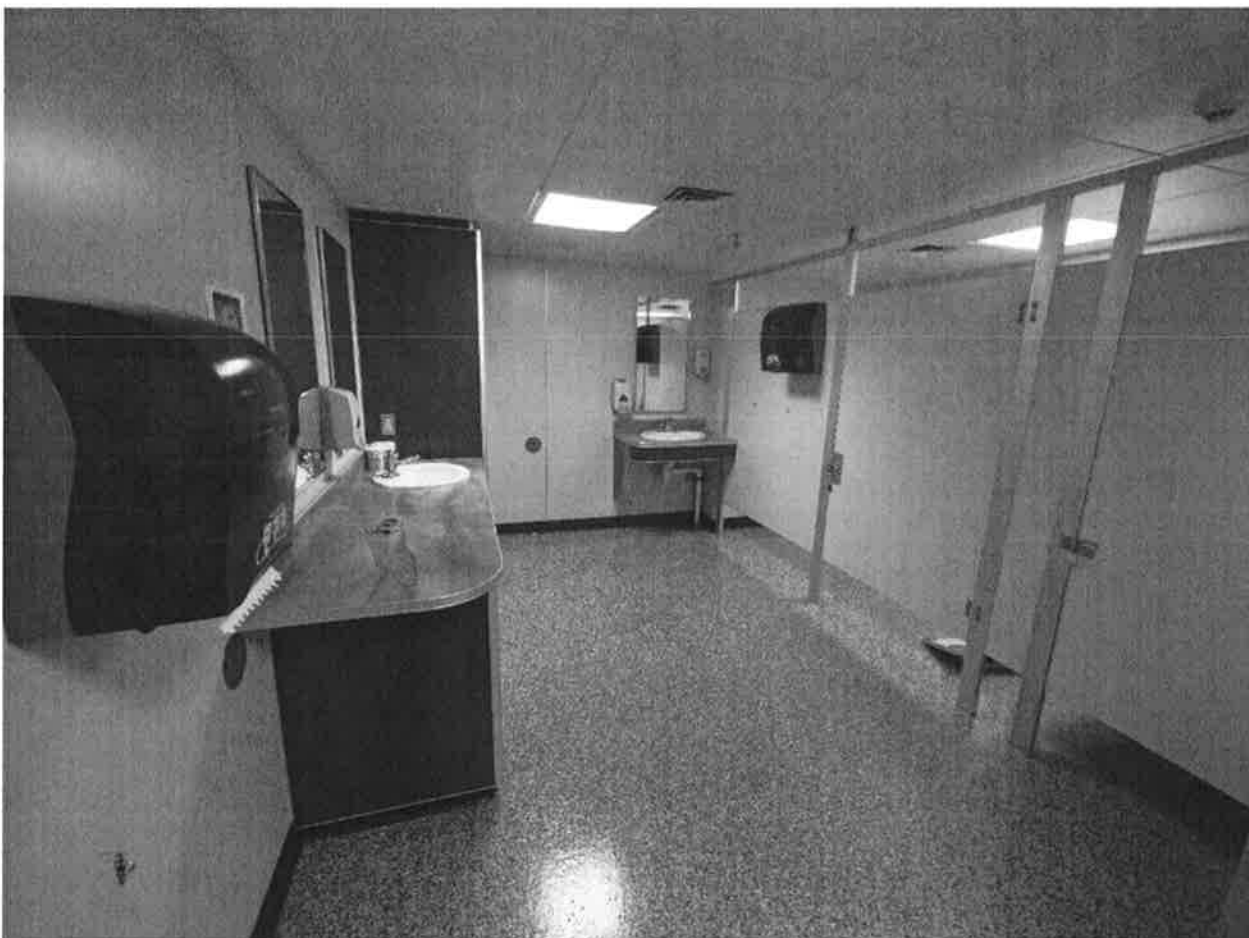
The Passenger Heads (Amidships and Aft) are in good condition (Figure 13). Deck coverings and overhead are in excellent condition.

Figure 13 Passenger Head on Passenger Deck

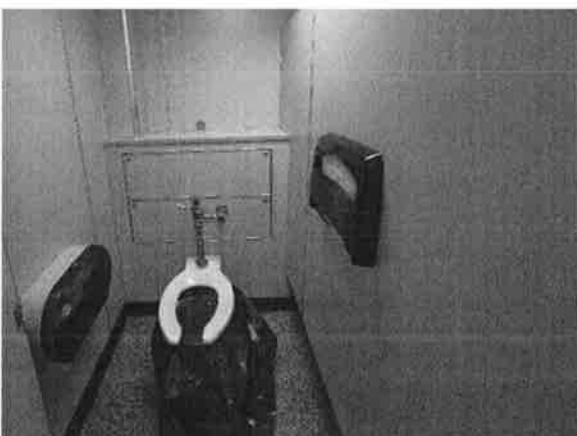
Some appliances are discolored and should be replaced (Figure 14).

Figure 14 Appliance discoloration in Passenger Head on Passenger Deck

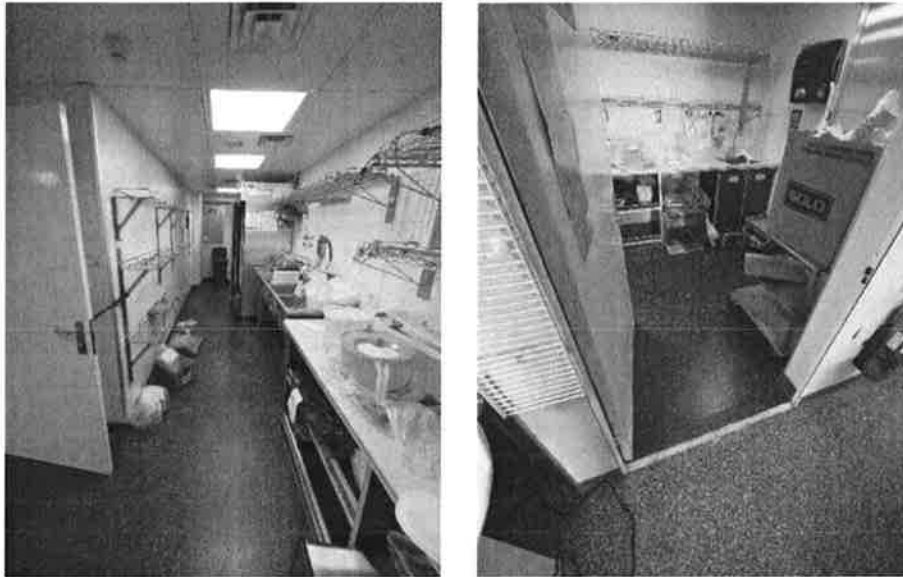
The Storage/Preparation Area is in good condition. The deck covering is stained and worn in some areas and should be replaced (Figure 15).

Figure 15 Worn deck covering evident in Storage/Preparation Area (left) and Storage/Preparation Area threshold (right) on Passenger Deck

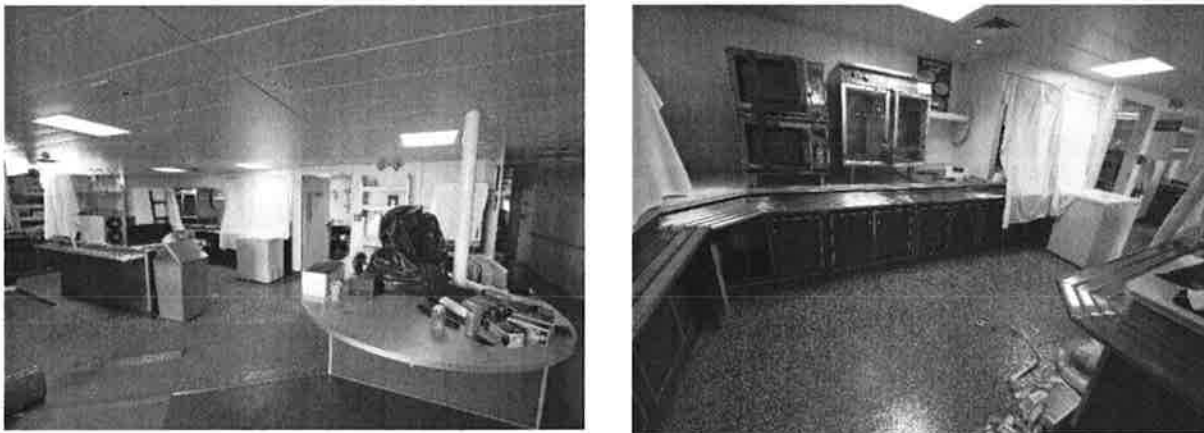
The Food Court is in good condition. The deck covering is discolored in some areas and should be cleaned or replaced. Increased lighting would improve visibility in the space (Figure 16).

Figure 16 Worn deck covering (left) and low lighting levels (right) in Food Court

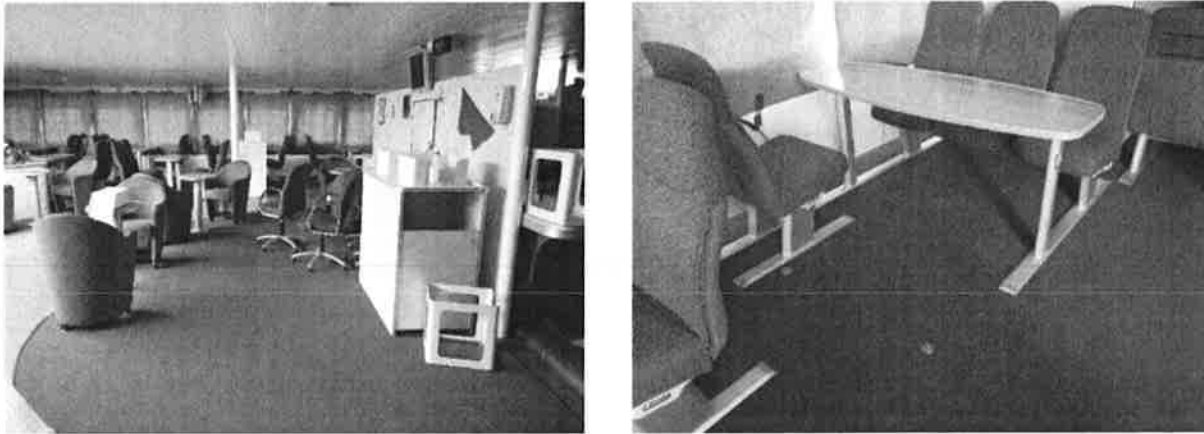
The Snack Bar and seating are in good condition. The deck covering shows minor stains with seams evident; it should be cleaned. The bucket seating is worn and would benefit from replacement (Figure 17).

Figure 17 Bucket seating (left) and gaps in bulkhead lining (right) in Snack Bar/Seating on Passenger Deck

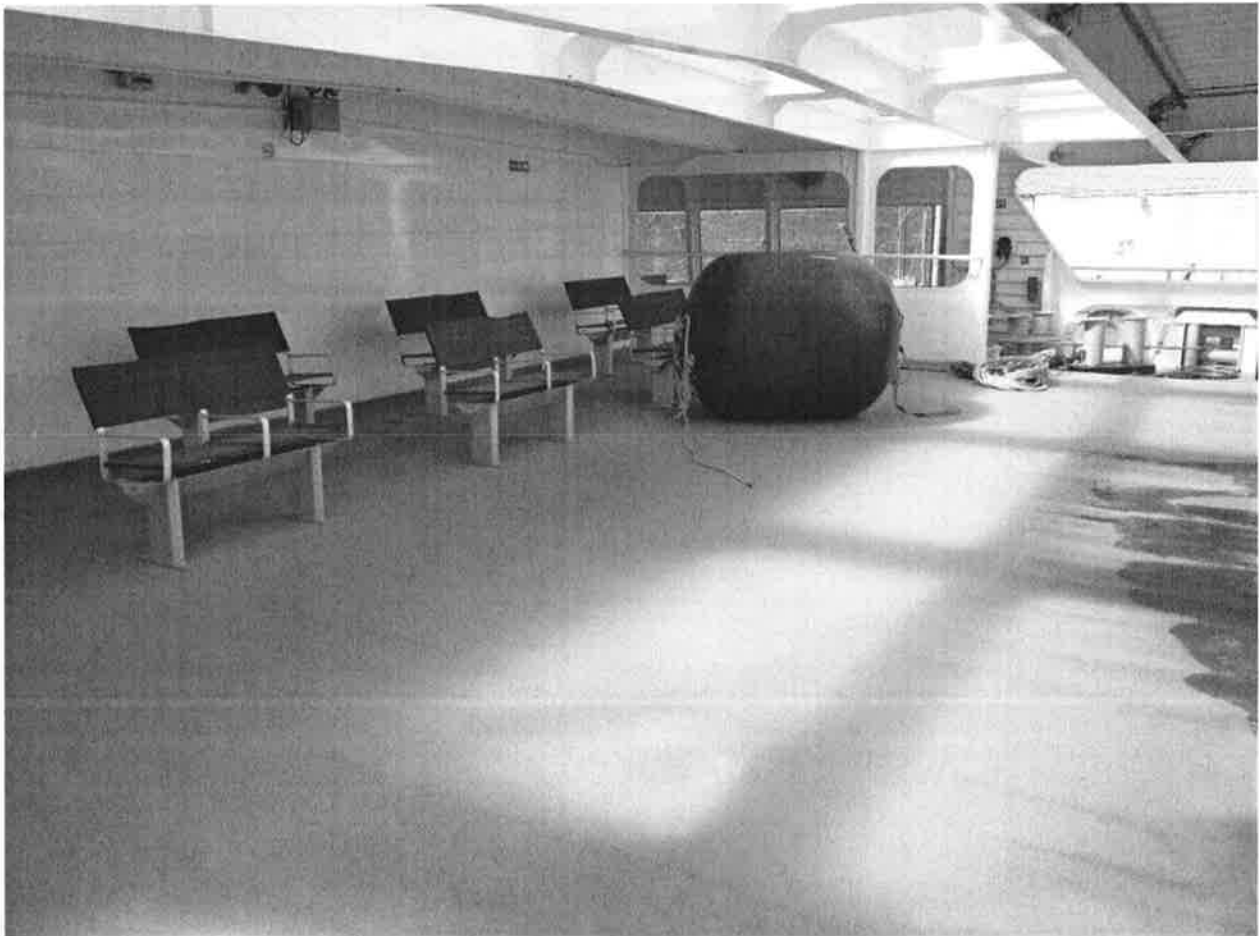
The Solarium is in fair condition. Dark stains are evident on the deck covering, which should be replaced (Figure 18).

Figure 18 Solarium

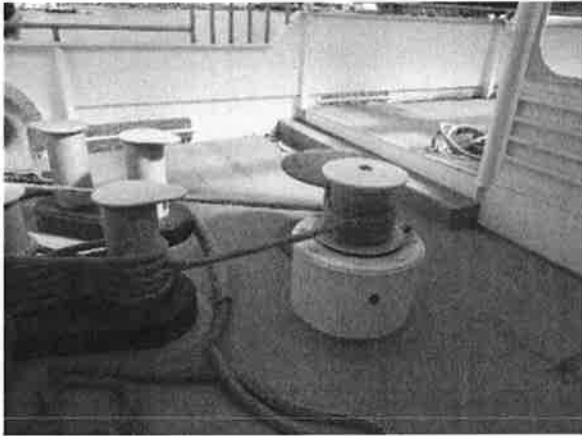
Mooring equipment is in excellent condition and shows no wear (Figure 19).

Figure 19 Mooring equipment in Solarium

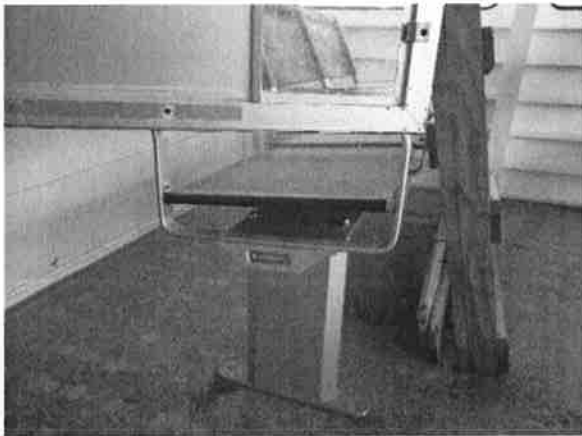
Despite the minimal use of the vessel, the furniture shows wear. The space would benefit from replacing the furniture with heartier, more robust furniture suited to the ferry route climates (Figure 20).

Figure 20 Furniture in Solarium

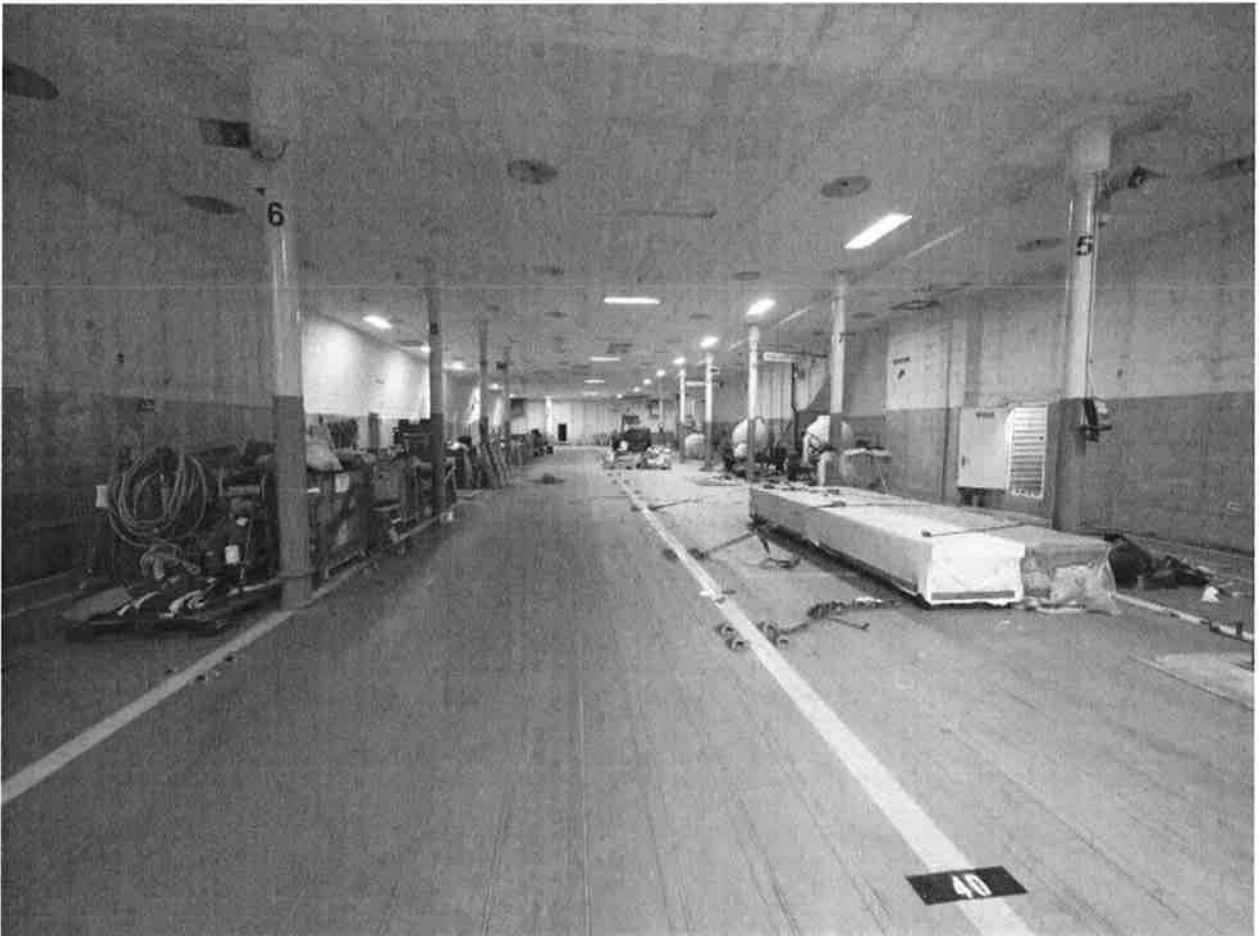
The Vehicle Deck is in excellent condition. The bulkheads, lighting, overhead, and structural fire protection appear to be in good condition. Figure 21 shows well maintained bulkheads and lane lines.

Figure 21 Vehicle Deck, looking forward

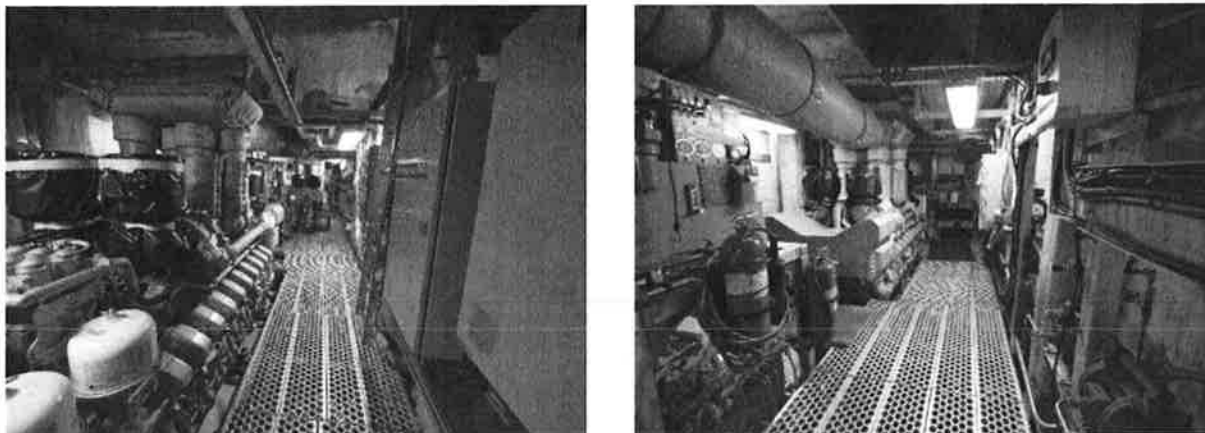
These spaces were not all photographed, but are assumed to be in excellent condition, commensurate with the condition of the Engine Rooms. Similar to the Engine Room (Figure 22), lighting in these spaces is assumed to be very good, and spaces are assumed clean.

Figure 22 Port Engine Room (left) and Starboard Engine Room (right)

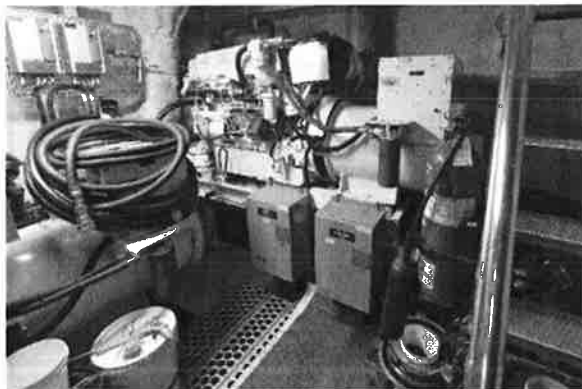
Figure 23 Generator 4 in Port Engine Room

The generators are in excellent condition.

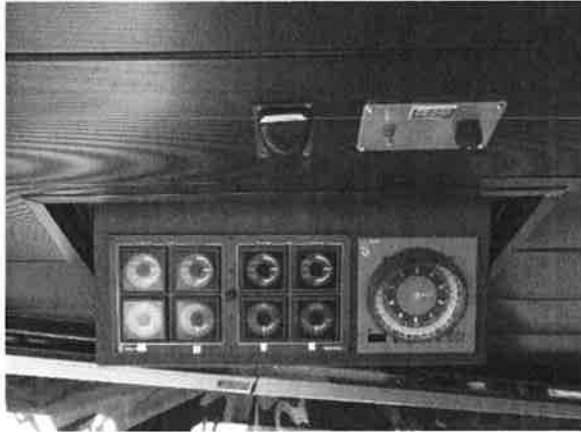
The steering system for the waterjets is hydraulic. The system piping is stainless steel tubing and is in excellent condition. No problems were reported with the system (Figure 26).

Figure 26 Waterjet steering system in Pilothouse on Bridge Deck

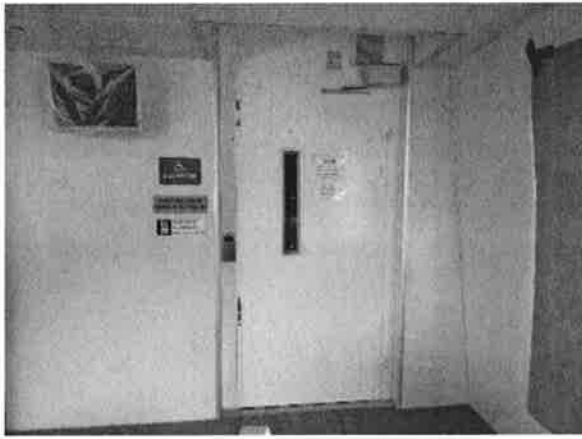
Figure 27 Passenger elevator on Passenger Deck

The elevator system was not tested on this survey but is assumed to be in good condition and functioning normally.

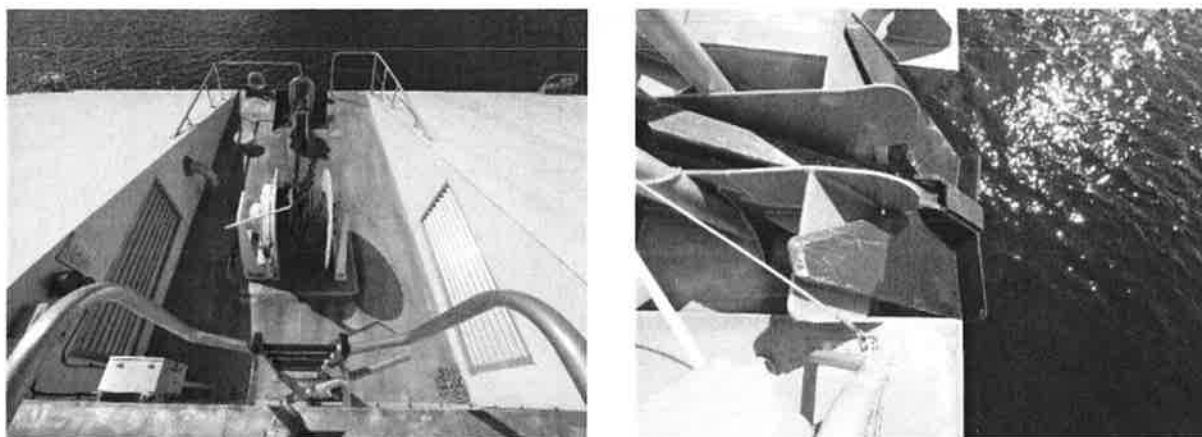
The anchor windlass and chain are in good condition and function normally (Figure 28).

Figure 28 Anchor windlass and chain (left) and anchor close-up (right) from Forward Mooring Deck

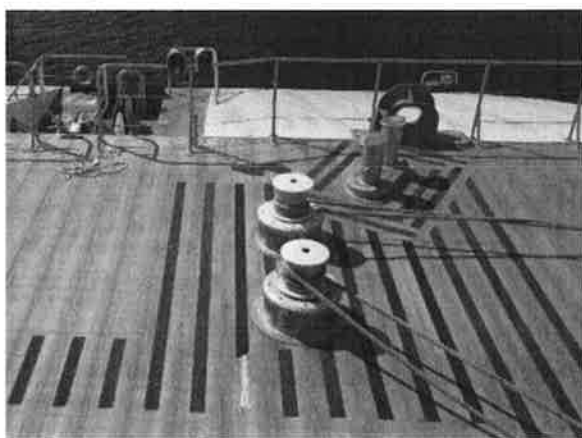
Mooring capstans and fairleads in the Solarium and on the Forward Mooring Deck (Figure 29) are in good condition and function normally.

Figure 29 Mooring capstans and fairlead on Forward Mooring Deck

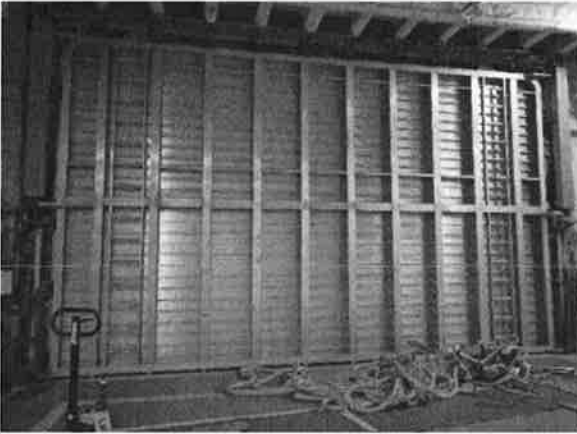
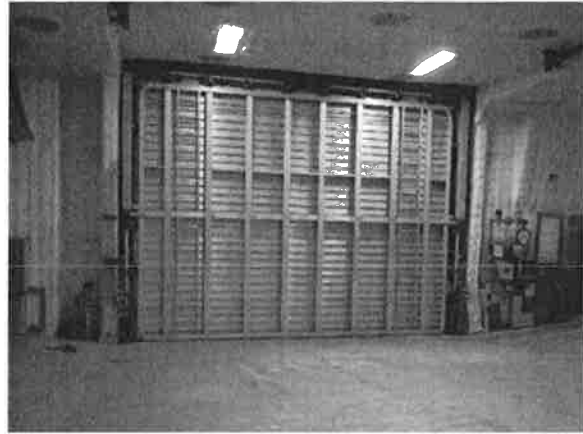
The vehicle deck cargo doors are both in excellent condition with no visual or reported damage. The stern and side door systems were not tested but are assumed to function as intended (Figure 30).

Figure 30 Vehicle Deck stern door (left) and side door (right)
