Attachment B
FVF Fairweather Condition Report

2018 - 2019 FLEET CONDITION SURVEY
FVF FAIRWEATHER

PREPARED FOR
ALASKA MARINE HIGHWAY SYSTEM

29 APRIL 2019
FILE NO.19041.01
REV.-

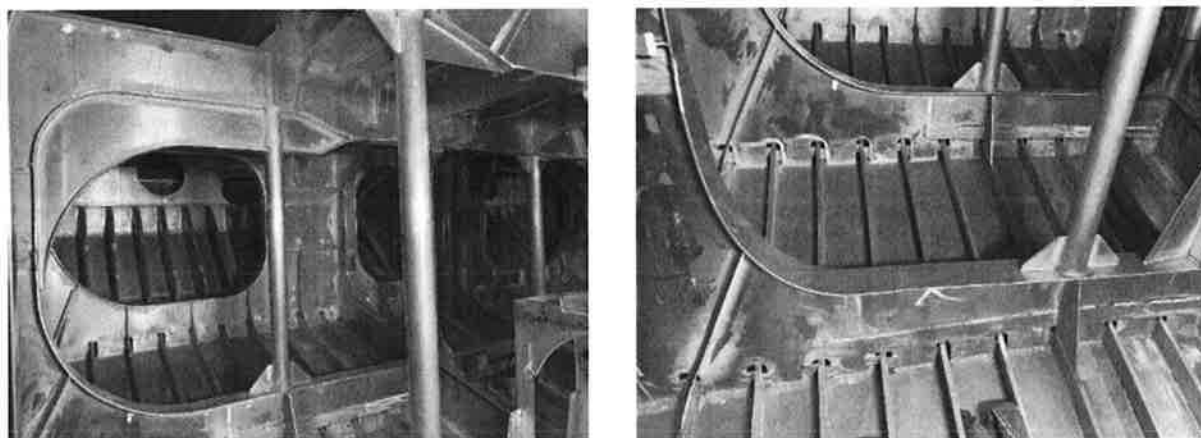
The forepeak suffered wave damage during the first year of operation. This incident resulted in significant deformation of the bottom plating and supporting structure in the vicinity of the centerline, Frames 52 through 58. This damage has been repaired, including redesign and structural modifications to the area. The modifications included adding stanchion connections of bottom structure to deck structure, webframe enhancements, and shell stiffener straightening (Figure 1). Evidence of the repairs is observable. Operating procedures have been modified since the incident and no further damage has resulted.

Figure 1 Additional stanchions (left) and shell stiffeners (right) in region of earlier forepeak damage

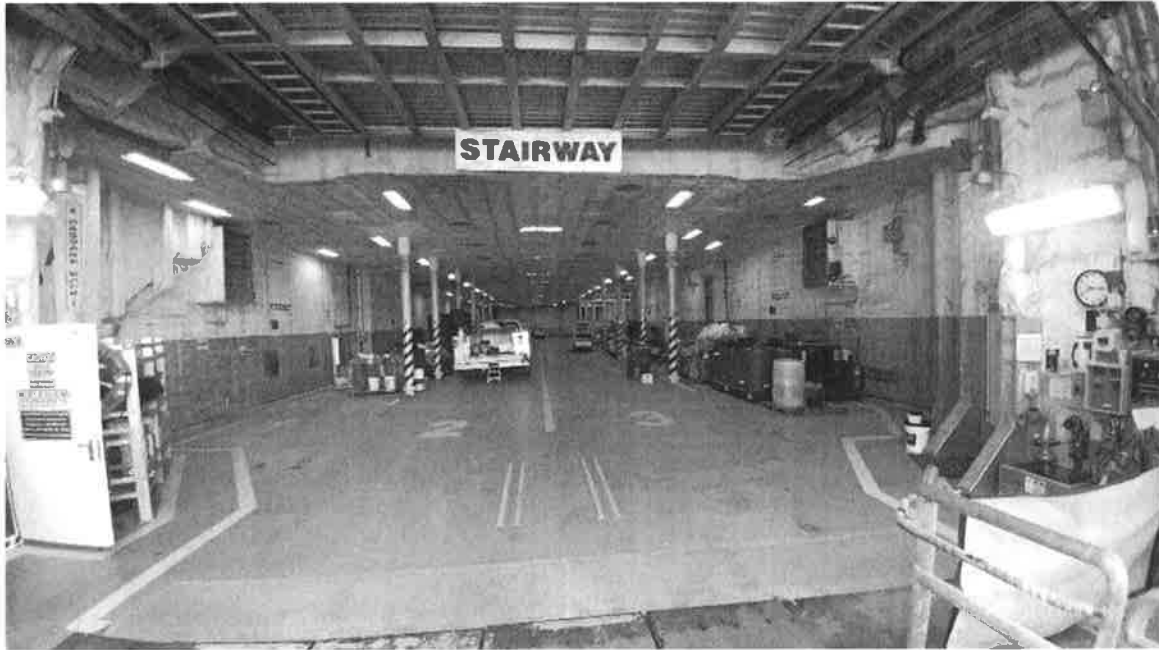
The vehicle deck bulkheads and overhead are entirely covered by insulation (Figure 2). In lower corners and within the scuppers there is no evidence of corrosion or cracking.

Figure 2 Vehicle deck view from stern door looking forward; insulation visible at sides and overhead

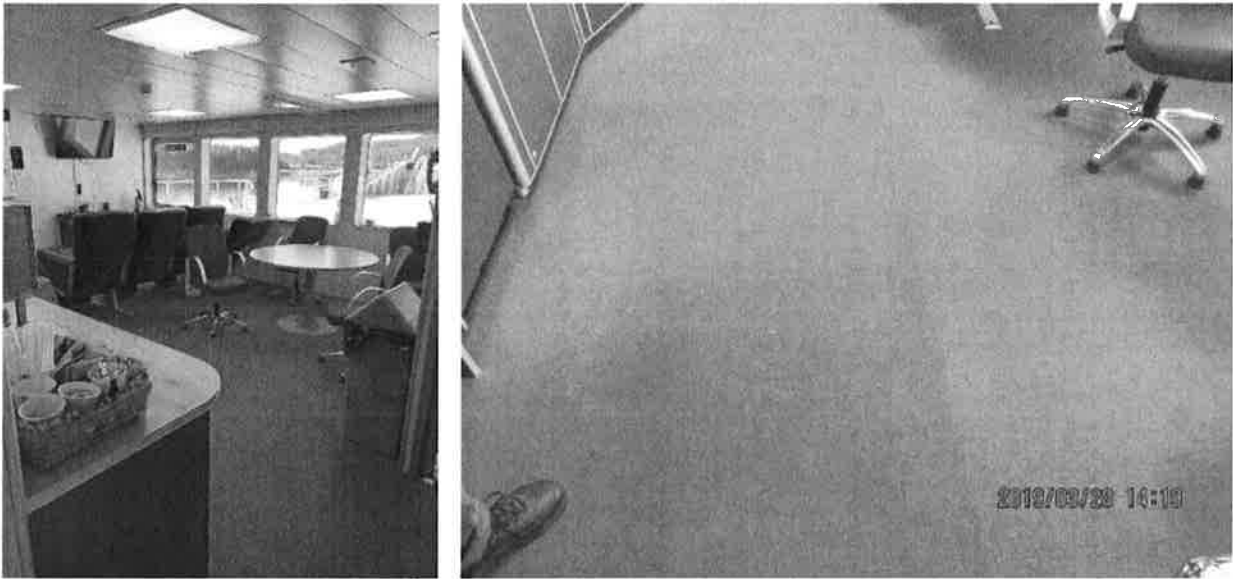
The Crew Day Room is in good condition. Stains, wear, and deformation are evident on the carpet; it should be cleaned or replaced (Figure 9).

Figure 9 Crew Day Room (left) with minor stains and deformation on carpet (right)

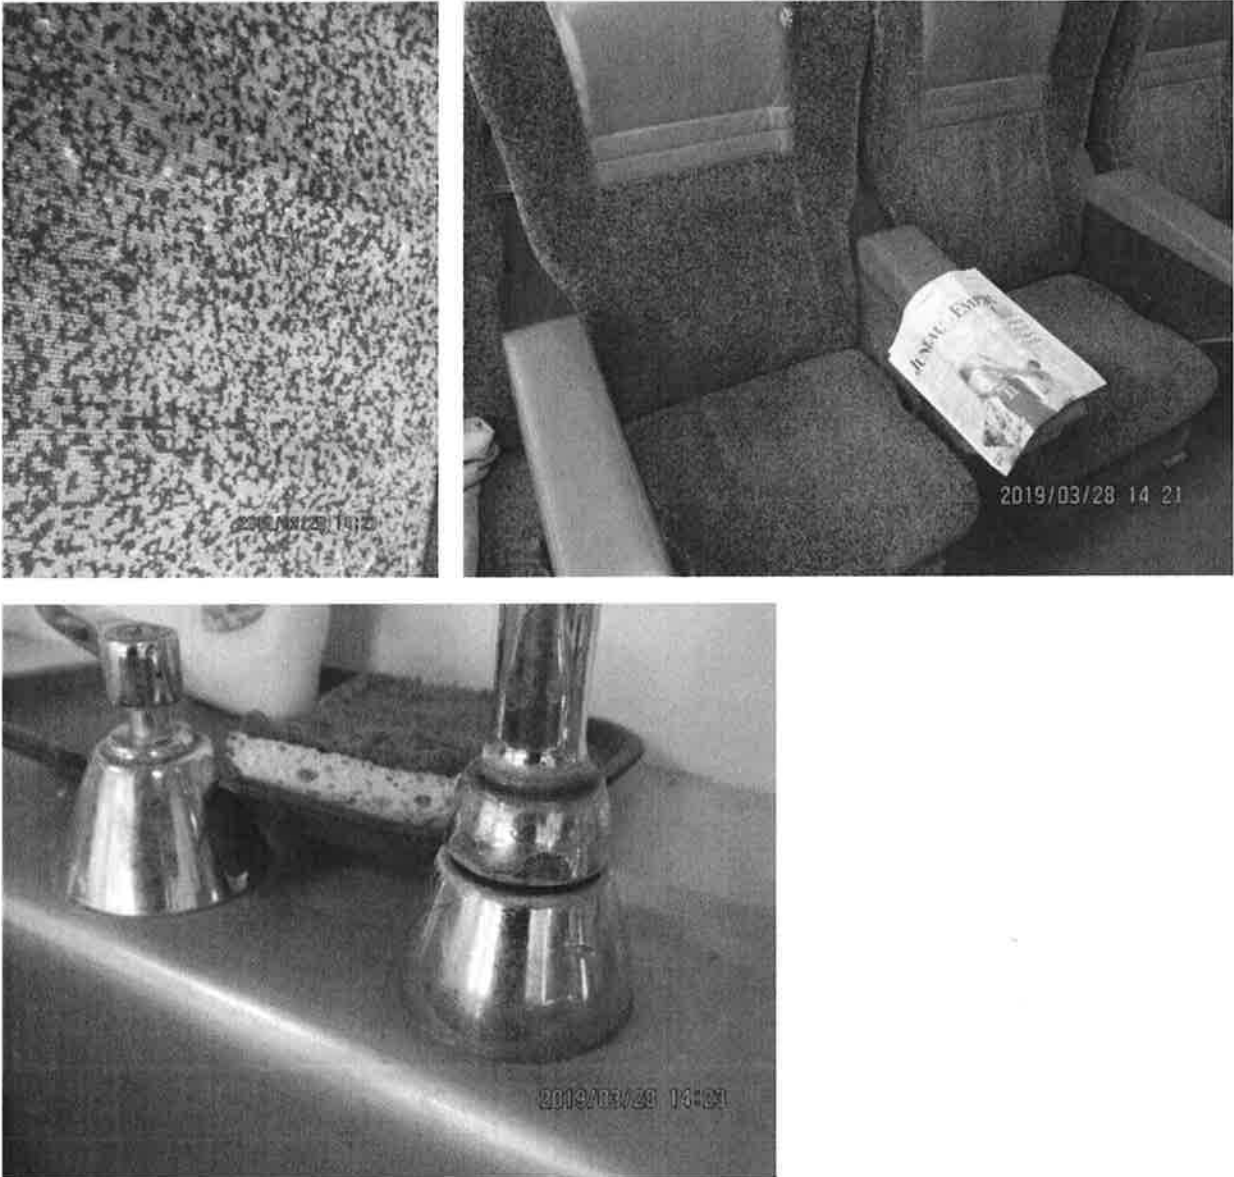
The furniture, bulkhead, and sink show some wear but are generally in good condition.

Figure 10 Minor wear on furniture (top) and sink (bottom) in Crew Day Room

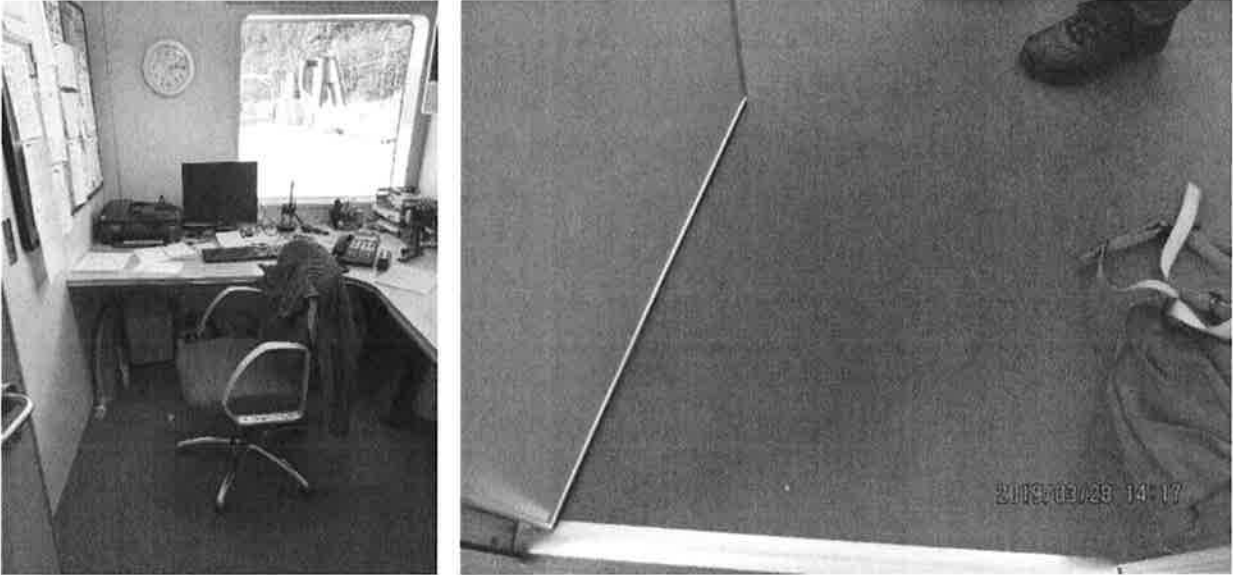
The Ship's Office is in good condition with lightly worn deck covering.

Figure 11 Ship's Office (left) and carpet (right) in good condition

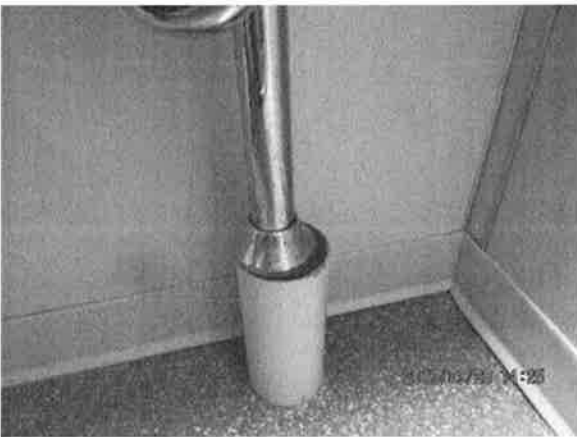
The Crew Head is generally in excellent condition. Penetration misalignment was noted underneath the sink (Figure 12).

Figure 12 Penetration misalignment under sink in Crew Head

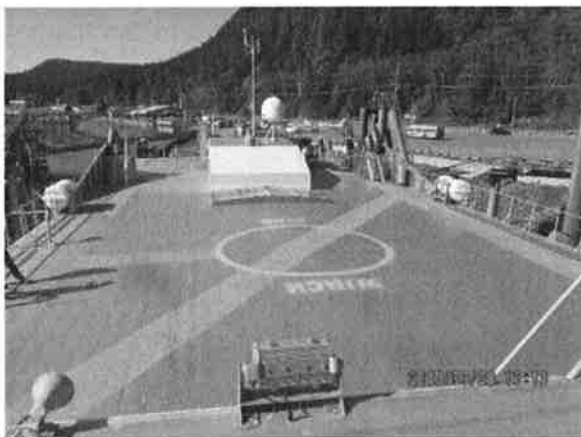
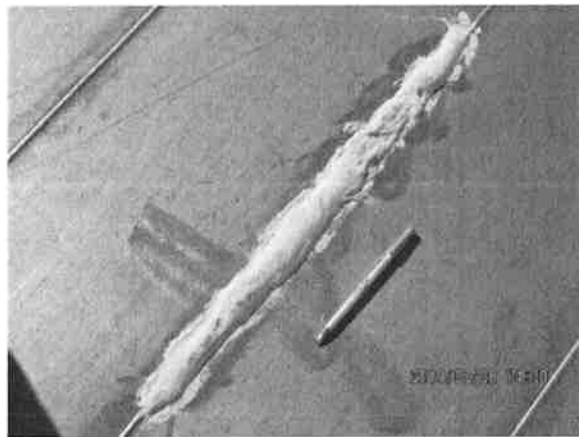
The House Top is in fair condition. The deck covering shows significant wear. Warping, cracking or flexing of the deck covering is very noticeable in some regions. Large regions of white caulking to repair leaks are evident in approximately a dozen areas (Figure 14).

Figure 14 House Top (left) with caulking evident in many regions (right)

Crew spaces are in good condition with few exceptions. On the Bridge Deck, the Crew Day Room would benefit from cleaning or replacing the carpet. The House Top deck covering should also be significantly repaired or replaced to eliminate white caulking and warping.

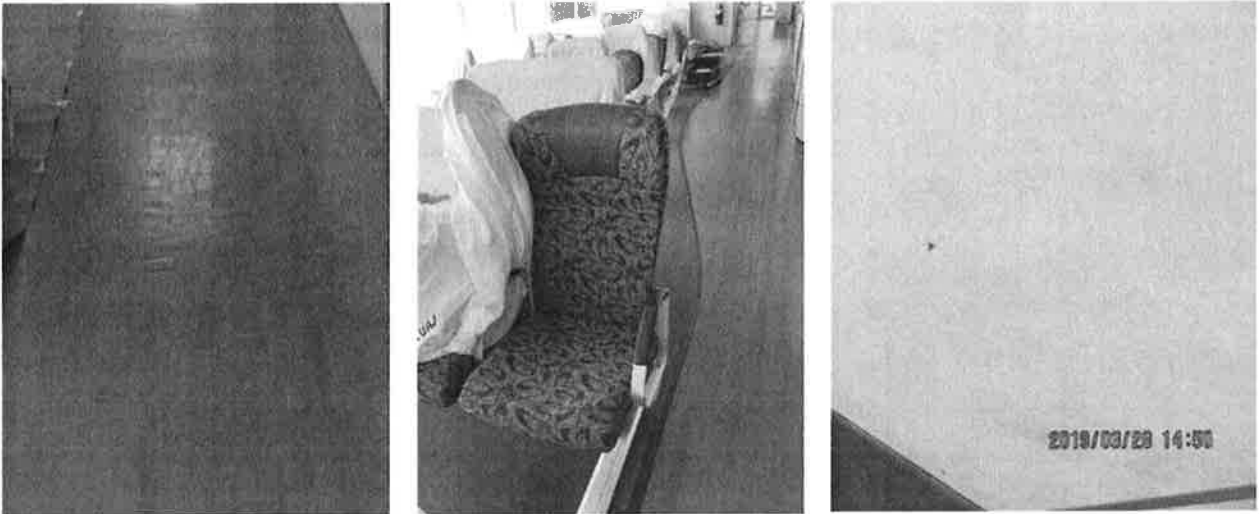
The Forward Observation Lounge is in good condition. In 2014, the carpeting and faux wood flooring was recommended to be replaced. Both deck covering types were replaced, but some warping or bubbling is now apparent in the replacement flooring. The armrest pads and seat cushions were also recommended for replacement in 2014. The replacement seats are in excellent condition. Minor dents and scratches are apparent in the bulkhead (Figure 15).

Figure 15 Bubbling in faux wood flooring (left), replacement seats (middle), and minor dents in bulkhead (right) in Forward Observation Lounge

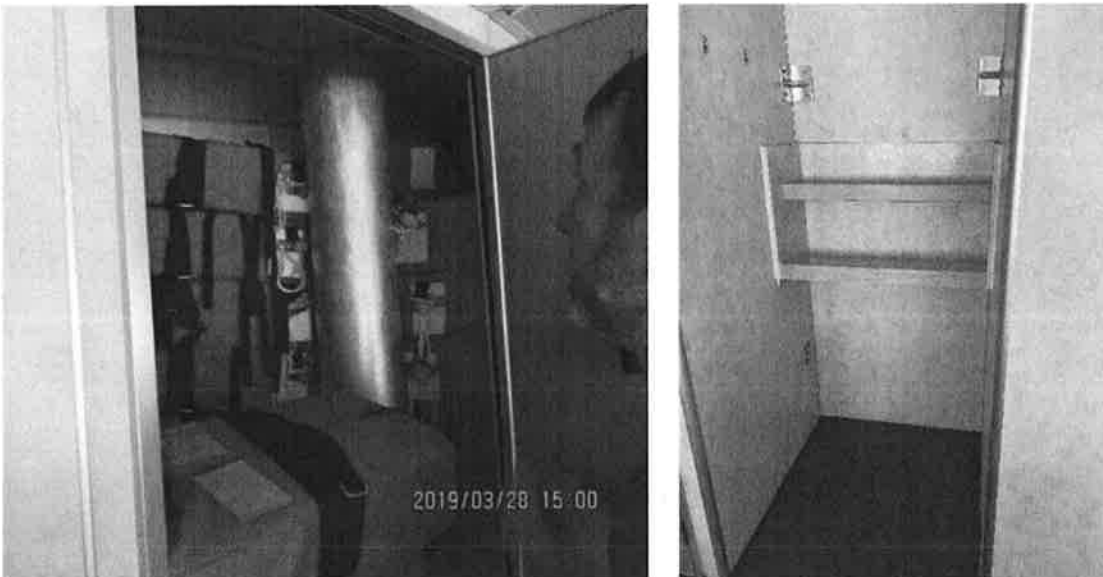
The lifejacket locker is in good condition. Next to the lifejacket locker, bracing leftover from a previous phone booth is still evident, above a recently installed bookshelf (Figure 16).

Figure 16 Lifejacket locker (left) and bracing from former phone booth (right)

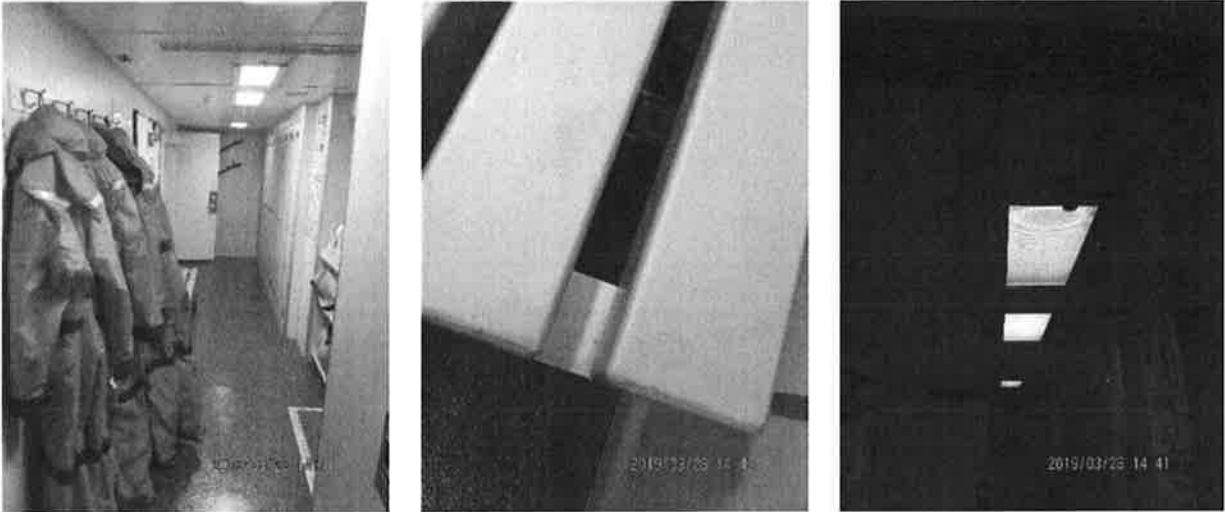
The Crew Locker Room is in good condition. Only minor wear is apparent on the furniture and bulkheads. Some lighting diffusers should be replaced (Figure 17).

Figure 17 Crew Locker (left) with some wear on bench (middle) and diffusers in need of replacement (right)

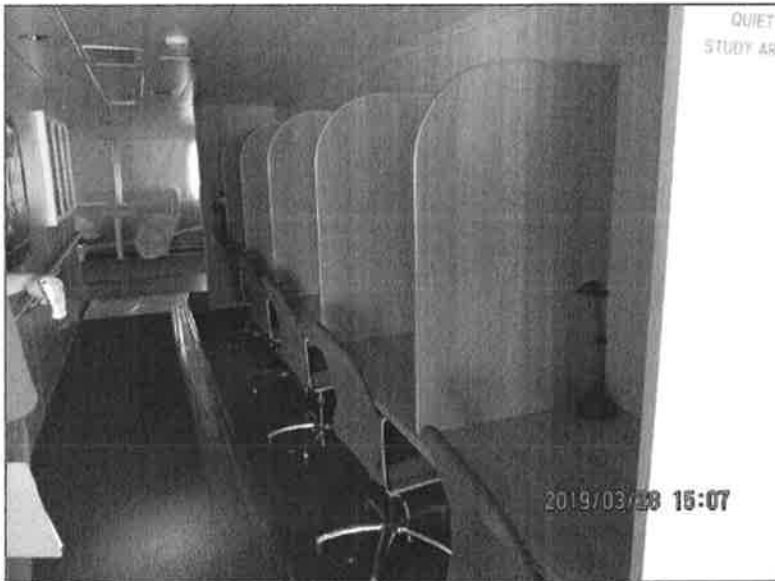
The Quiet Work Area is in excellent condition (Figure 18). During the survey, the crew noted that this space receives minimal use due to lack of outlets for purposes such as charging phones and plugging in laptops. It is recommended to add more outlets to this space.

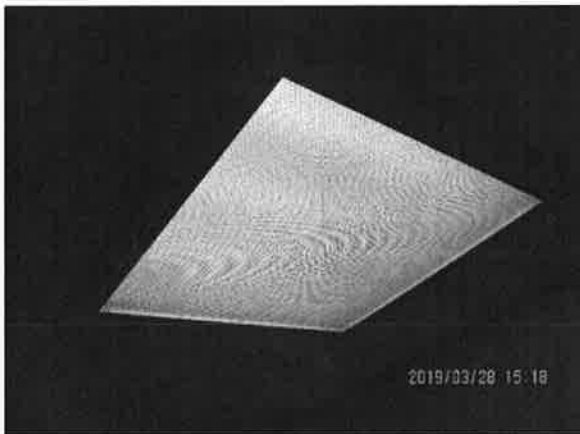
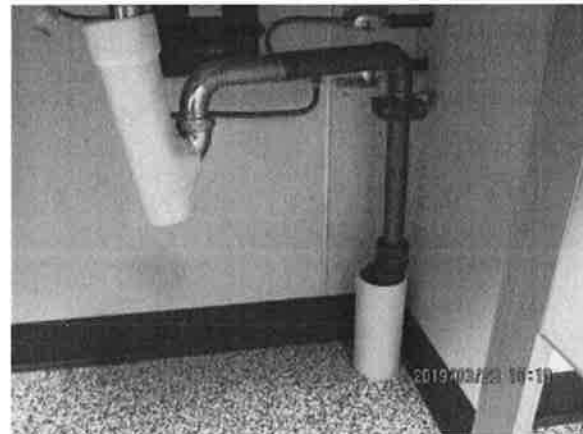
Minor diffuser discoloration is apparent in both the Men's (Port) and Women's (Starboard) Amidships Passenger Heads. There is minor wear around the base of some fixtures, and penetration misalignment is apparent at the base of the sink (Figure 20).

Figure 20 Diffuser discoloration (left) and penetration misalignment (right) in Men's (Port) Amidships Passenger Head

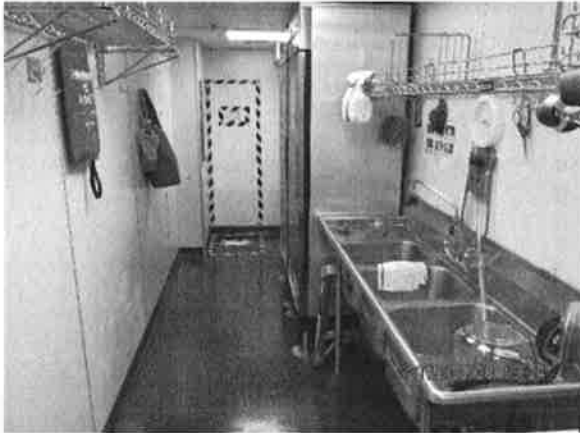
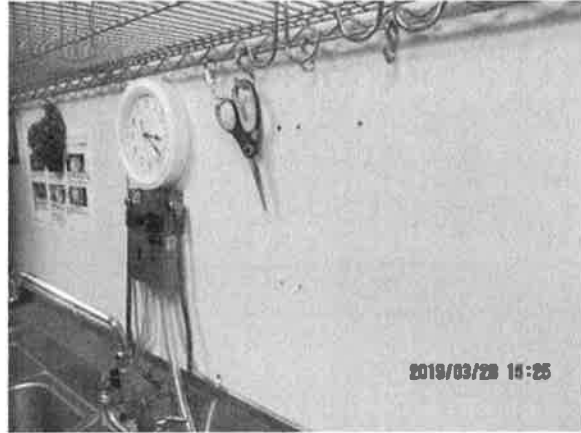
The Storage/Preparation Area is in good condition. Minor holes in the bulkhead are visible from previously moved equipment (Figure 21).

Figure 21 Storage/Preparation Area (left) with minor holes in bulkhead (right)

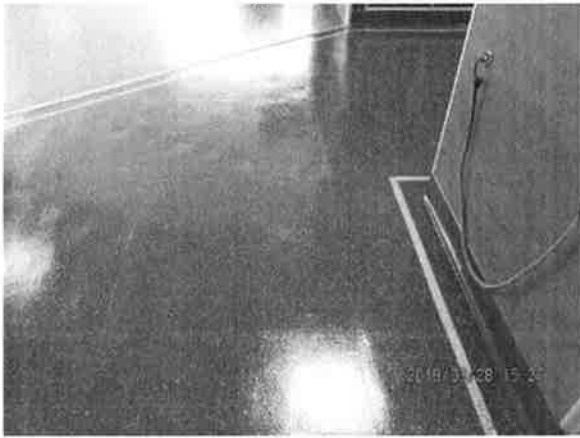
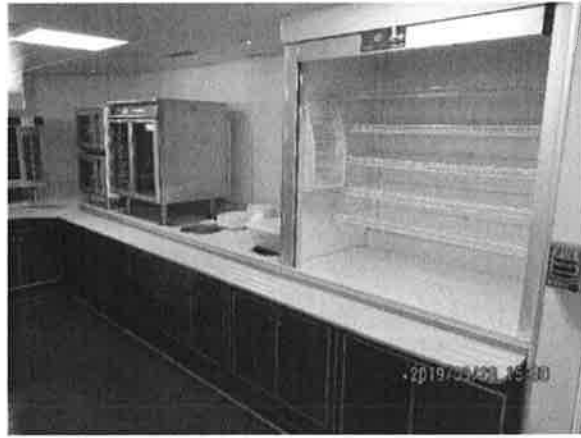
The Food Court is in fair condition. The deck covering is worn and deforming in some areas. Increased lighting would improve visibility in the space (Figure 22).

Figure 22 Worn deck covering (left) and low lighting levels (right) in Food Court

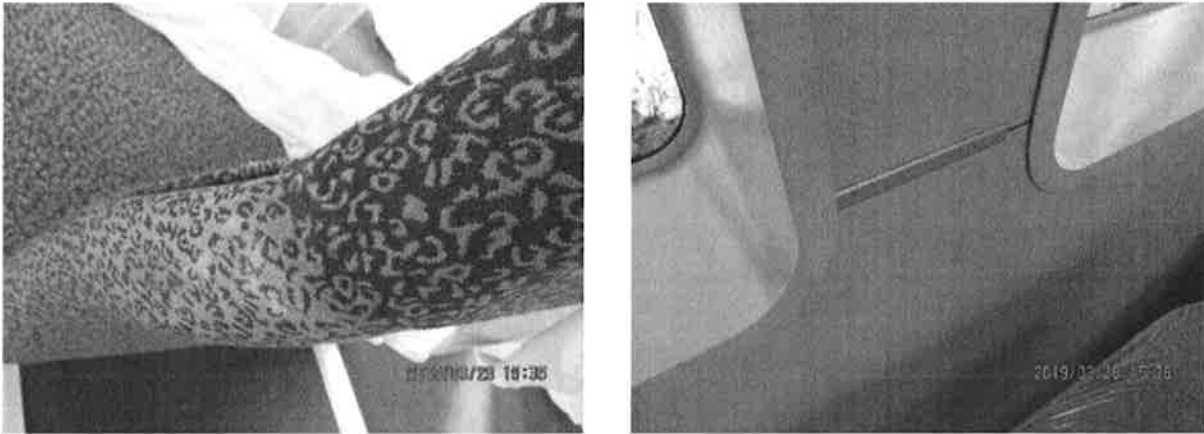
The Snack Bar and seating are in good condition. The deck covering shows minor stains and wear, and minor dents are apparent in the bulkhead. Wear is visible on the seats. Gaps in the bulkhead liner between windows are apparent (Figure 23).

Figure 23 Wear on seats (left) and gaps in bulkhead lining (right) in Snack Bar and seating

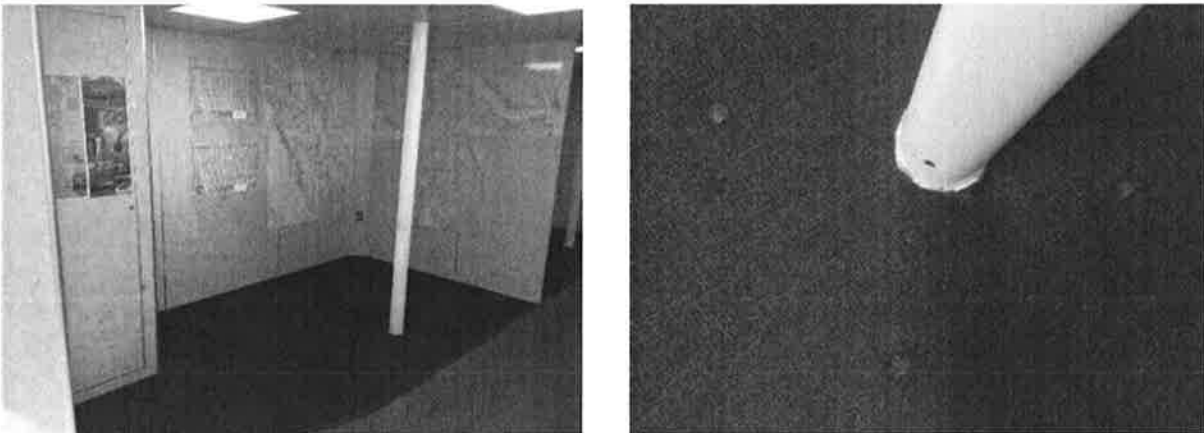
The Information Area is in good condition. The deck covering shows minor stains and wear, and minor dents are apparent in the bulkhead (Figure 24).

Figure 24 Information Area (left) with minor wear in carpet (right)

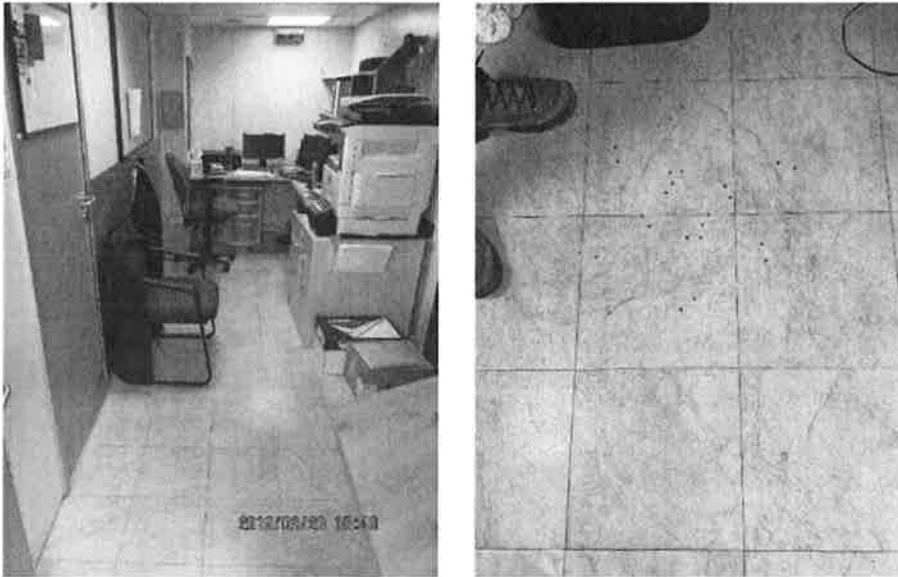
The Passenger Service Office is in fair condition. The deck covering is damaged by holes and should be replaced (Figure 25).

Figure 25 Passenger Service Office (left) with holes in deck covering (right)

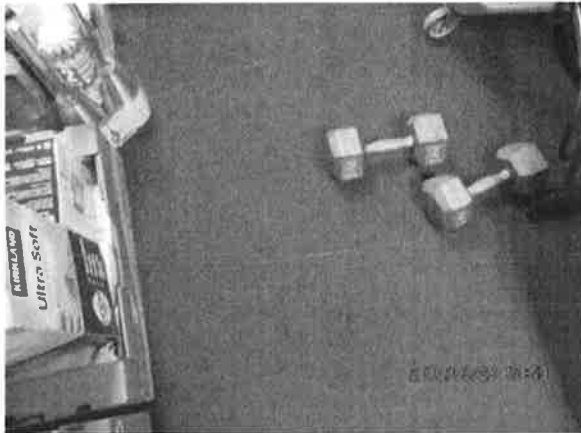
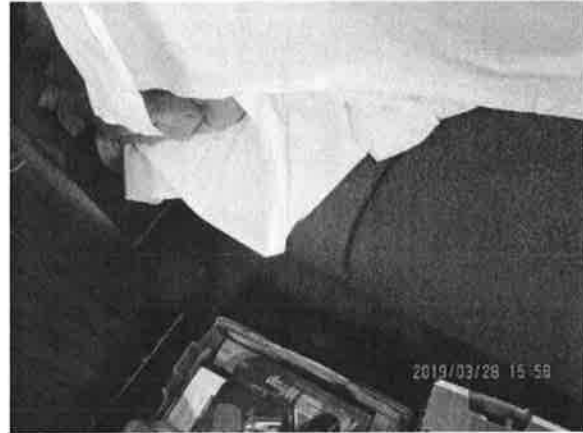
The Children's Play Area is in good condition. Seams are evident in the carpet, and the furnishings are lightly worn (Figure 27).

Figure 27 Apparent seams (left) and lightly worn furnishings (right) in Children's Play Area

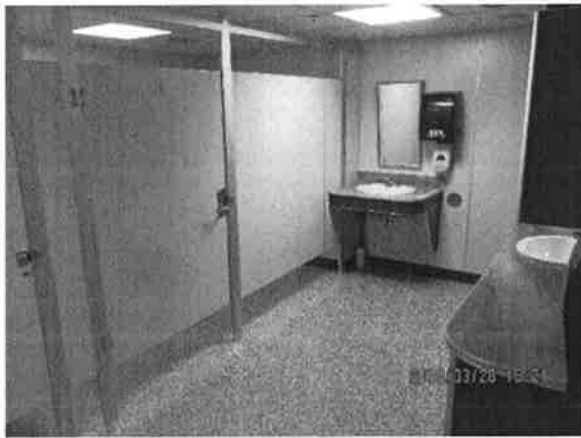
The Aft Passenger Heads are in good condition. Minor dents and wear are evident in the bulkhead partitions in the Women's (Stbd) Aft Passenger Head (Figure 28).

Figure 28 Women's (Starboard) Aft Passenger Head (left) and minor dent in partitions (right)

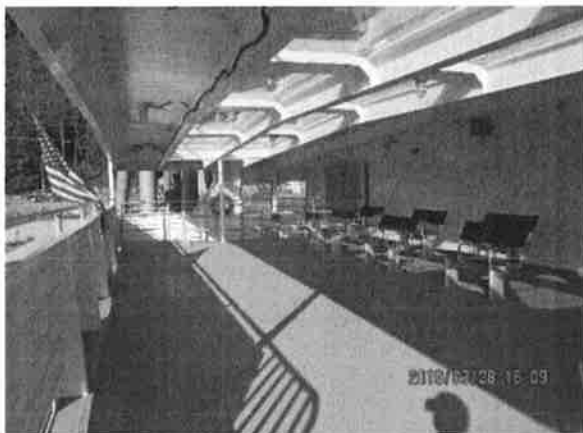
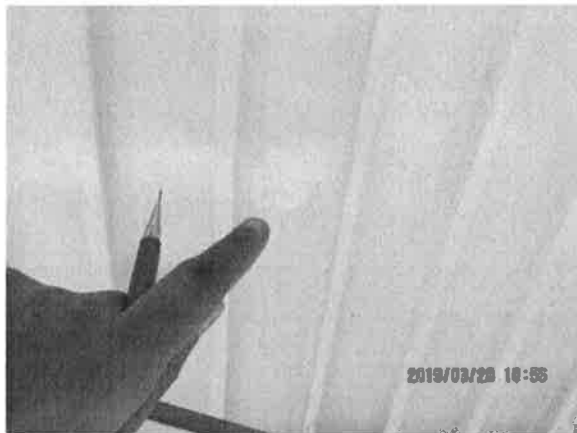
The Solarium is in fair condition. A hole has worn through the overhead. Either this hole should be repaired, or the overhead should be replaced (Figure 29).

Figure 29 Solarium (left) and hole in Solarium overhead (right)

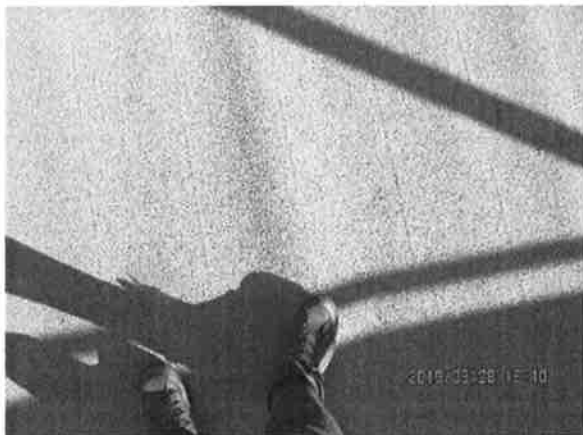
Stains and deck deformation are evident in the deck covering, and it is uneven in places. Paint is peeling on the bulkhead in some places, such as the overhead windows (Figure 30).

Figure 30 Deck deformation (left) and overhead window paint peeling (right) in Solarium

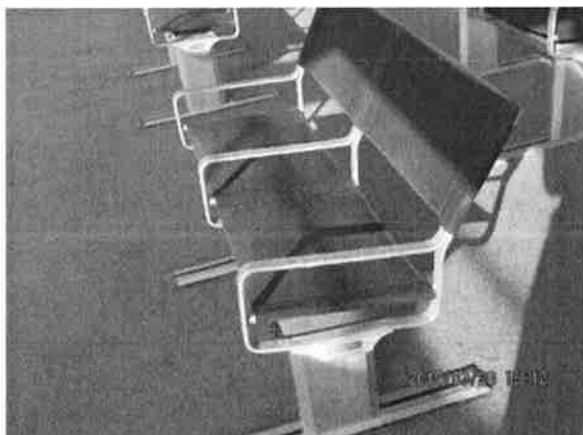
The furniture shows wear. The space would benefit from replacing the furniture with heartier, more robust furniture suited to the ferry route climates (Figure 31).

Figure 31 Furniture in Solarium

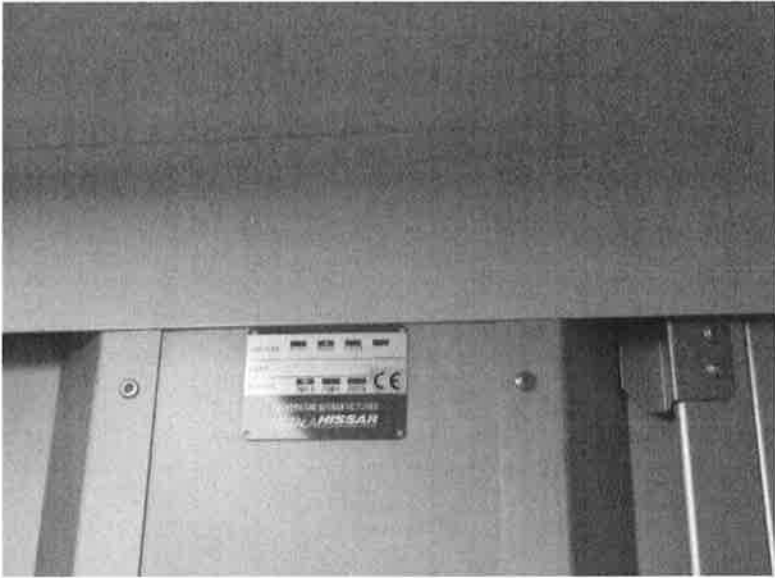
Figure 45 Minor spots in overhead of Passenger Elevator

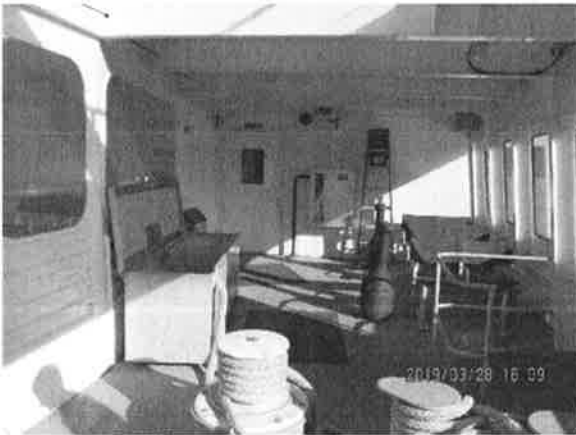
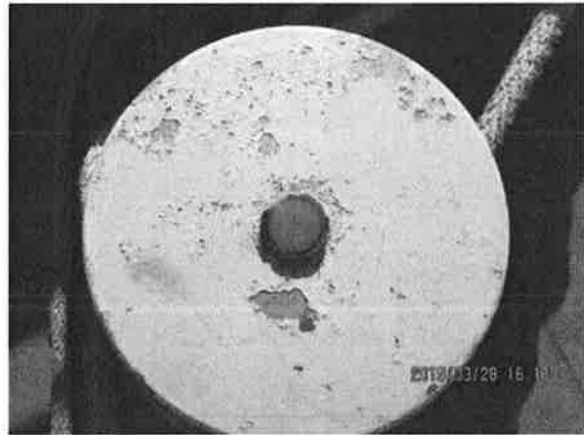
Figure 47 Paint peeling on mooring capstan on Solarium Deck

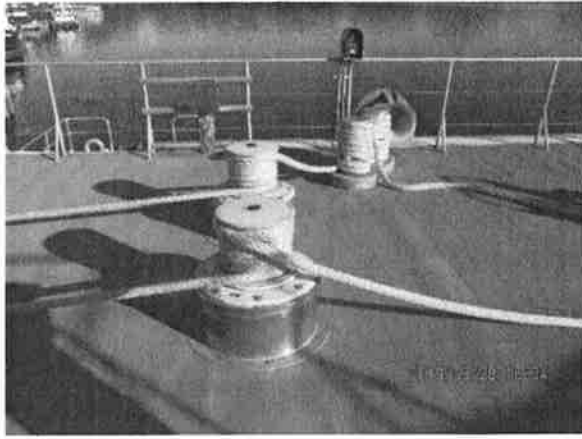
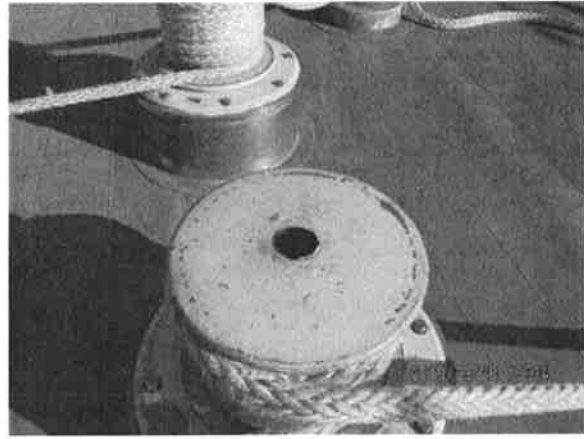
Figure 48 Paint peeling on mooring capstan on Forward Mooring Deck
