# 2016 BULK FUEL UPGRADES LETTER REPORT CHALKYITSIK, ALASKA

AUGUST 2016

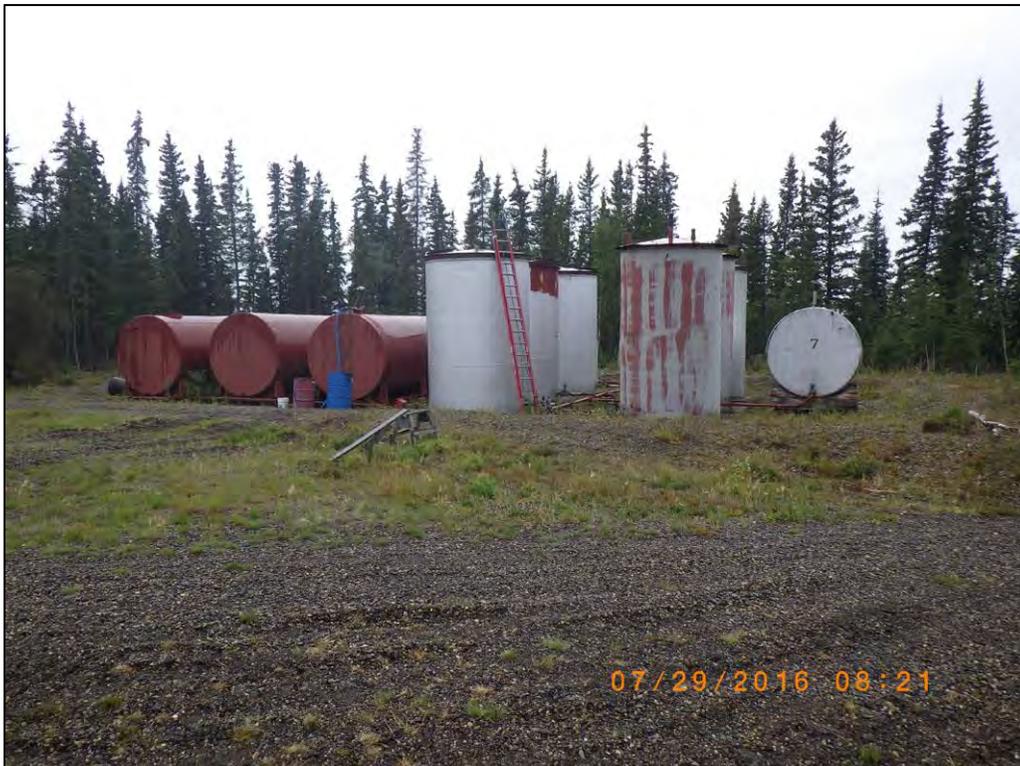
Photograph 2: Tank Farm #1; red horizontal tanks are owned by Chalkyitsik Village (Power Plant) and remainder are owned by the Yukon Flats School District (Tsuk Taih school)

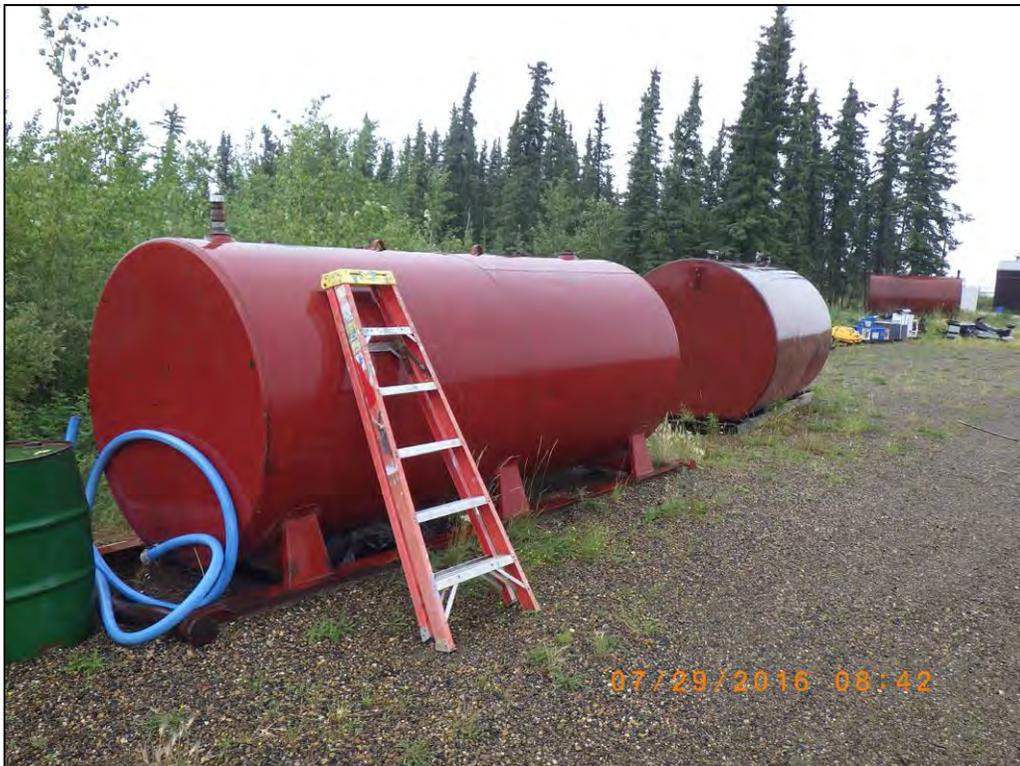
Photograph 14: Tank Farm #4 airstrip tanks; tank in background not-in-service

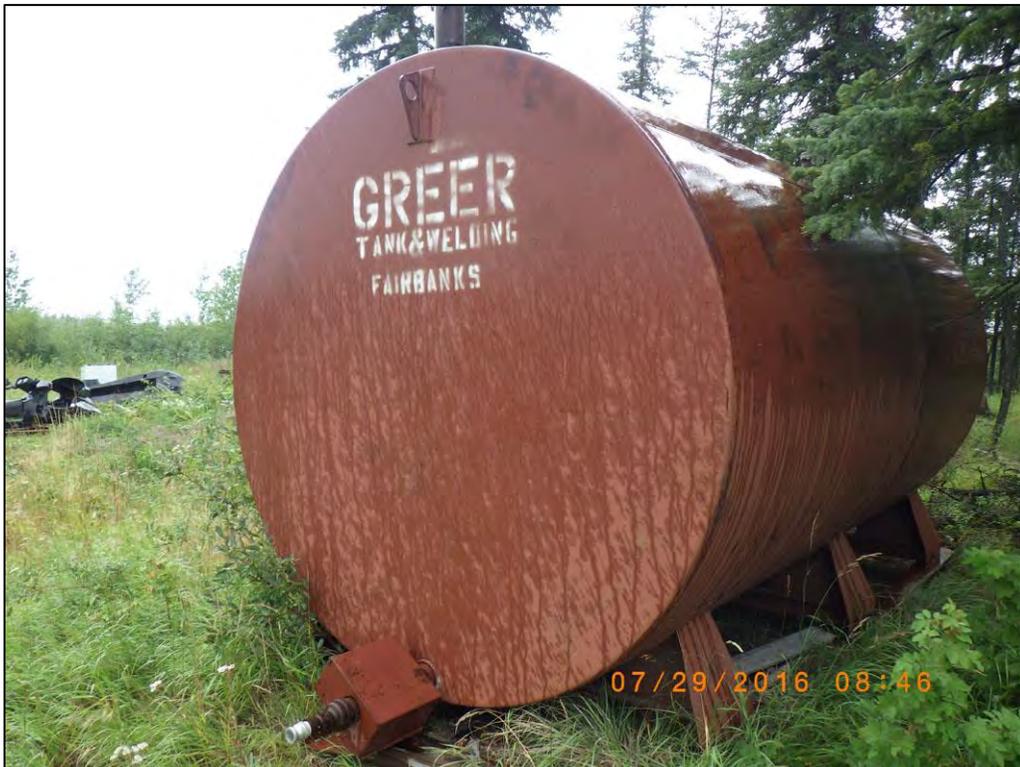
Photograph 16: Tank Farm #4 airstrip tanks; tank not-in-service
