PALMER CORRECTIONAL CENTER - DEFERRED MAINTENANCE

65% REVIEW DOCUMENTS

ROOF ASBESTOS & LEAD
SAMPLE LOCATIONS & RESULTS

H201

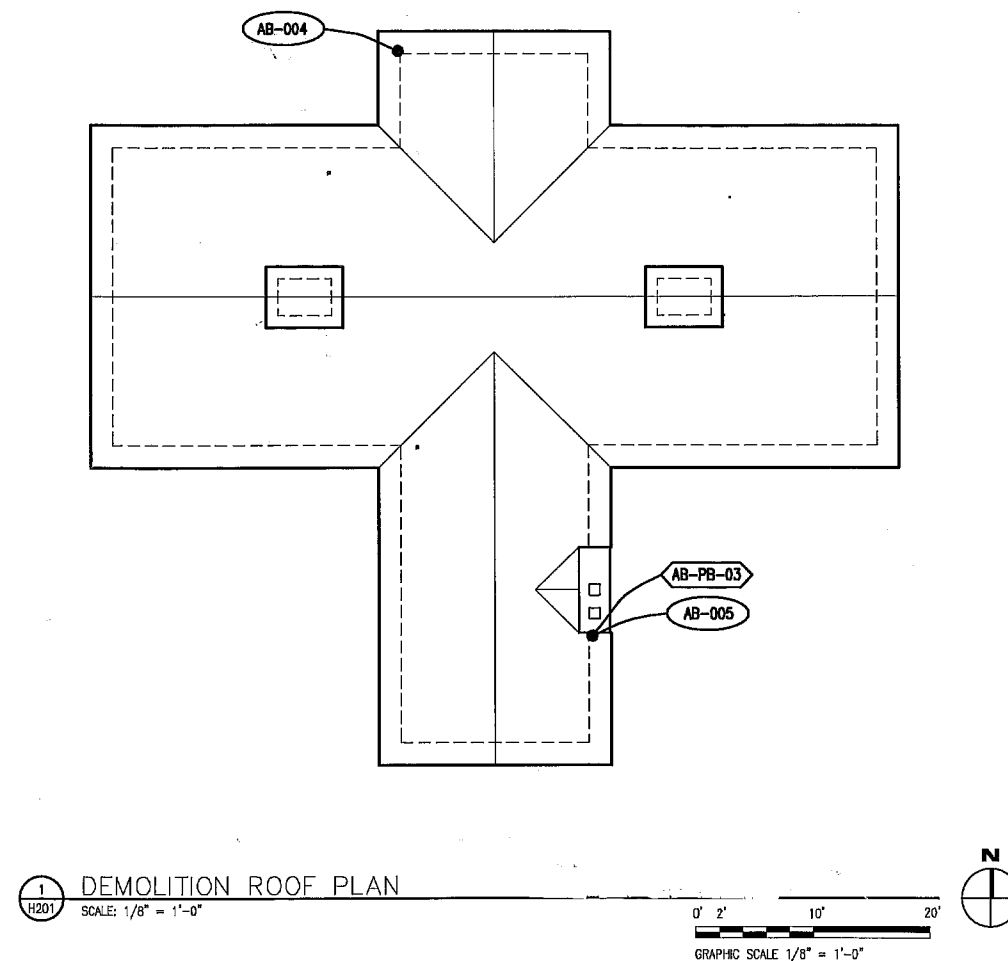
Asbestos Sample Results (Method EPA 600/R-93/116)			
Sample ID	Location	Description	Result
AB-004	Admin Building Northeast Entrance	Tar Shingle Roofing and Silver Sealant	ND
AB-005	Admin Building Southwest Chimney	Tar Shingle Roofing and Silver Sealant	ND
Lead Sample Results (Method SW 846 3050B/7000B)			
Sample ID	Description	Location	Result
AB-PB-03	Green paint on concrete (2" by .5")	Admin Building Chimney	0.1
