Attachment A
FVF Chenega Condition Report

2018 - 2019 FLEET CONDITION SURVEY

FVF CHENEGA

29 APRIL 2019
FILE NO.19041.01
REV.-

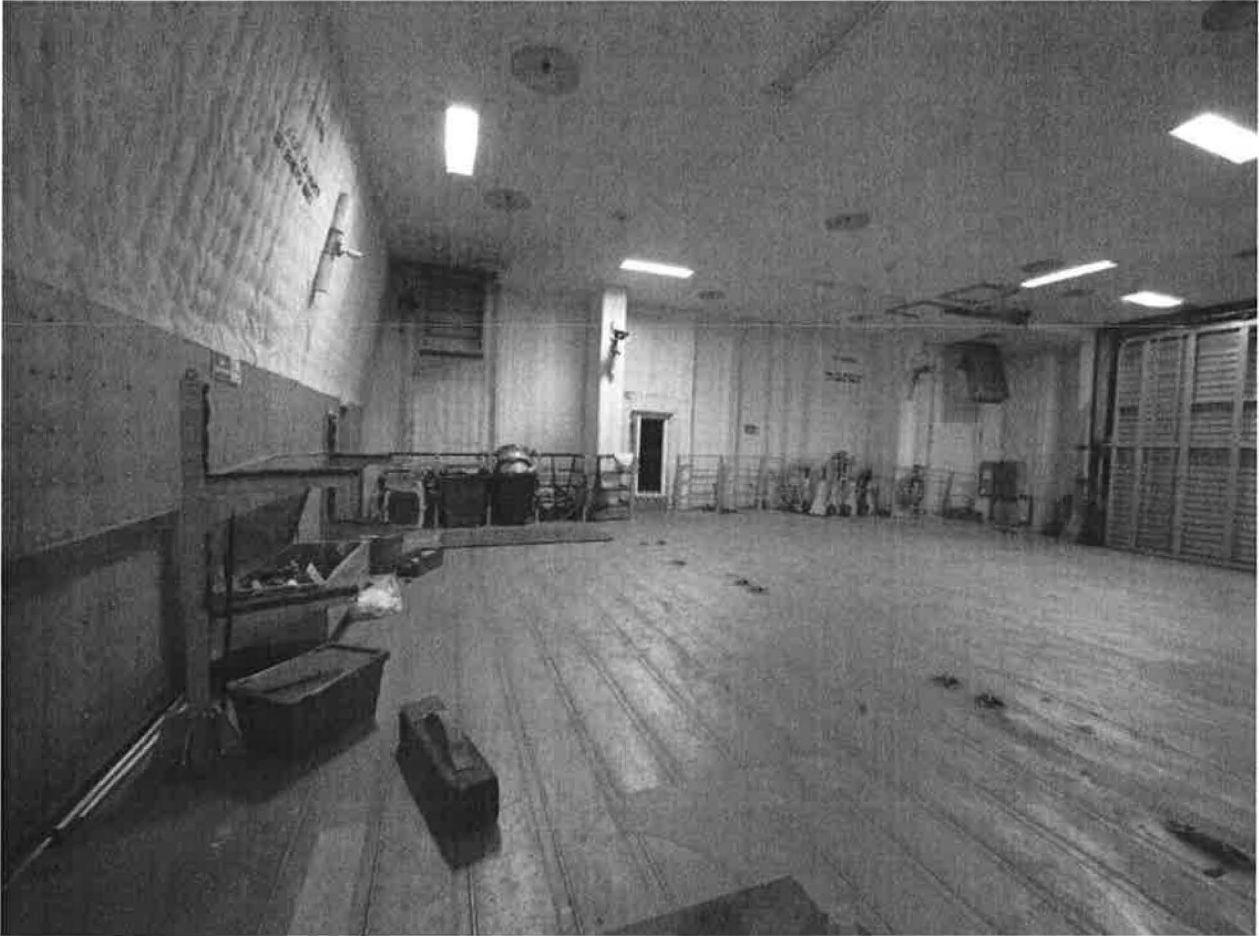
The vehicle deck bulkheads and overhead are entirely covered by insulation (Figure 1). There is no evidence of corrosion or cracking.

Figure 1 Vehicle deck view looking forward towards side door; insulation visible at sides and overhead

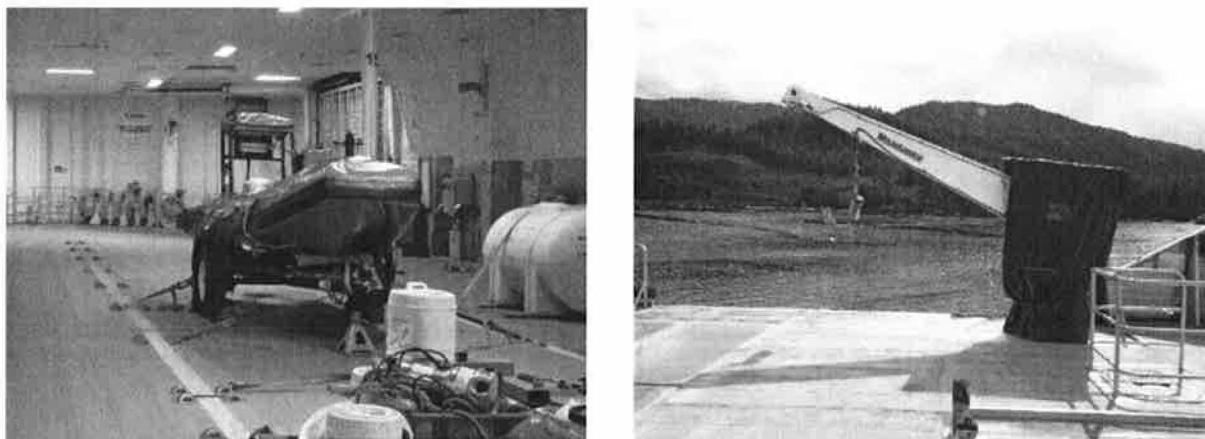
The rescue boat is currently secured on the Vehicle Deck, and the davit is installed on the House Top. Both are in good condition (Figure 2).

Figure 2 Rescue boat secured on Vehicle Deck; davit installed on House Top

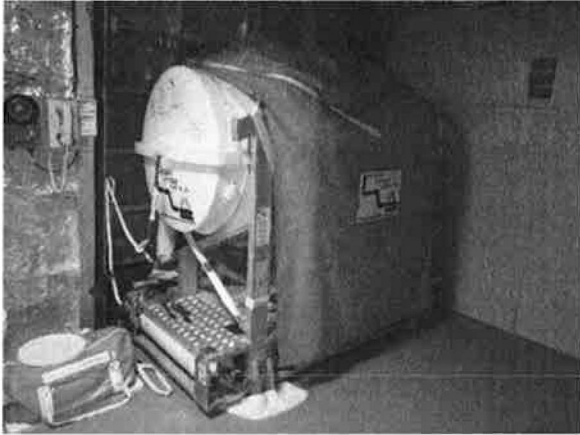
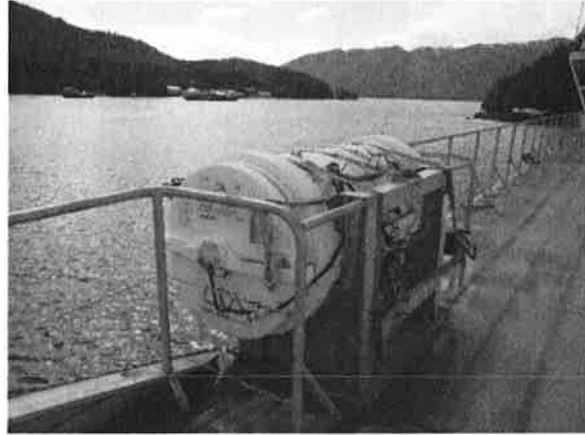
Figure 3 (Left) Slide/Life Raft unit in Starboard MES; (Right) Life Raft unit on House Top, Port

The MES equipment is manufactured and serviced by Liferaft Systems Australia. The equipment is in excellent condition.

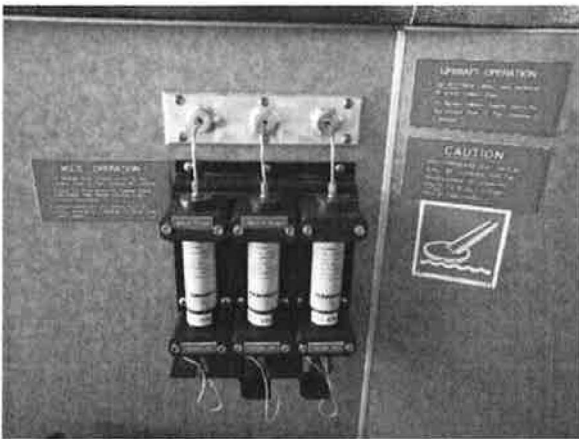
Figure 4 Remote deploying of MES, in Pilothouse

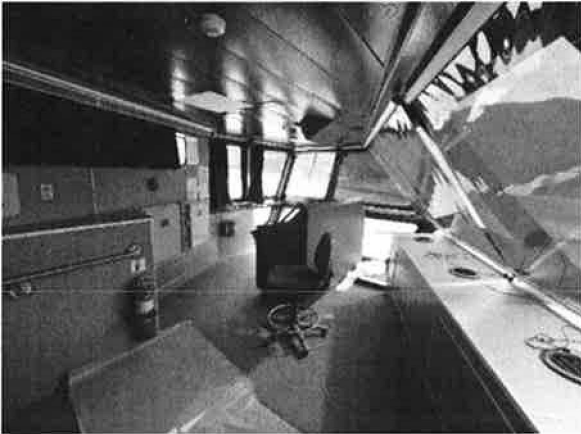
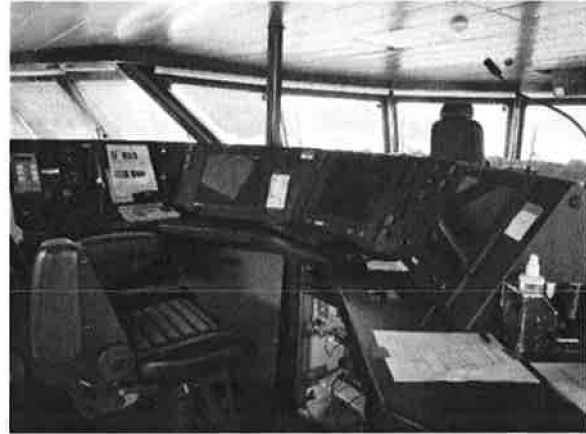
Figure 5 Pilothouse on Bridge Deck

The Pilothouse is generally in excellent condition (Figure 5).

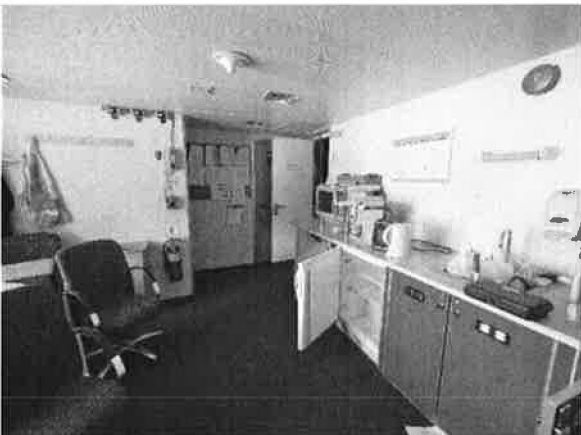
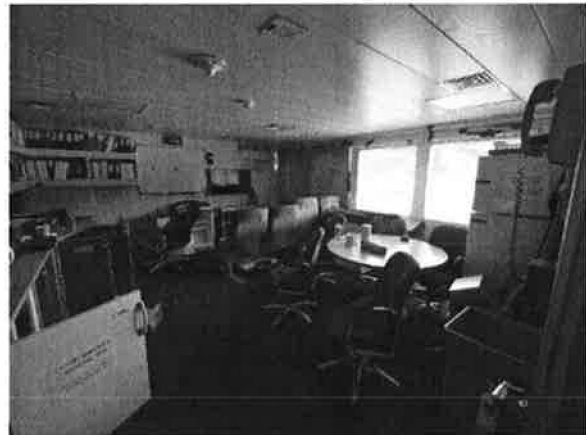
Figure 6 Crew Day Room on Bridge Deck

The Crew Day Room is in good condition. Appliances should be cleaned and polished as applicable. Stains, wear, and deformation are evident on the carpet; it should be cleaned or replaced (Figure 6).

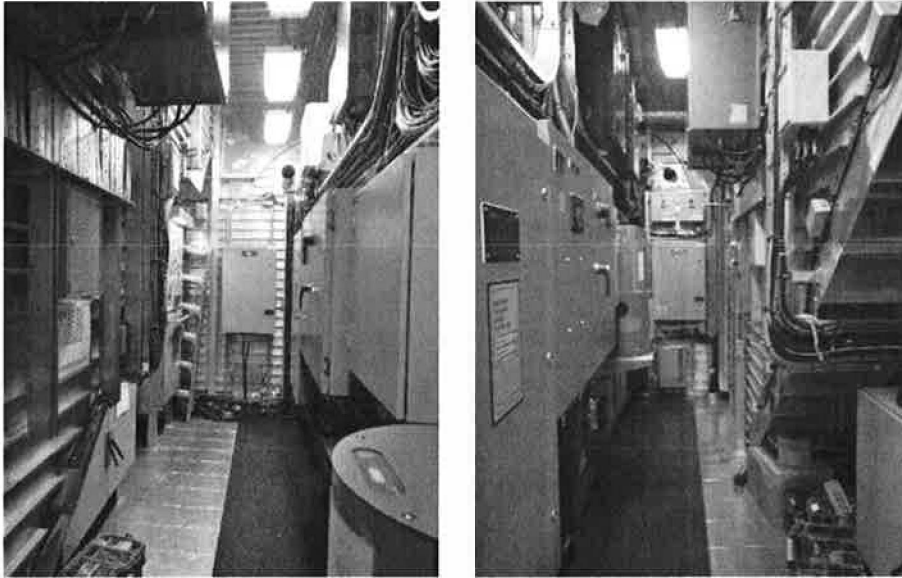
Figure 7 Bridge Electrical Room on Bridge Deck

The Bridge Electrical Room is in excellent condition (Figure 7).

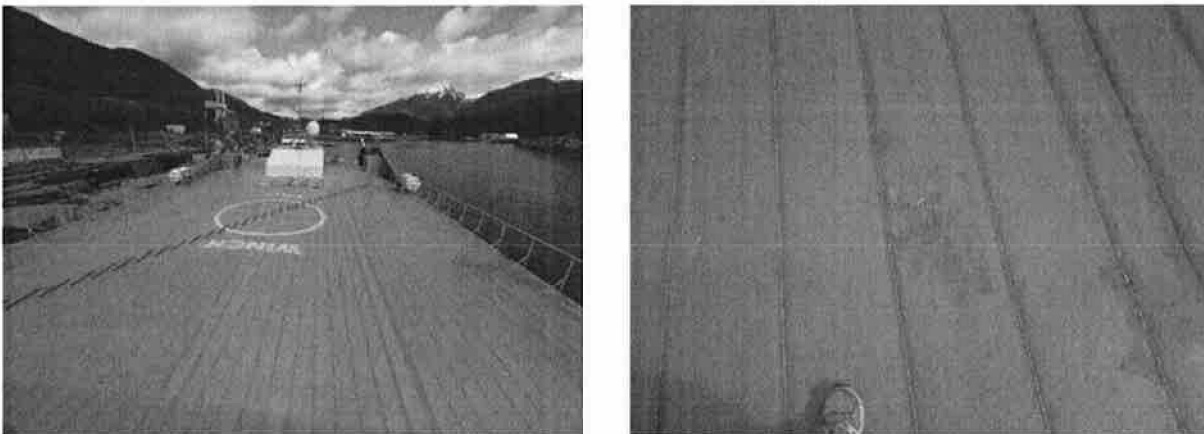
The House Top is in good condition. Small regions of repair are evident in some areas (Figure 8).

Figure 8 House Top (left) with repair evident (right) on Bridge Deck

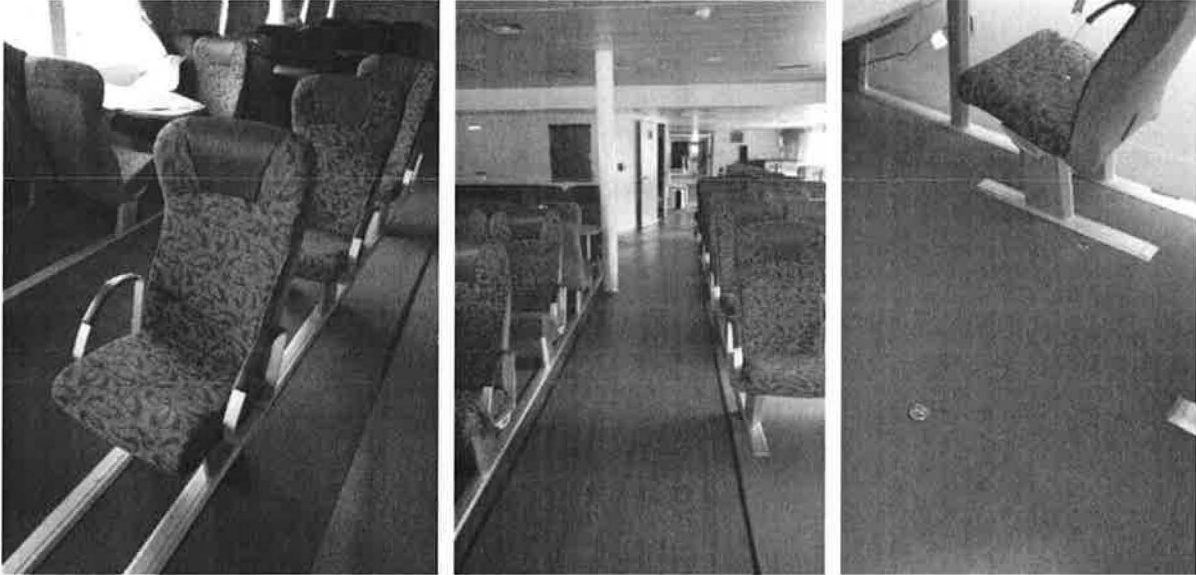
The Forward Observation Lounge is in excellent condition. In 2014, the carpeting and faux wood flooring were recommended to be replaced. Both deck covering types were replaced and are now in excellent condition. The armrest pads and seat cushions were also recommended for replacement in 2014. The replacement seats are in excellent condition (Figure 9).

Figure 9 Replacement seats (left), replacement faux wood flooring (middle), and replacement carpet (right) in Forward Observation Lounge

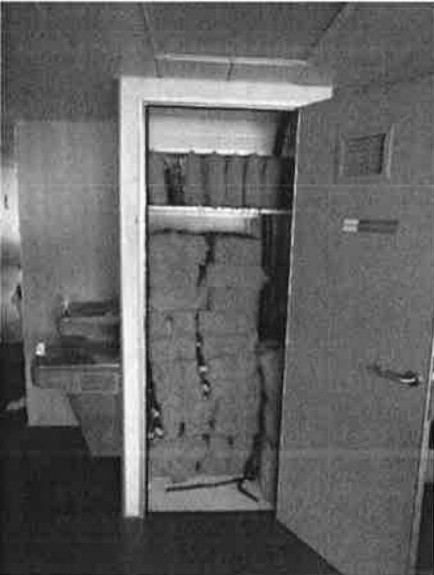
Figure 10 Lifejacket locker on Passenger Deck

The lifejacket locker is in excellent condition (Figure 10).

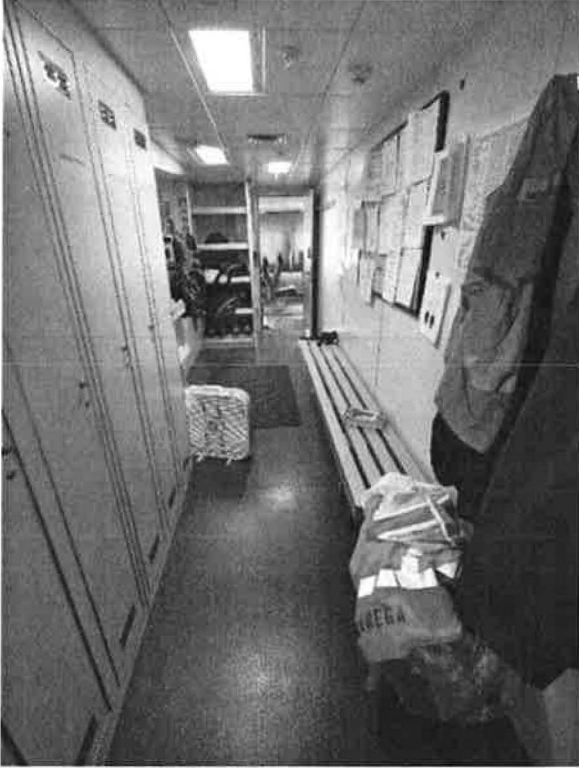
Figure 11 Crew Locker on Passenger Deck

The Crew Locker Room is in excellent condition (Figure 11).

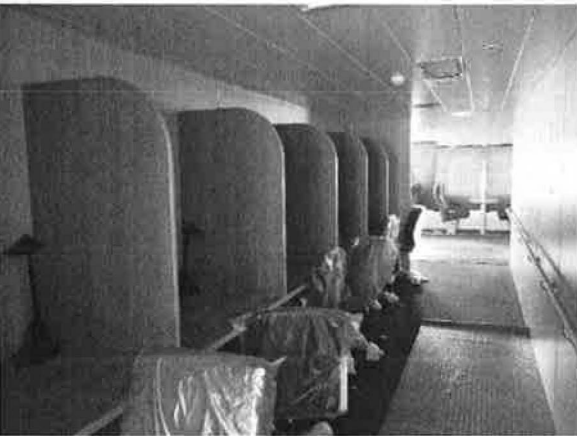
Figure 12 Quiet Work Area on Passenger Deck

The Quiet Work Area is in excellent condition (Figure 12). During the survey on the *Fairweather*, the crew noted that this space receives minimal use due to lack of outlets for purposes such as charging phones and plugging in laptops. It is recommended to add more outlets to this space.

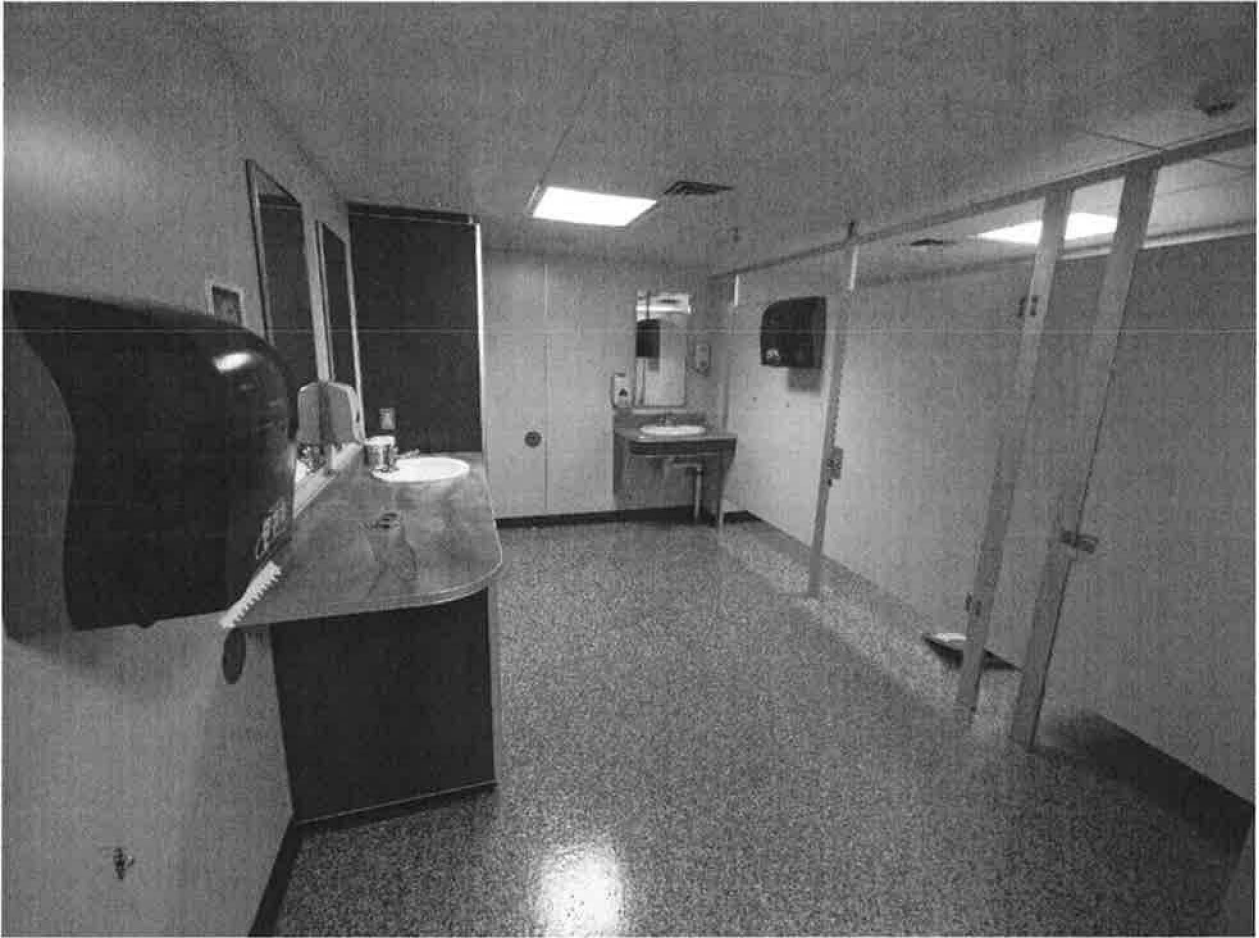
Figure 13 Passenger Head on Passenger Deck

The Passenger Heads (Amidships and Aft) are in good condition (Figure 13). Deck coverings and overhead are in excellent condition.

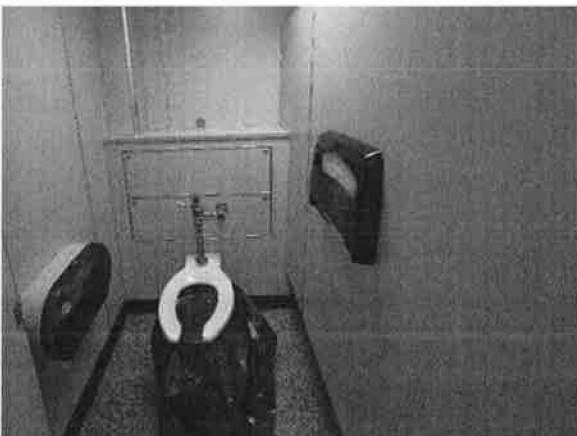
Some appliances are discolored and should be replaced (Figure 14).

Figure 14 Appliance discoloration in Passenger Head on Passenger Deck

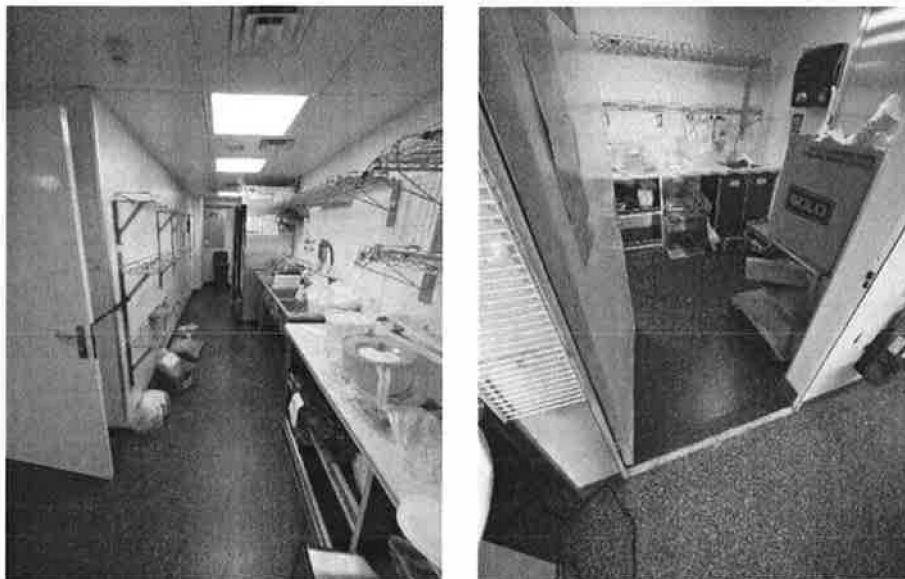
The Storage/Preparation Area is in good condition. The deck covering is stained and worn in some areas and should be replaced (Figure 15).

Figure 15 Worn deck covering evident in Storage/Preparation Area (left) and Storage/Preparation Area threshold (right) on Passenger Deck

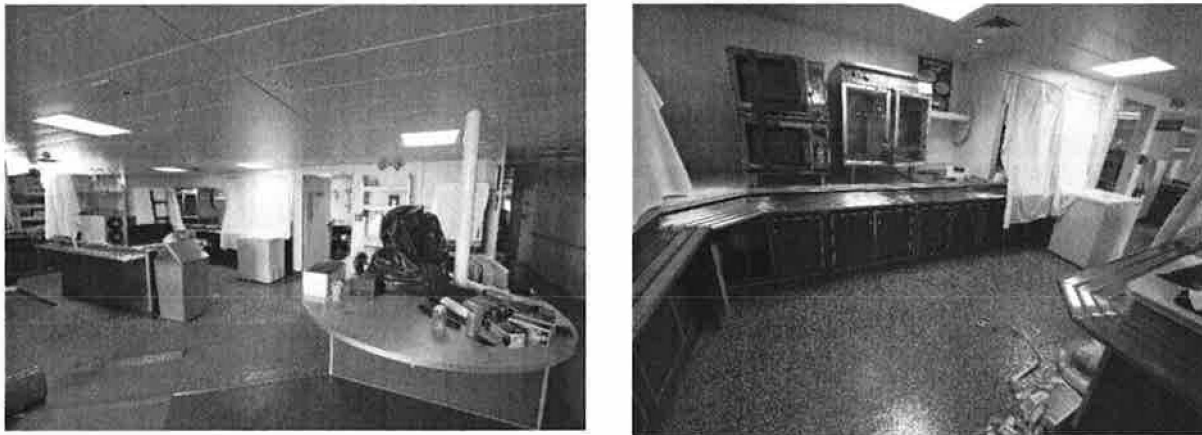
The Food Court is in good condition. The deck covering is discolored in some areas and should be cleaned or replaced. Increased lighting would improve visibility in the space (Figure 16).

Figure 16 Worn deck covering (left) and low lighting levels (right) in Food Court

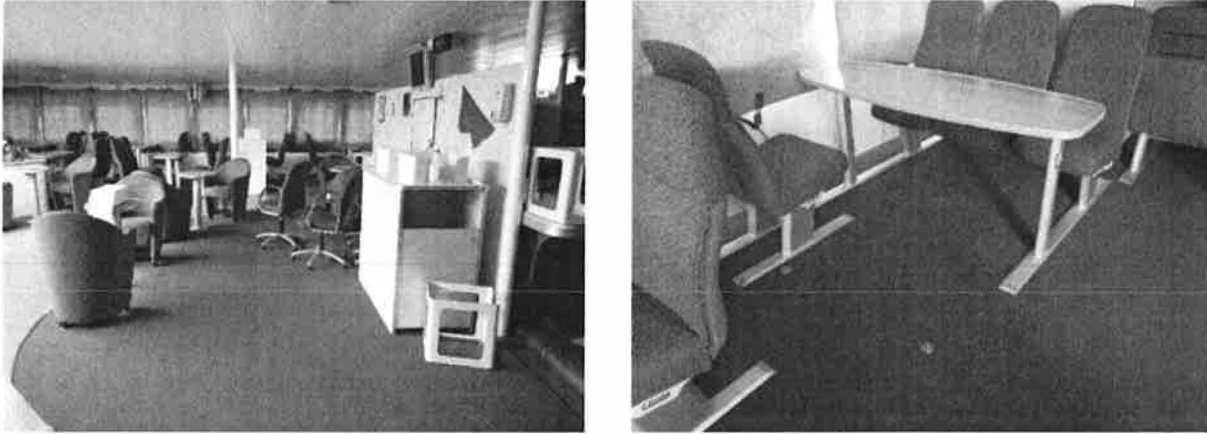
The Snack Bar and seating are in good condition. The deck covering shows minor stains with seams evident; it should be cleaned. The bucket seating is worn and would benefit from replacement (Figure 17).

Figure 17 Bucket seating (left) and gaps in bulkhead lining (right) in Snack Bar/Seating on Passenger Deck

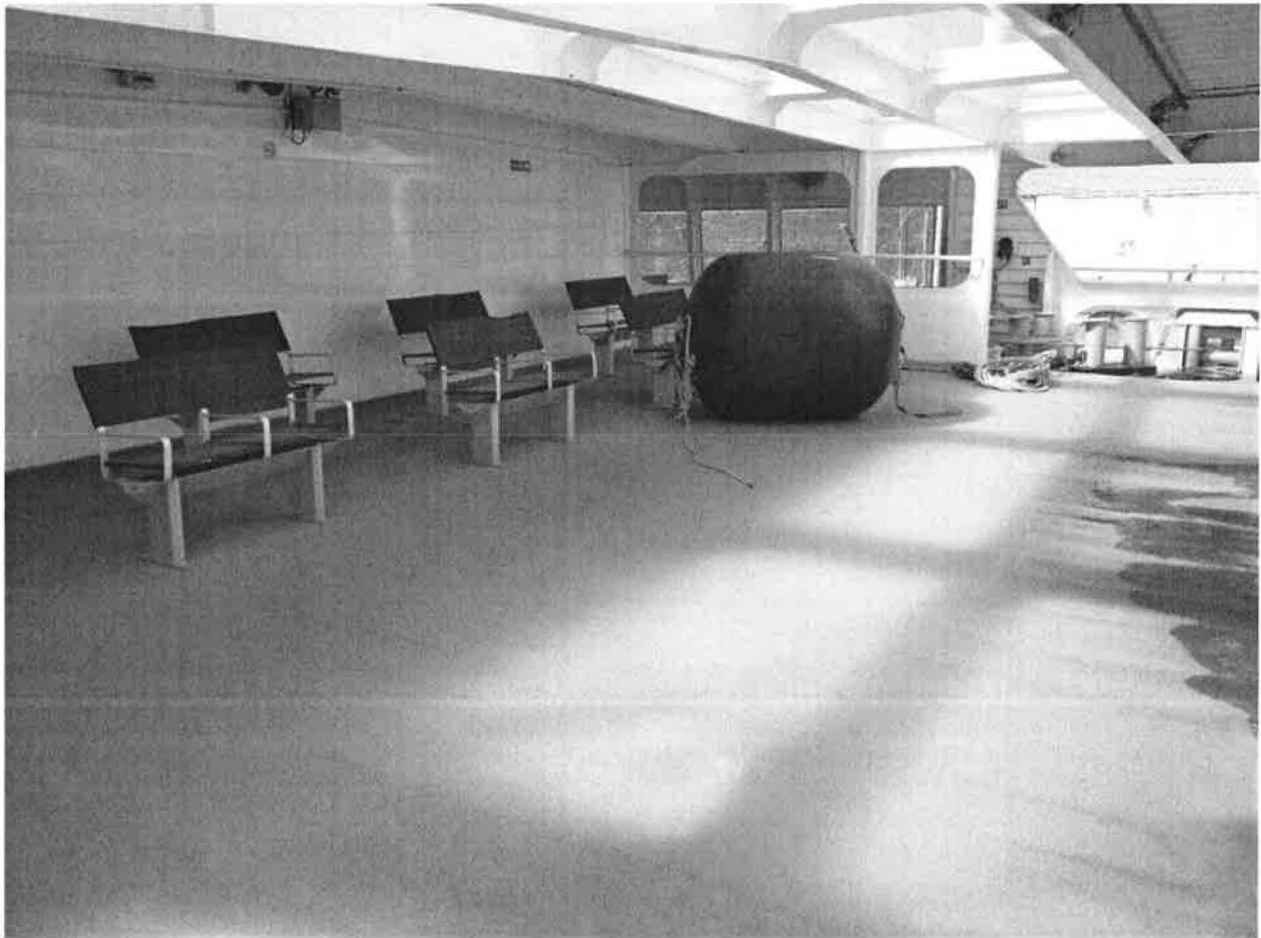
Figure 18 Solarium

The Solarium is in fair condition. Dark stains are evident on the deck covering, which should be replaced (Figure 18).

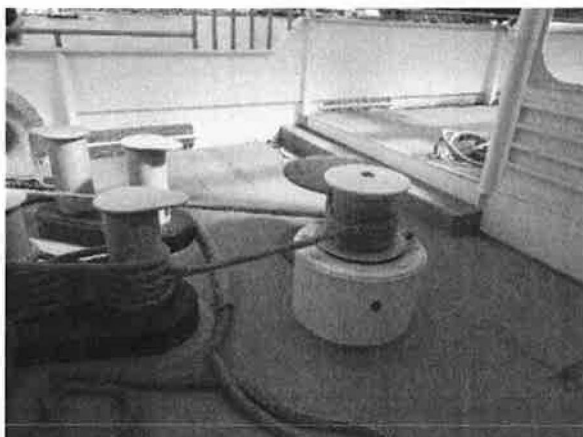
Mooring equipment is in excellent condition and shows no wear (Figure 19).

Figure 19 Mooring equipment in Solarium

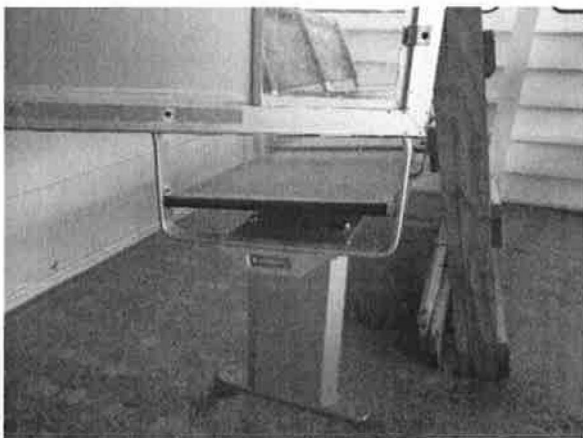
Figure 20 Furniture in Solarium

Despite the minimal use of the vessel, the furniture shows wear. The space would benefit from replacing the furniture with heartier, more robust furniture suited to the ferry route climates (Figure 20).

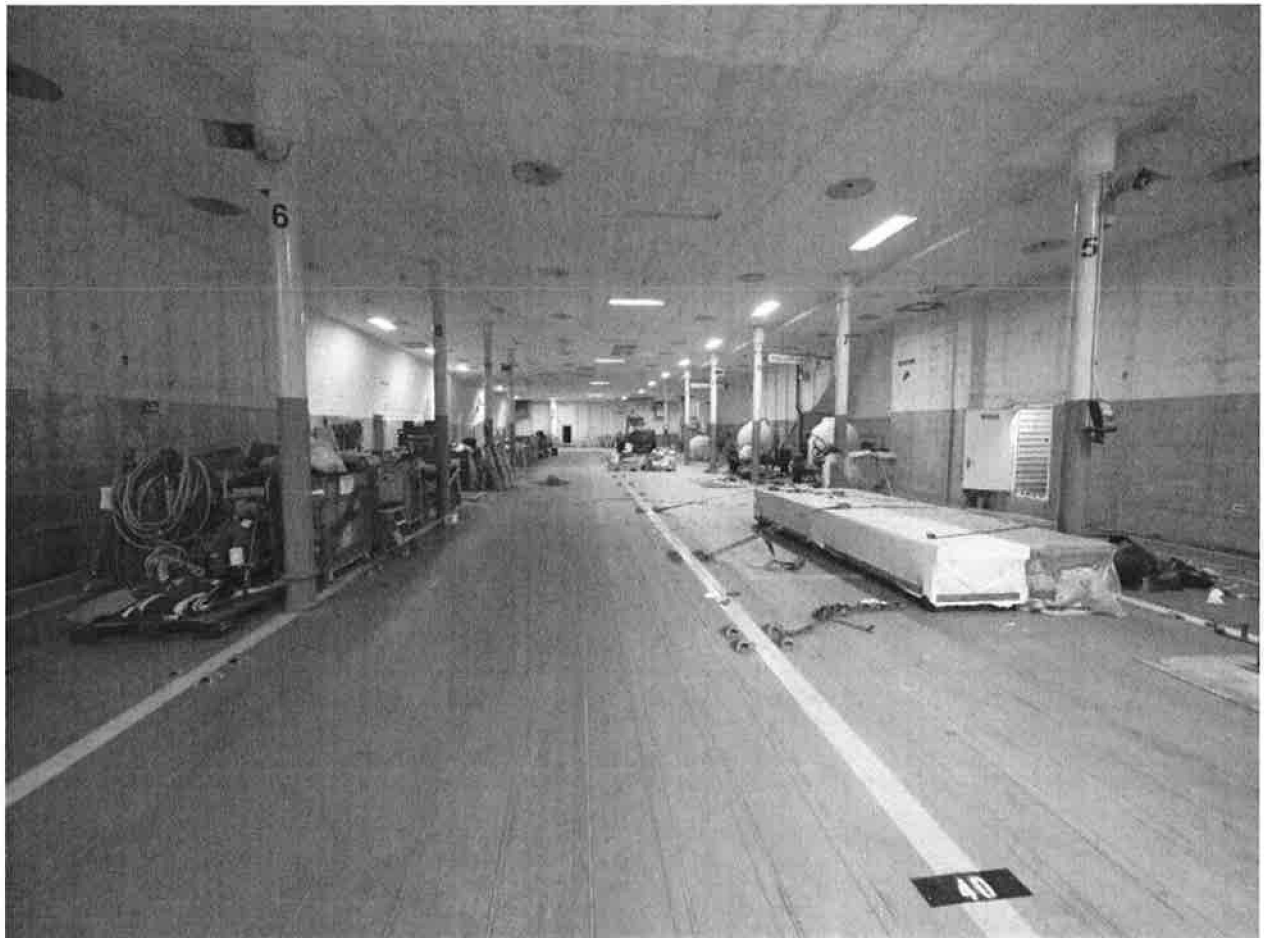
Figure 21 Vehicle Deck, looking forward

The Vehicle Deck is in excellent condition. The bulkheads, lighting, overhead, and structural fire protection appear to be in good condition. Figure 21 shows well maintained bulkheads and lane lines.

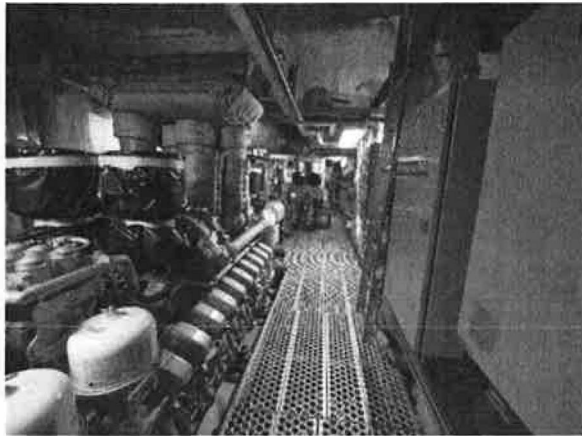
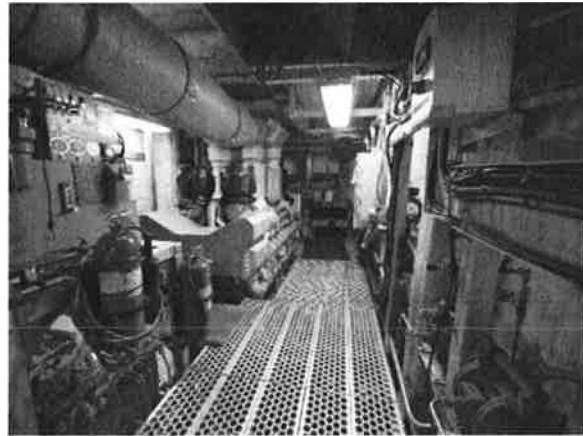
Figure 22 Port Engine Room (left) and Starboard Engine Room (right)

These spaces were not all photographed, but are assumed to be in excellent condition, commensurate with the condition of the Engine Rooms. Similar to the Engine Room (Figure 22), lighting in these spaces is assumed to be very good, and spaces are assumed clean.

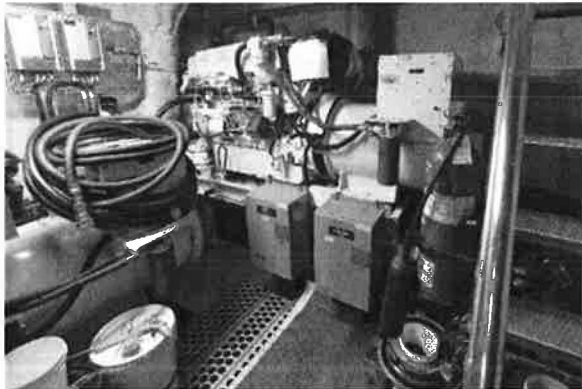
Figure 23 Generator 4 in Port Engine Room

The generators are in excellent condition.

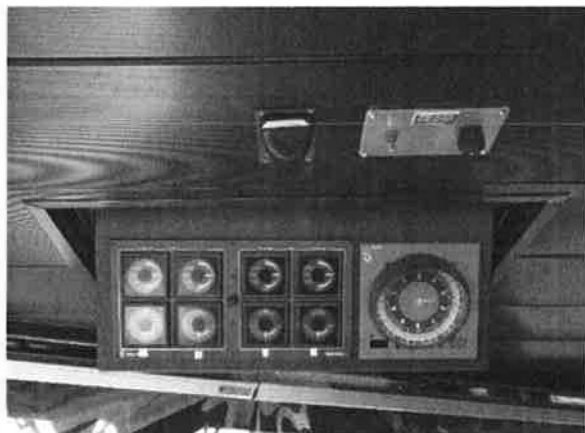
Figure 26 Waterjet steering system in Pilothouse on Bridge Deck

The steering system for the waterjets is hydraulic. The system piping is stainless steel tubing and is in excellent condition. No problems were reported with the system (Figure 26).

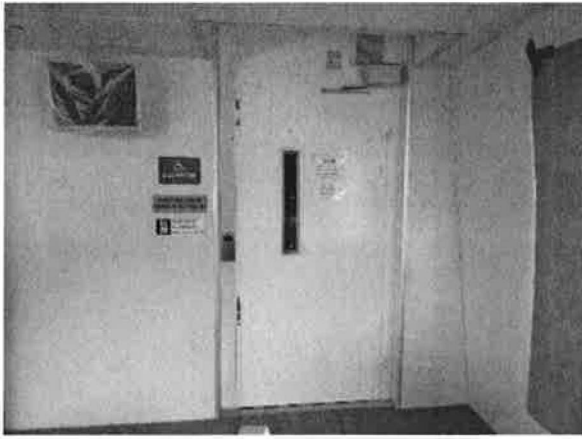
Figure 27 Passenger elevator on Passenger Deck

The elevator system was not tested on this survey but is assumed to be in good condition and functioning normally.

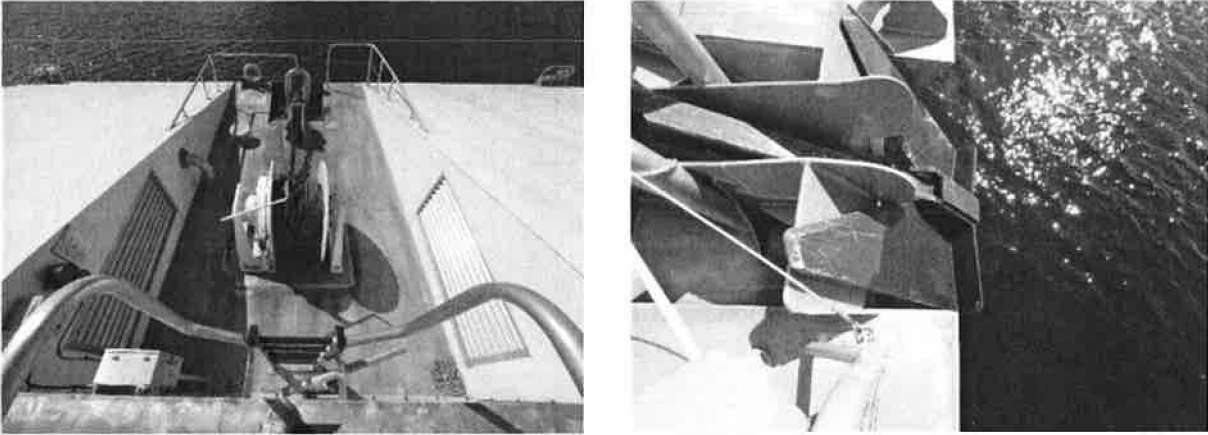
The anchor windlass and chain are in good condition and function normally (Figure 28).

Figure 28 Anchor windlass and chain (left) and anchor close-up (right) from Forward Mooring Deck

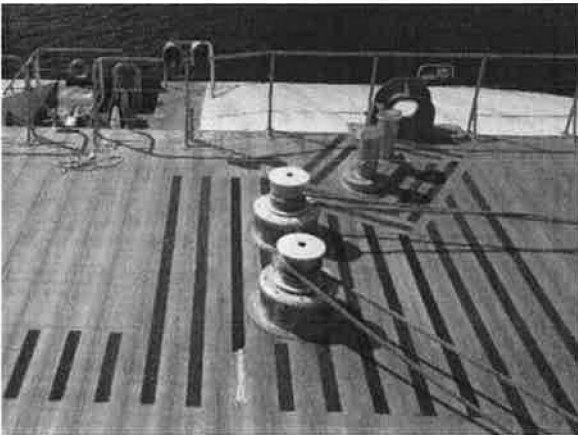
Figure 29 Mooring capstans and fairlead on Forward Mooring Deck

Mooring capstans and fairleads in the Solarium and on the Forward Mooring Deck (Figure 29) are in good condition and function normally.

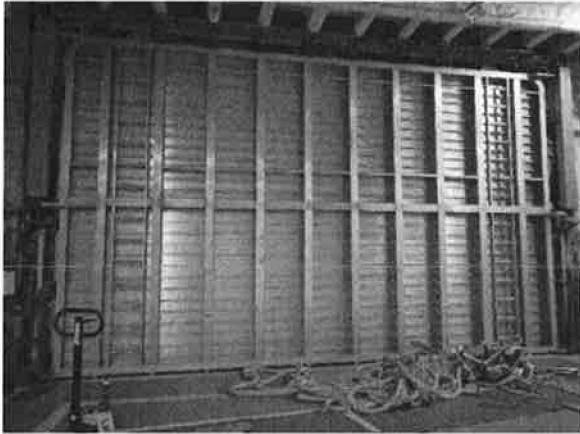
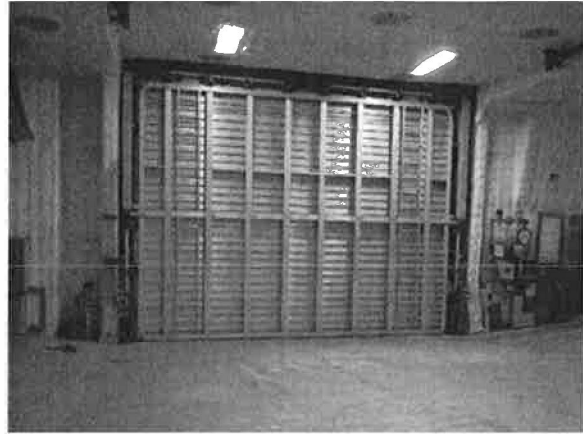
Figure 30 Vehicle Deck stern door (left) and side door (right)

The vehicle deck cargo doors are both in excellent condition with no visual or reported damage. The stern and side door systems were not tested but are assumed to function as intended (Figure 30).
