**Attachment B  
FVF Fairweather Condition Report**

2018 - 2019 FLEET CONDITION SURVEY  
**FVF FAIRWEATHER**

PREPARED FOR  
**ALASKA MARINE HIGHWAY SYSTEM**

29 APRIL 2019  
FILE NO.19041.01  
REV.-

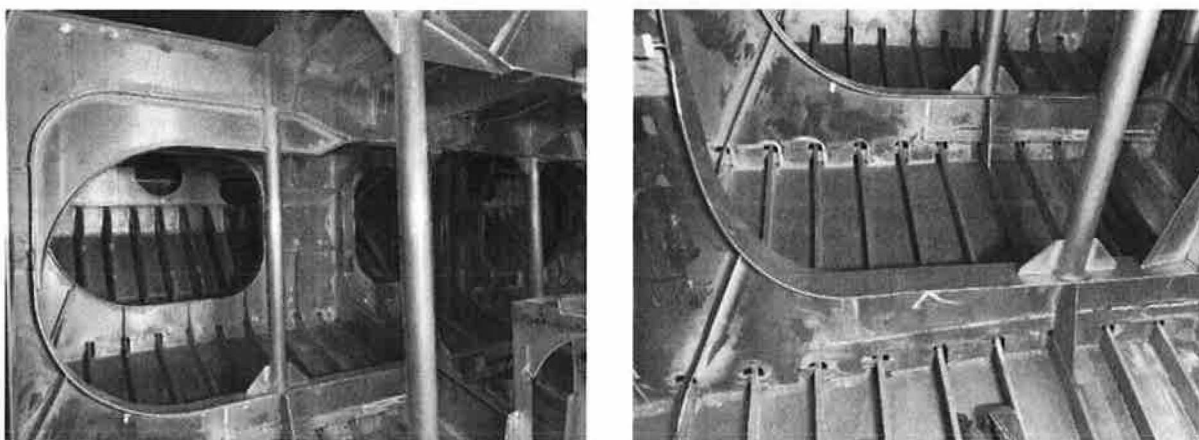
The forepeak suffered wave damage during the first year of operation. This incident resulted in significant deformation of the bottom plating and supporting structure in the vicinity of the centerline, Frames 52 through 58. This damage has been repaired, including redesign and structural modifications to the area. The modifications included adding stanchion connections of bottom structure to deck structure, webframe enhancements, and shell stiffener straightening (Figure 1). Evidence of the repairs is observable. Operating procedures have been modified since the incident and no further damage has resulted.

**Figure 1 Additional stanchions (left) and shell stiffeners (right) in region of earlier forepeak damage**

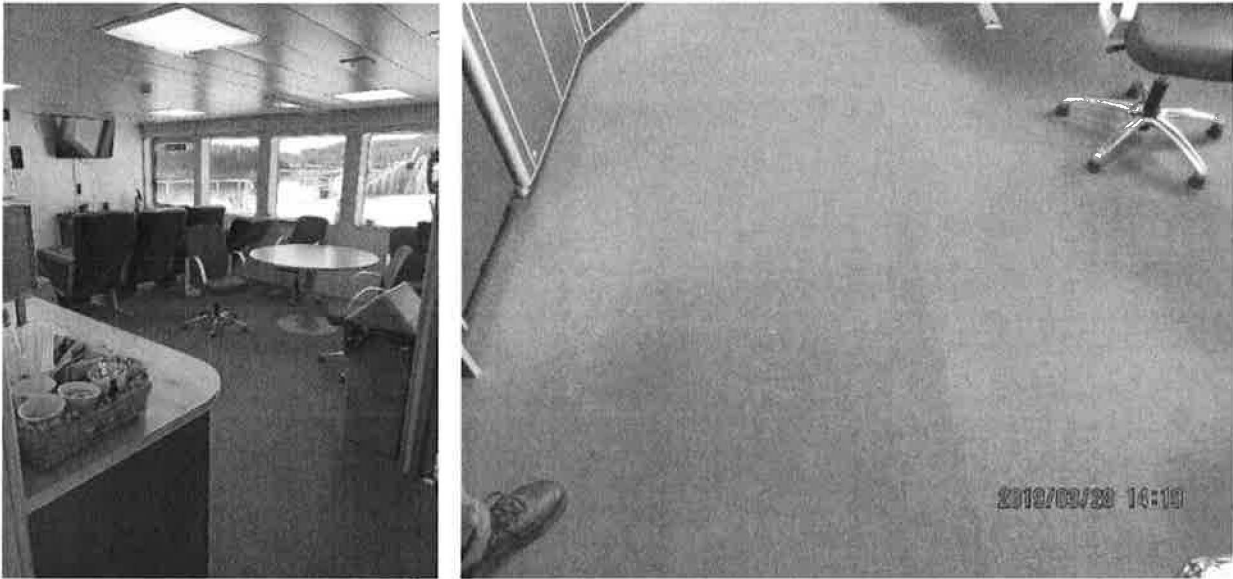
The Crew Day Room is in good condition. Stains, wear, and deformation are evident on the carpet; it should be cleaned or replaced (Figure 9).

**Figure 9 Crew Day Room (left) with minor stains and deformation on carpet (right)**

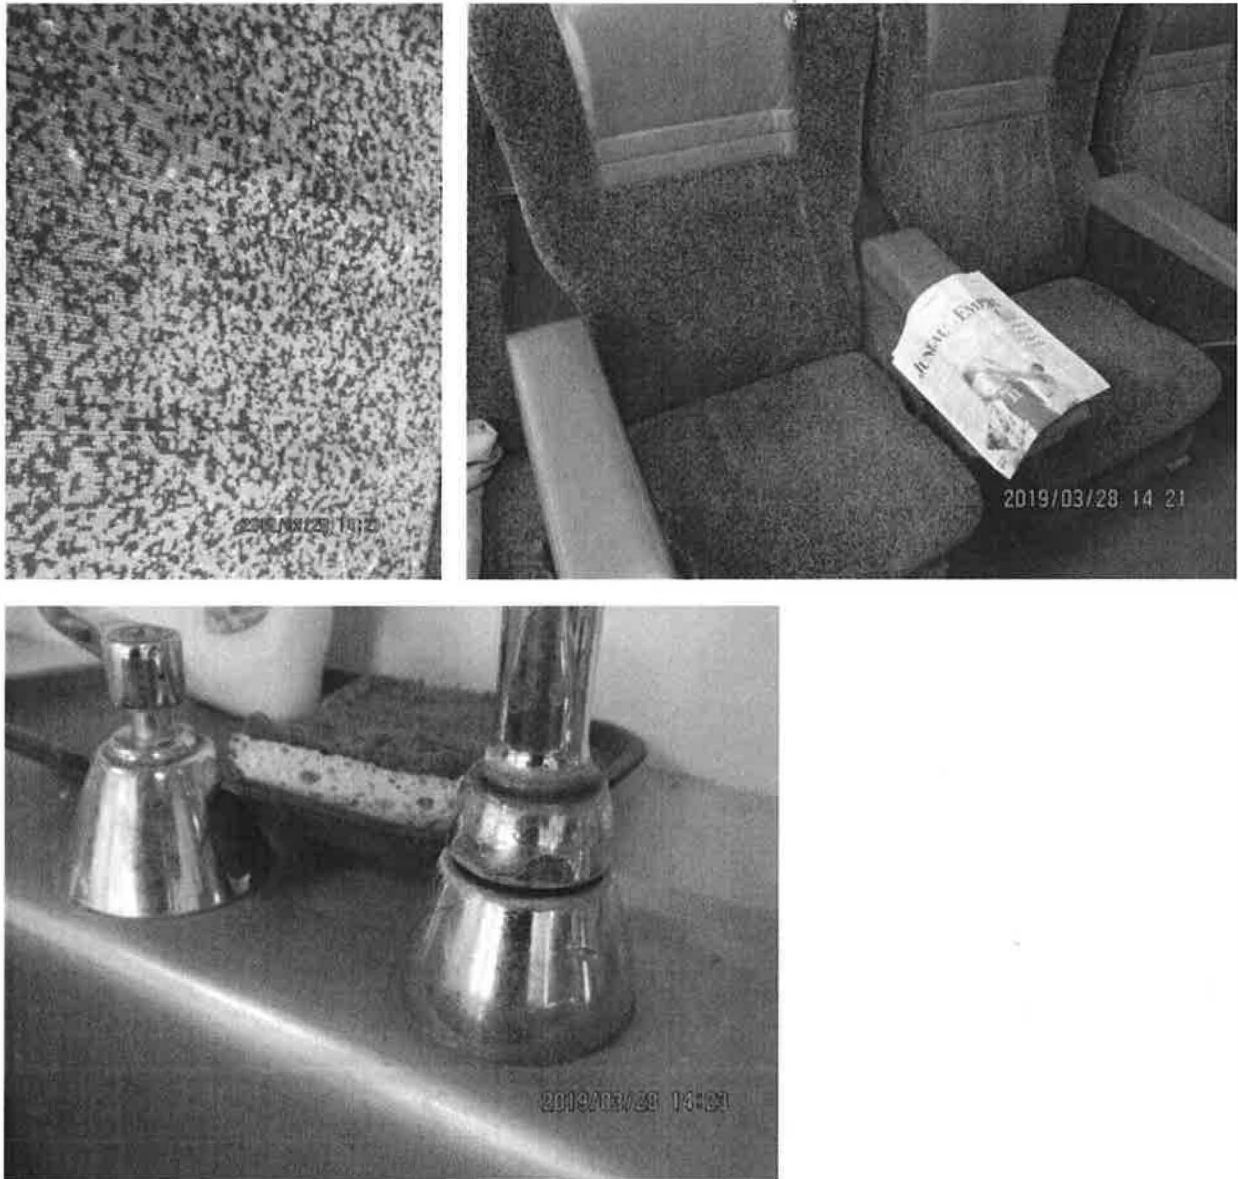
The furniture, bulkhead, and sink show some wear but are generally in good condition.

**Figure 10** Minor wear on furniture (top) and sink (bottom) in Crew Day Room

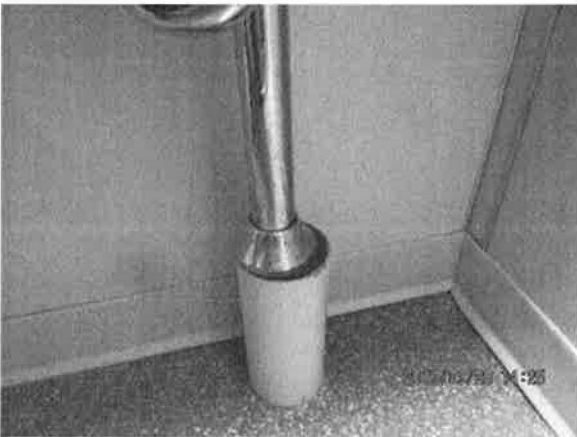
The Crew Head is generally in excellent condition. Penetration misalignment was noted underneath the sink (Figure 12).

Figure 12 Penetration misalignment under sink in Crew Head

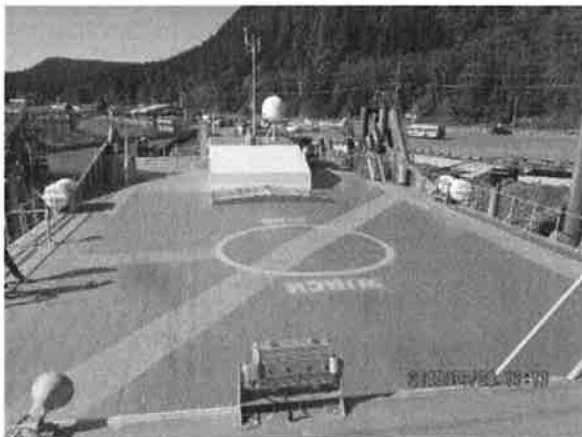
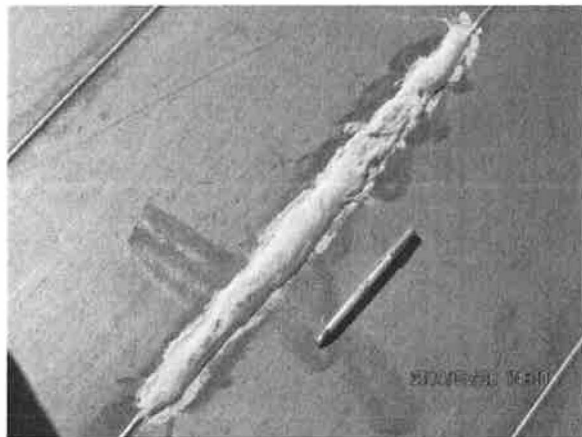
The House Top is in fair condition. The deck covering shows significant wear. Warping, cracking or flexing of the deck covering is very noticeable in some regions. Large regions of white caulking to repair leaks are evident in approximately a dozen areas (Figure 14).

Figure 14 House Top (left) with caulking evident in many regions (right)

Crew spaces are in good condition with few exceptions. On the Bridge Deck, the Crew Day Room would benefit from cleaning or replacing the carpet. The House Top deck covering should also be significantly repaired or replaced to eliminate white caulking and warping.

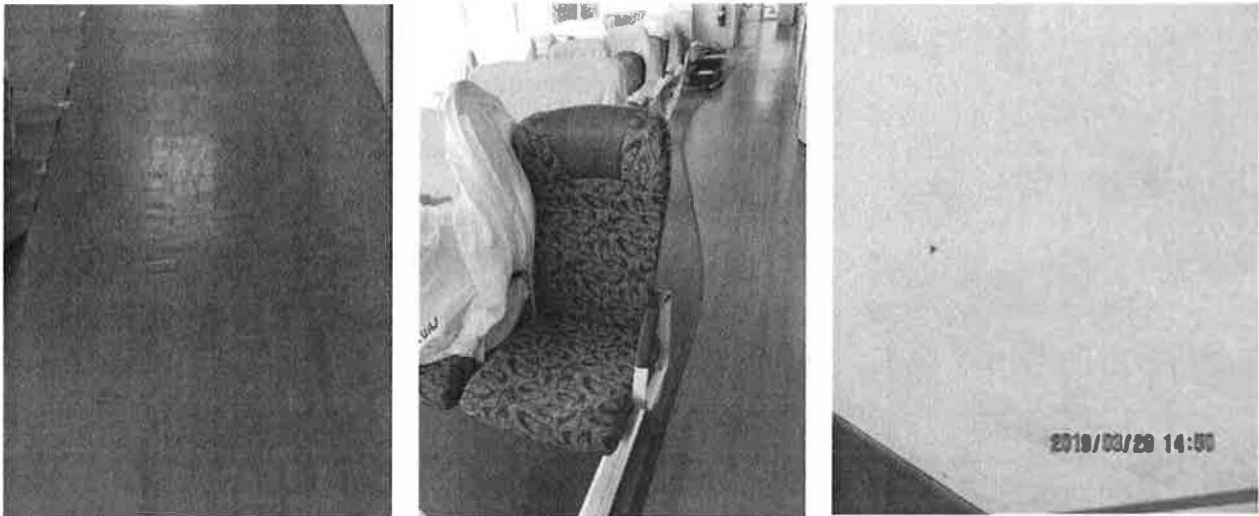
The Forward Observation Lounge is in good condition. In 2014, the carpeting and faux wood flooring was recommended to be replaced. Both deck covering types were replaced, but some warping or bubbling is now apparent in the replacement flooring. The armrest pads and seat cushions were also recommended for replacement in 2014. The replacement seats are in excellent condition. Minor dents and scratches are apparent in the bulkhead (Figure 15).

**Figure 15** Bubbling in faux wood flooring (left), replacement seats (middle), and minor dents in bulkhead (right) in Forward Observation Lounge

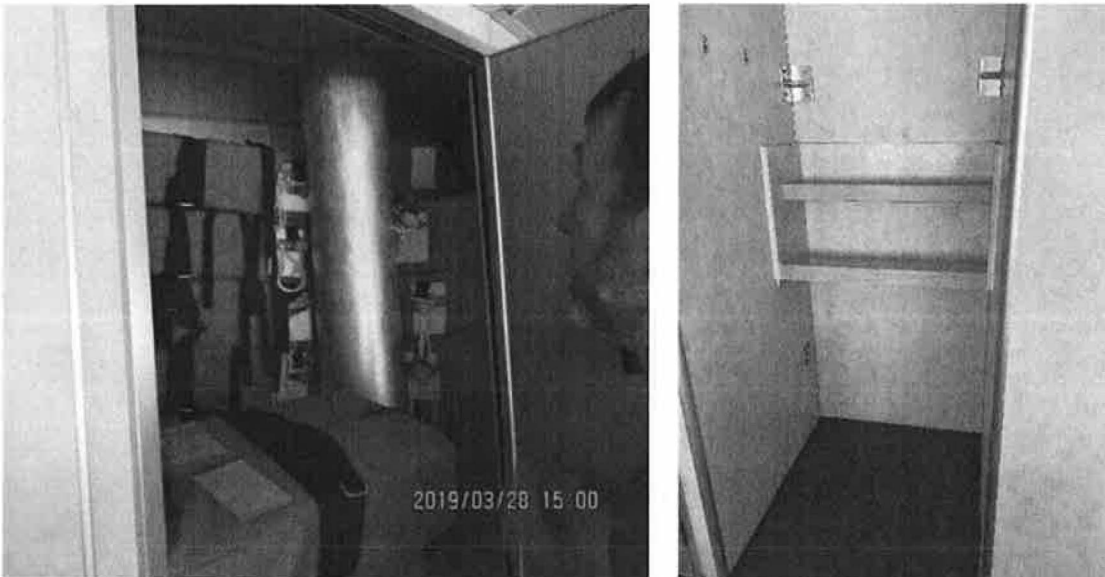
The lifejacket locker is in good condition. Next to the lifejacket locker, bracing leftover from a previous phone booth is still evident, above a recently installed bookshelf (Figure 16).

**Figure 16** Lifejacket locker (left) and bracing from former phone booth (right)

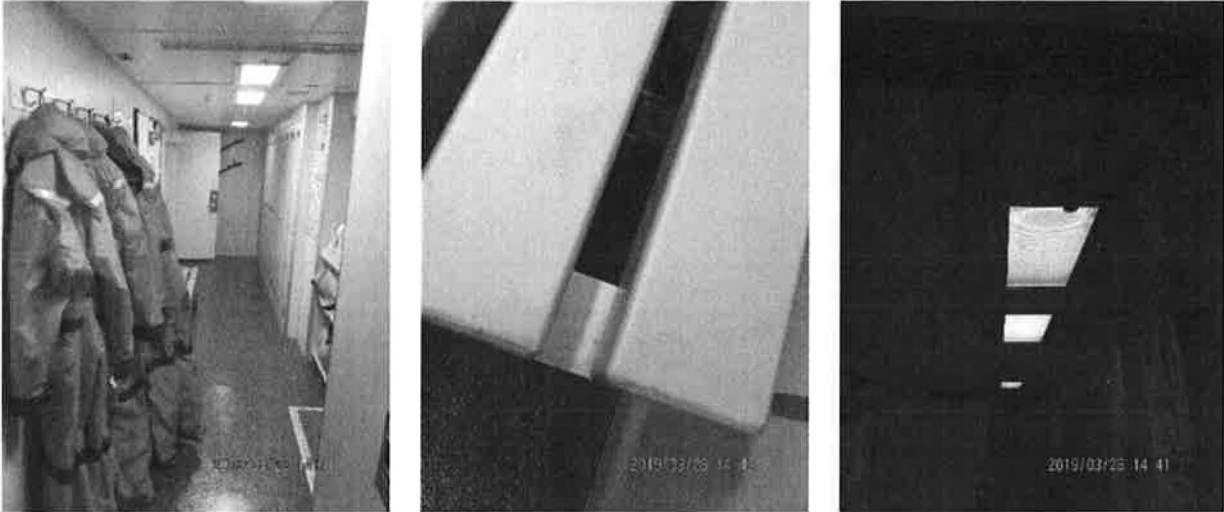
The Crew Locker Room is in good condition. Only minor wear is apparent on the furniture and bulkheads. Some lighting diffusers should be replaced (Figure 17).

Figure 17 Crew Locker (left) with some wear on bench (middle) and diffusers in need of replacement (right)

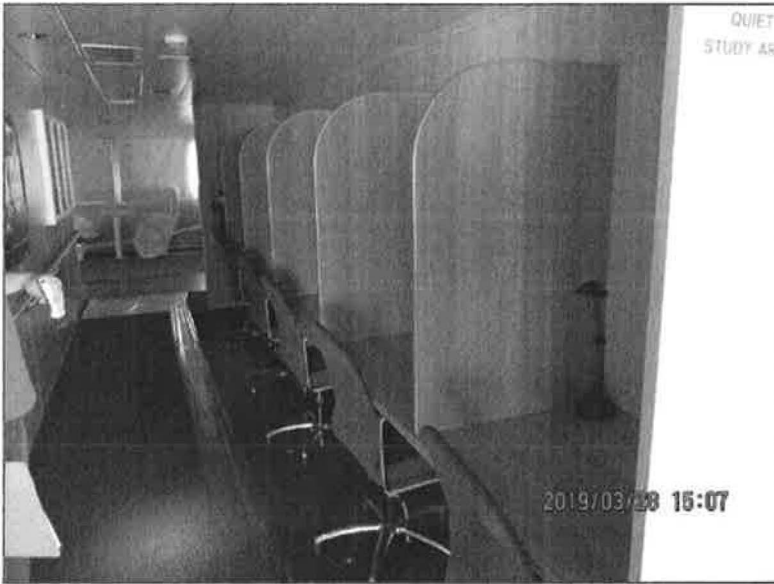
Figure 18 Quiet Work Area

The Quiet Work Area is in excellent condition (Figure 18). During the survey, the crew noted that this space receives minimal use due to lack of outlets for purposes such as charging phones and plugging in laptops. It is recommended to add more outlets to this space.

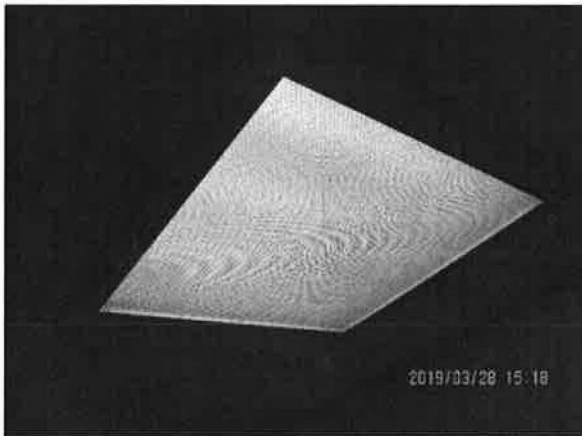
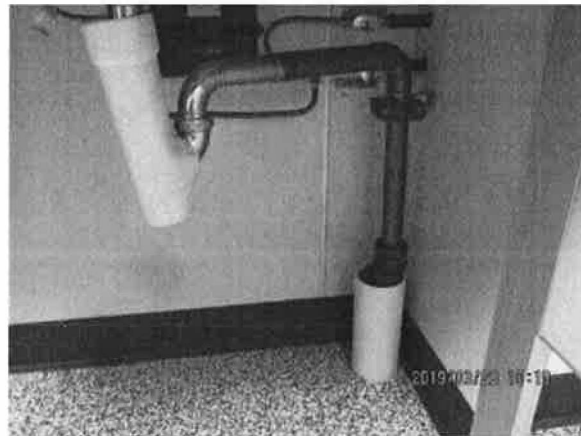
Minor diffuser discoloration is apparent in both the Men's (Port) and Women's (Starboard) Amidships Passenger Heads. There is minor wear around the base of some fixtures, and penetration misalignment is apparent at the base of the sink (Figure 20).

**Figure 20 Diffuser discoloration (left) and penetration misalignment (right) in Men's (Port) Amidships Passenger Head**

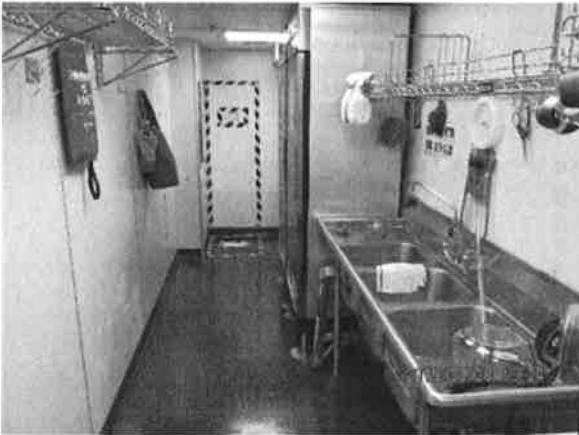
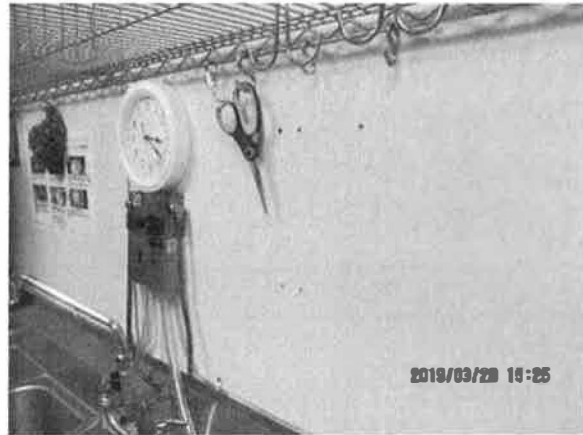
The Storage/Preparation Area is in good condition. Minor holes in the bulkhead are visible from previously moved equipment (Figure 21).

Figure 21 Storage/Preparation Area (left) with minor holes in bulkhead (right)

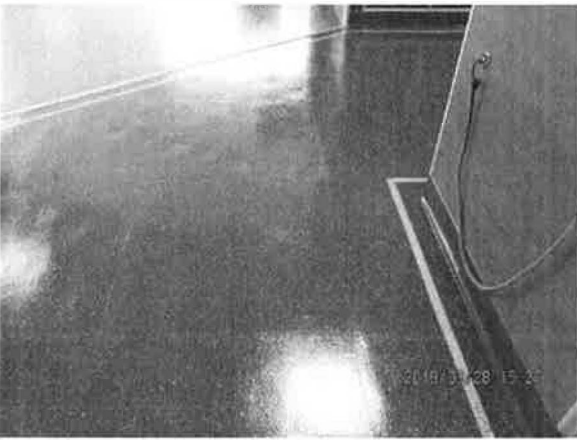
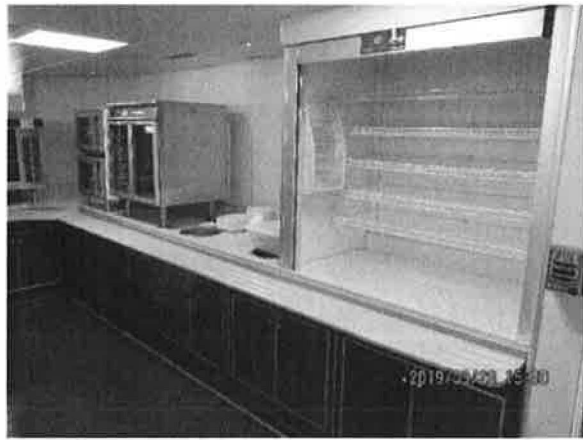
The Food Court is in fair condition. The deck covering is worn and deforming in some areas. Increased lighting would improve visibility in the space (Figure 22).

Figure 22 Worn deck covering (left) and low lighting levels (right) in Food Court

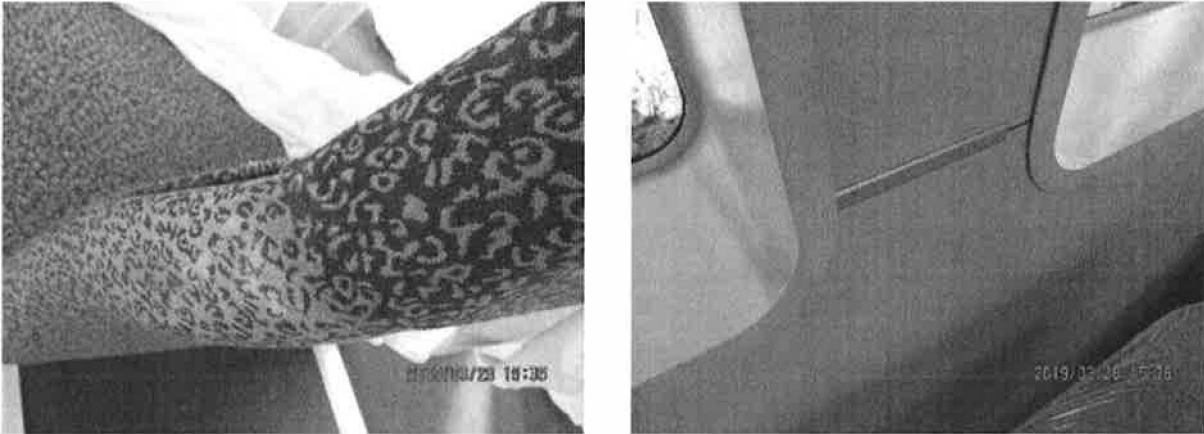
The Snack Bar and seating are in good condition. The deck covering shows minor stains and wear, and minor dents are apparent in the bulkhead. Wear is visible on the seats. Gaps in the bulkhead liner between windows are apparent (Figure 23).

Figure 23 Wear on seats (left) and gaps in bulkhead lining (right) in Snack Bar and seating

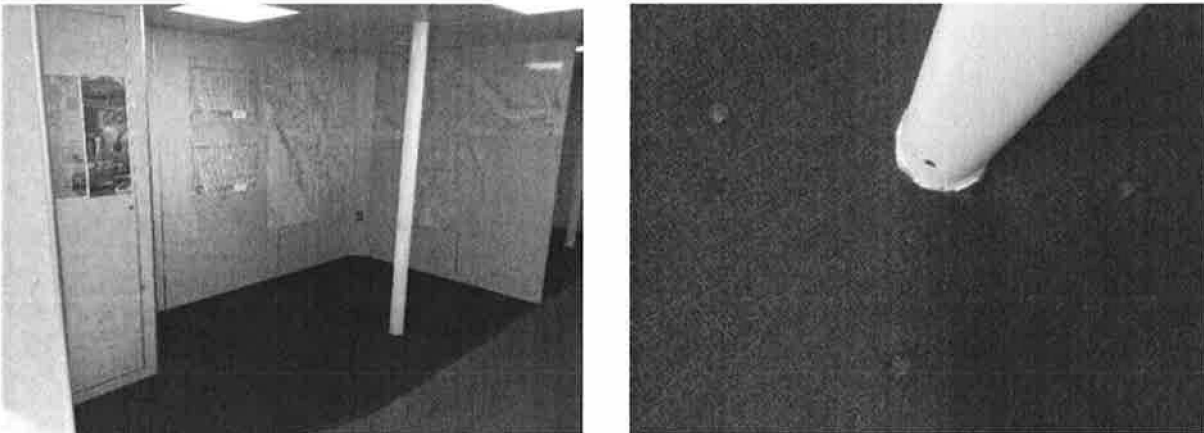
The Information Area is in good condition. The deck covering shows minor stains and wear, and minor dents are apparent in the bulkhead (Figure 24).

Figure 24 Information Area (left) with minor wear in carpet (right)

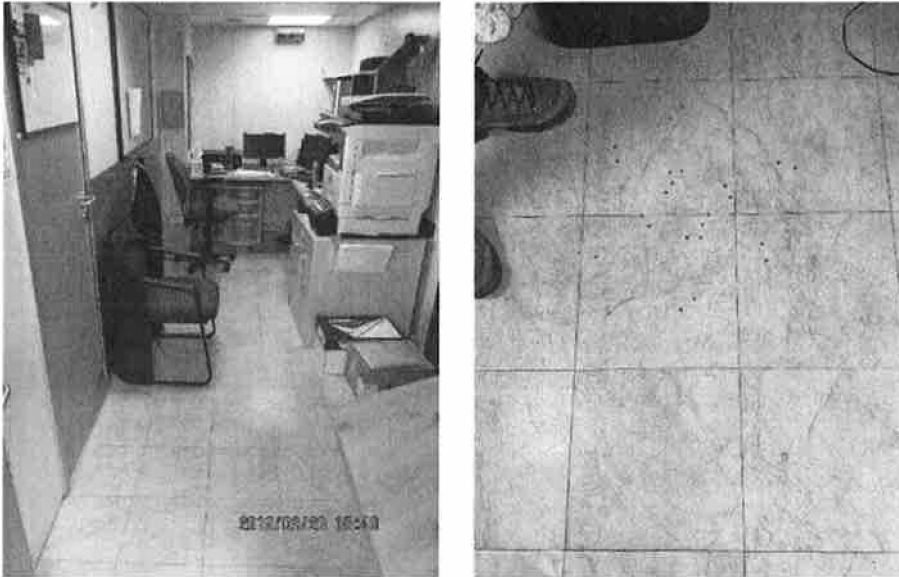
The Passenger Service Office is in fair condition. The deck covering is damaged by holes and should be replaced (Figure 25).

**Figure 25 Passenger Service Office (left) with holes in deck covering (right)**

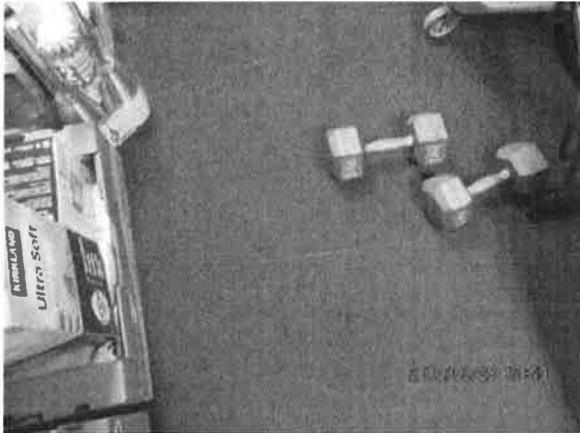
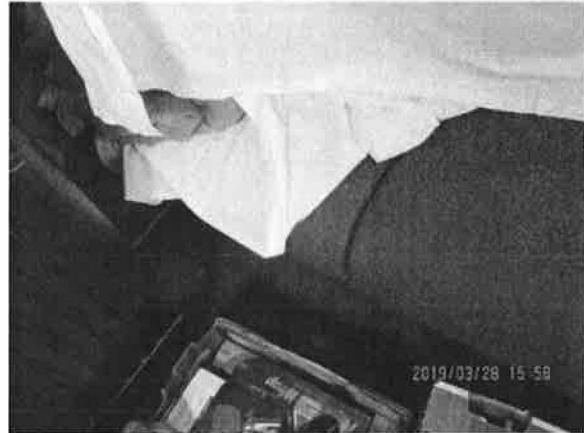
The Children's Play Area is in good condition. Seams are evident in the carpet, and the furnishings are lightly worn (Figure 27).

Figure 27 Apparent seams (left) and lightly worn furnishings (right) in Children's Play Area

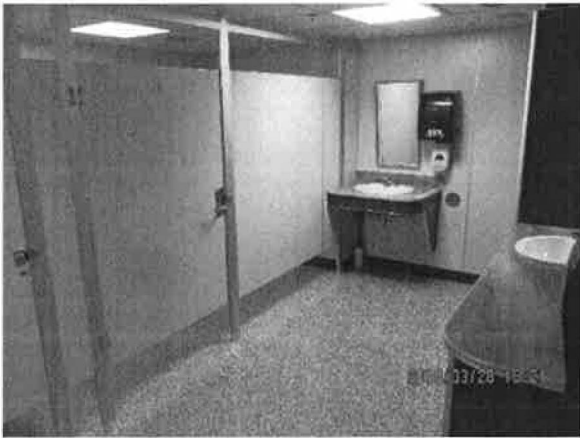
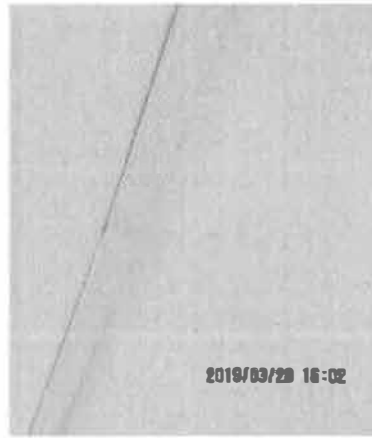
The Aft Passenger Heads are in good condition. Minor dents and wear are evident in the bulkhead partitions in the Women's (Stbd) Aft Passenger Head (Figure 28).

Figure 28 Women's (Starboard) Aft Passenger Head (left) and minor dent in partitions (right)

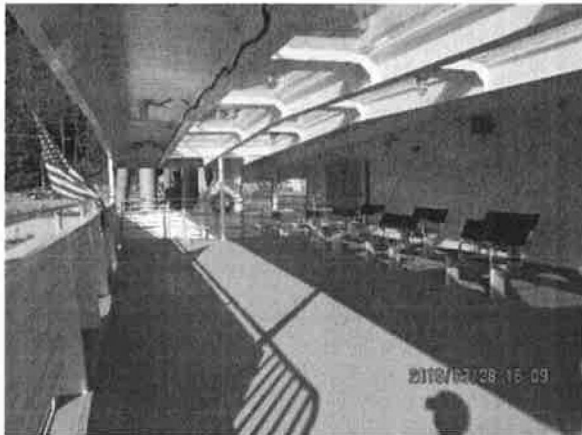
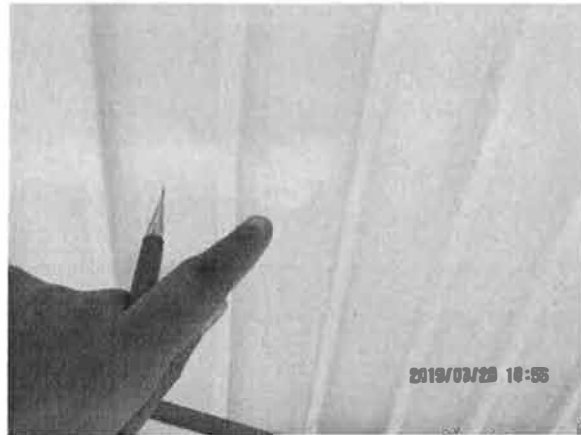
The Solarium is in fair condition. A hole has worn through the overhead. Either this hole should be repaired, or the overhead should be replaced (Figure 29).

**Figure 29 Solarium (left) and hole in Solarium overhead (right)**

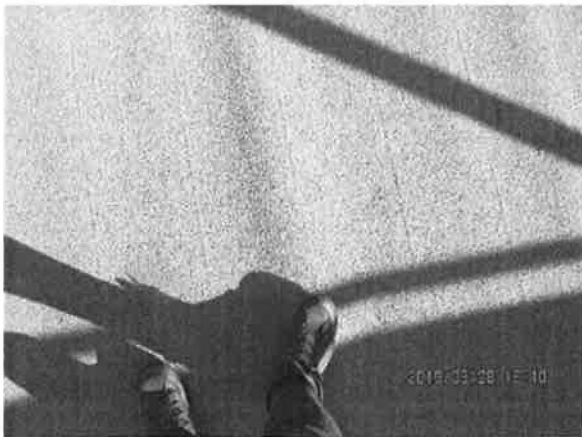
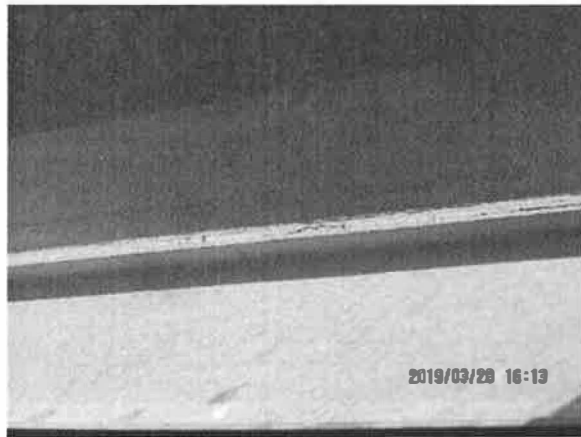
Stains and deck deformation are evident in the deck covering, and it is uneven in places. Paint is peeling on the bulkhead in some places, such as the overhead windows (Figure 30).

**Figure 30 Deck deformation (left) and overhead window paint peeling (right) in Solarium**

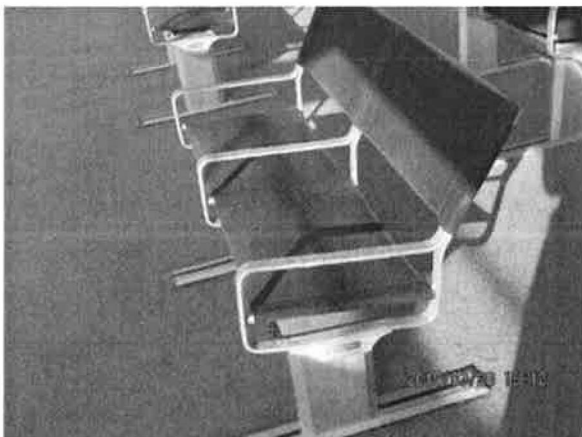
The furniture shows wear. The space would benefit from replacing the furniture with heartier, more robust furniture suited to the ferry route climates (Figure 31).

**Figure 31 Furniture in Solarium**

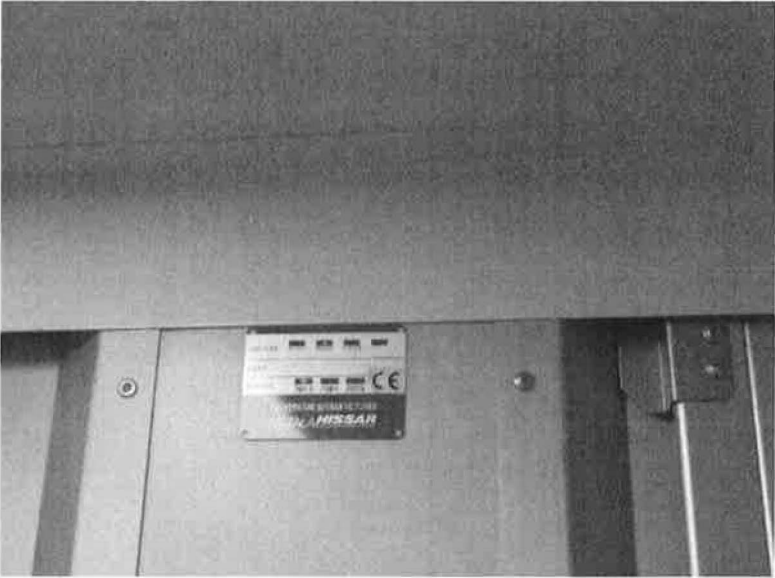
**Figure 45** Minor spots in overhead of Passenger Elevator

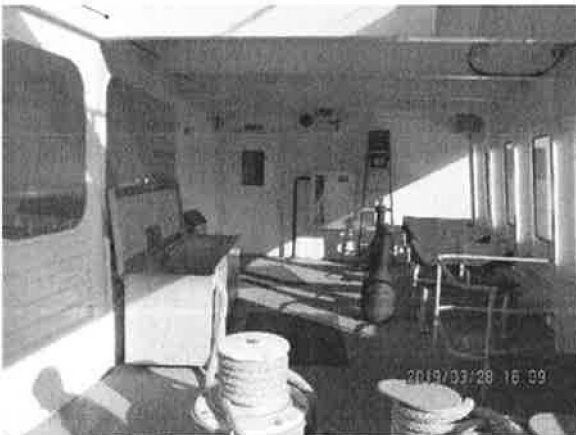
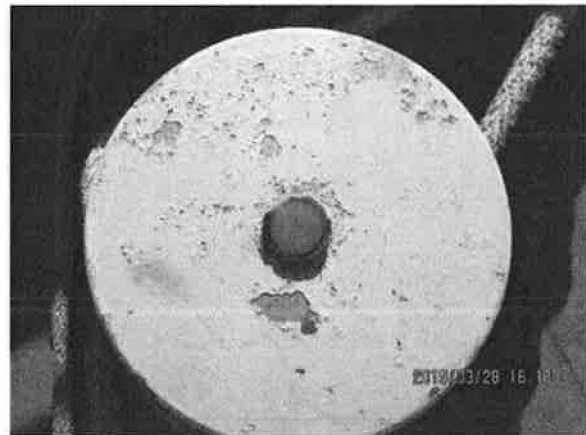
Figure 47 Paint peeling on mooring capstan on Solarium Deck

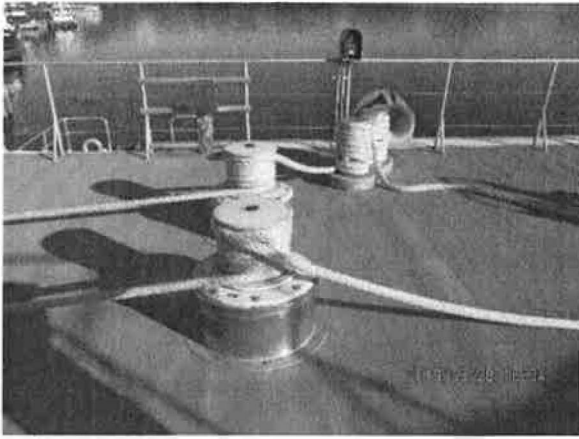
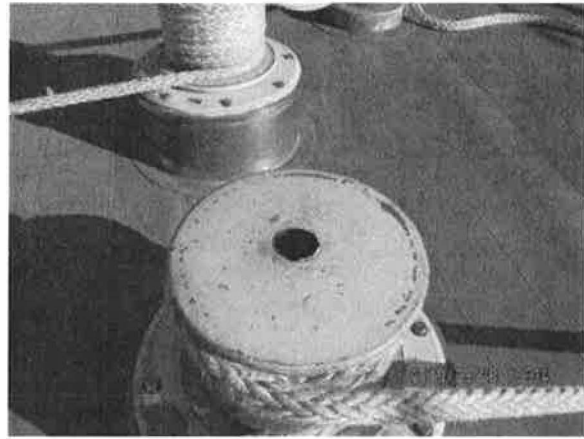
**Figure 48** Paint peeling on mooring capstan on Forward Mooring Deck
