SURVEY STATEMENT

Name of vessel: **FAIRWEATHER**
 Owner: **Alaska Marine Highway System Operations**
 IMO Number: **9265809**

Laid Up Annual Survey

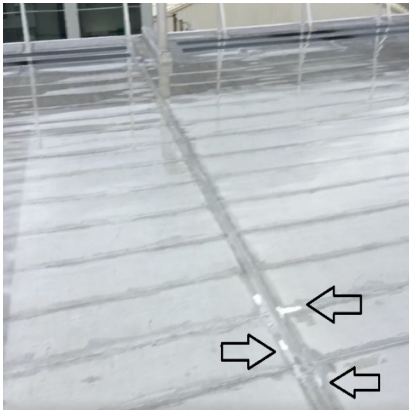
Cracks

Within given due date, cracks were noted on uppermost deck, behind navigation bridge are to be repaired. Before repairs, a repair plan is to be submitted for review and approval. This CC can be postponed based on satisfactory sighting survey by vessel's crew. In case of further deterioration, DNVGL is to be notified immediately.

Multiple cracks were noted on uppermost deck (behind navigation bridge), adjacent to transverse bar (covering end of planks. Signs of multiple repair attempts noted. Considering failed repair attempts, rewelding was not accepted at this time. Owner is advised to work out a repair plan and submit for evaluation.

Damage condition is considered satisfactory for postponement until next survey.
