PAVEMENT DATA SUMMARY REPORT

TO:	Robert Trousil, P.E. Regional Materials Engineer	Date:	March 6, 2020	
		Telephone No.: Fax No:	(907) 465-4383 (907) 465-3506	
FROM:	Troy Bowthorpe Pavement Management	PROJECT NO:	SFHWY00269

RE: JNU Glacier Avenue, Ross Way to Egan Dr., SR 1R Recon, Pavement Data Summary

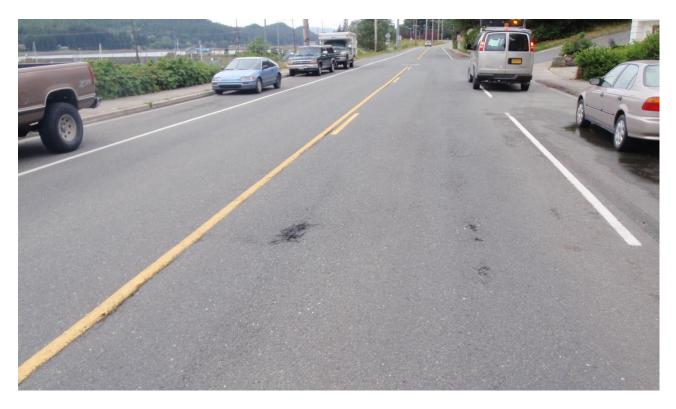
Figure 2: Observation just South of Ross Way in Sept. 2012

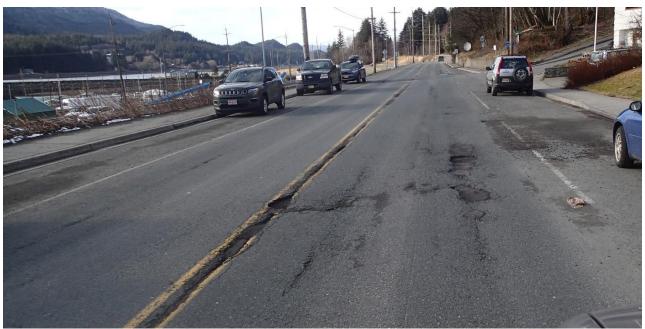
Observed surface distresses included; limited Cracking on shoulders, stress cracking both longitudinal and transverse, raveling, and rutting. Figures 2 and 3 below show the progression of distress from 2012 to 2020 in that specific location.

Figure 3: Same location as Figure 2, just South of Ross Way in Feb. 2020 shows significant deterioration including raveling and rutting.

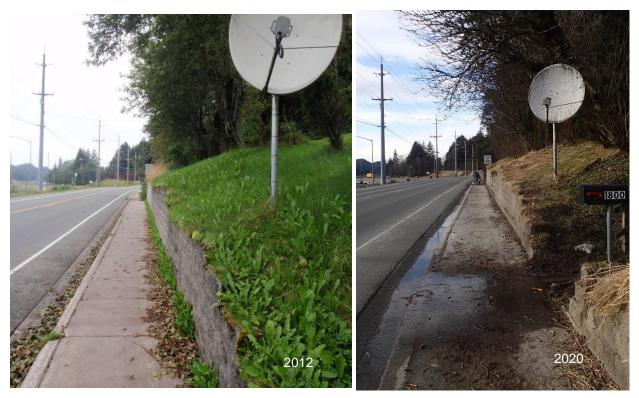
Figure 4: Typical retaining wall showing some leaning out at the top.

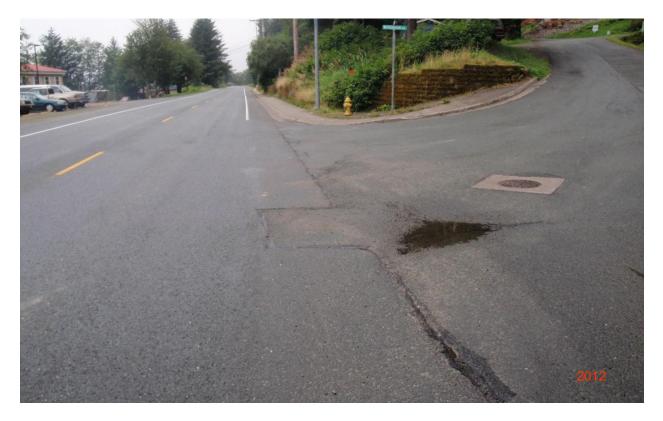
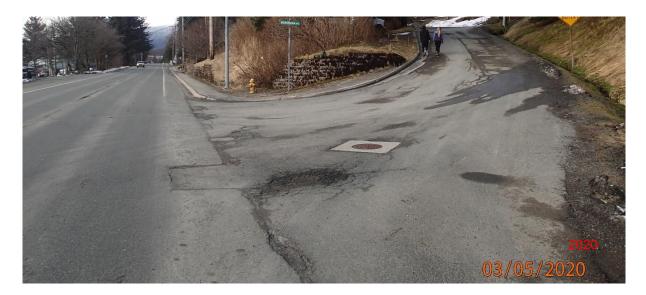
Figure 5-split: The continued deterioration of the intersection of Glacier Ave. and Wickersham Dr..

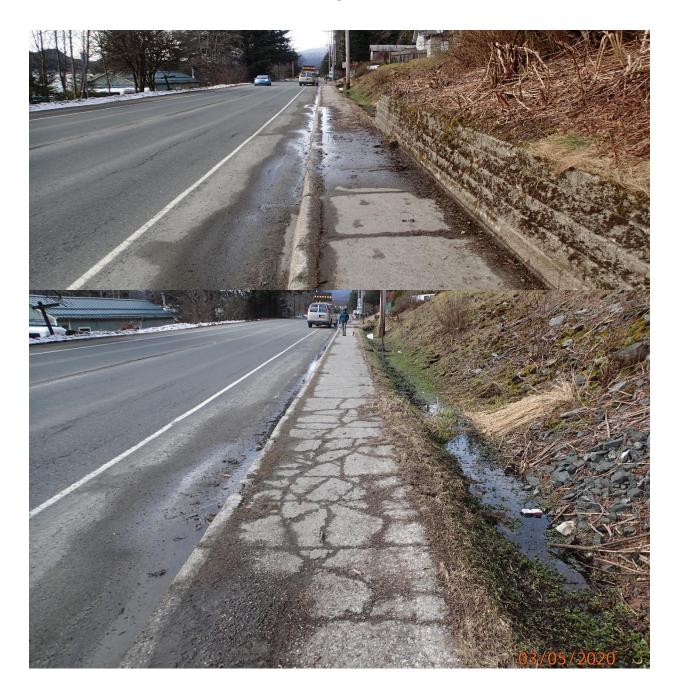
Figure 6: The sidewalk and Curb/Gutter at Sta. 59+00 and 59+75, has deteriorated significantly since 2012. It is possible this was caused from excavation efforts at the broken end of the retaining wall at that location. This location continues to "Weep" water from above.

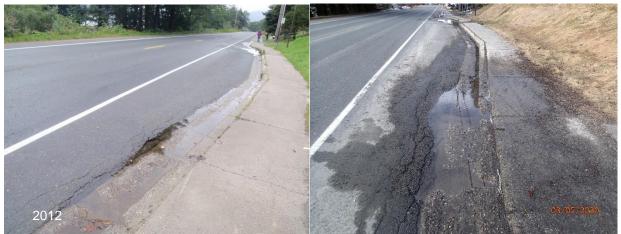
Figure 7: Continued deterioration and Heavy Cracking at the HDCP Ramp at the Bus stop STA. 61+50.

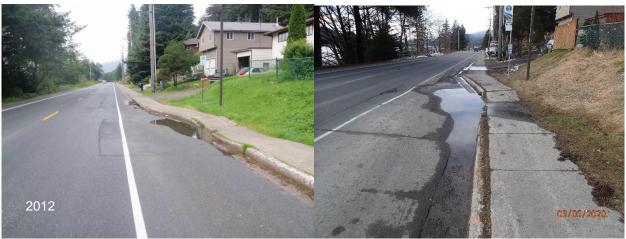
Figure 8: Continued deterioration and Heavy Cracking at the HDCP Ramp at the Bus stop STA. 62+10.

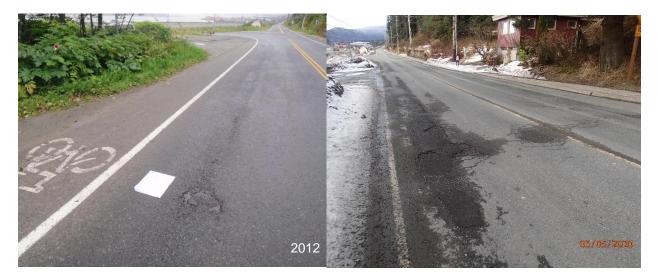
Figure 9: Continued deterioration and Heavy Cracking in the SB Lane at STA. 76+80.

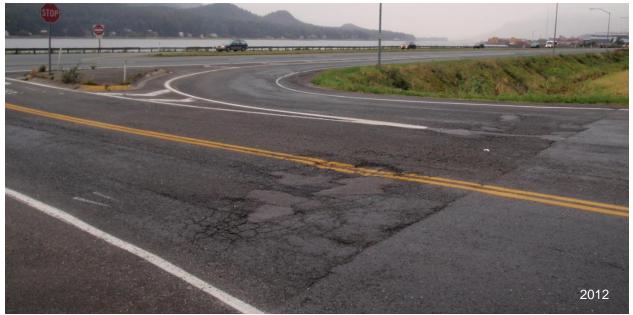
Figure 10: This Photograph taken 9/5/2012 at intersection of Glacier Ave and Egan Dr.

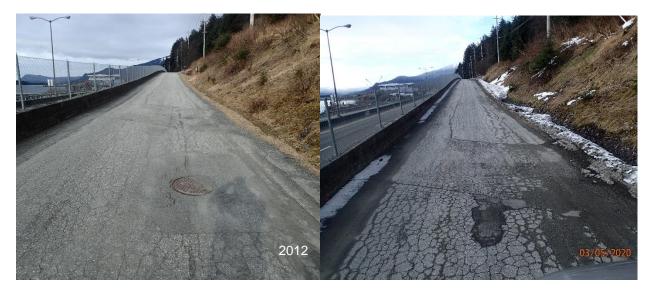
Figure 11: This is the Typical condition of Channel Vista Dr. from start to finish.

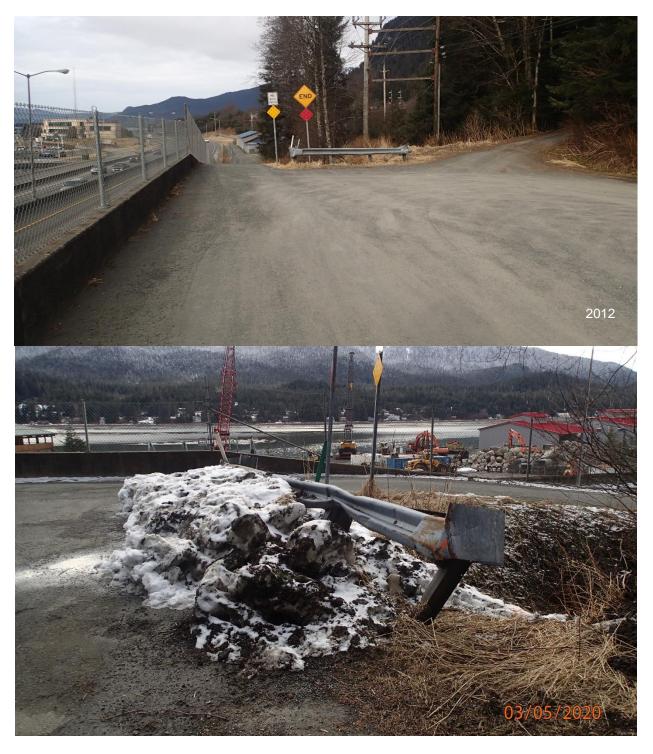
Figure 12: The end of the road and guardrail at Channel Vista Dr.
