### 3. Phase 2 (High Criticality of Wall Failure)

Milepost 354.94 Wall #36

ALASKA RAILROAD RETAINING WALL INSPECTION FORM						
Milepost: 354.94 Wall Number: 36			Inspectors: Andy Kubic, Eric Thornley			
Date:	July 29, 2021 1:30 PM		Engineer review required:		Date Forwarded:	
Nearest Hwy Intersection:	Parks Highway at Denali Park			Nearest RR Crossing:		
GPS Coordinates	-148.95979, 63.81798 WGS 1984					
Nearest Siding:	Healy Siding			Fiber Optic location: East Side of Tracks		
Authorized Track Speed	Passenger: 15		Freight: 15		Overhead Utilities: None	
Track & Slope						
Wall Condition Rating <b>Poor</b>			Rating scale: 5-Excellent, 4-Good, 3-Adequate, 2-Marginal, 1-Poor (see back for rating description)			
Line & Surface:	CWR/Ballast		Tangent/Curve: Tangent			
Tie condition:	Good					
Tie type:	Concrete					
Distance from end of tie to wall (feet)	South End:	6.5		North End:	6.5	
Distance from end of tie to toe (feet)	South End:			North End:		
Culverts:	No					
Ditchline:	Gravel

Milepost 355.22 Wall #41

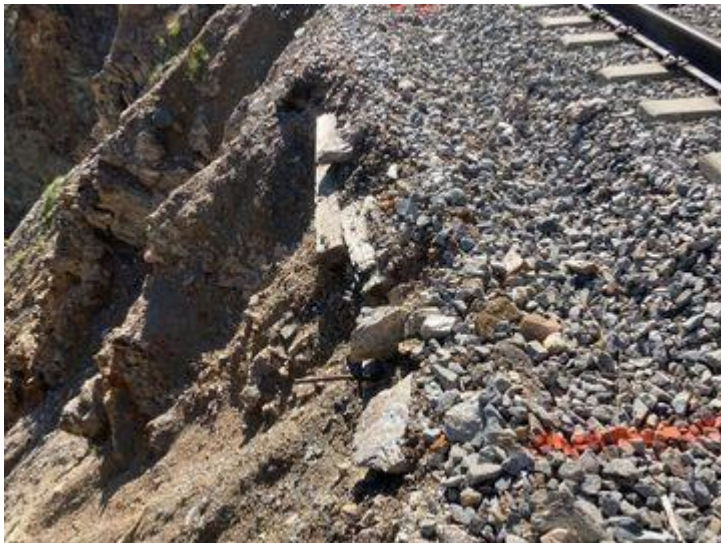
Comments:	Misaligned in damage timbers	Date:	7/29/2021
		Photo:	9
Wall # 36 Wall Condition Rating: Poor		MP #:	354.94

Wall 36 is critically damaged or in need of immediate repair, well past useful life. The consequences associated are the proximity of the wall to track. Lateral timber members exhibit section loss, which could result in failure.

- Piles-Timber piles sections exhibit up to 100% section failure and need replacement; steel piles and sheet piles to remain.
- Lagging-At-grade segments exhibit section failure, appear to be non-existent in certain areas, and need replacement.
- Tiebacks-Timber tiebacks with cabling will require further investigation to determine if tiebacks are to remain.

Excavate and replace damaged and decaying timbers.

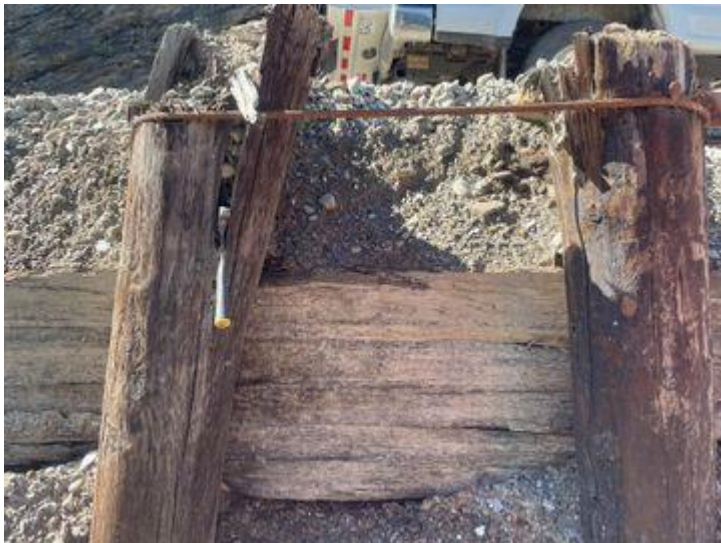
Comments:	Hollow sounding for entire height of exposed pile with splitting and decay	Date:	7/29/2021
		Photo:	9
Wall # 41 Wall Condition Rating: Poor		MP #:	355.22

- Piles-Exposed timber piles exhibit up to 100% section failure and are in need replacement.
- Lagging-Above grade segments are missing or exhibit up to 100% section failure and need replacement. Unable to inspect below grade segments due to apparent excavated fill from the opposite side of the track placed on the exterior toe of the wall. Further investigation is required to determine if below grade lagging is structurally sound and adequately retaining the fill supporting the track.
- Tiebacks-Unable to inspect tieback anchors. Further investigation is required to determine if steel cable tiebacks are to remain, but the current state of the wall indicates that these cables are not functioning as designed and could be the cause of the wall rotation.

Replace with soldier pile wall and lagging wall or steel sheet pile wall in front of the existing wall. May need tiebacks.

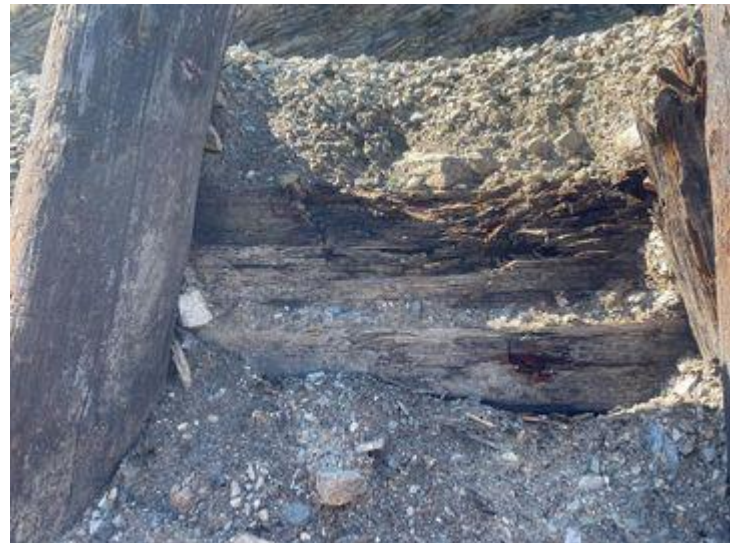
Comments:	Lateral member decay	Date:	7/29/2021
		Photo:	10
Wall # 41 Wall Condition Rating: Poor		MP #:	355.22

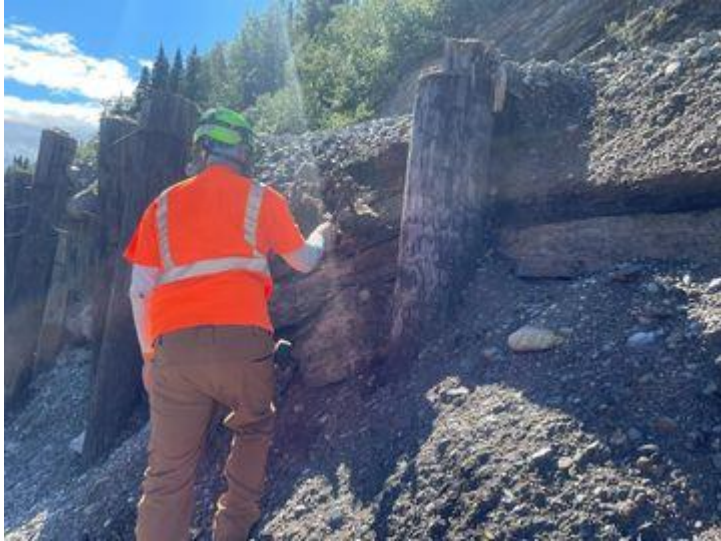
Comments:	Up to hundred percent of section loss top horizontal member	Date:	7/29/2021
		Photo:	11
Wall # 41 Wall Condition Rating: Poor		MP #:	355.22
