**ASBESTOS SURVEY
ALASKA ARMY NATIONAL GUARD
FORT RICHARDSON AVIATION COMPLEX
ANCHORAGE, ALASKA
APRIL 1996**

**State of Alaska
Department of Military and Veteran Affairs
Army National Guard
Environmental Office
Box 5-549
Fort Richardson, Alaska 99505**

**Ogden Environmental and Energy Services, Co., Inc.
4040 B Street
Anchorage, AK 99503-5999**

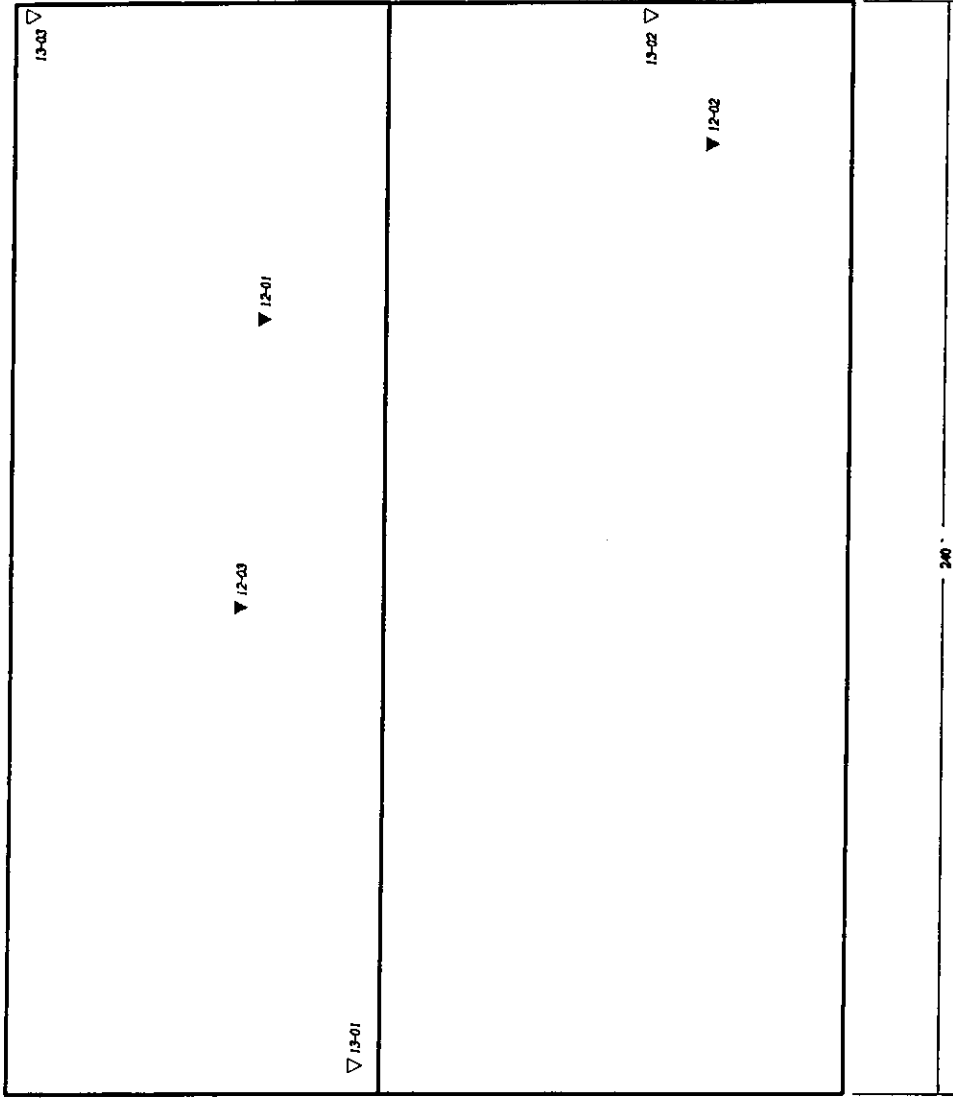
FIGURE 3

ROOF DIAGRAM

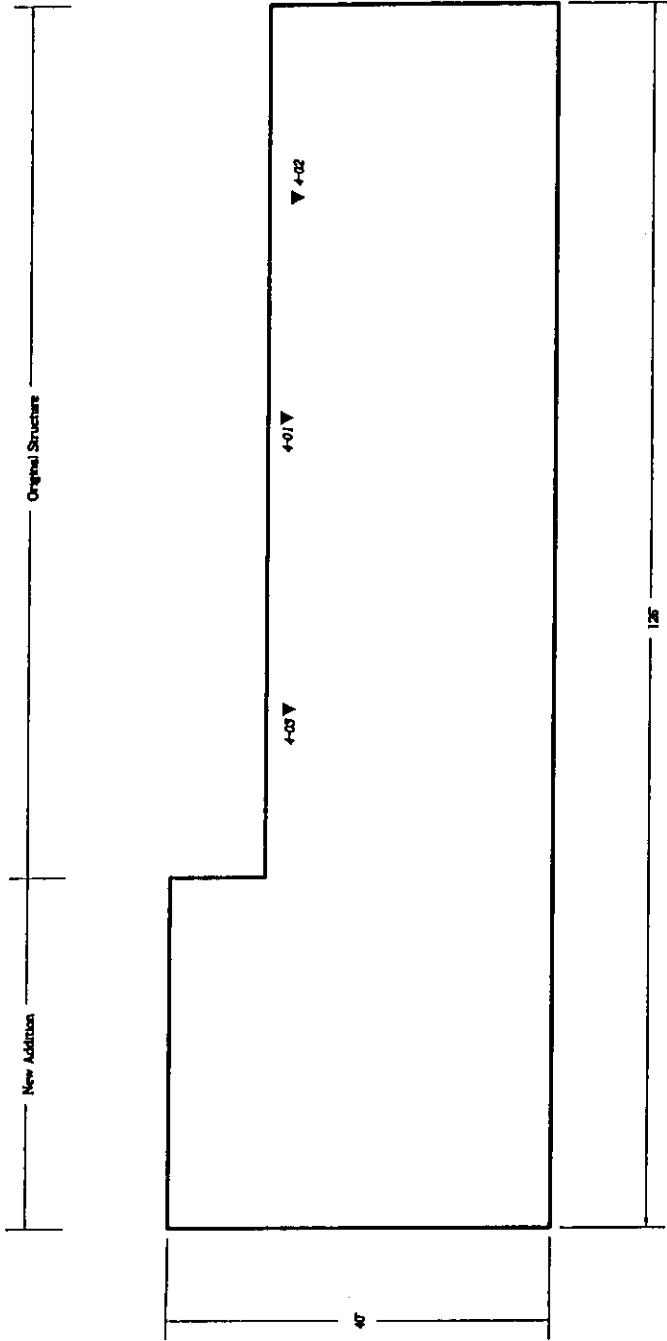
FIGURE 7

ROOF DIAGRAM

▼ 4-01 Locations where Asbestos was found.
