RE: Project Name: Hooper Bay Roof and Envelope
Project Number: 0252123001
Project Location: Hooper Bay, Alaska

Addendum # Two (2)

**ASBESTOS SURVEY
ALASKA ARMY NATIONAL GUARD
HOOPER BAY FEDERAL SCOUT ARMORY
HOOPER BAY, ALASKA
APRIL 1996**

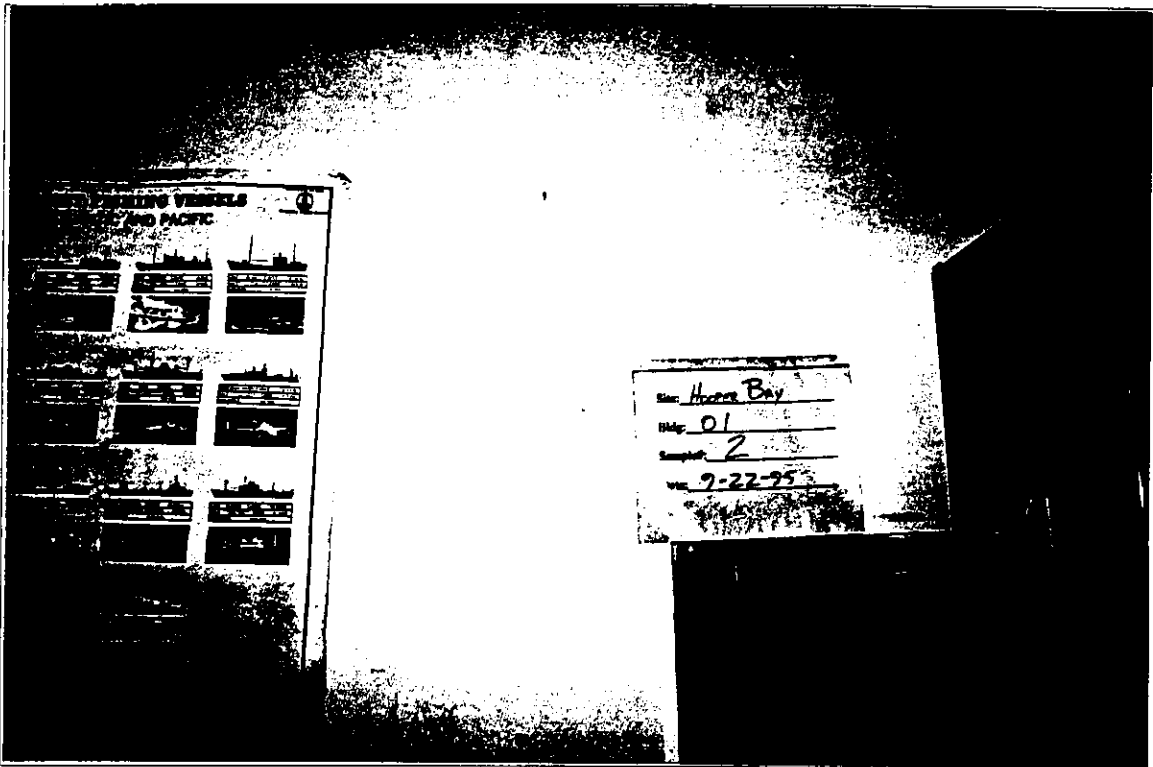
Gypsum Board
Building No. 1 HA No. 2 *Photo No. 2*
Old Armory
Hooper Bay, Alaska

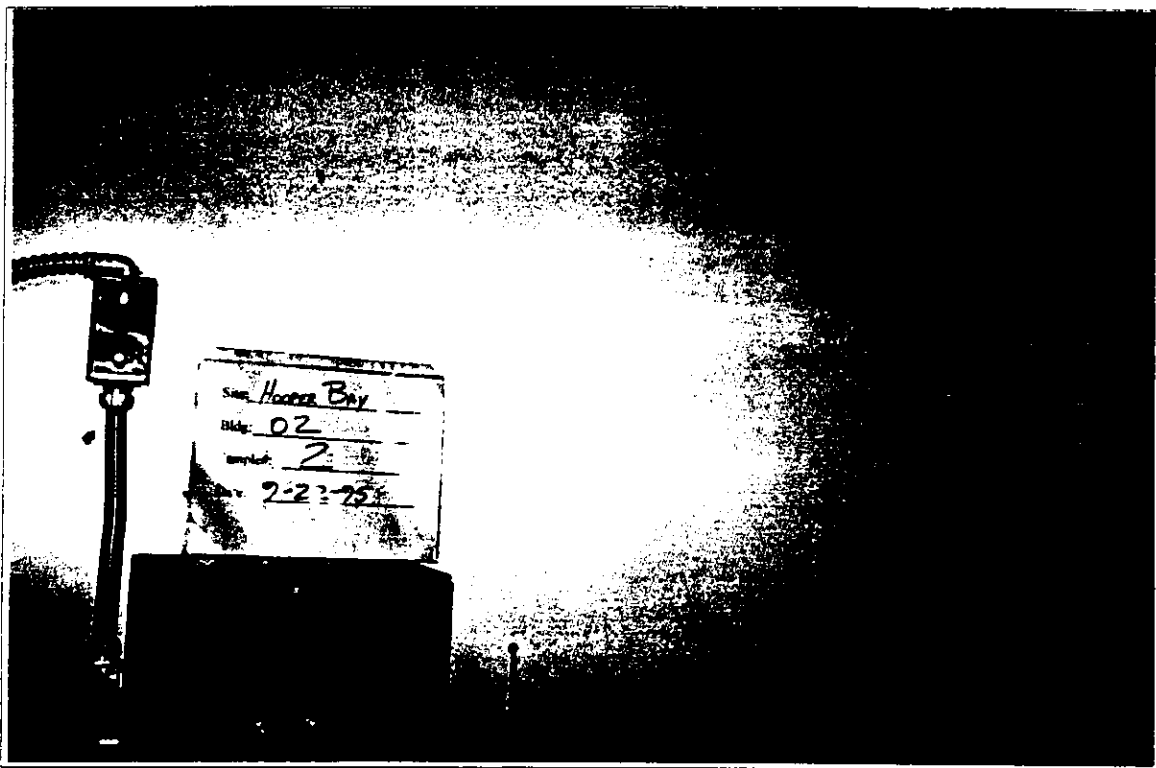
Photo No. 4

Gypsum Board
Building No. 2 HA No. 2
New Armory
Hooper Bay, Alaska
