2023 PAVEMENT INSPECTION REPORT

Alaska DOT&PF

Pavement Inspection Report Petersburg Airport

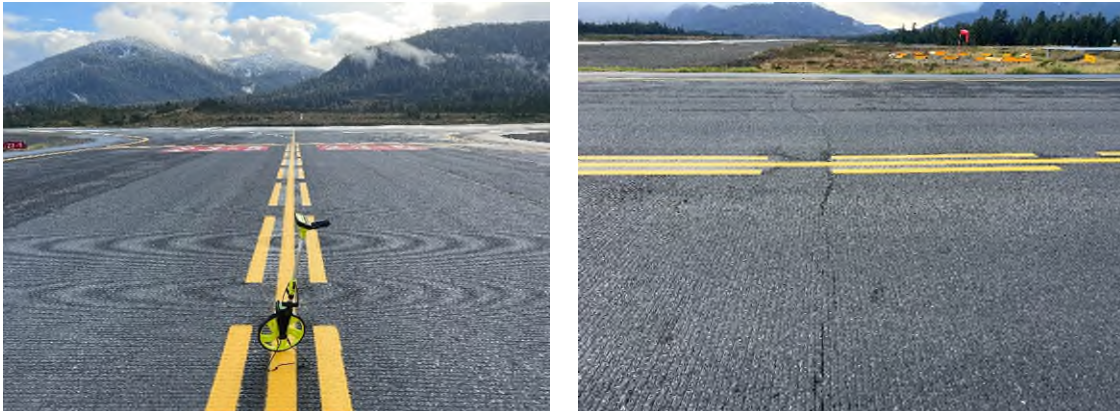
Branch ID	Branch Name	Branch Use	No. of Sections	Area (sf)	Weight Average PCI
0100	Taxiway A	Taxiway	1	53,430	76

Taxiway A was initially constructed in 1981 and its most recent major work was a mill and overlay of 6" in 2014. The most common distresses observed are low severity longitudinal and transverse cracking, low severity raveling, and low severity weathering. In field observations include the degradation of the paving joints causing longitudinal cracking and raveling to develop.

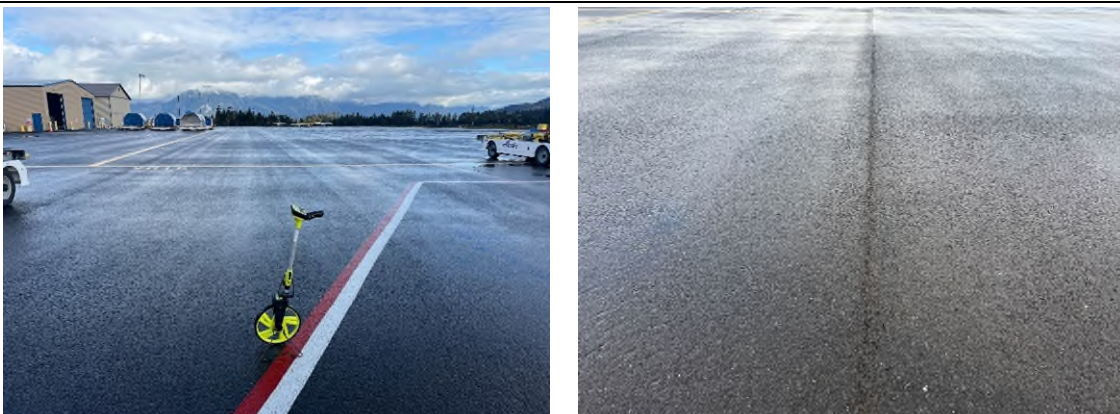
Sections 4100-01 (94 PCI) / 4100-02 (90 PCI) / 4100-03 (88 PCI)

Sections 02 and 03 of the aprons were initially constructed in 1981 while section 01 was initially constructed in 1996. All three sections' most recent major work was a mill and overlay of 6" in 2014. The most common distresses observed are low severity longitudinal and transverse cracking, small quantities of low severity raveling, and low severity weathering. In field observations include the degradation of the paving joints causing longitudinal cracking and raveling to develop.

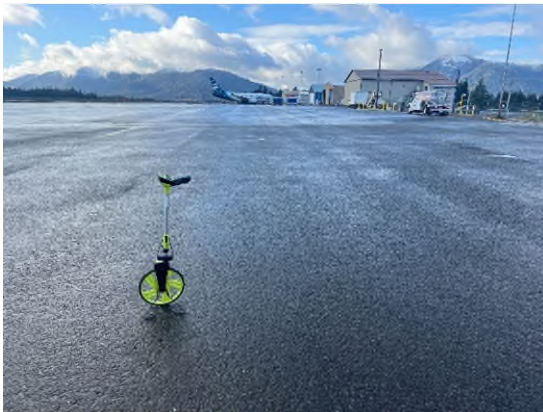
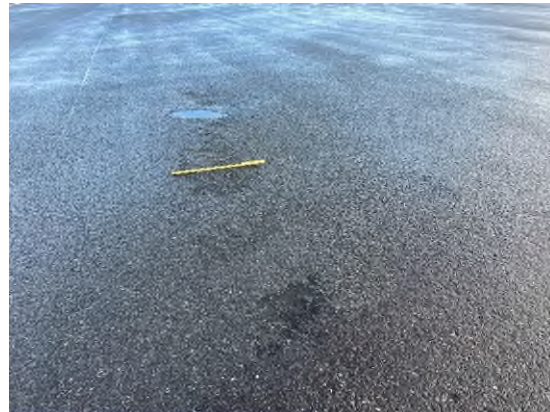
Section 4100-04 (61 PCI)

Section 04 of the apron was initially constructed in 2004 and has had no major work since. The most common distresses observed are low severity longitudinal and transverse cracking, large quantities of low to high severity raveling, and low severity weathering. In field observations include an increased loss of the fine aggregate which is exposing the coarse aggregate and in some areas the removal of the coarse aggregate altogether.

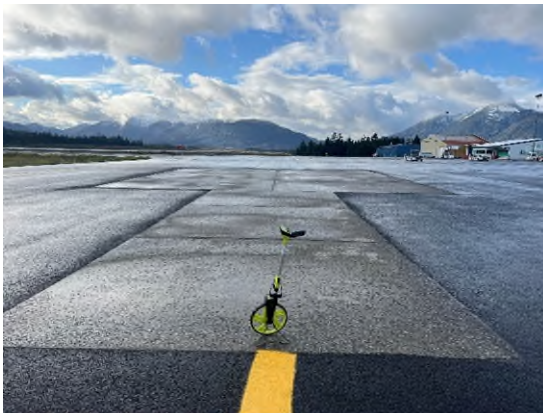
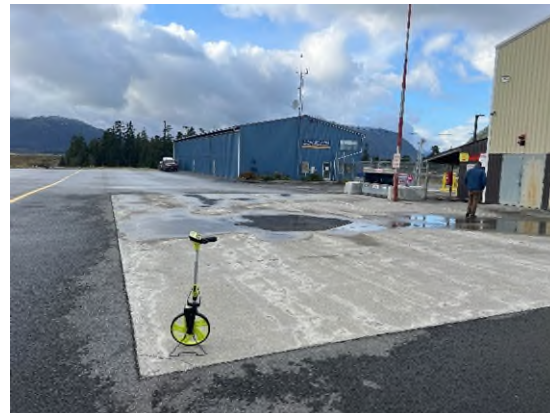
Sections 4100-05 (63 PCI) / 4100-06 (83 PCI) / 4100-07 (78 PCI)

Sections 05/06/07 of the apron are concrete (PCC). Sections 05 and 07 were built in 2004 and section 06 was built in 1987. The most common distresses observed are low severity joint and corner spalling, low to medium severity scaling, and low to medium severity joint seal damage. In field observations include section 06 that was built in 1987 is showing its age with all slabs affected by scaling due to environmental factors. The sections that were built in 2004 have grading and drainage issues where water will collect and pool. In the winter the water will freeze which maintenance crews have difficulty removing.

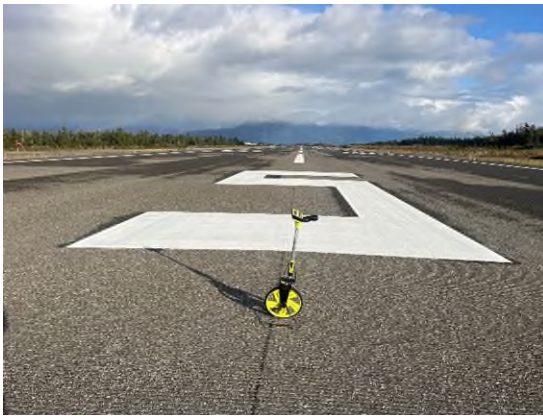
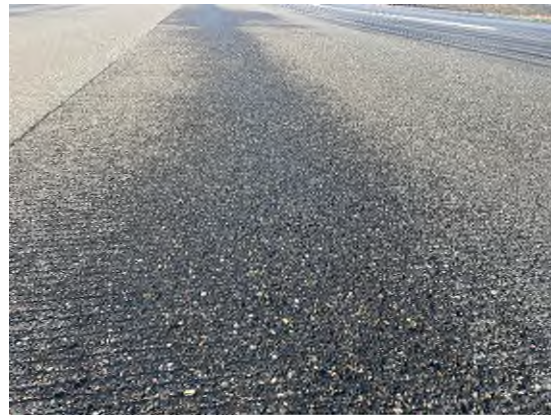
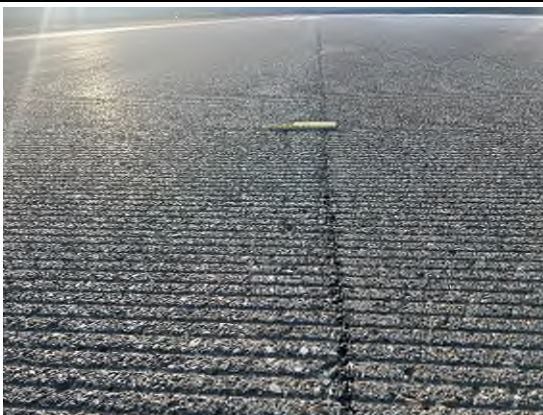
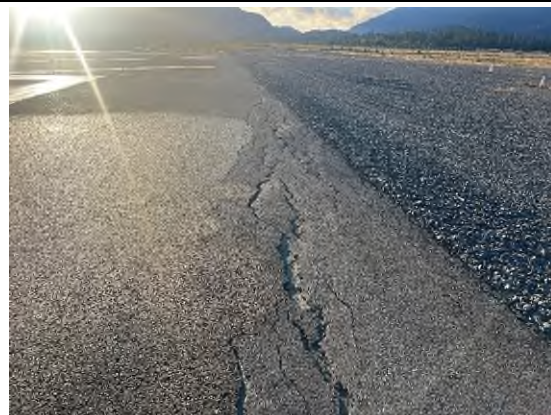
Branch ID	Branch Name	Branch Use	No. of Sections	Area (sf)	Weight Average PCI
6100	Runway 5/23	Runway	8	1,040,000	68

Runway 5/23 was initially constructed in 1981 with a runway length of 6,000 ft. In 2009 it was expanded another 400 ft giving it a total length of 6,400 ft. The most recent major work was an overlay of 4" in 2010. The most common distresses observed are low severity longitudinal and transverse cracking, low to medium severity raveling, and low severity weathering. In field observations include an increased loss of the fine aggregate which is exposing the coarse aggregate and, in some areas, leading to raveling. On the northern side of the 05 (southwest) end of the runway the edge of the pavement is sinking and cracking (bottom right photograph). This is due to snowplow operations reaching the end of the runway and pushing heavy loads onto the edges. In addition, maintenance staff mentioned that the Runway Safety Area (RSA) is sinking in areas and work is needed to keep the slopes consistent.
