Re: Amendment 1  
RFP 25-VSW-SAKK-019  
Water Intake and Water Transmission Line  
RFP Due Date: March 4, 2025 @ 2:00 PM AST

# Shaktoolik PER Site Visit Trip Report

Project: Shaktoolik Water Source PER SKK-WO-04-20

Subject: Shaktoolik Site Visit Report

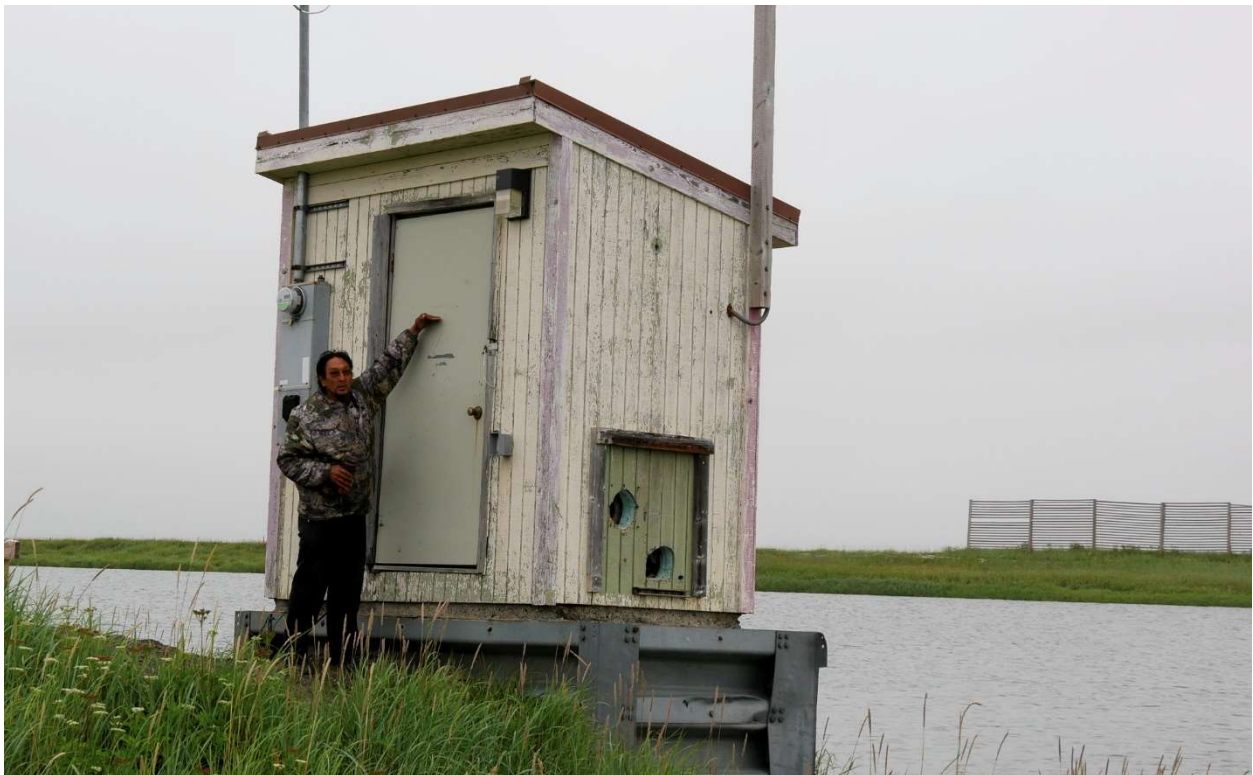
**Figure 8: WTP Operator Mr. Nakarak indicating the estimated high water line during fall storm surge flooding. Note the location of the electrical box. No remote service disconnect switch is available to de-energize the pump house during extreme flooding.**

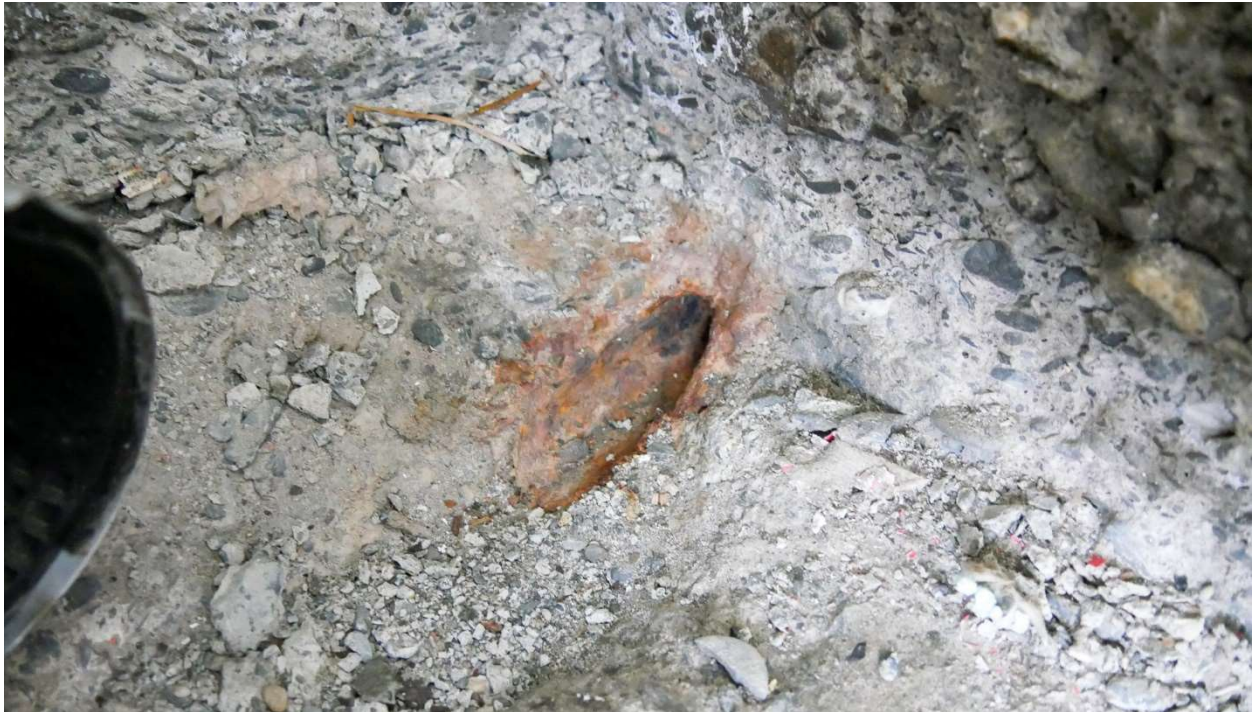
**Figure 13: Floor drain hole within the winter water source pump house. Mr. Nakarak indicated that the drain hole occasionally freezes, impeding drainage after flooding. Note the concrete degradation of the floor.**

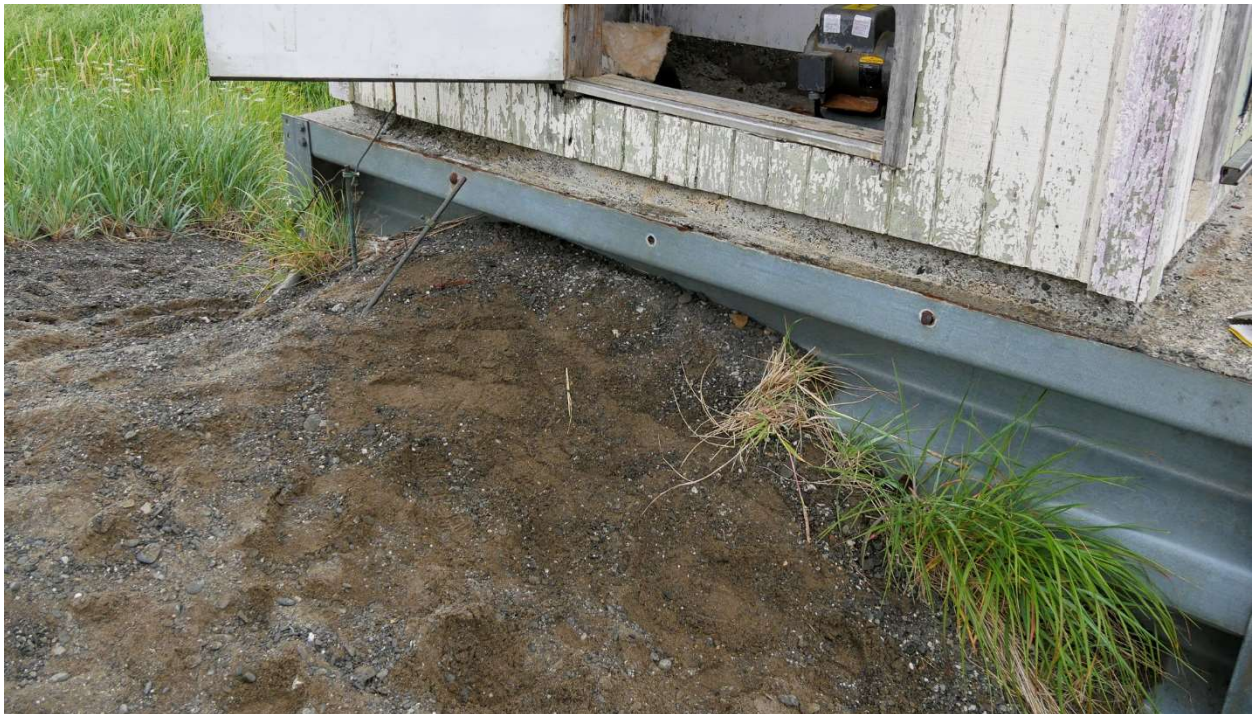
**Figure 14: Mild erosion around the foundation of the winter water source pump house.**

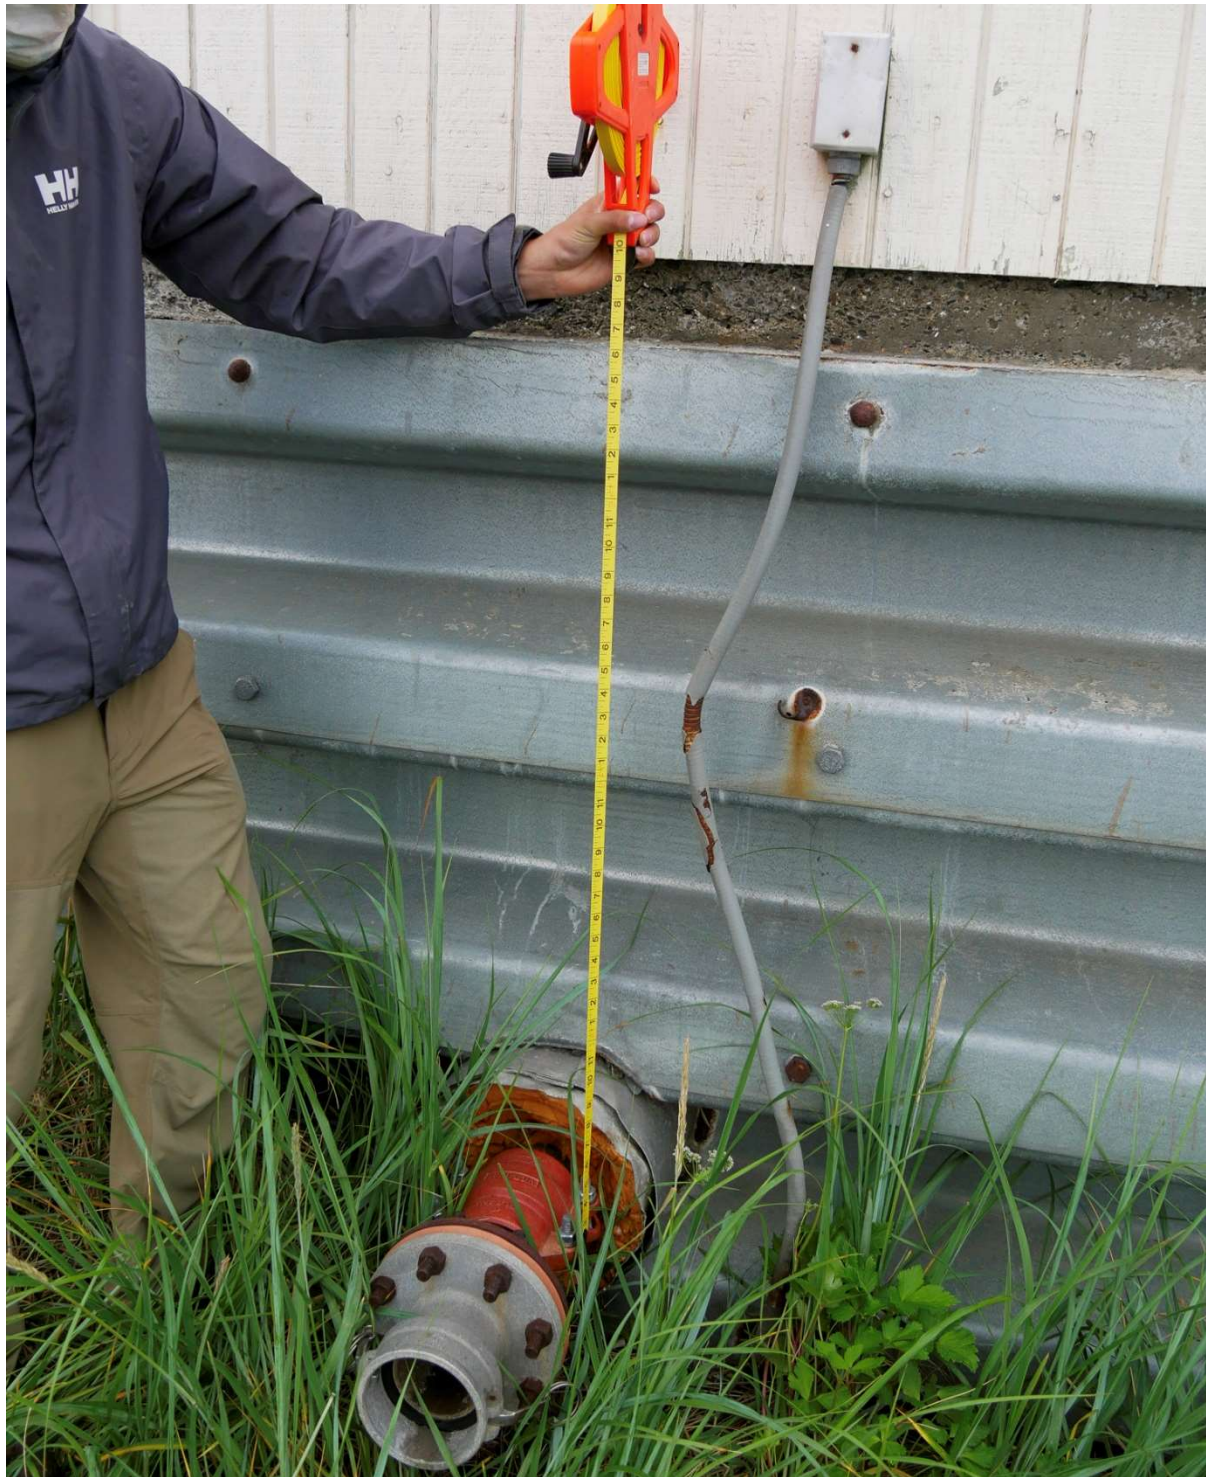
**Figure 15: The raw water line connection point (at the pump house) that connects to the WTP via 600 feet of buried arctic pipe. The 600 foot long arctic pipe runs at approximately a 1% grade to gravity drain back to the river. The connection point features a cam-lock hose connection fitting, but no valve. The connection is regularly inundated at high tide such that seawater surcharges into the pipe and freezes within the pipe. The heat trace previously run through the arctic pipe is no longer functional. Frozen seawater inside this pipe is the primary concern with the existing winter water source. The frozen seawater is impossible to prevent without a valve, is challenging to thaw, and frequently delays wintertime pumping operations (Raw water line connection point photo 1 of 5).**

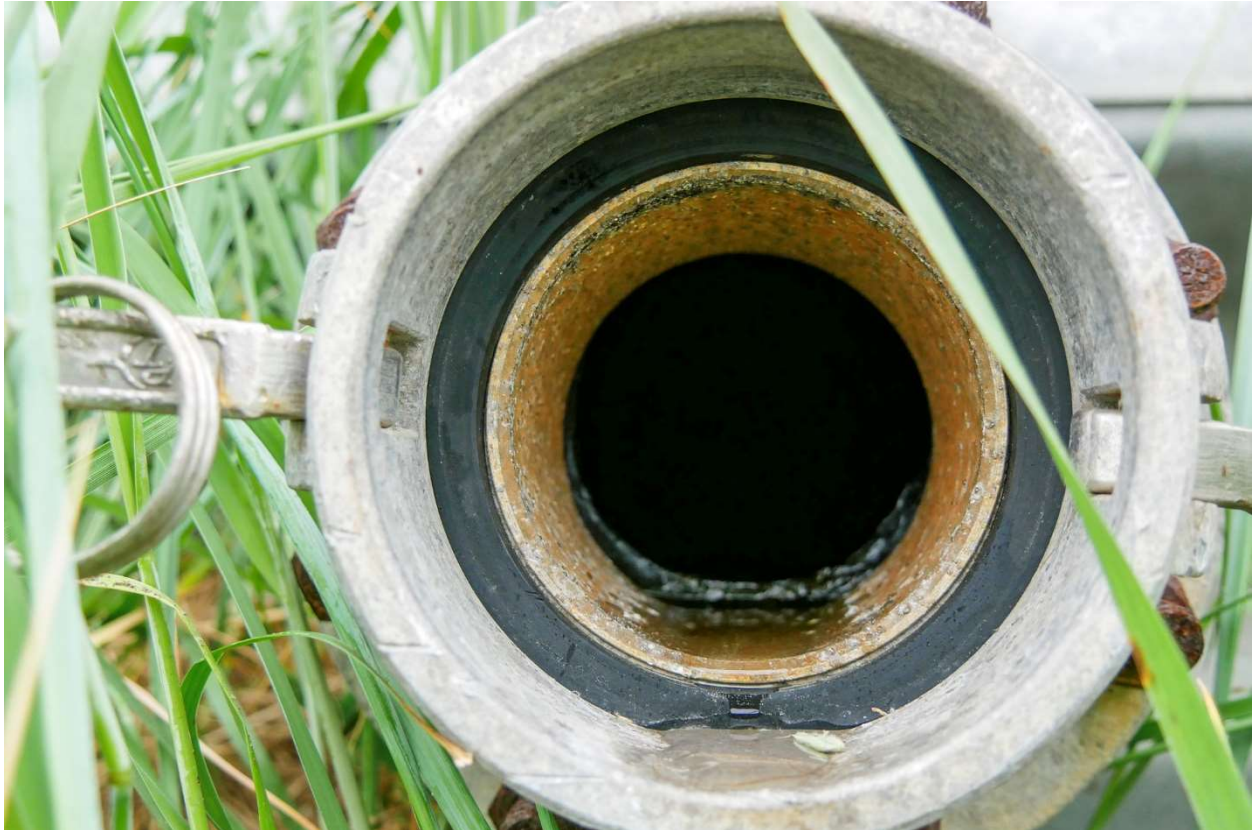
**Figure 18: Raw water line connection point, with residual water from high tide visible (photo 4 of 5).**

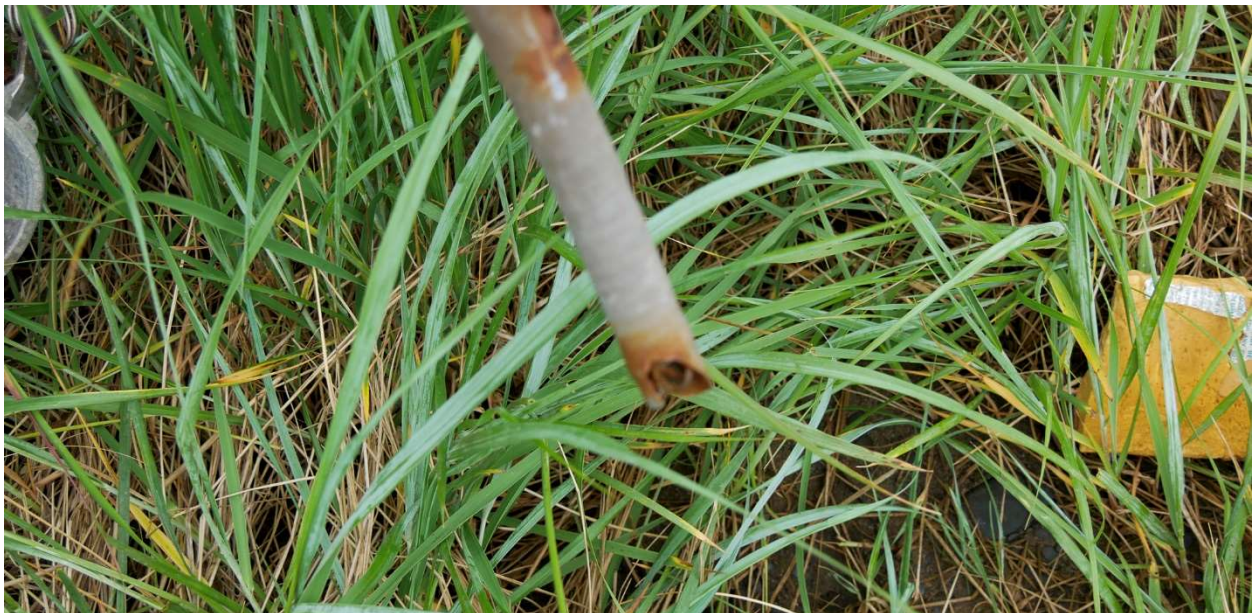
**Figure 19: Corroded and disconnected heat trace wire at the raw water line connection point (photo 5 of 5).**

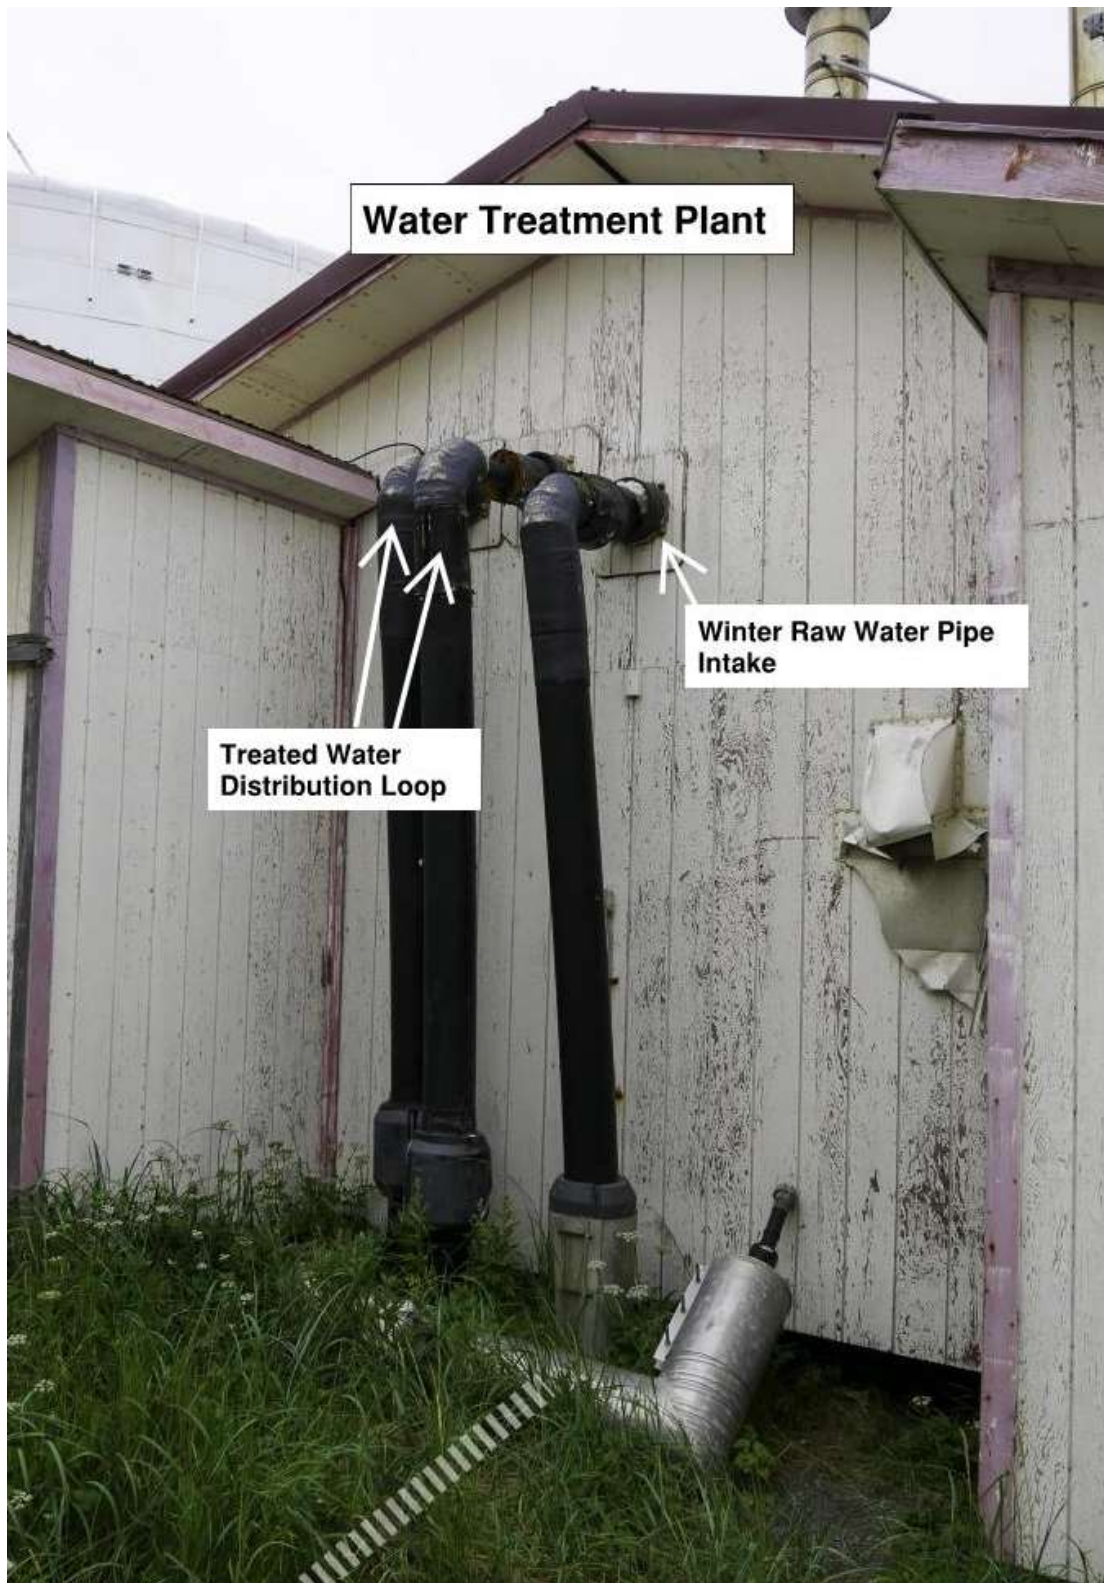
Figure 23: Winter raw water pipe routing into Water Treatment Plant. Note, differential settlement has caused the insulation jacket on the winter raw water pipe to separate where it penetrates the building.

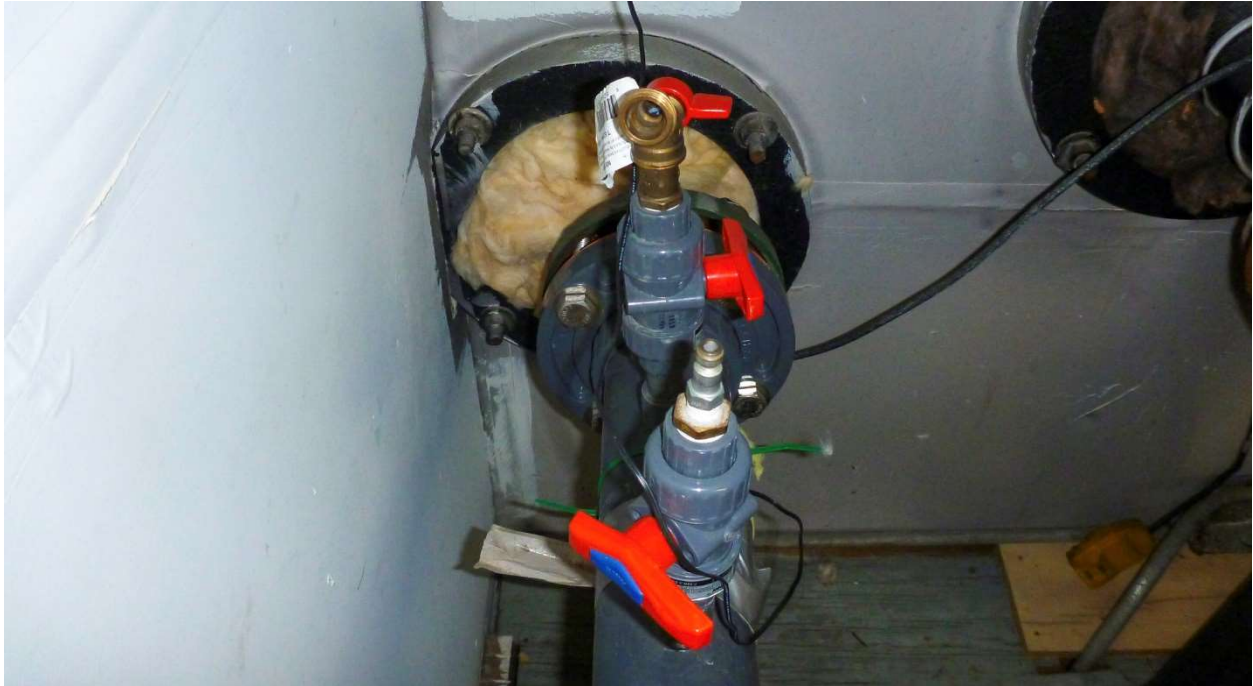
Figure 24: Winter raw water pipe as it penetrates inside the WTP. The small valves and attachments are used by operators to attempt to thaw ice in the pipe by alternately injecting warm water and compressed air.

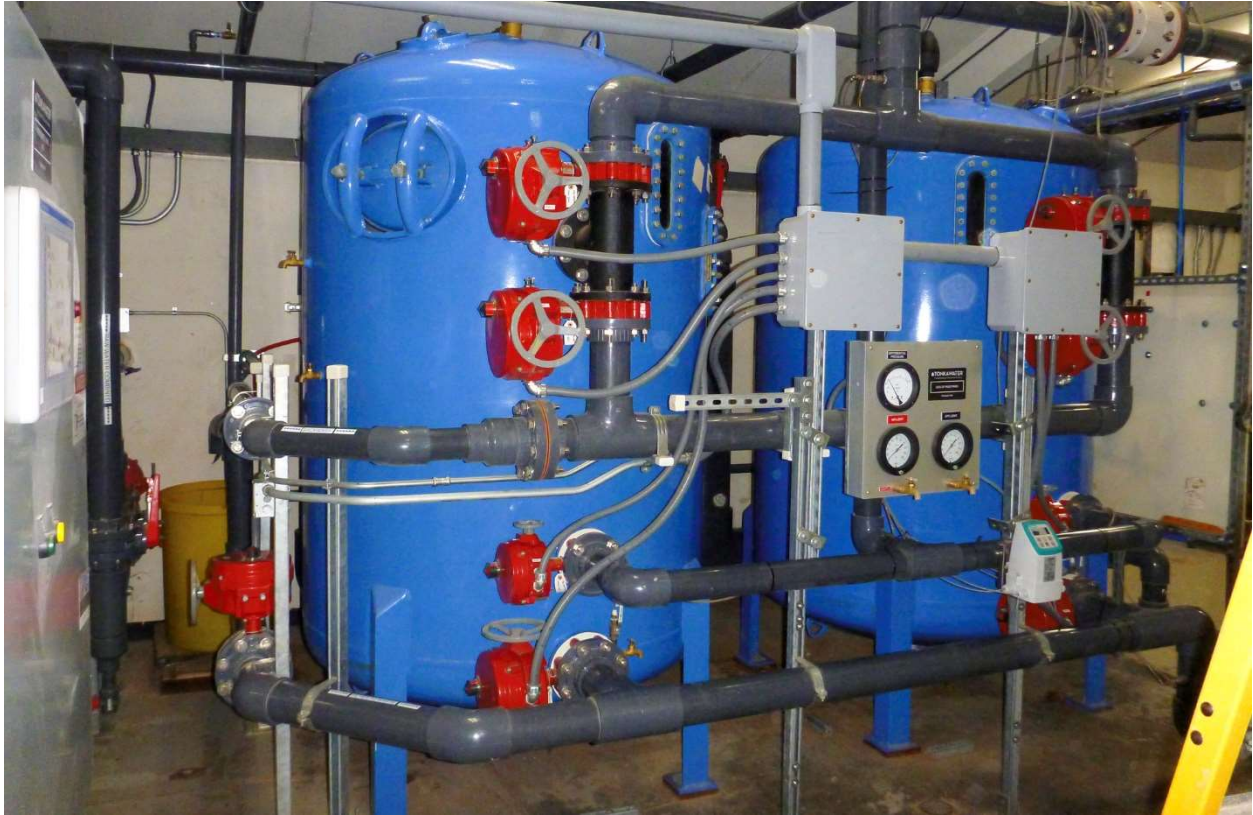
**Figure 31: WTP mixed media filters (5 feet diameter by 8 feet tall. The WTP operator reported that these filters were installed as part of a 2018 project by Bristol construction. The new filters are larger than the old filters. Community officials believe the additional weight of the new filters is causing foundation settlement and structural issues at the WTP.**

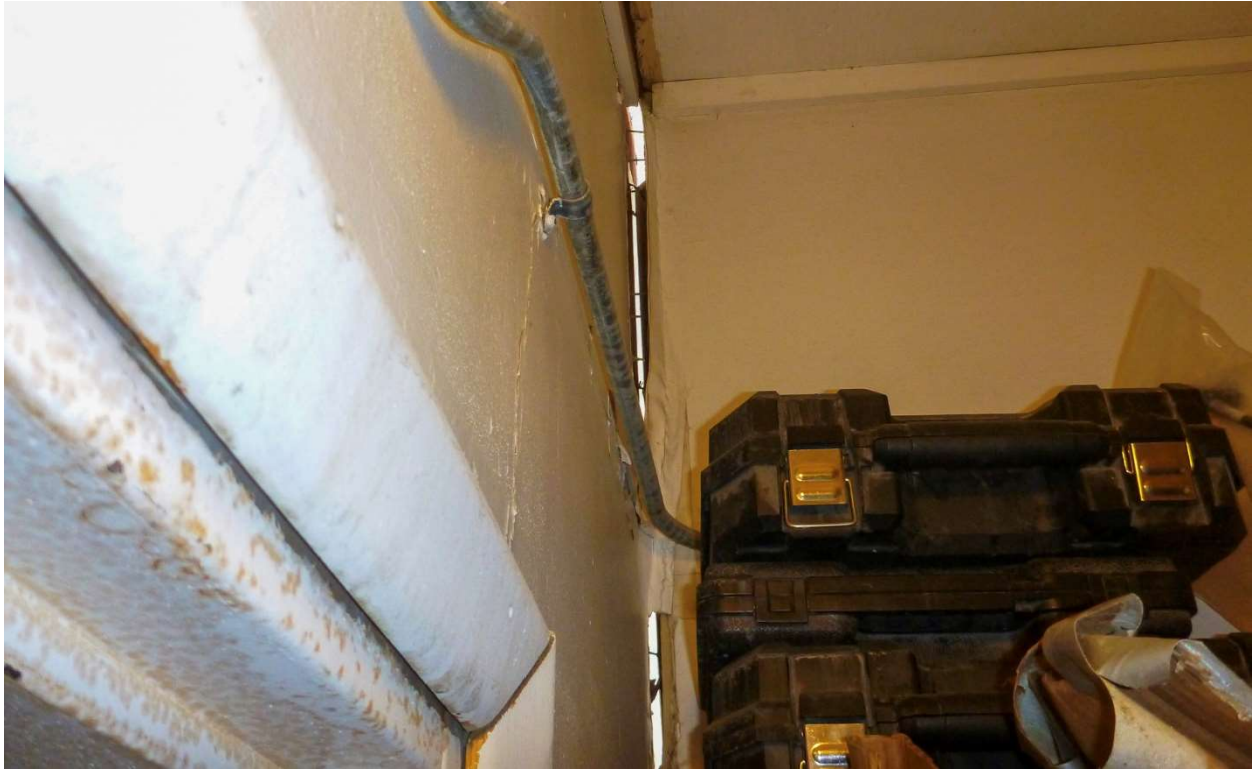
**Figure 33: One of several locations where daylight is visible along exterior walls of the WTP . WTP operation logs indicated the facility is unable to maintain room temperature during winter within the building. Community officials reported these cracks appeared after installation of the new mixed media filters (Photo 1 of 5).**

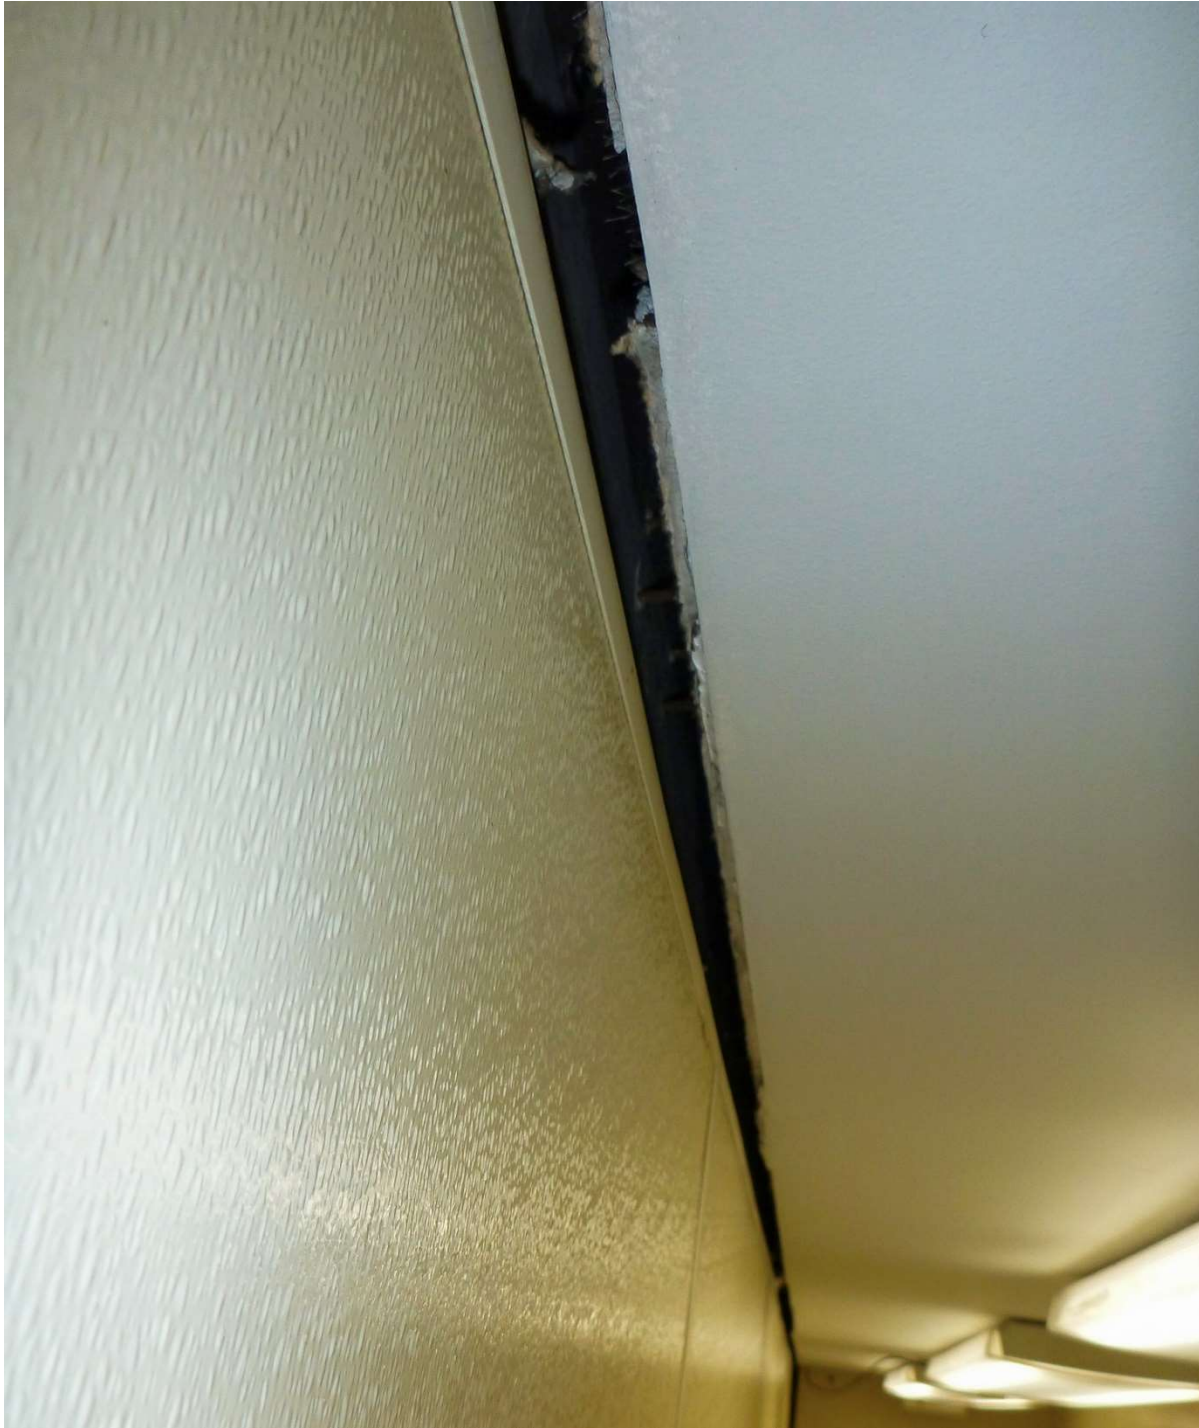
**Figure 34: Cracks along exterior walls of the WTP. WTP operation logs indicate the facility is unable to maintain room temperature during winter within the building. Community officials reported these cracks appeared after installation of the new mixed media filters (photo 2 of 5).**

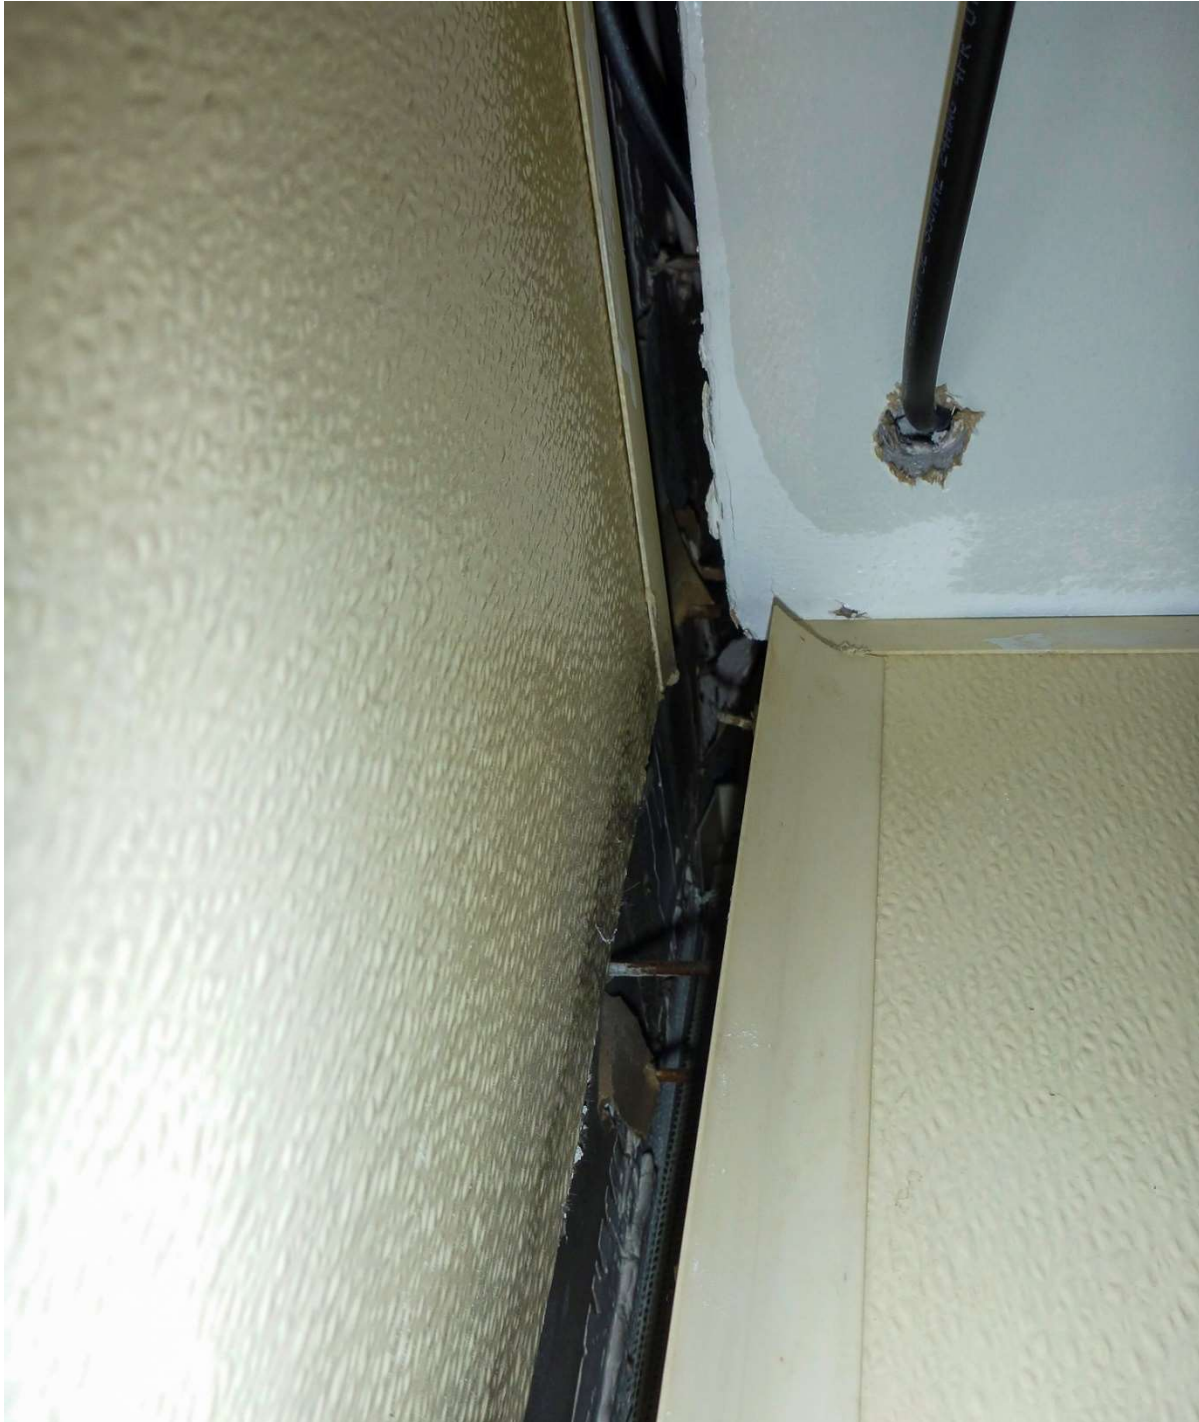
**Figure 35: Cracks along exterior walls. WTP operation logs indicate the facility is unable to maintain room temperature during winter within the building. Community officials reported these cracks appeared after installation of the new mixed media filters (photo 3 of 5).**

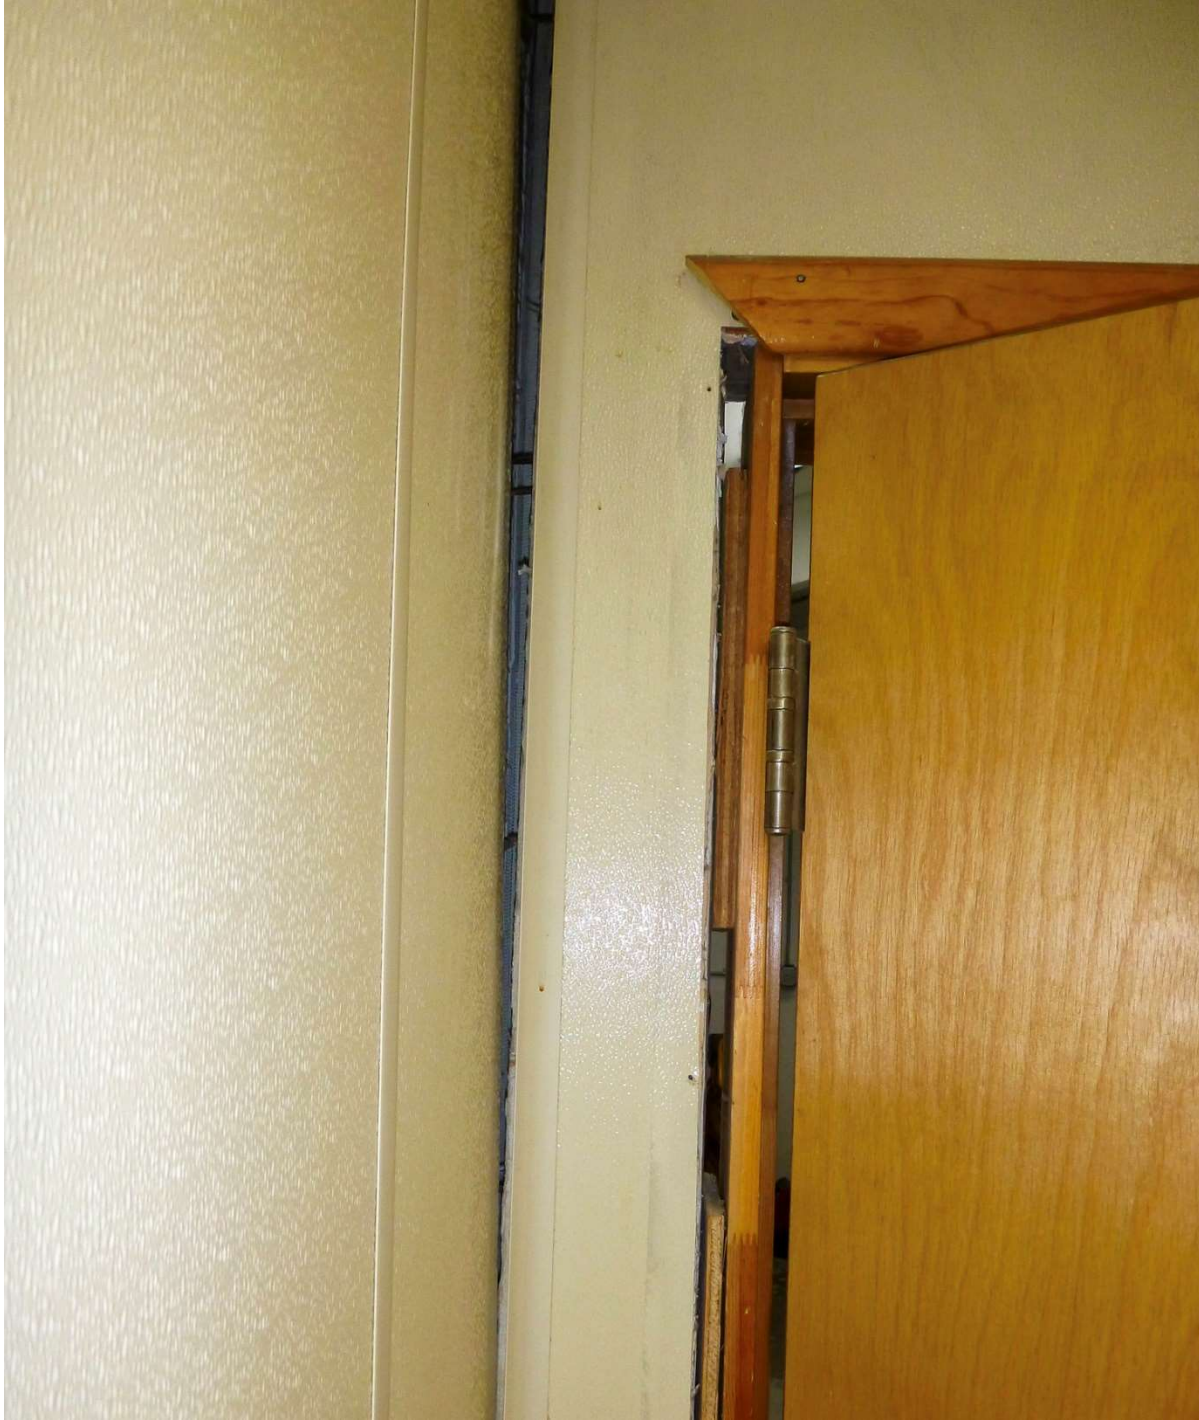
**Figure 36: Cracks along exterior walls. WTP operation logs indicate the facility is unable to maintain room temperature during winter within the building. Community officials reported these cracks appeared after installation of the new mixed media filters (photo 4 of 5).**

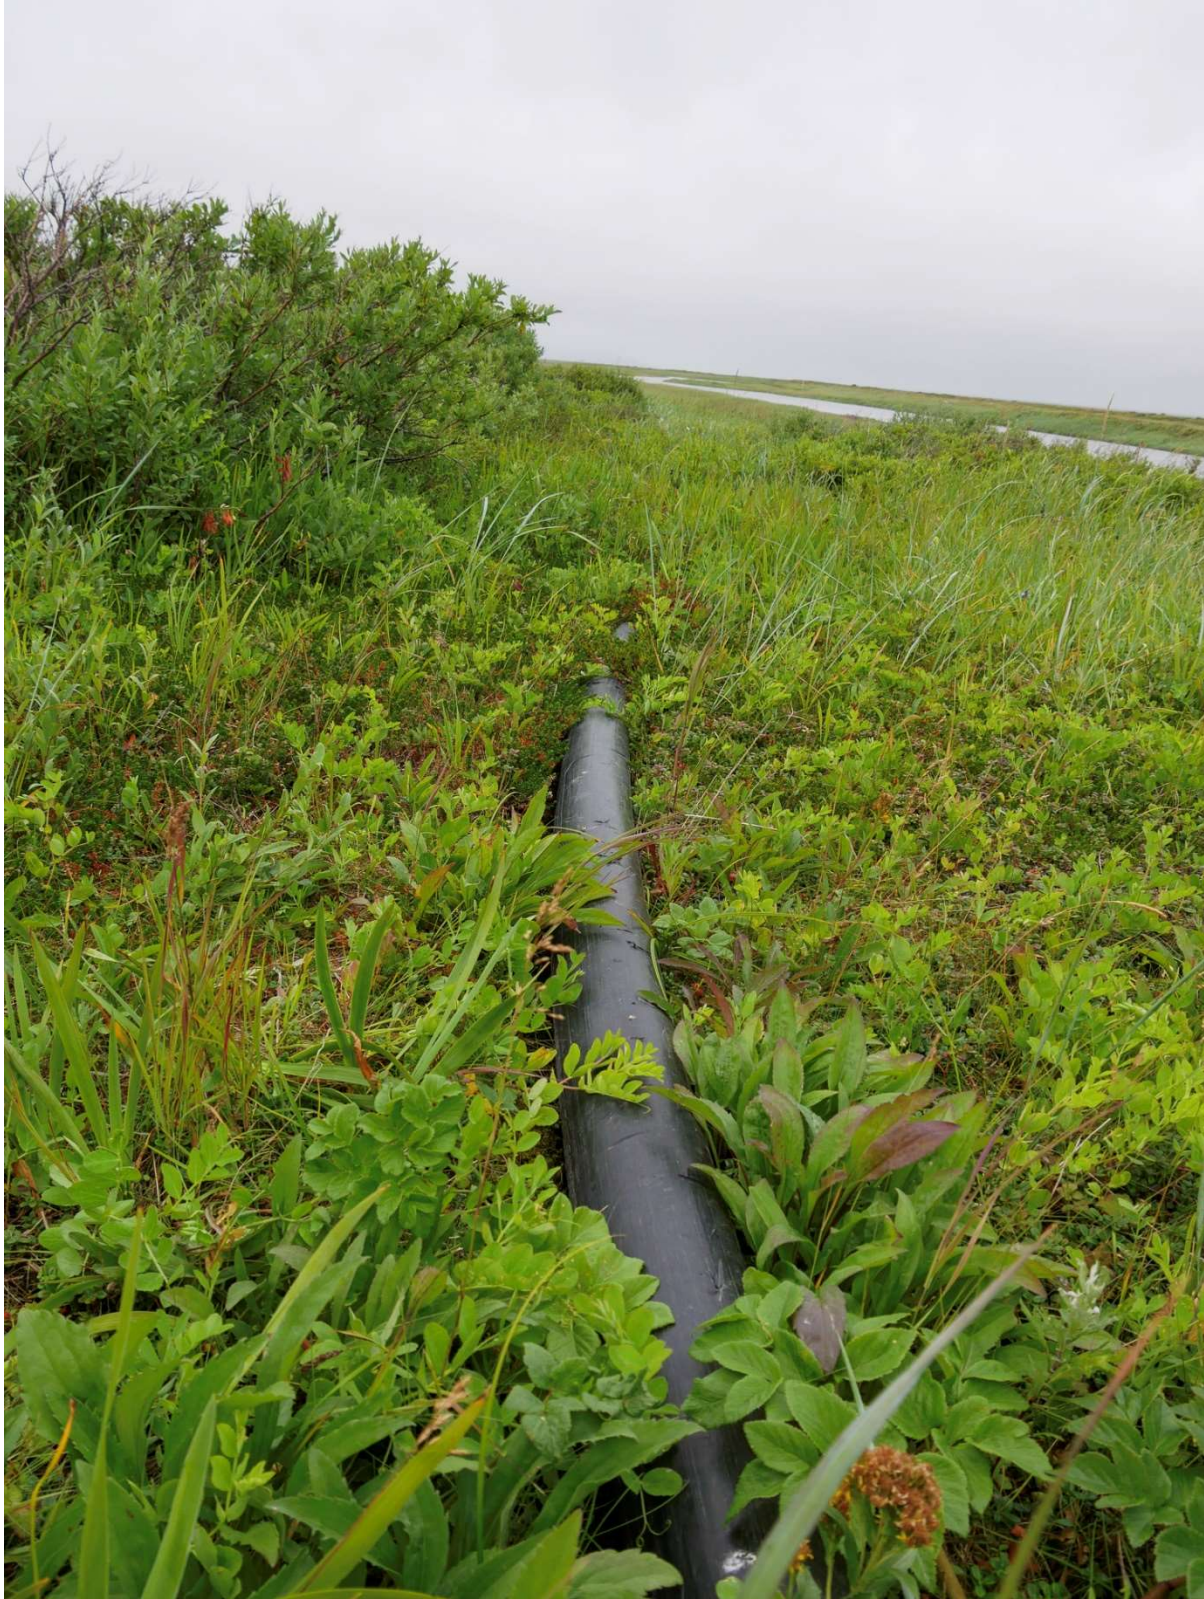
**Figure 42: HDPE summer raw water supply line running across the surface of the tundra back to town. The line is approximately 6500 feet long, and is not insulated nor heat taped. The line is purged with air at the end of the year to prevent freezing.**

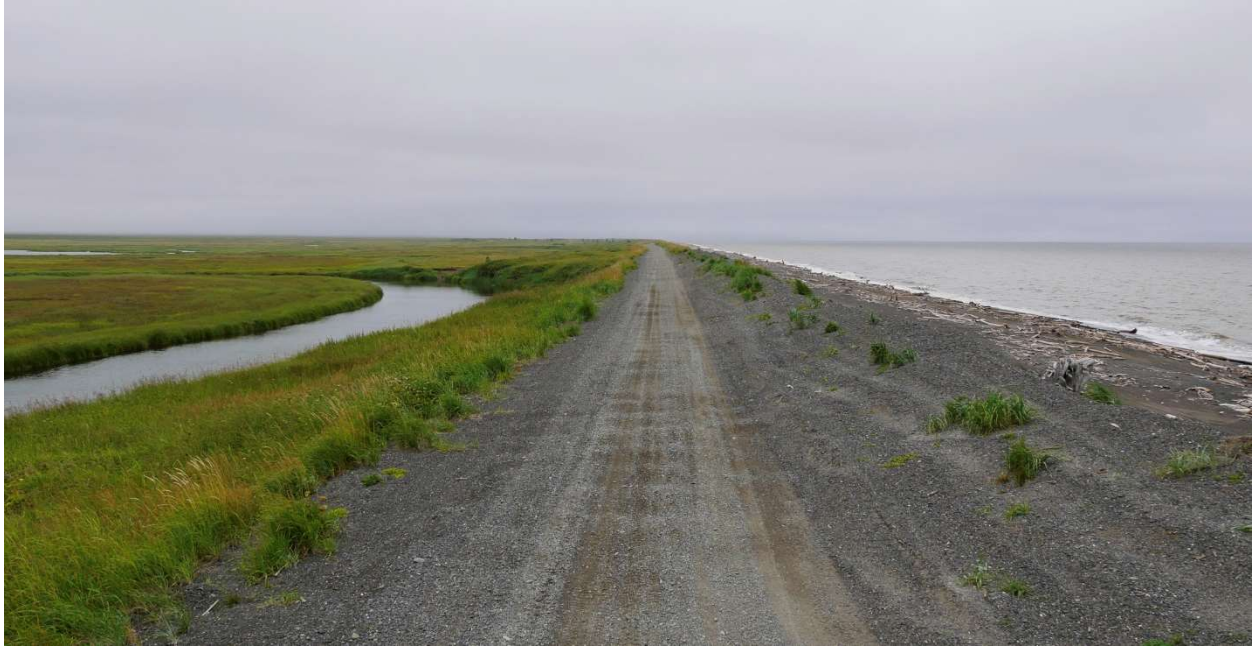
**Figure 43: The most pressing threat to the community is “the berm” a narrow point approximately three miles south of town where an oxbow bend in the Tagoomenik river cuts dangerously close to Norton Sound. Storm surge flooding and waves from a large fall storm could possibly breach the berm and relocate the mouth of the river to this location, cutting Shaktoolik off from its summer and winter water supply points as well as a primary evacuation route. A permanent breach of the berm would likely require relocation of the community. A separate project is currently underway to study and reinforce the berm in this location.**

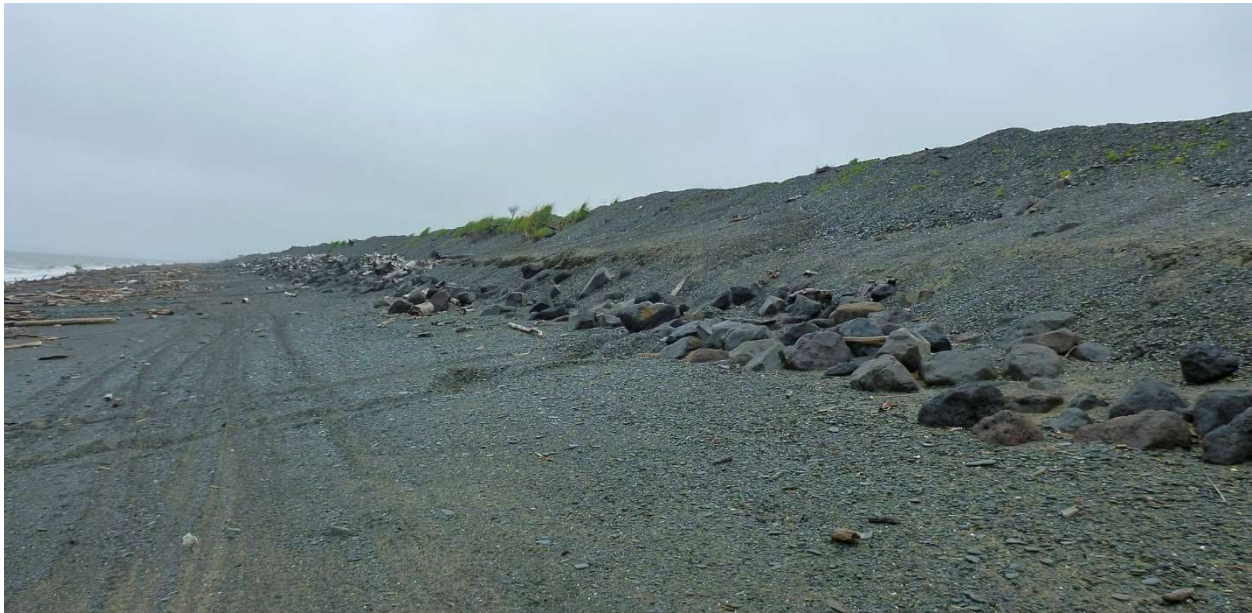
**Figure 44: Collapsed rock protection placed along the berm. (Looking from the berm north toward Shaktoolik)**

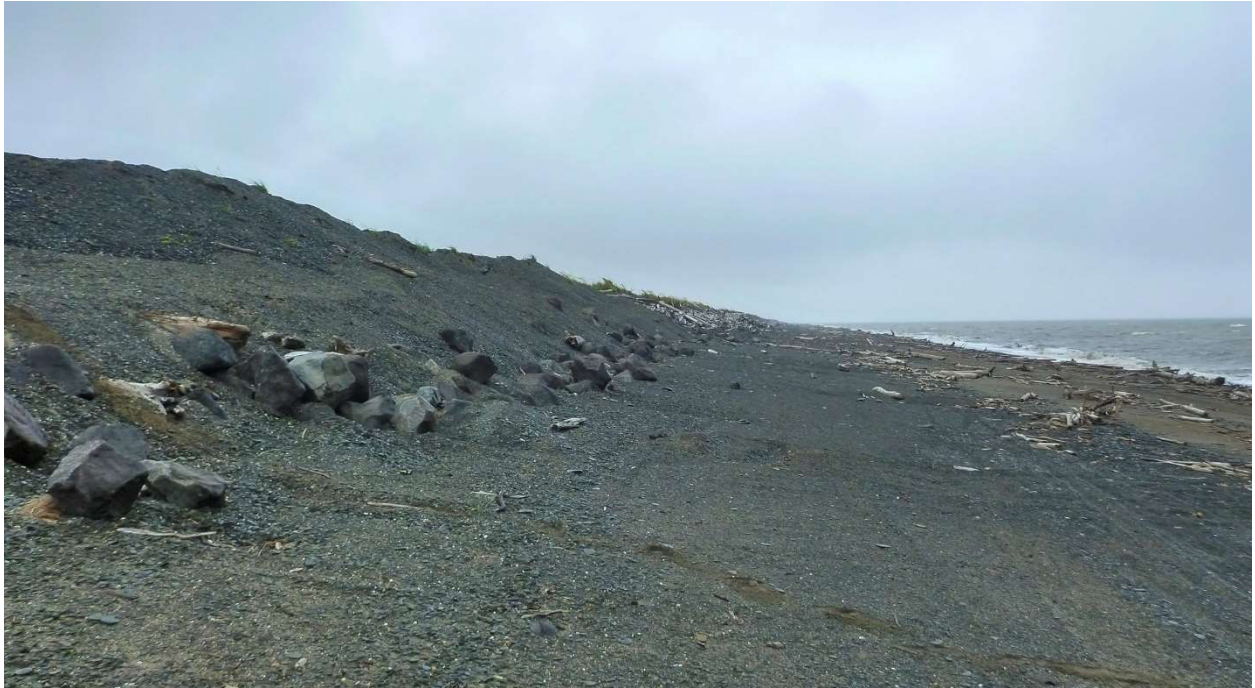
**Figure 45: Collapsed rock protection placed along the berm. (Looking from the berm south away from Shaktoolik).**

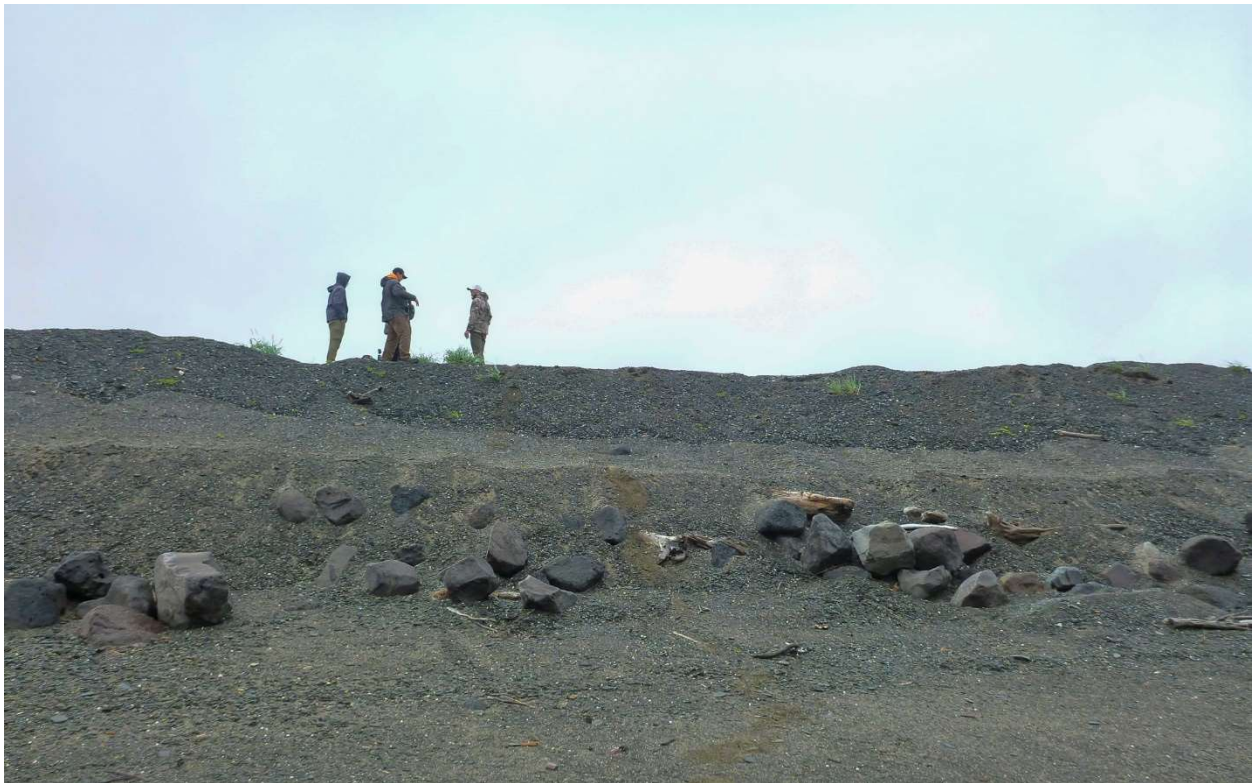
**Figure 46: Collapsed rock protection and high water line visible along the berm (Looking from ocean shore inland).**
