**STATE OF ALASKA**  
**Department of Transportation & Public Facilities**  
**Central Materials Lab**  
 5750 EAST TUDOR RD, ANCHORAGE AK 99507  
 Phone (907)-269-6200 FAX (907) 269-6201  
**Laboratory Report**

PROJECT NAME: Williamsport to Pile Bay Rd. Repair PROJECT NO. 51651 LABORATORY NO. 05A-0973  
 SAMPLE OF: \_\_\_\_\_ ITEM/SPECIFICATION NO.: \_\_\_\_\_ FIELD NO.: FS05-8  
 SAMPLED FROM: Stockpile @ Pit, MP 4.0 DATE SAMPLED: 06/22/2005  
 SOURCE/SUPPLIER: Centerline QUANTITY REPRESENTED \_\_\_\_\_ DATE RECEIVED: 06/24/2005  
 LOCATION/ADDRESS: \_\_\_\_\_ SUBMITTED BY: C. Boeckman DATE COMPLETED: 07/20/2005  
 EXAMINED FOR: Gradation, LA, Deg, Sulfate Soundness & SpG DATE REPORTED: 07/20/2005

PROJECT NAME: Williamsport to Pile Bay Rd. Repair PROJECT NO. 51651 LABORATORY NO. 05A-0974  
 SAMPLE OF: \_\_\_\_\_ ITEM/SPECIFICATION NO.: \_\_\_\_\_ FIELD NO.: FS05-9  
 SAMPLED FROM: Rock Cut MP 1.0 , Depth Surface DATE SAMPLED: 06/23/2005  
 SOURCE/SUPPLIER: Centerline QUANTITY REPRESENTED \_\_\_\_\_ DATE RECEIVED: 06/24/2005  
 LOCATION/ADDRESS: \_\_\_\_\_ SUBMITTED BY: C. Boeckman DATE COMPLETED: 07/11/2005  
 EXAMINED FOR: LA, Deg, Nordic Abrasion & SpG DATE REPORTED: 07/18/20

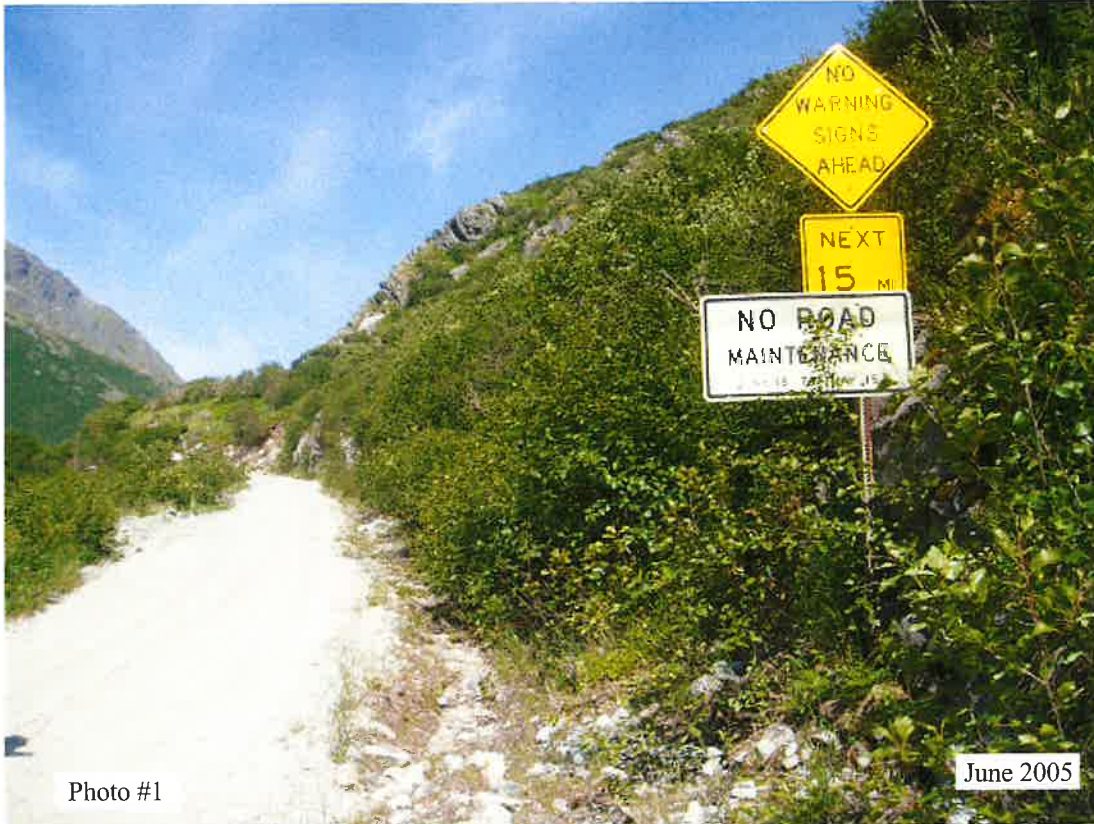
Photo #1

MP 0.35 - Little to no rock fall problems from 0.35 (start of rock cuts) to MP 0.9. Relatively small cuts. There is significant vegetation cover that stabilizes the slopes.

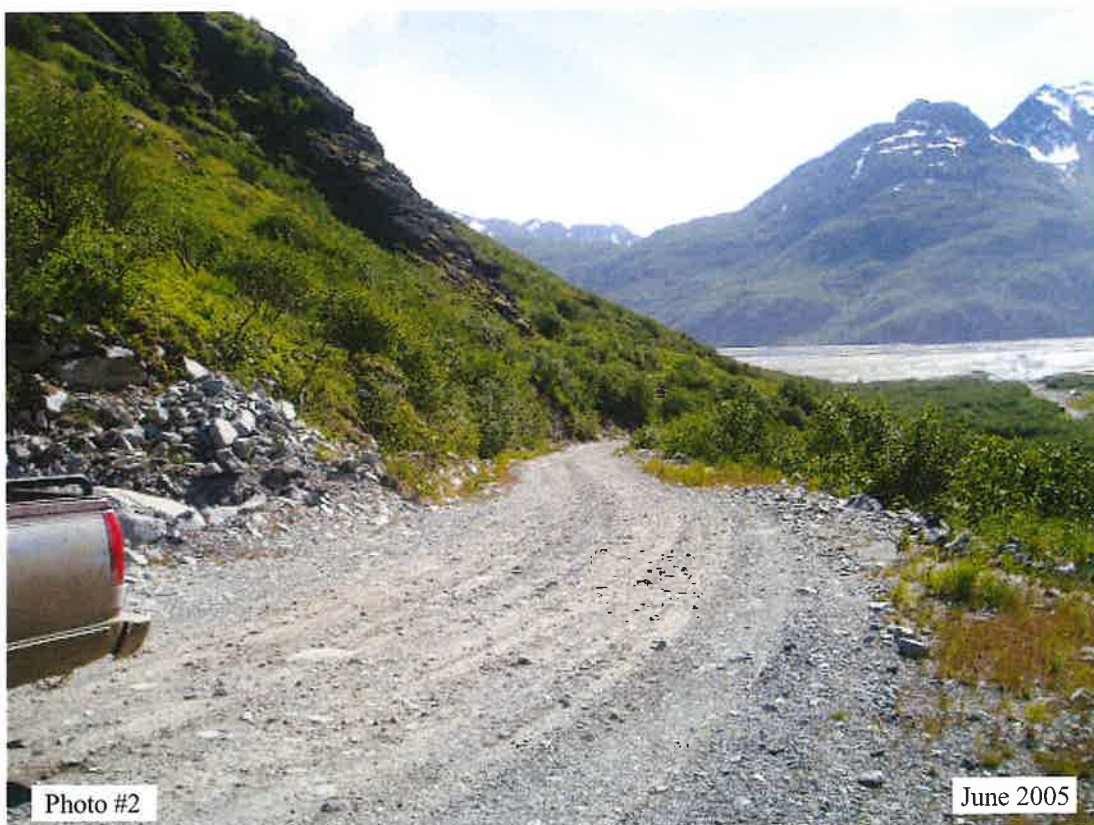
Photo #2

MP 0.85 - Looking back at Williamsport from MP 0.85.

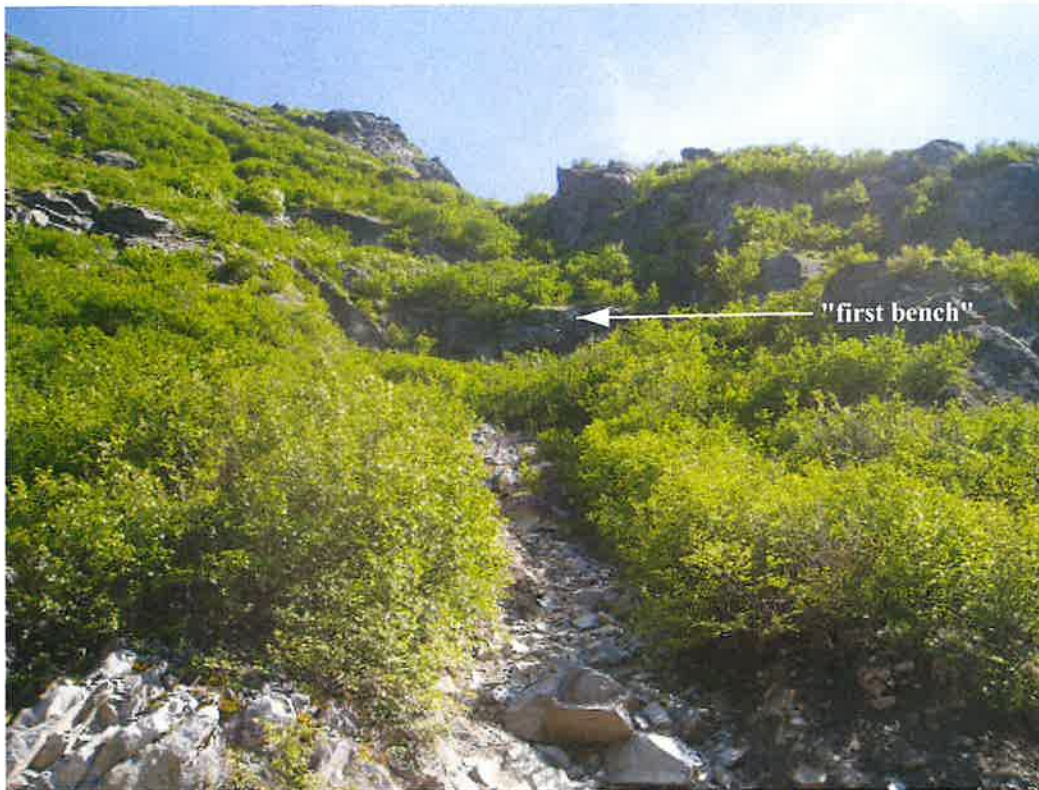
MP 1.0 - Looking up at the rock "chute" and the talus fan at the road. Rock fall area.

The slope of the chute is 49 degrees.  
The distance up to the first bench is about 330 ft.

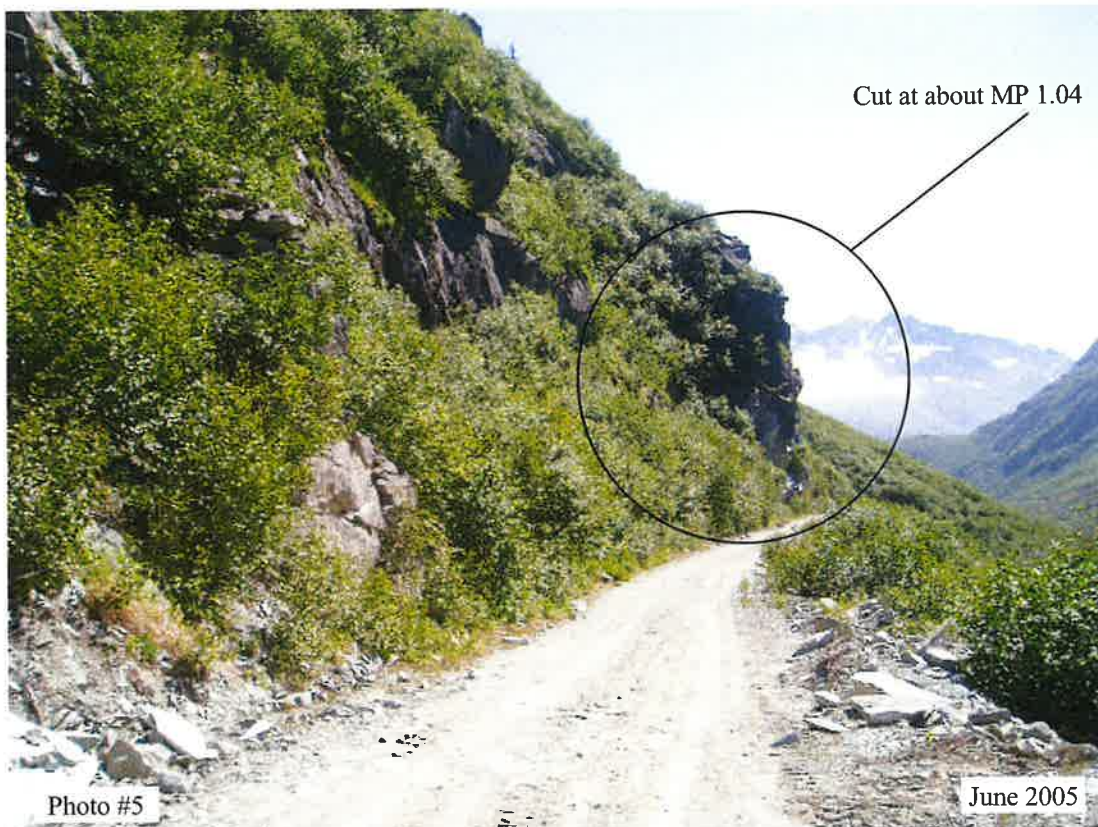
From MP 1.1 - Looking back at MP 1.04 cut area.

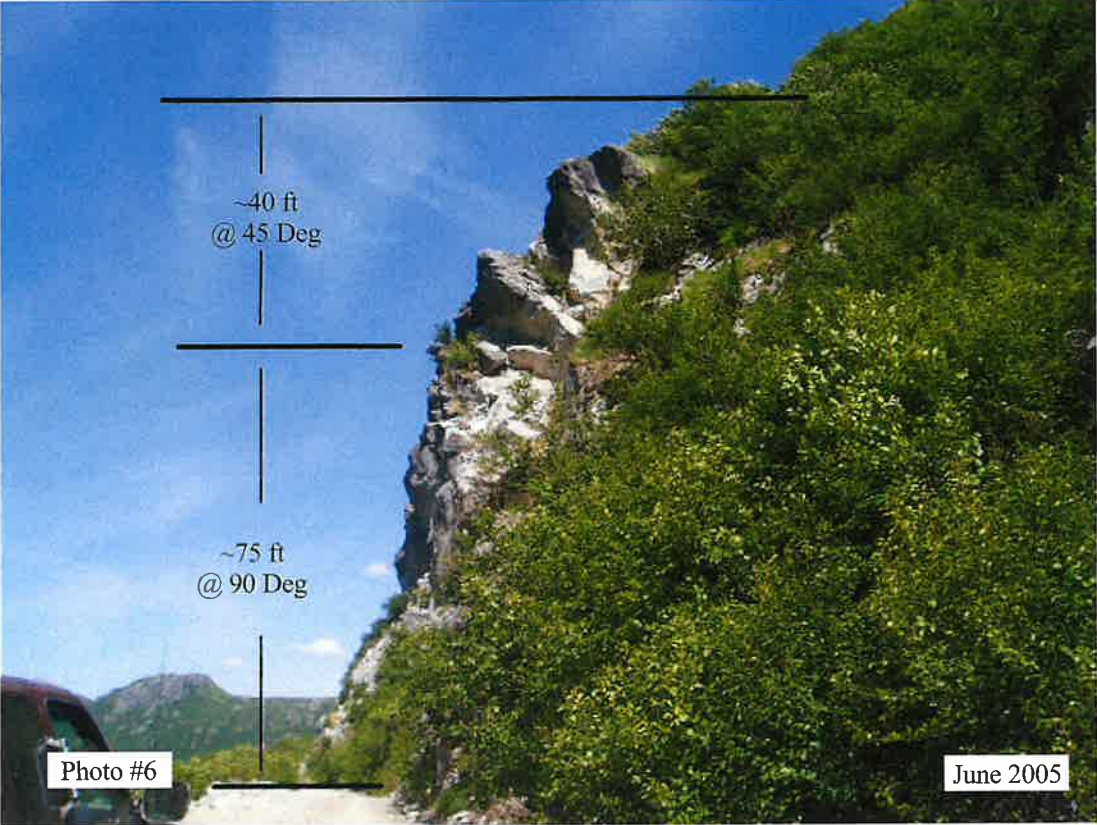
MP 1.04 - Rough dimensions of the slope.

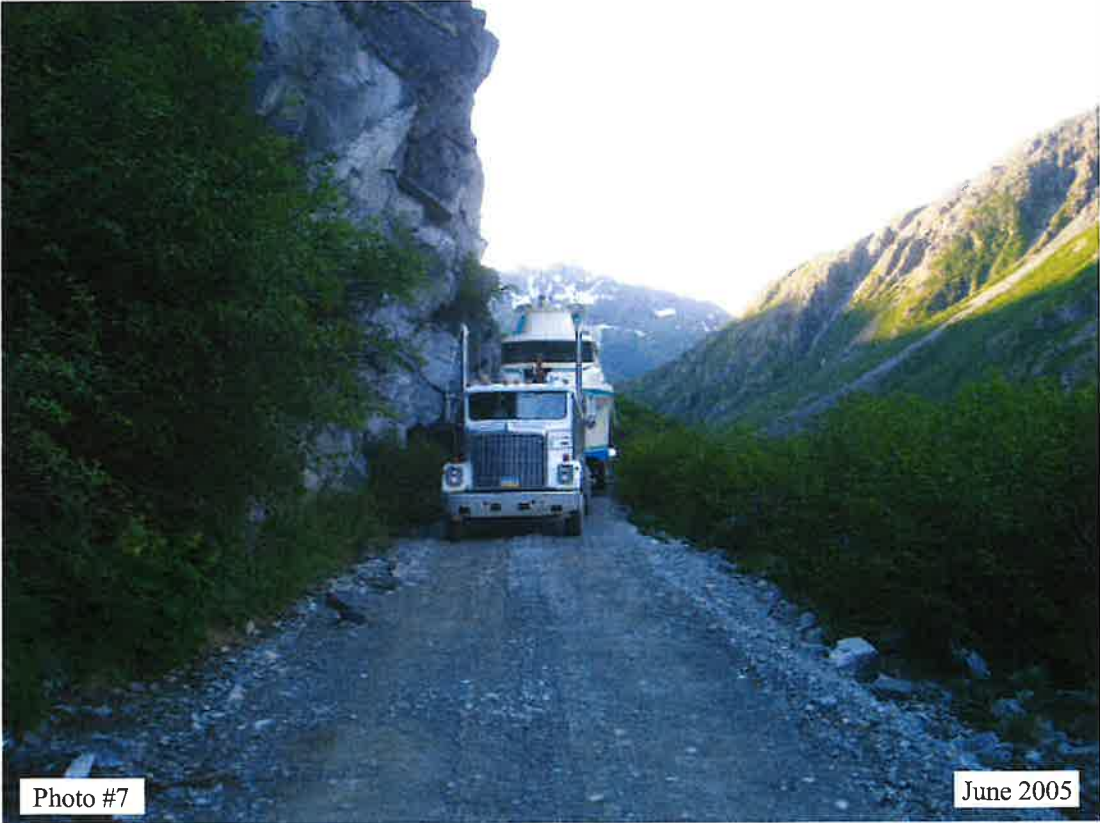
MP 1.04 - Looking at a gillnet type boat being hauled past the cut.

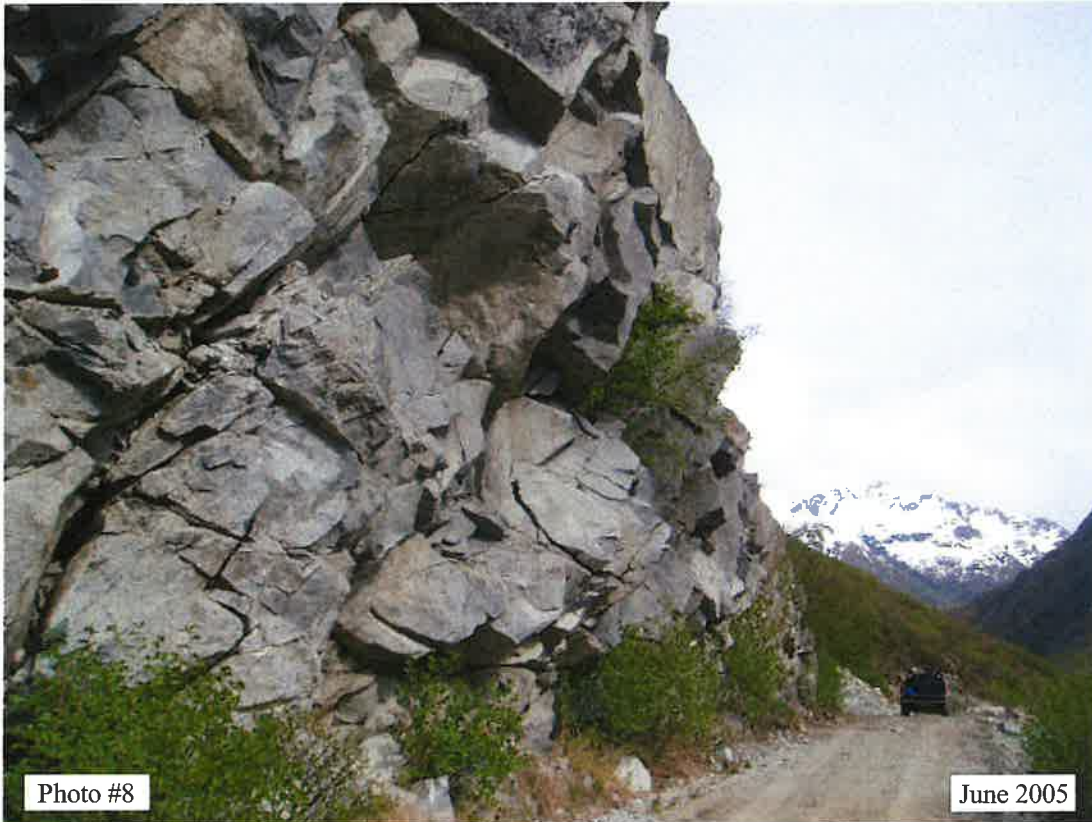
Photo of the rock cut at MP 1.04 (local maintenance contractor calls this "1-mile bluff"). The road is only 12 ft wide here. North is to the left in the photo.

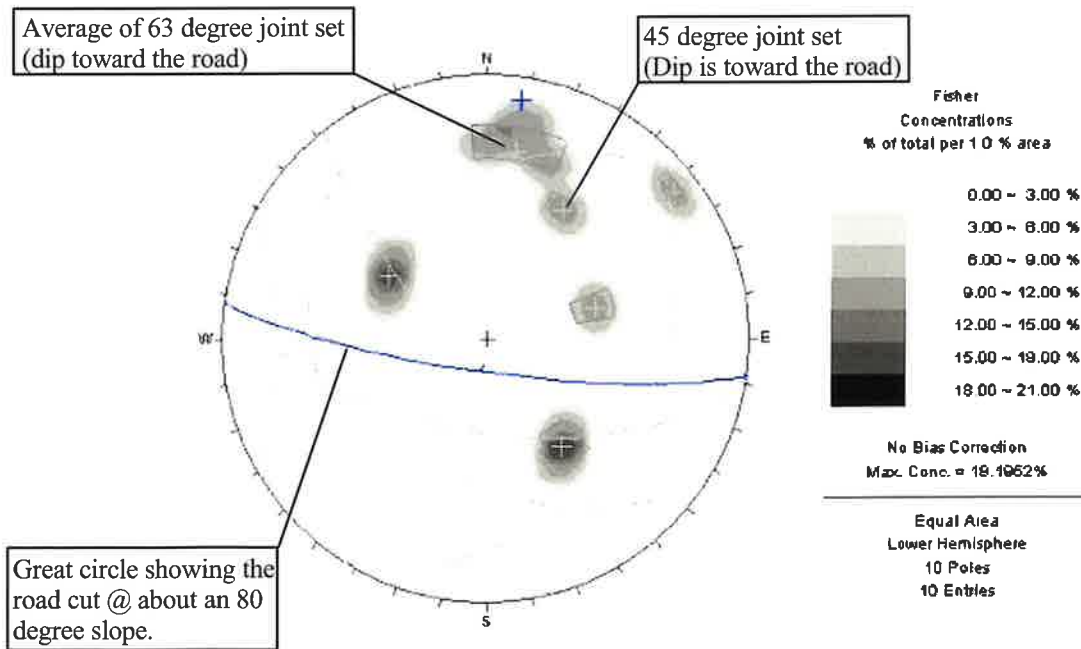
Stereonet of major joints at MP 1.0 cut - This contour stereonet presents limited data of the rock structure at this cut.

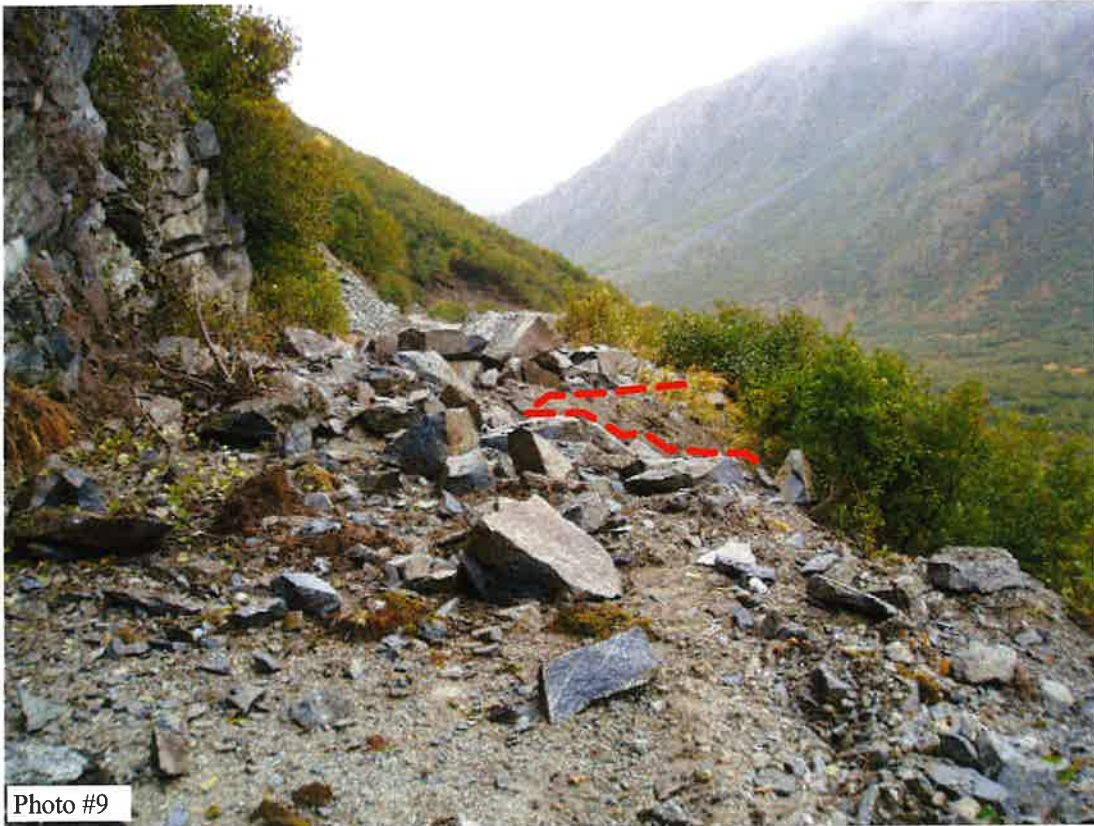
Photo #9

MP 1.04 - Looking at rock fall from 9-2004. Ray Williams photo. A large rock hit the edge of the road and failed the embankment. The road was only 8 ft wide as a result of the rock fall (see red dashed line in the photo).

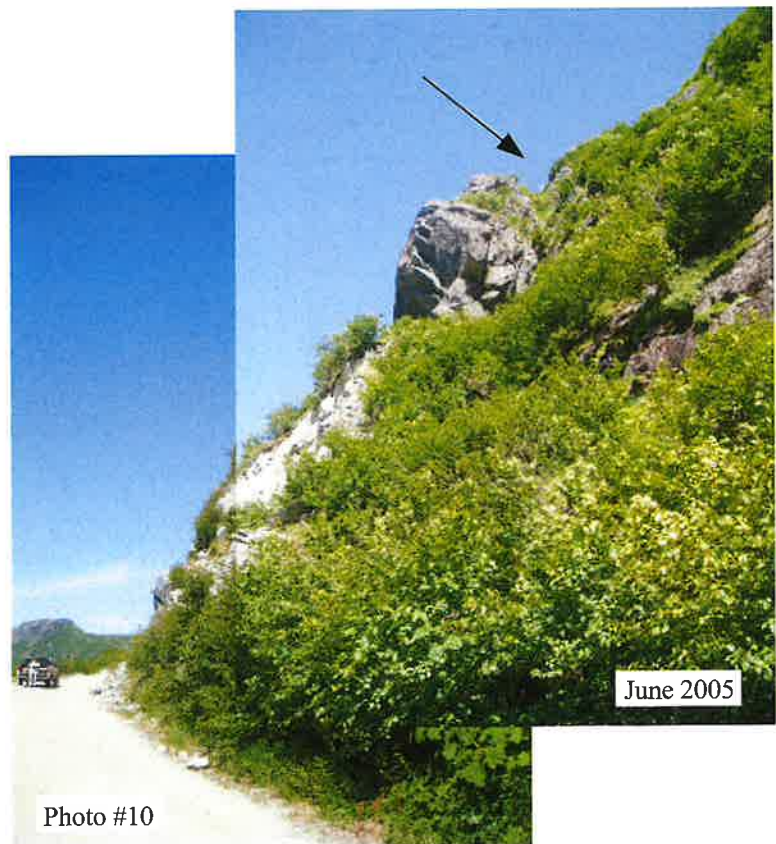
Photo #10

MP 1.1 - Looking upstation at the slope.

Arrow points to a deep open joint or fracture behind the rock overhang.

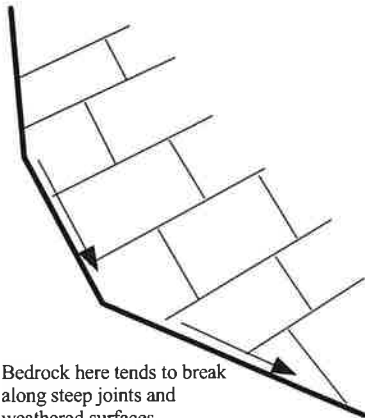
MP 1.1 - Looking at the slope and the curved failure surface. This slope was shot in the 1950s.

Bedrock here tends to break along steep joints and weathered surfaces forming a curvature.

80 degree joint set

65 degree joint set

48 degree failure surface

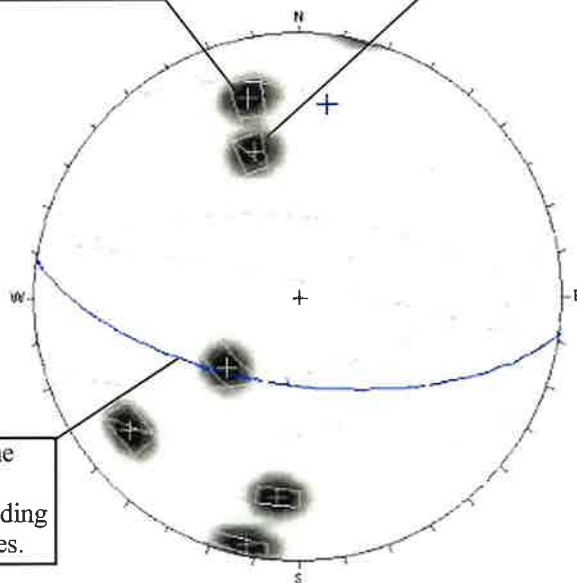
Stereonet of major joints at MP 1.1 bluff - This contour stereonet presents limited data of the rock structure at this cut.

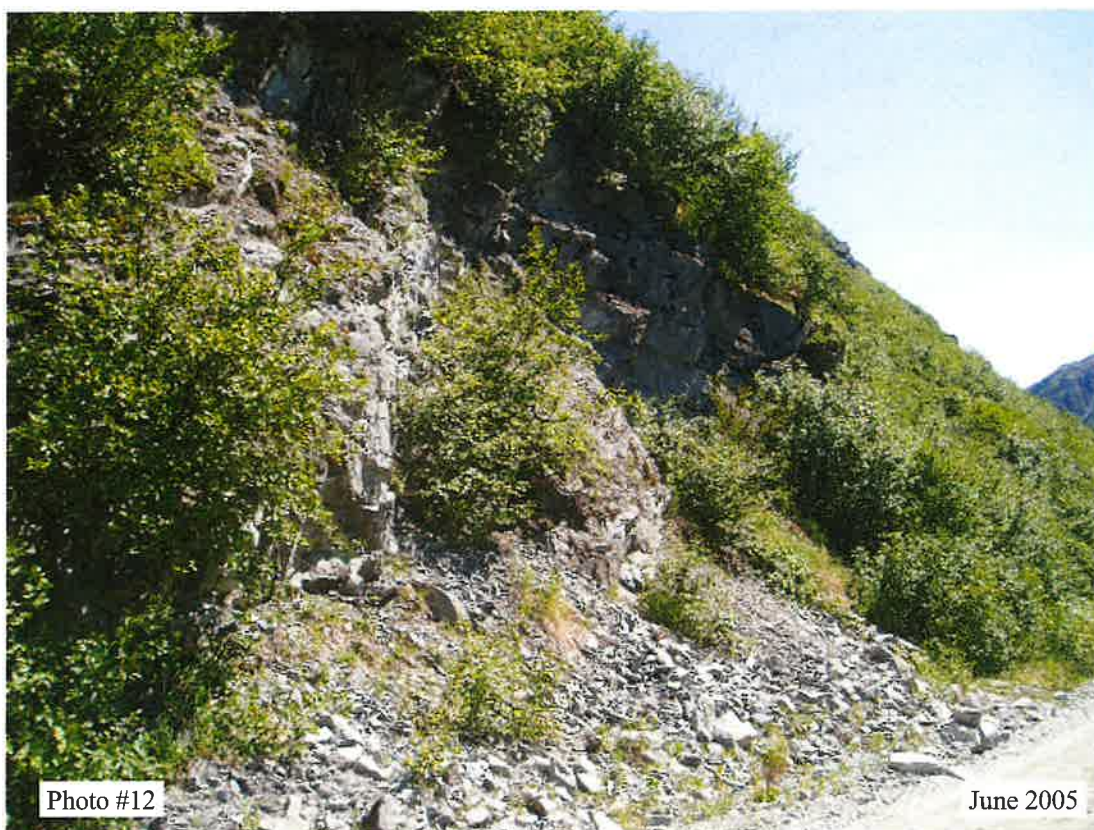
MP 1.35 - Relatively smaller cuts. Less rock fall problems. Rock structure is similar as MP 1.1.

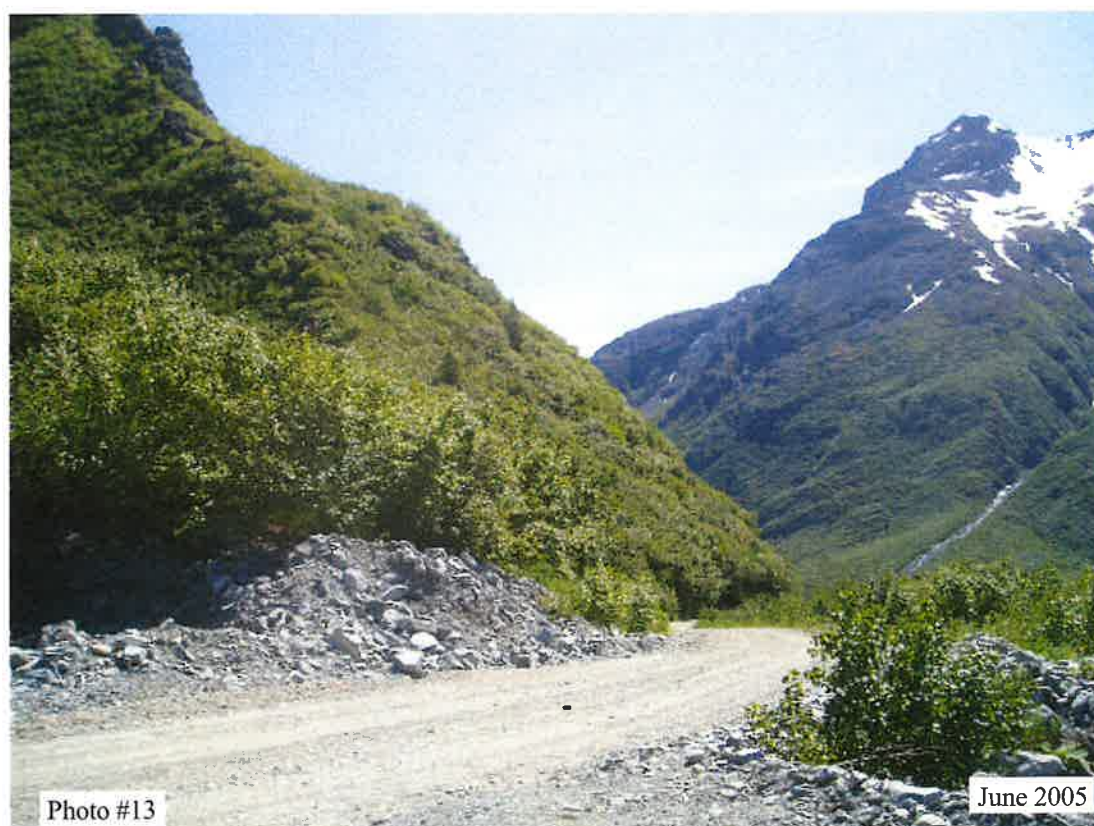
MP 1.45 - Looking downstation at the slopes. From about MP 1.2 the slopes becomes less steep. Possible material source at this site. A colluvium washout from a deep valley.

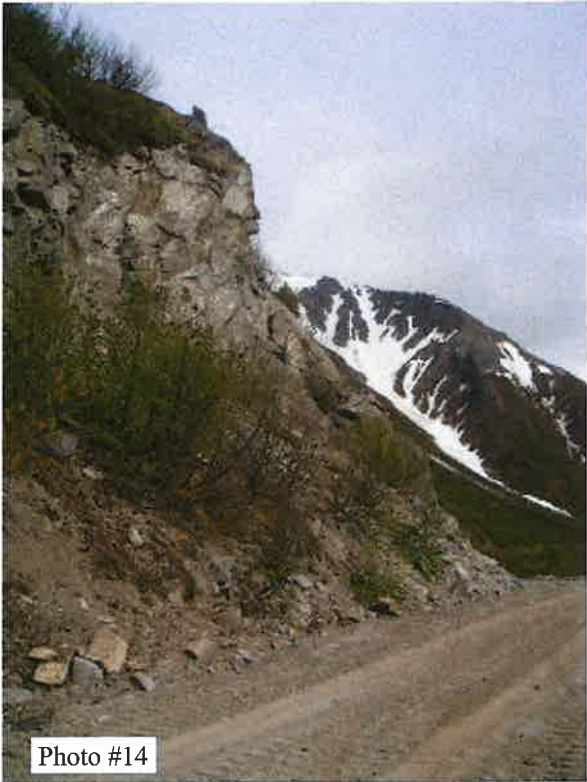
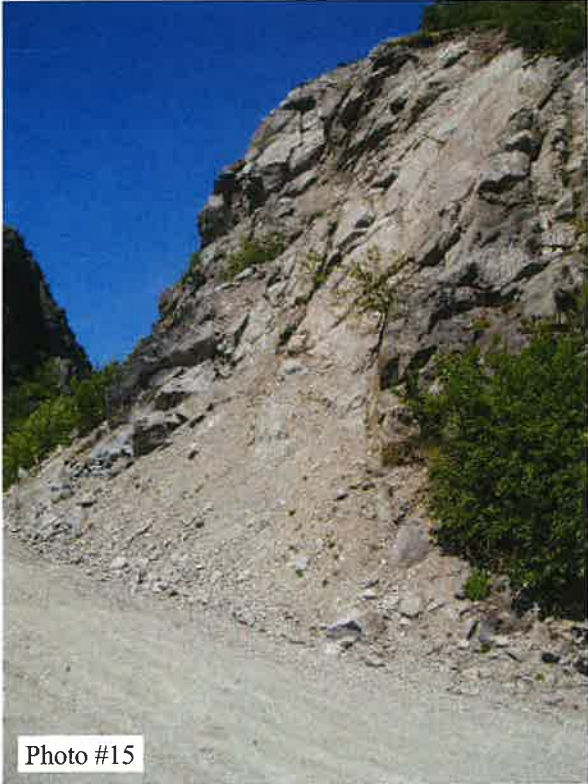
Photo #15

MP 1.9 - Poor rock quality due to nearby fault zone? Possible road instability issues here if the rock below the road is weathering. The slope above the road is about 53 degrees.

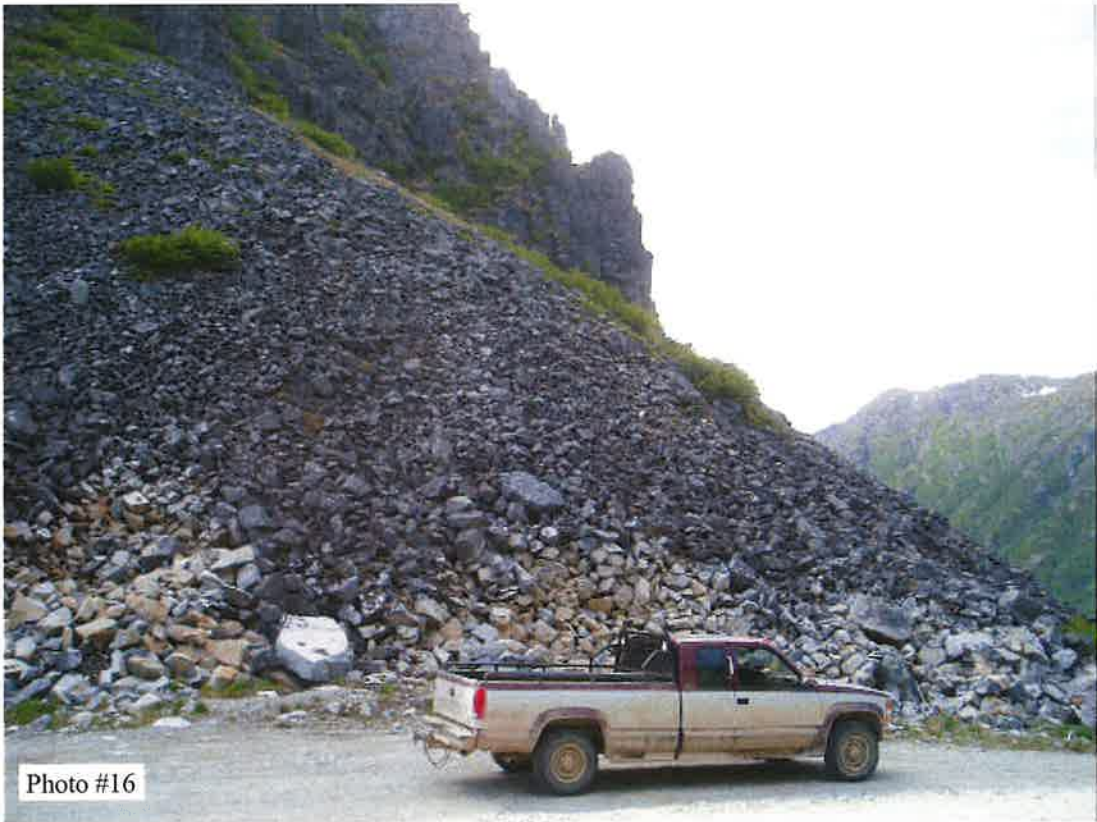
Photo #16

MP 2.05 - Pass. Talus boulders.

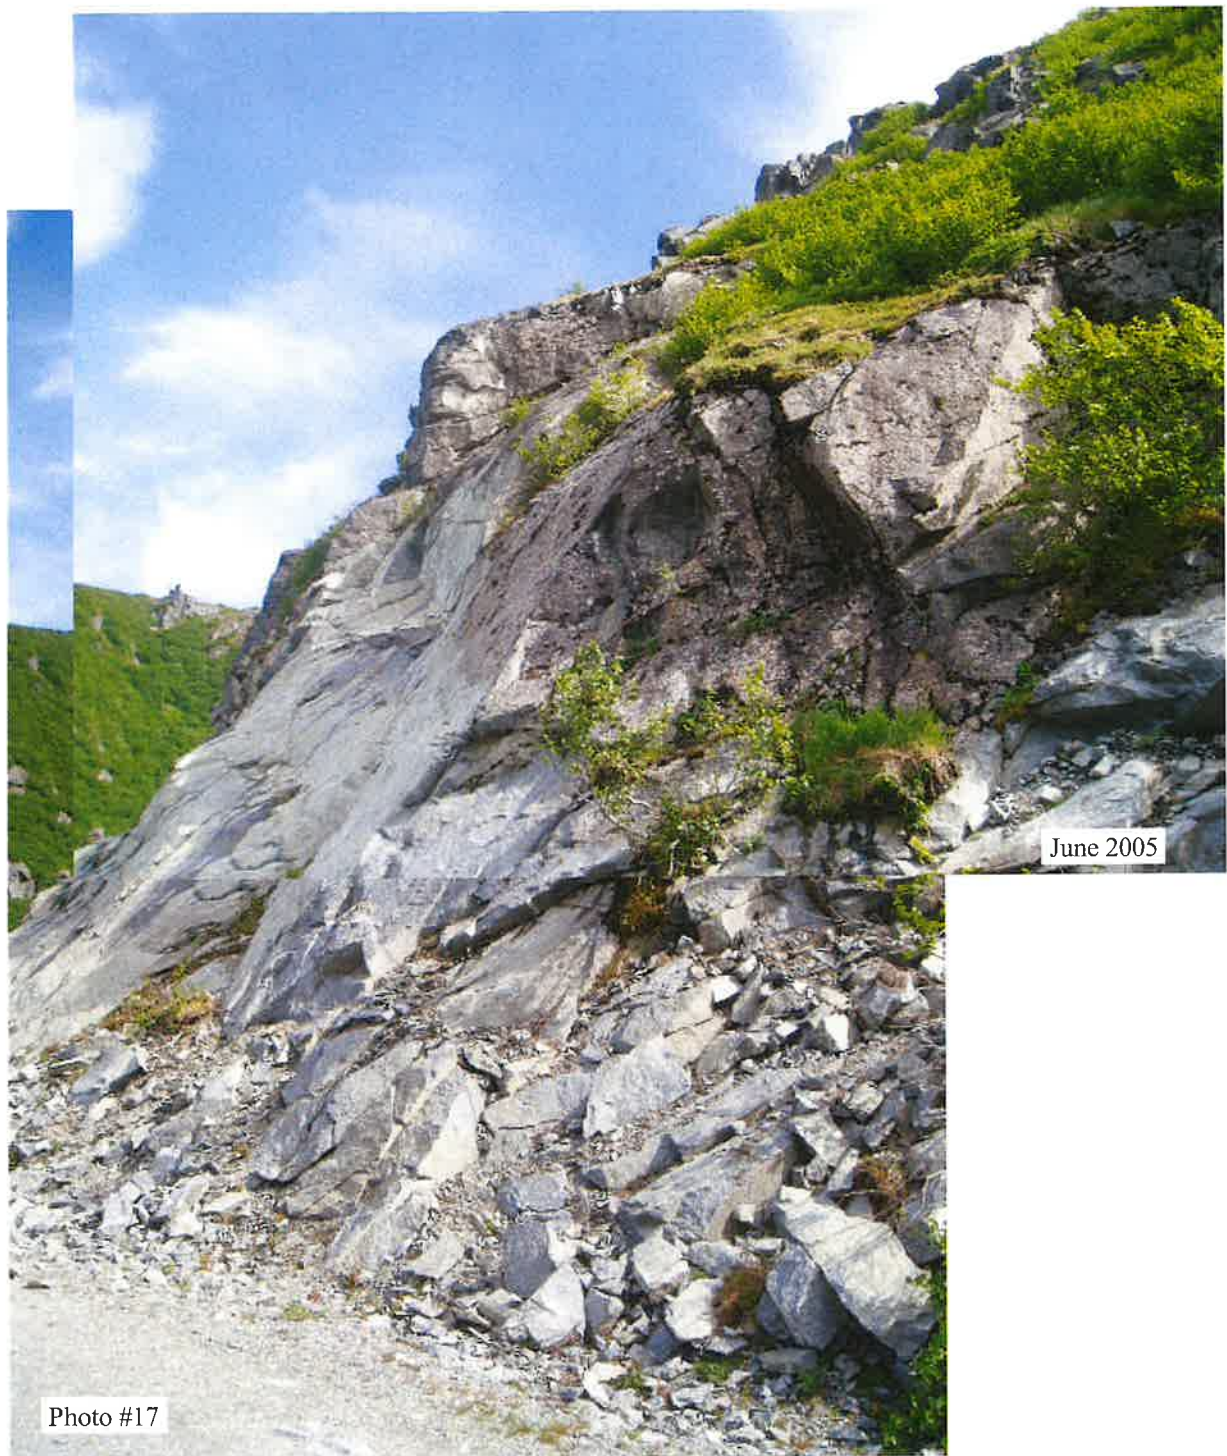
MP 2.2 - Construction fatality here during blasting  
in the 1950s. Rock fails along exfoliation surfaces that start at joints.

Joints 63 to 80 degrees.  
Failure surface from 36 to 50 degrees.

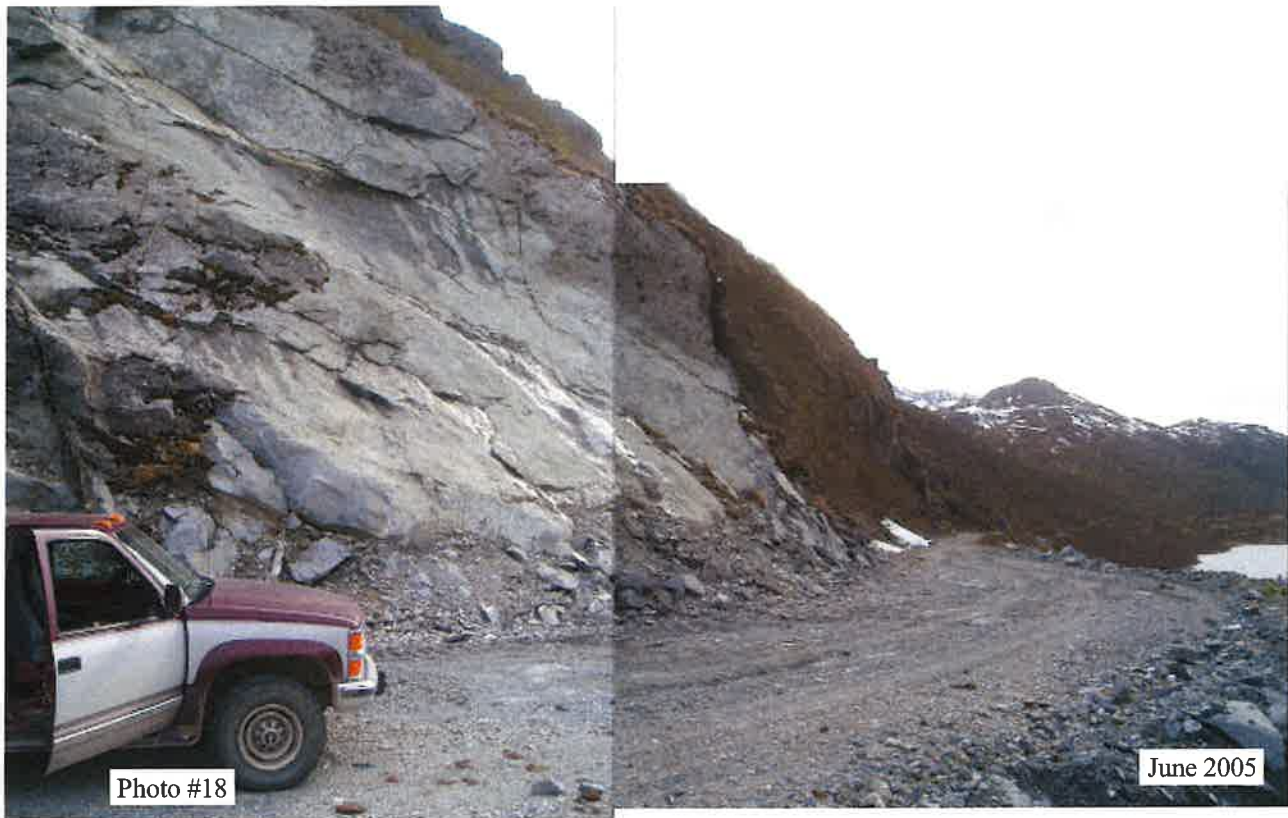
MP 2.2 - Slope failure surfaces/exfoliation type weathering along joints. North is to the right in the photo.

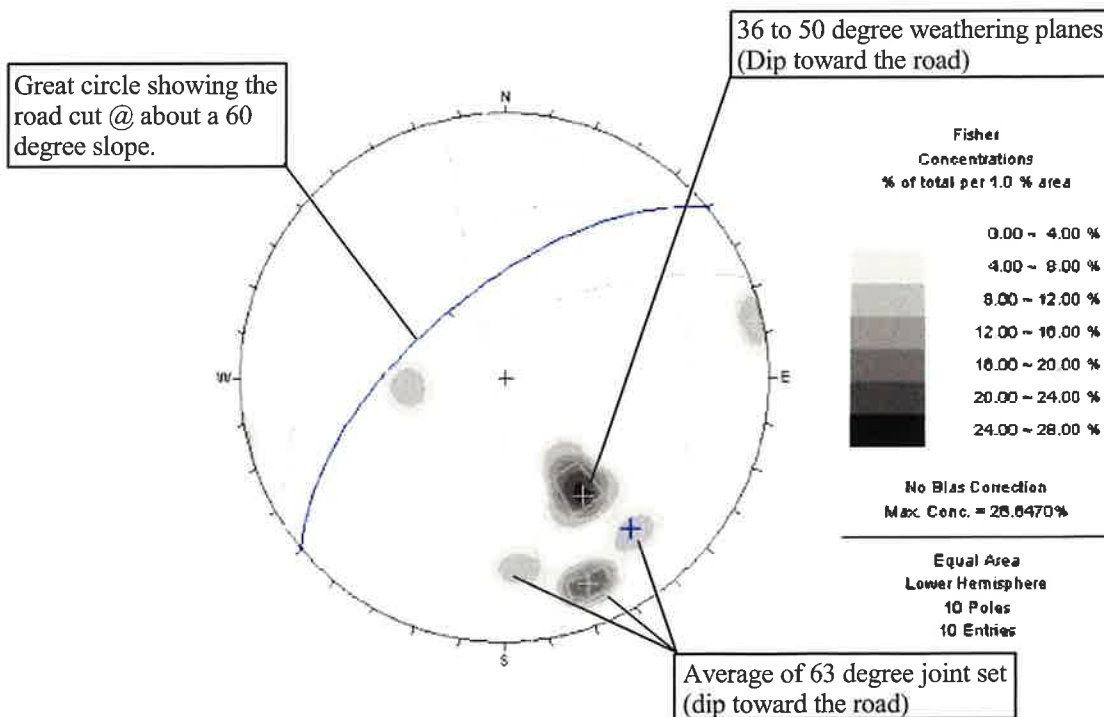
Stereonet of major joints and weathering planes between MP 2.1 and 2.4 - This contour stereonet presents limited data of the rock structure along this slope.

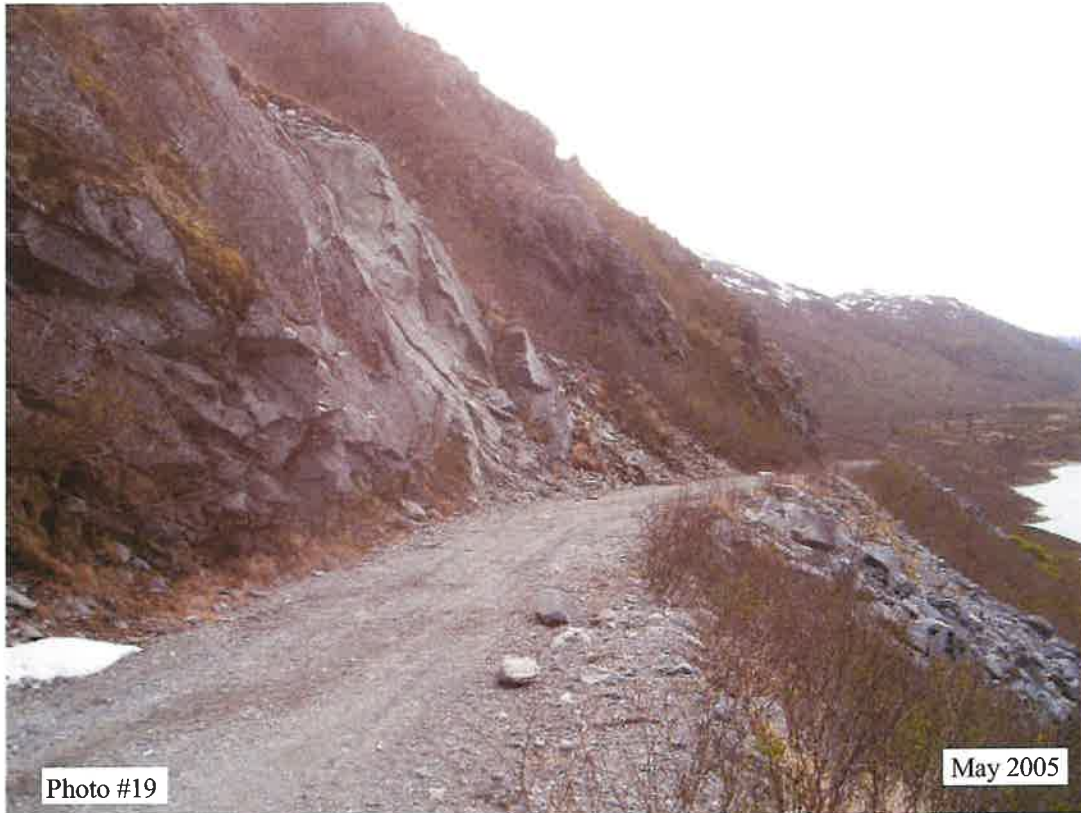
MP 2.4 - Rock fall from steep joints and exfoliation planes.

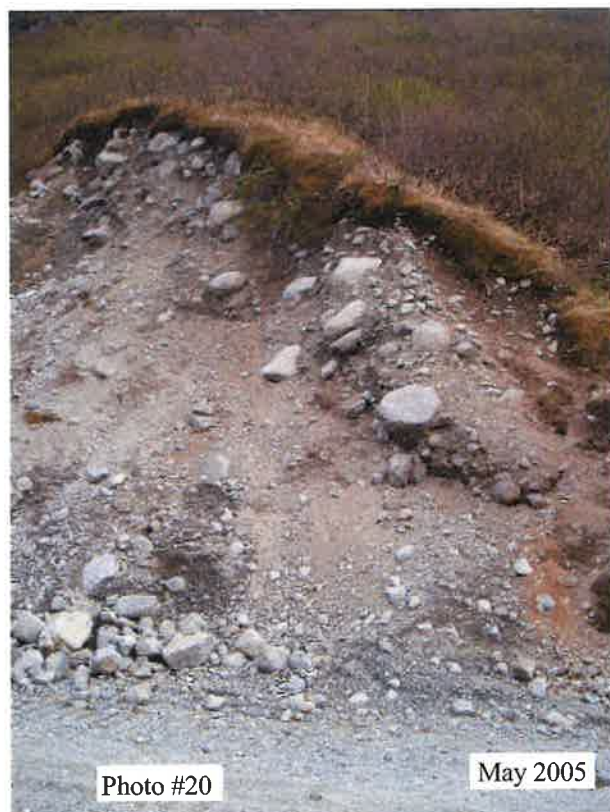
Photo #20

MP 2.6 - Glacial till boulders frequently roll from this slope.

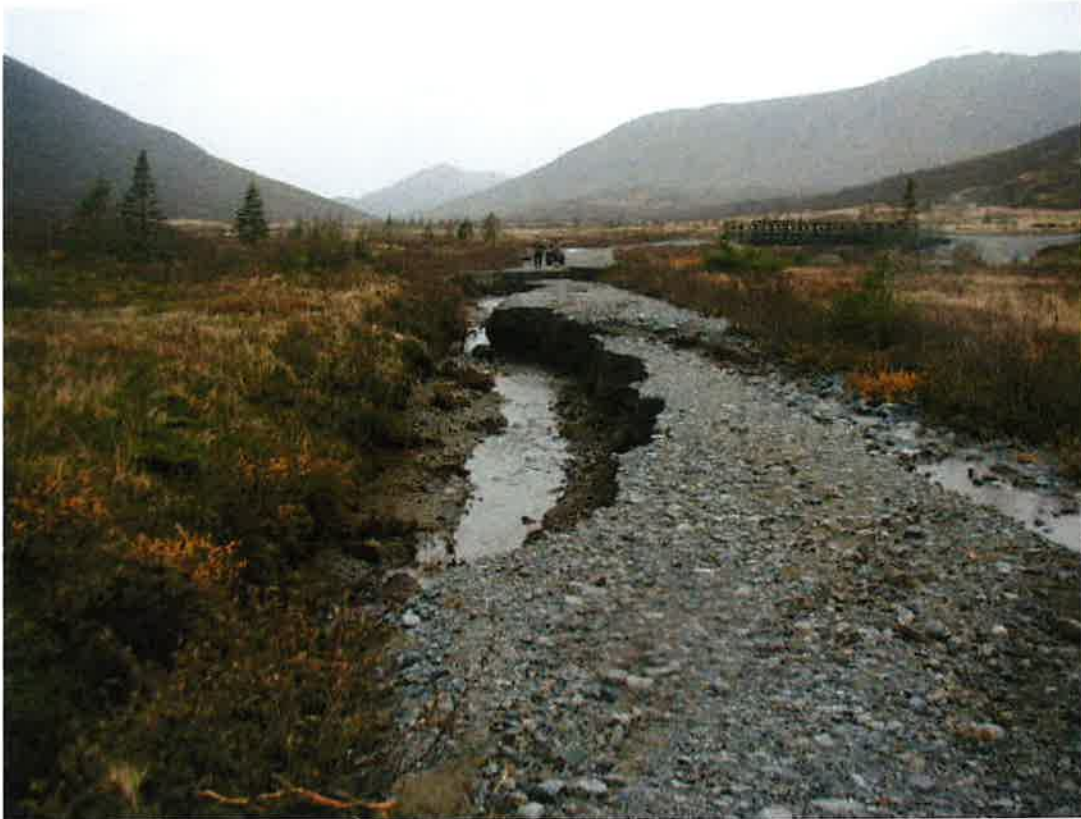
MP 3.6 - Looking at the road washed out at the bridge that crosses Chinkelyes Creek. The bridge is in the background of photo. Looking back toward Williamsport.

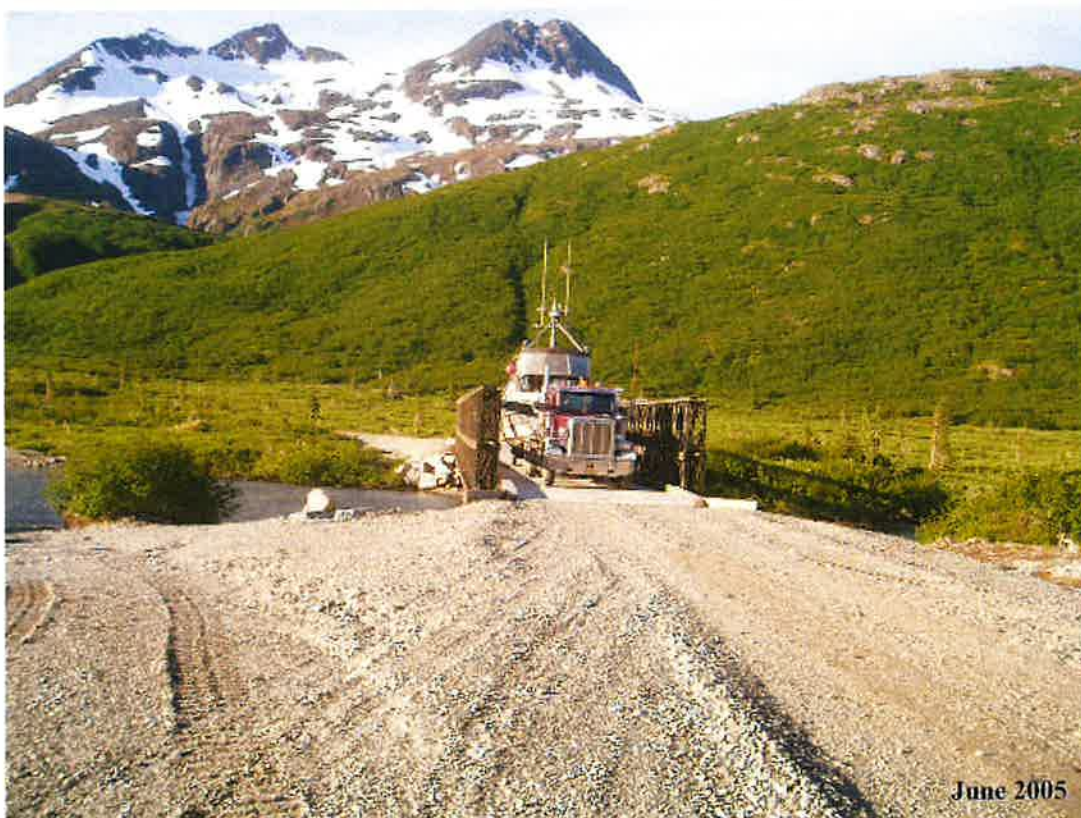
MP 3.5 - Photo of the Bridge over Chinkelyes Creek and a boat being hauled over the bridge.

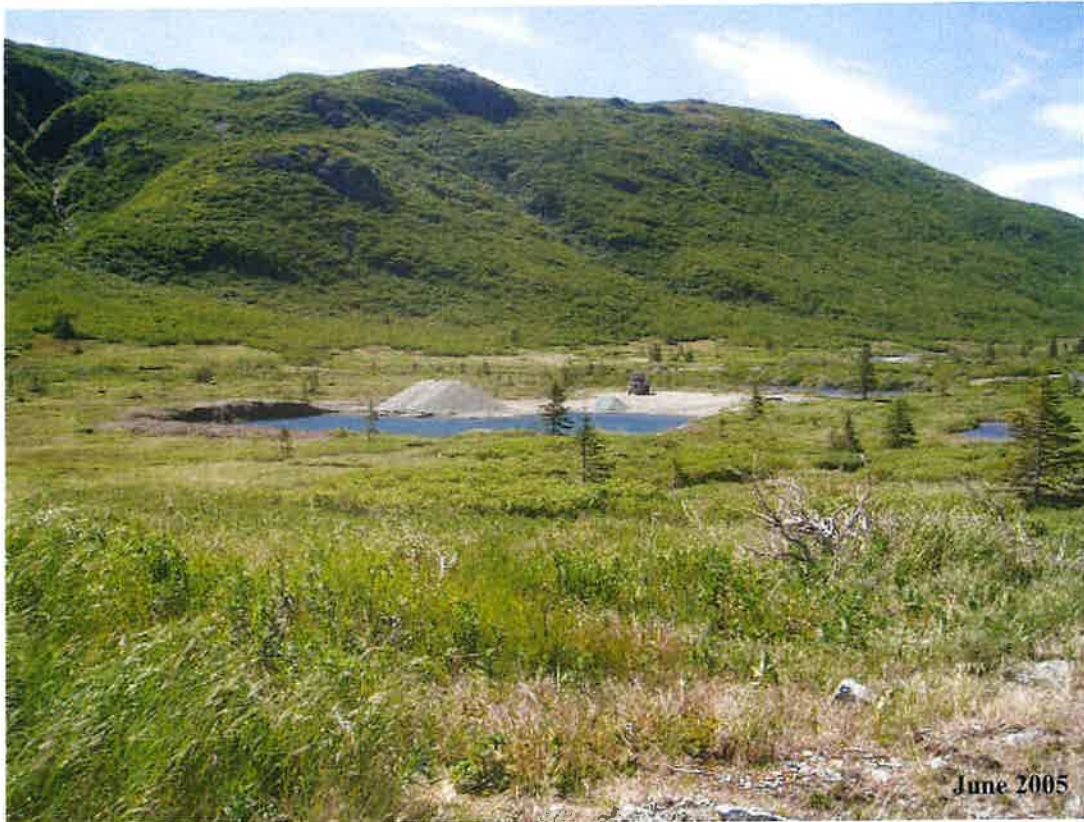
MP 3.9 - Looking at the existing material site at MP 4.0 from the road.

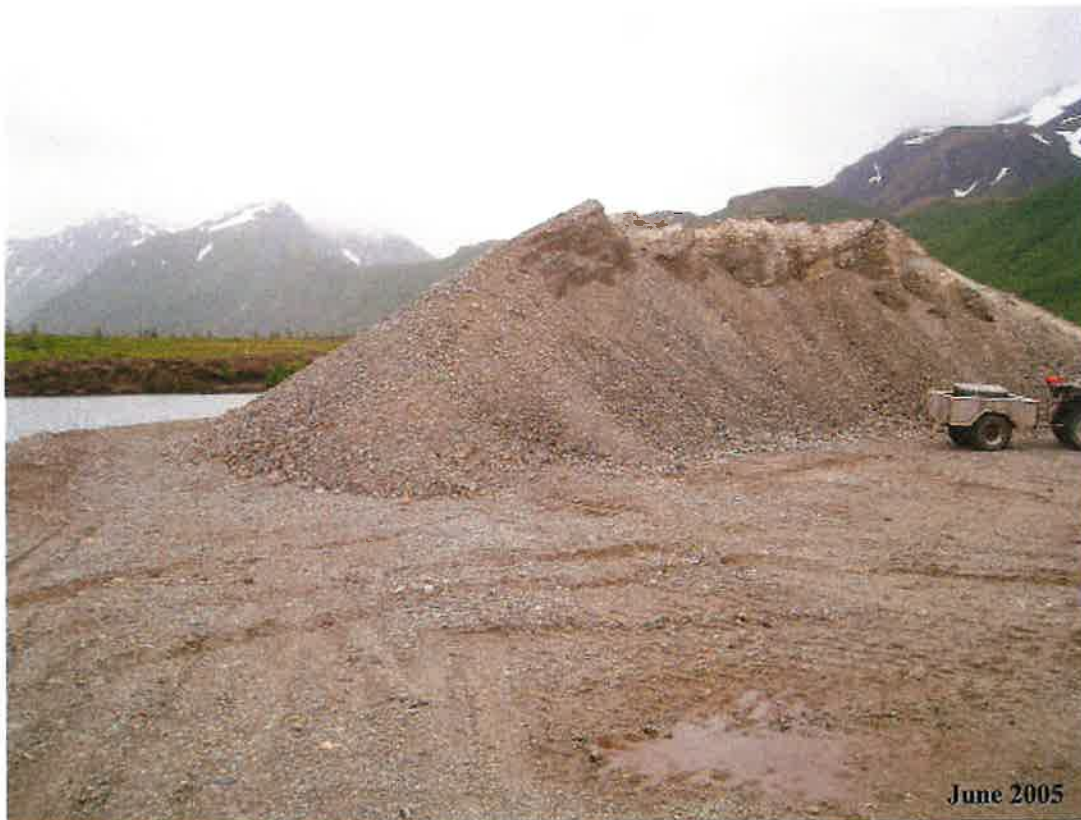
MP 4 Pit - Existing gravel pit at MP 4. Owned by CIRI. Collected a sample from the stockpile. The material is mined from below water. Groundwater is only 2 ft below ground.

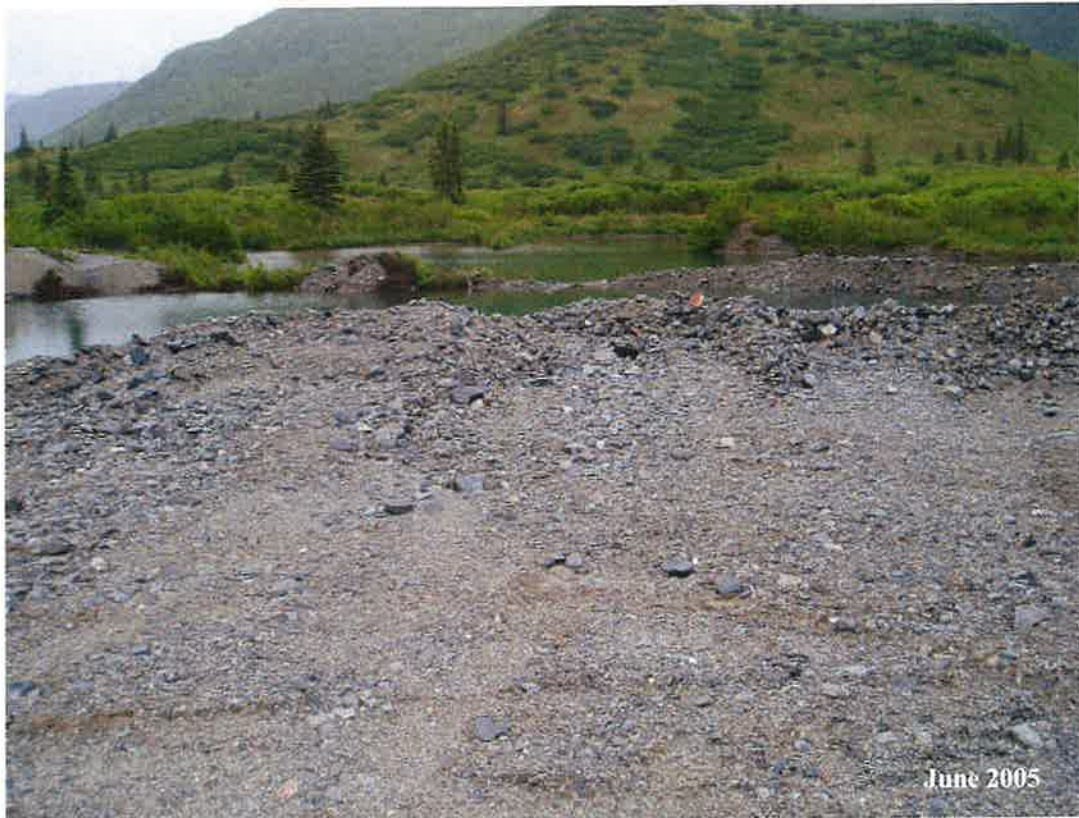
MP 6 Pit - Existing gravel pit at MP 6. Owned by CIRI. Collected a sample from the edge of the pond at berm/stockpile. The material is mined from below water. Groundwater is only 2 ft below ground.
