**STATE OF ALASKA**  
**Department of Transportation & Public Facilities**  
**Central Materials Lab**  
 5750 EAST TUDOR RD, ANCHORAGE AK 99507  
 Phone (907)-269-6200 FAX (907) 269-6201  
**Laboratory Report**

PROJECT NAME: Williamsport to Pile Bay Rd. Repair PROJECT NO. 51651 LABORATORY NO. 05A-0973  
 SAMPLE OF: \_\_\_\_\_ ITEM/SPECIFICATION NO.: \_\_\_\_\_ FIELD NO.: FS05-8  
 SAMPLED FROM: Stockpile @ Pit, MP 4.0 DATE SAMPLED: 06/22/2005  
 SOURCE/SUPPLIER: Centerline QUANTITY REPRESENTED \_\_\_\_\_ DATE RECEIVED: 06/24/2005  
 LOCATION/ADDRESS: \_\_\_\_\_ SUBMITTED BY: C. Boeckman DATE COMPLETED: 07/20/2005  
 EXAMINED FOR: Gradation, LA, Deg, Sulfate Soundness & SpG DATE REPORTED: 07/20/2005

PROJECT NAME: Williamsport to Pile Bay Rd. Repair PROJECT NO. 51651 LABORATORY NO. 05A-0974  
 SAMPLE OF: \_\_\_\_\_ ITEM/SPECIFICATION NO.: \_\_\_\_\_ FIELD NO.: FS05-9  
 SAMPLED FROM: Rock Cut MP 1.0 , Depth Surface DATE SAMPLED: 06/23/2005  
 SOURCE/SUPPLIER: Centerline QUANTITY REPRESENTED \_\_\_\_\_ DATE RECEIVED: 06/24/2005  
 LOCATION/ADDRESS: \_\_\_\_\_ SUBMITTED BY: C. Boeckman DATE COMPLETED: 07/11/2005  
 EXAMINED FOR: LA, Deg, Nordic Abrasion & SpG DATE REPORTED: 07/18/20

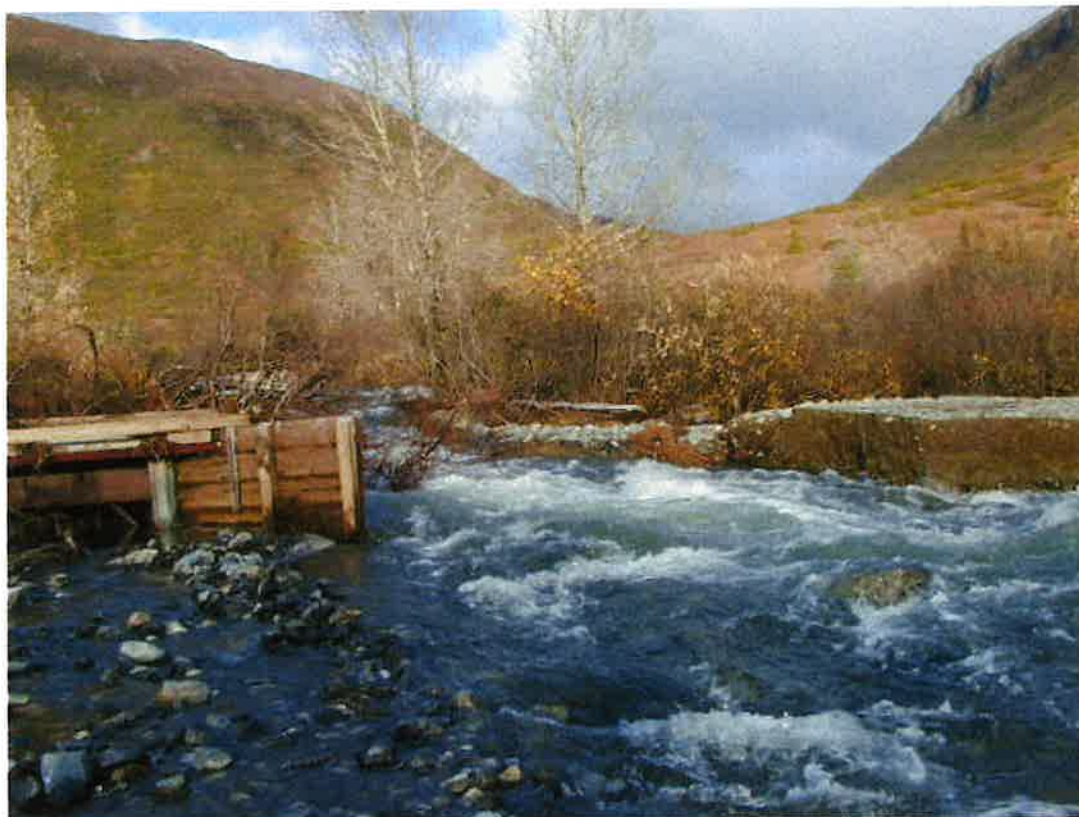
MP 7.6 - Embankment wash out at the bridge that crosses Timberline Creek.

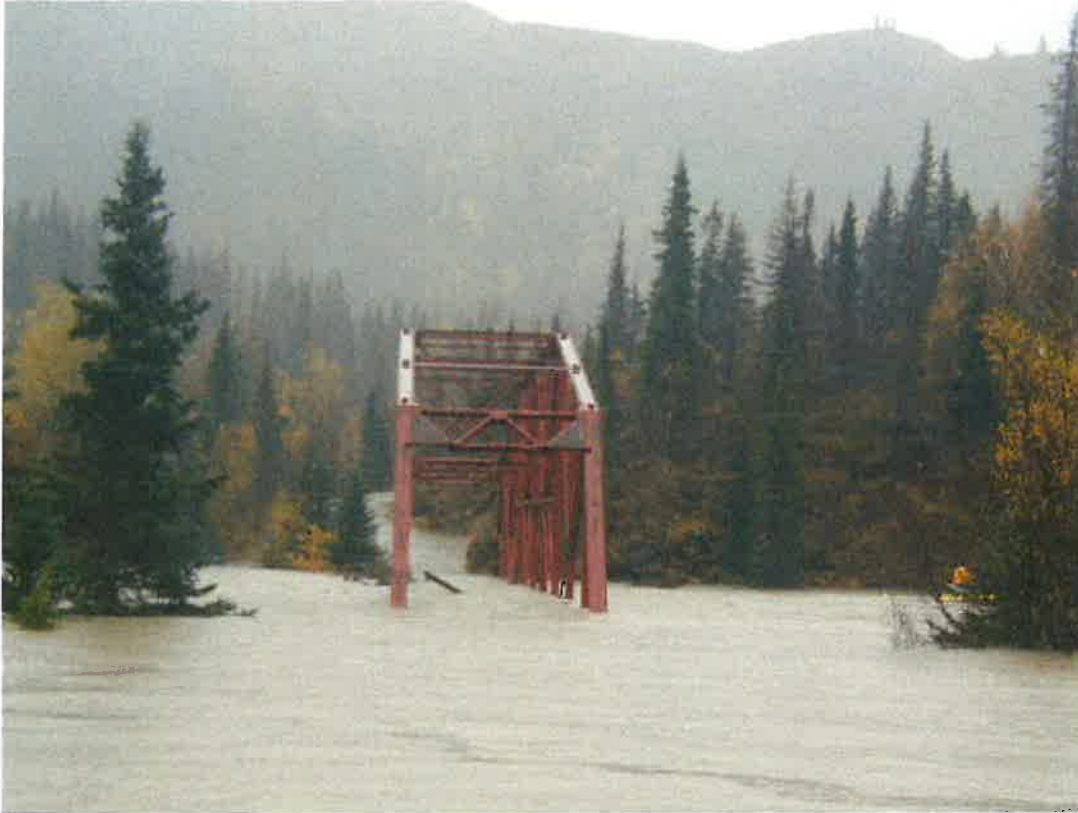
MP 11 - "old" bridge that crosses the Iliamna River at flood stage.

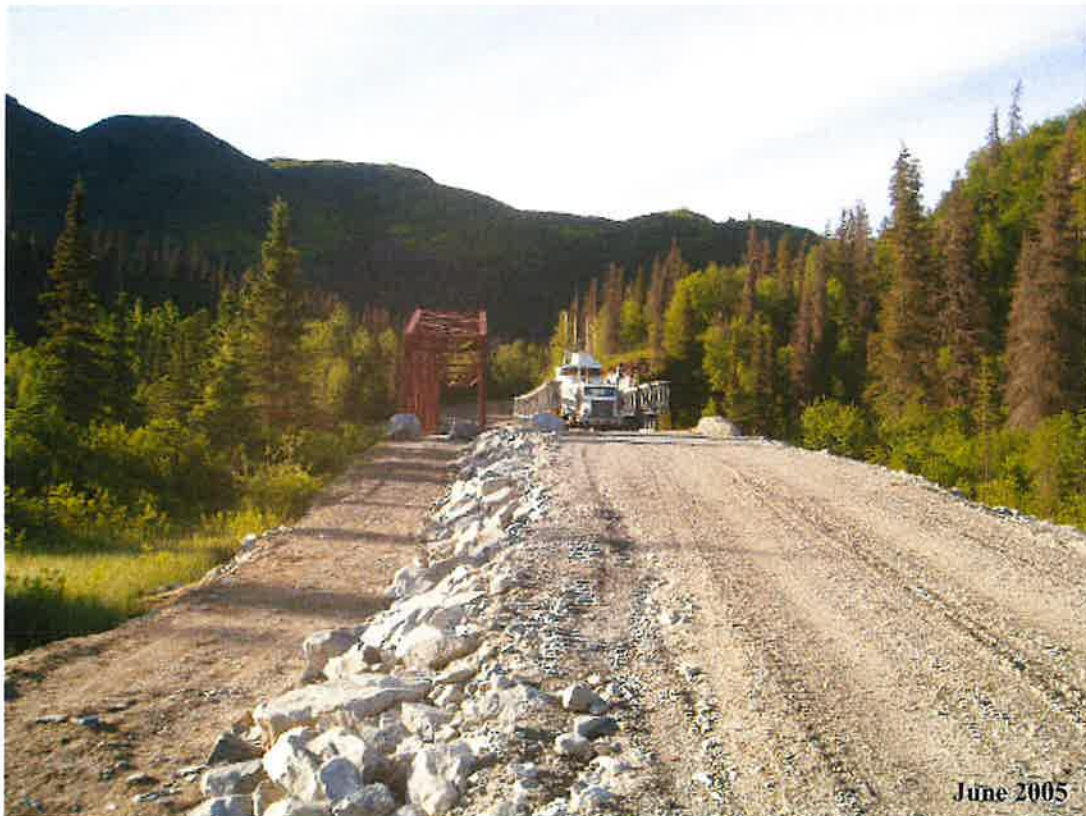
MP 11 - New bridge next to the old bridge at the Iliamna River. The bridge is about 2-3 ft higher than the old bridge.

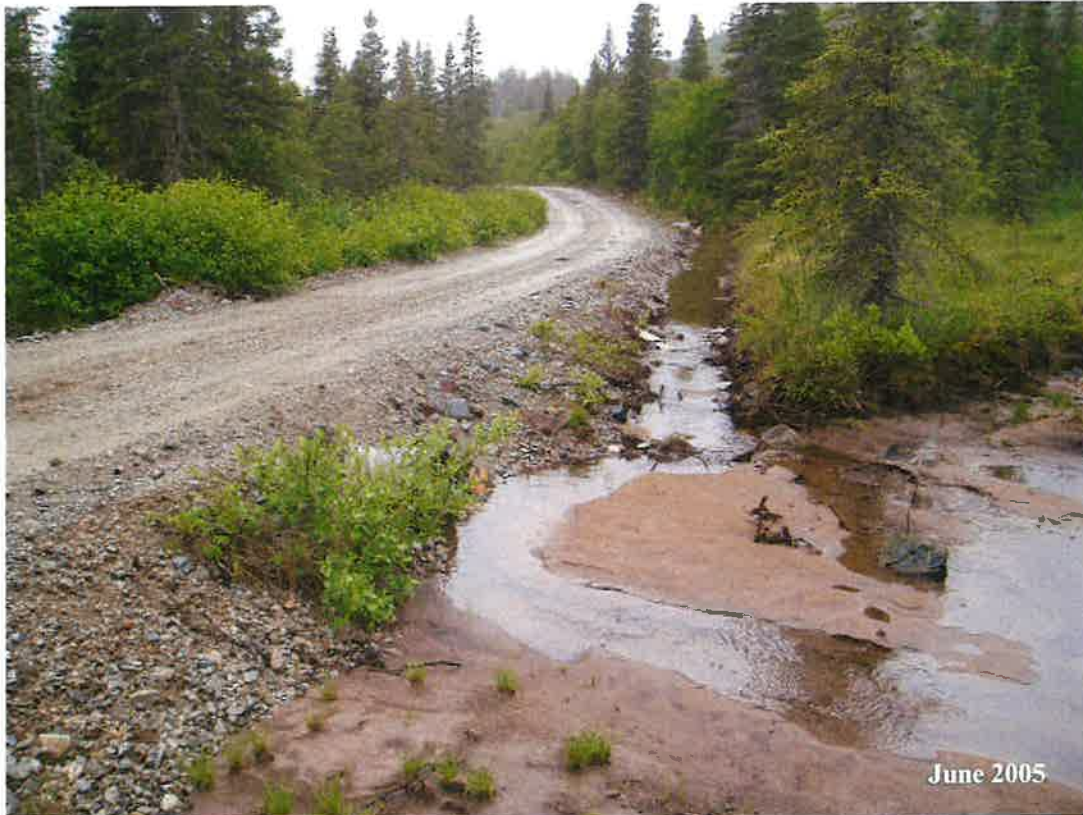
MP 9.2 - Looking northwest along the road. Two culverts allow for drainage in this area.

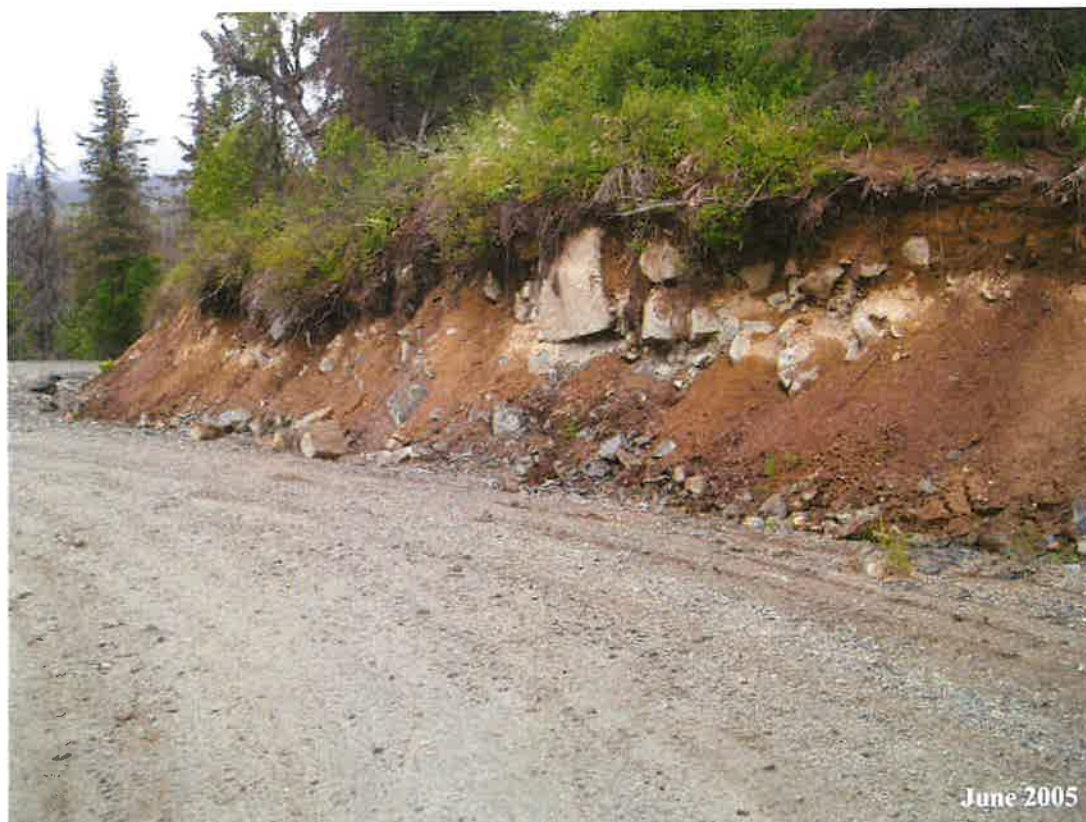
MP 9.4 - Top of the "S-curve". The embankment shown consists of organic and silt overburden, glacial till, and bedrock.

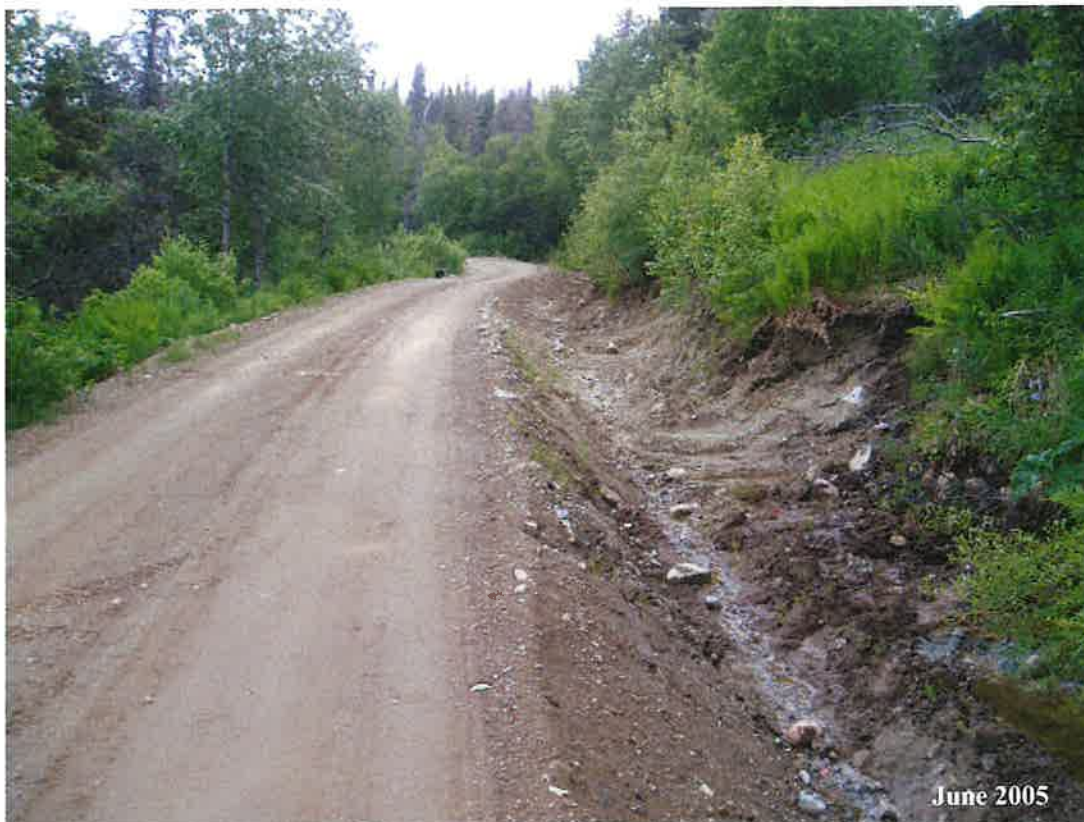
MP 11.4 - The maintenance contractor widened the ditch in this area for better drainage.

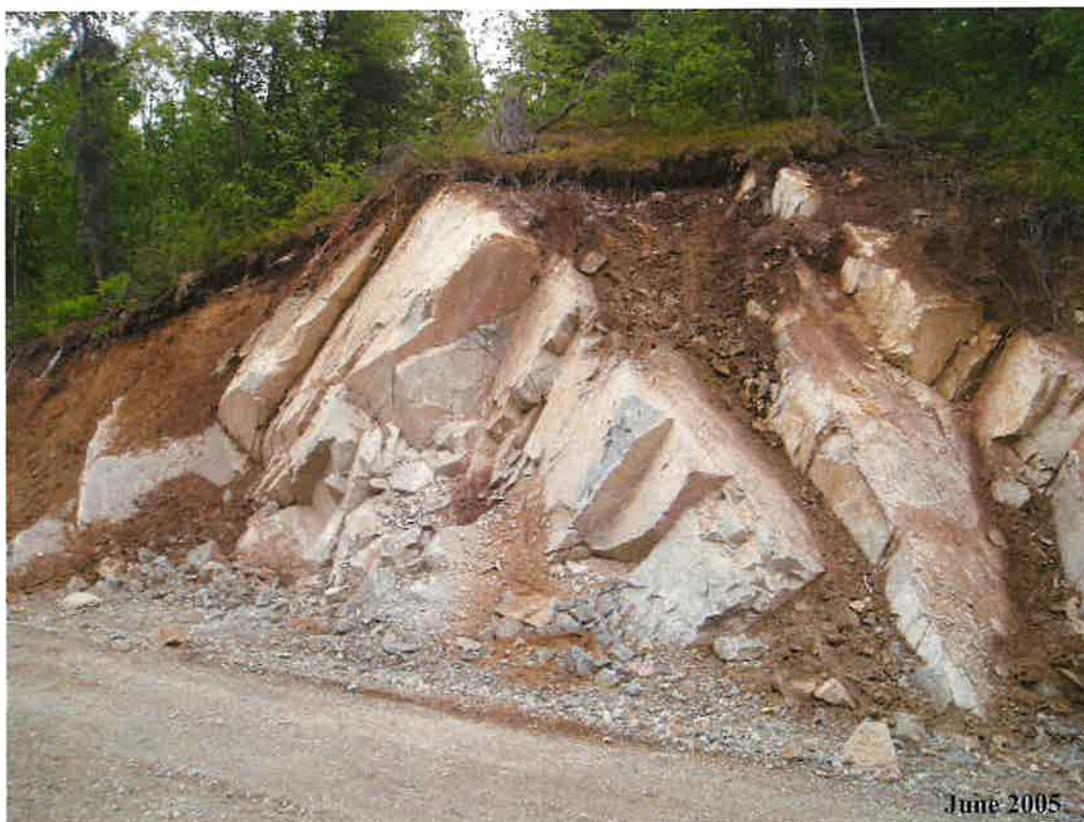
MP 13.4 - Bedrock exposed in the cut. Wide spaced joint pattern in this cut makes it a good prospect for a rip rap source.
