December 15, 2021

RE: Kodiak Airport Buildings Limited Hazardous Materials Assessment Report

◆
NORTECH is pleased to provide R&M Consultants with the following limited Hazardous Materials Assessment (HMA) Report for buildings located at Lot 5A and Lot 3 of the 1400 Block at the Kodiak Airport. This report documents **NORTECH**'s methods, sample locations and materials, assessment results, and demolition considerations for both buildings within the proposed project scope.

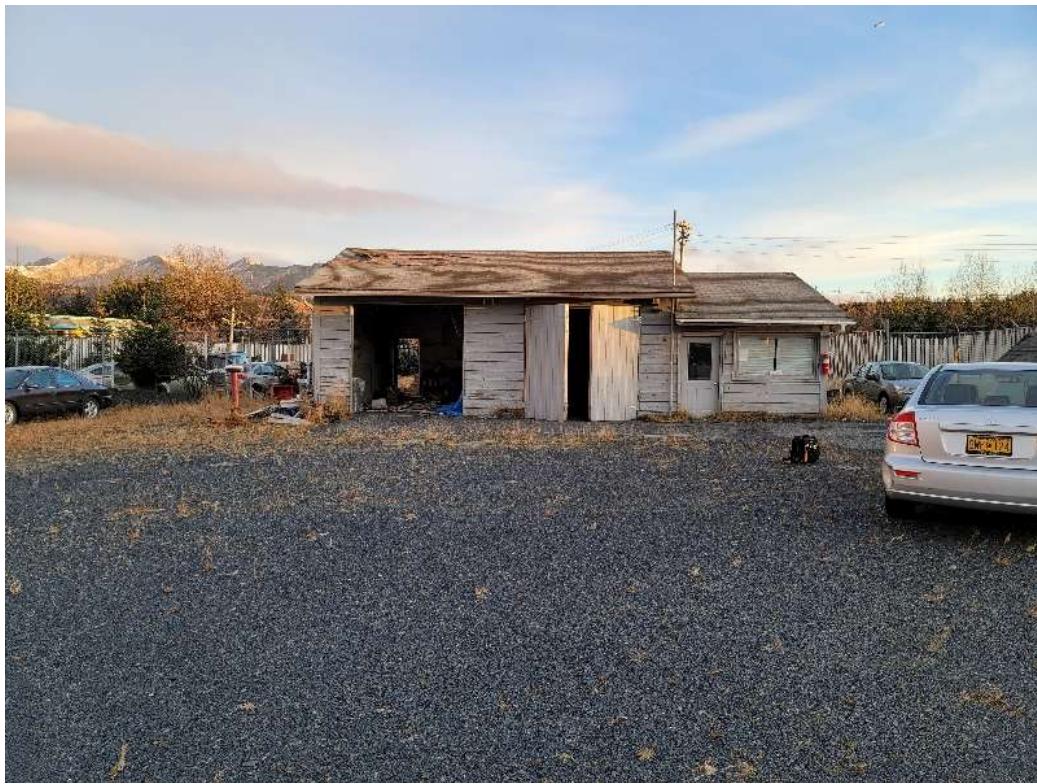
Photo 1: Lot 3 building. Note the abandoned vehicles on the property and roof damage on the upper left corner.

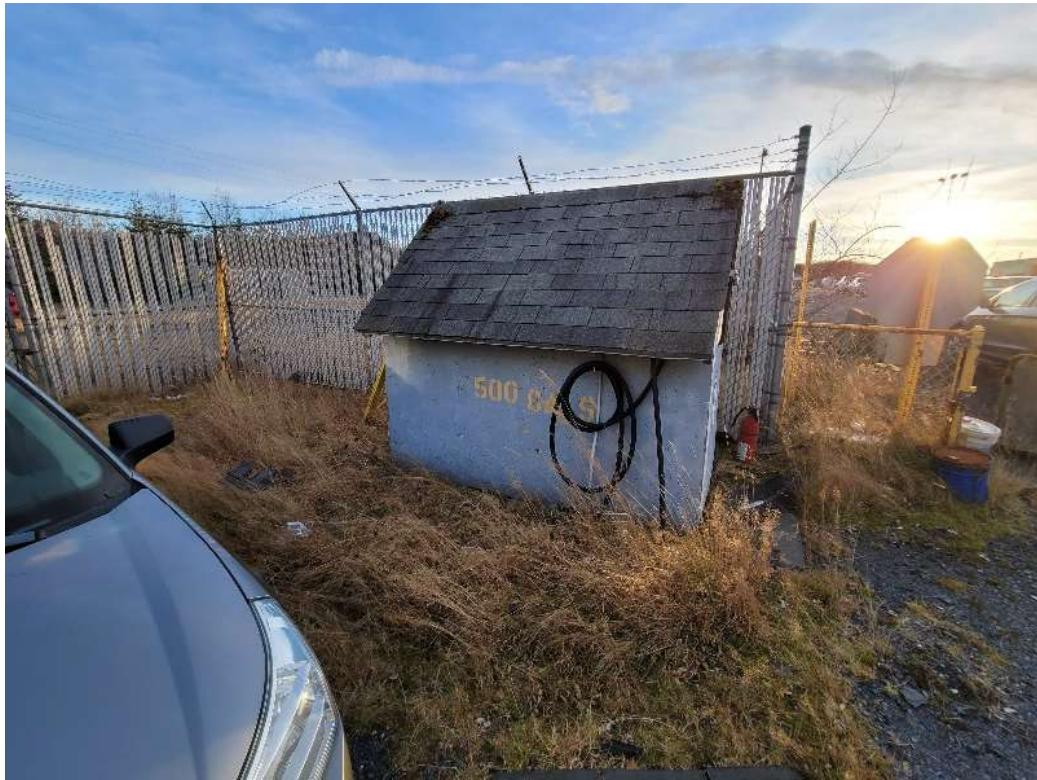
Three 500-gallon fuel tanks were observed between the two lots. One 500-gallon AST was labeled as containing diesel (Photo 14, Appendix 2) and located on Lot 5A. Two ASTs were located on Lot 3. Based on the dispenser observed on one of the 500-gallon ASTs on Lot 3 (Photo 2, Appendix 2) and the number of abandoned vehicles present on that lot, it is likely the AST with the dispensing pump may have contained gasoline. All observed tanks were in poor condition and should not be reused. All ASTs on Lot 3 and Lot 5A should be disconnected from any remaining piping, pumped of any residual fuel they may contain, and properly disposed of according to local, State, and Federal regulations.

Photo 2: Outbuilding on Lot 3 housing a 500-gallon AST, presumed to have dispensed gasoline.

- Remove prior to demolition and dispose of properly
- Once removed, inspect soils for evidence of contamination
- Further investigation may be needed if signs of contamination are observed
- Floor drain
 - After demolition, inspect soils around the floor drain for signs of contamination
 - Further investigation may be needed if signs of contamination are observed

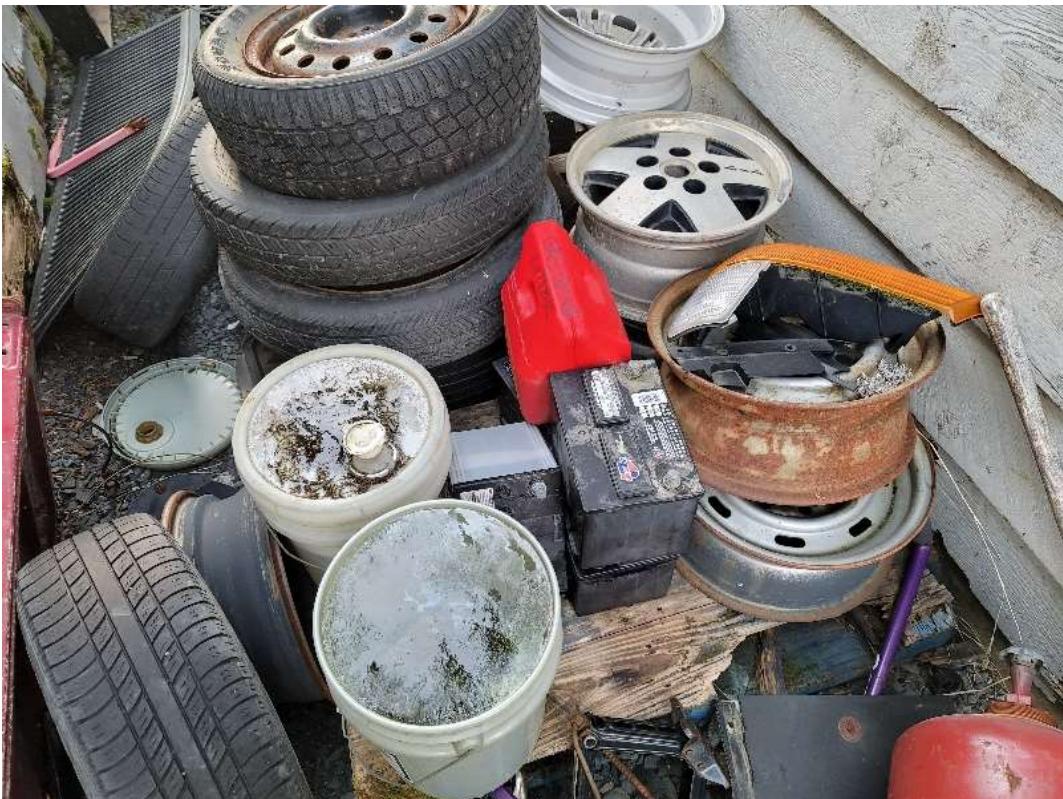
NORTECH observed numerous chemicals, lubricants, and coolants associated with the repair and maintenance of vehicles on both Lot 3 and Lot 5A (Photos 12-13, Appendix 2). A total of 19 lead-acid batteries were also observed throughout the two lots (Photos 3,11, Appendix 2). Chemicals, lubricants, coolants, and batteries located on the two lots should be collected and disposed of in accordance with local, State, and Federal regulations. Once batteries have been removed from both lots, a visual inspection of soils in areas where batteries were stored outside should occur. If indications of soil staining from leaking batteries is observed, further investigation and laboratory testing of the soils may be needed.

Photo 3: Example of various universal wastes improperly stored throughout Lot 3. Note the lead-acid batteries (center of photo) and compressed gas cylinder (lower right corner).

- Lead-acid batteries
 - Removed prior to demolition and disposed of properly
 - Inspect soils under batteries stored outside for signs of contamination from leaking batteries

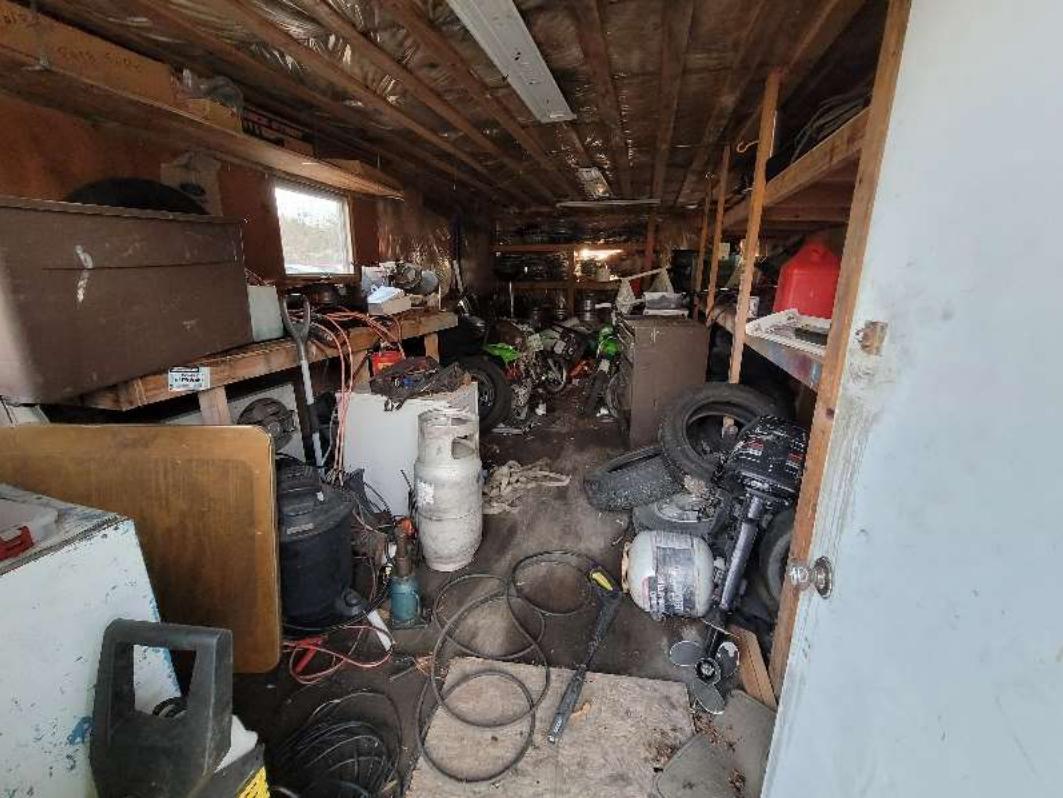
A total of 46 abandoned vehicles, 1 motorhome (Photo 6, Appendix 2), and various outboard boat motors (Photo 4, Appendix 2) were also found on Lot 3. The vehicles and motorhome may contain lead-acid batteries. In addition, the vehicles, motorhome, and outboard motors should also be assumed to contain fuel, lubricants, and coolants that should be disposed of in accordance with local, State, and Federal regulations. Once the vehicles, motorhome, and outboard motors have been removed from Lot 3, a visual assessment of the ground surface should be conducted to determine if fluids or batteries contained within the engines and motors have leaked and potentially impacted Site soils. If indications of soil staining from fluids or batteries are observed, further investigation and laboratory testing of soils may be needed.

Photo 4: Miscellaneous wastes stored on Lot 3's outbuilding. Note the outboard motor, fuel containers and compressed gas cylinders.

- Further investigation may be needed if signs of contamination are observed
 - Abandoned vehicles, motorhome, outboard motors
 - Removed prior to demolition and disposed of properly

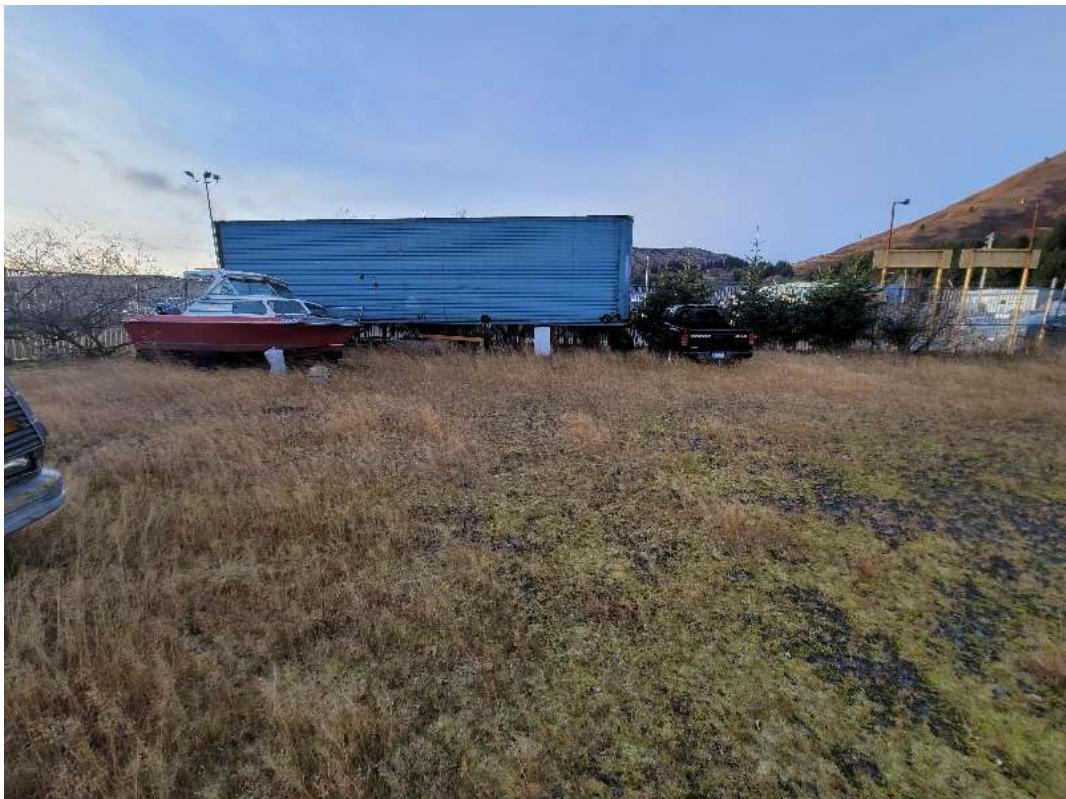
A motor home and semi-truck trailer were present on Lot 3, but were not assessed for potential hazardous materials as **NORTECH** could not gain access to their interiors. Additional hazardous materials not discussed in this report may be present in both the motor home and trailer. A total of 46 abandoned vehicles were also observed on the property. **NORTECH** did not inspect any of the vehicles for potential hazardous materials, but for disposal purposes, it should be assumed all vehicles (including the motor home) contain lead-acid batteries and fluids (coolants, lubricants, and fuel).

Photo 5: Semi-truck trailer and boat stored on Lot 3. NORTECH could not access the interior of the trailer.

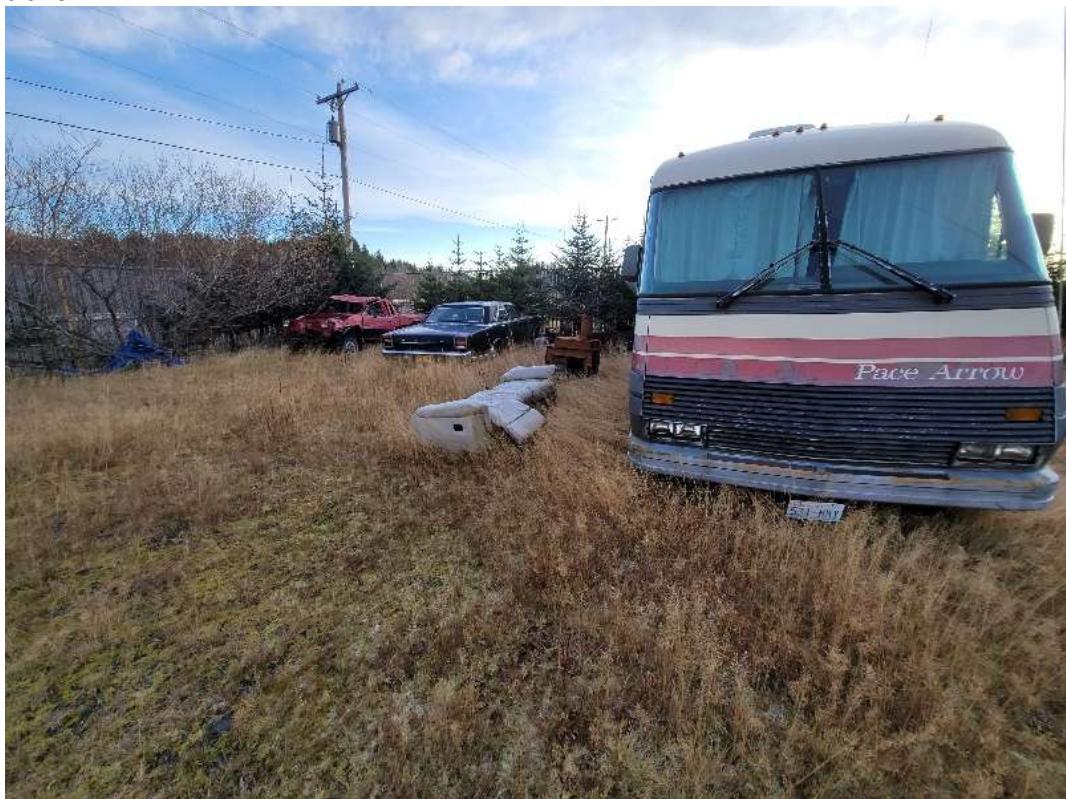
Photo 6: Motorhome stored on Lot 3.

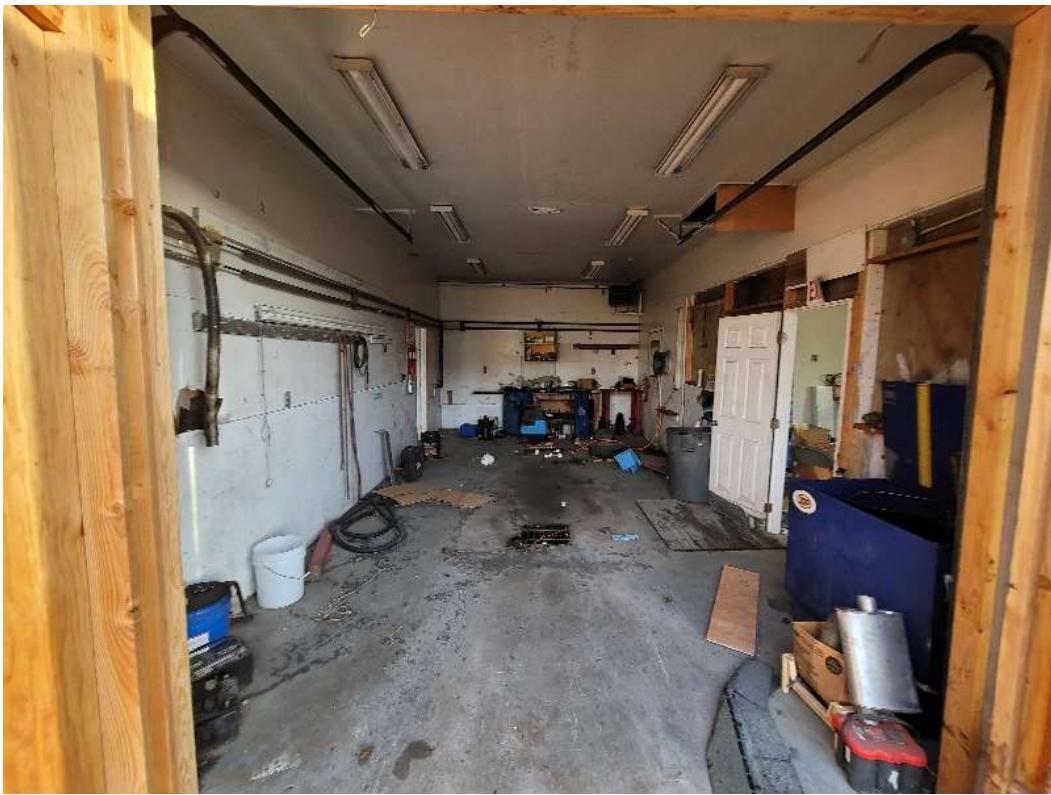
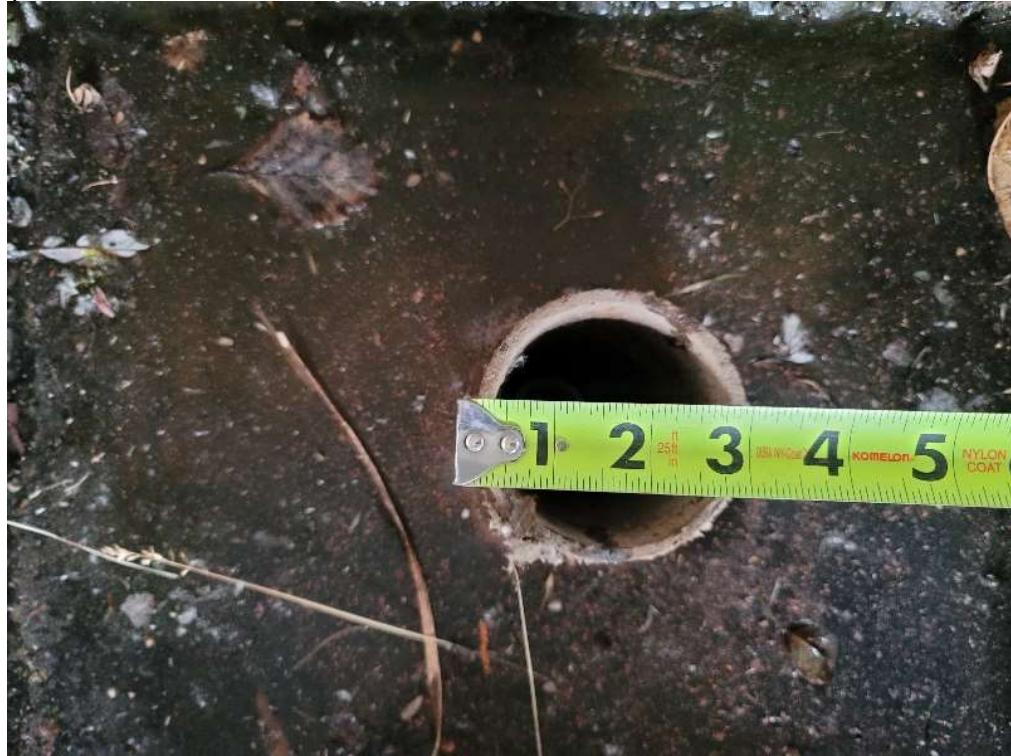
NORTECH observed a floor drain located within the garage portion of the building on Lot 3. It is not clear where the floor drain outlet is located and tracing the floor drain below the concrete pad was outside the scope of work for this project. If the concrete pad the building is located on is demoed during project activities, the floor drain outlet should be assessed at that time.

NORTECH observed a floor drain within the garage section of the building located on Lot 3 (Photos 7-8, Appendix 2). Standing fluid was observed in the drain and **NORTECH** noted the fluid appeared to be oily and may contain petroleum products. It is not known if the floor drain is connected to an oil/water separator, municipal sewer, or if it discharges to the ground. The outlet for the floor drain should be investigated once the building on Lot 3 has been demoed and if the concrete pad is also removed. If visual or olfactory cues indicate that soils under or around the floor drain may have been impacted by petroleum or other contaminants, further investigation and laboratory testing of soils may be needed.

Photo 7: Interior of garage portion of main building on Lot 3. Note the floor drain in the center of the photo.

Photo 8: Close up of floor drain in garage on Lot 3.

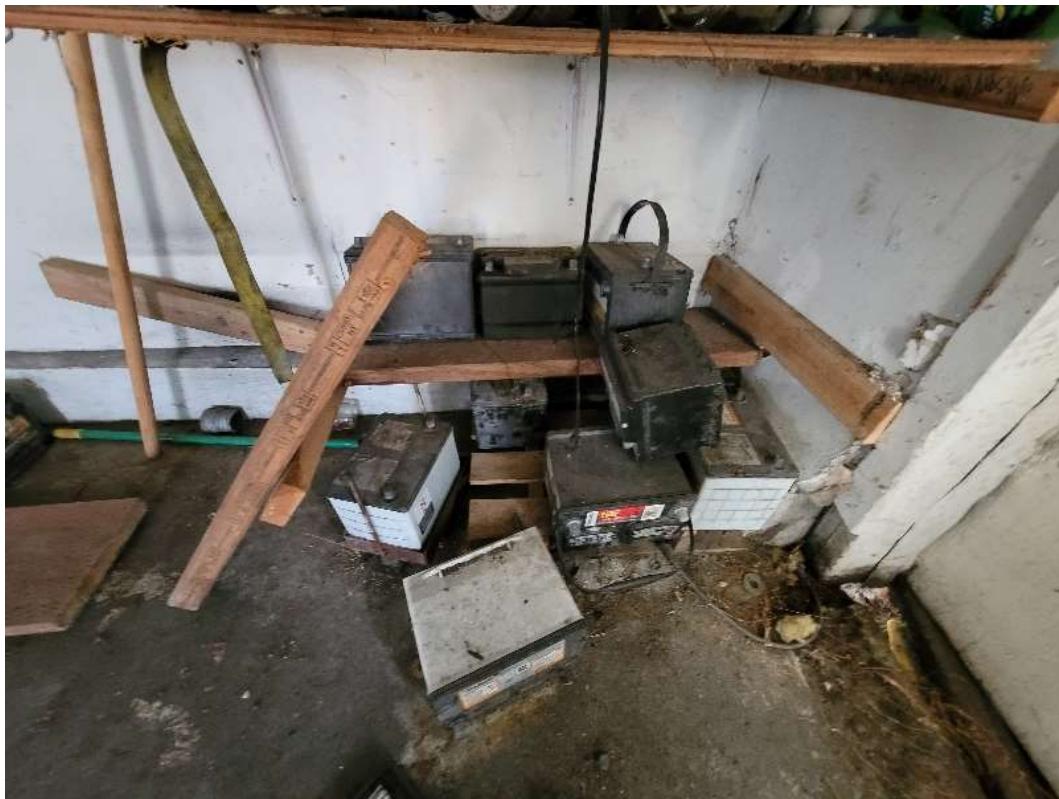
Photo 11: Stack of lead-acid batteries observed in the shop area of the main building on Lot 5A.

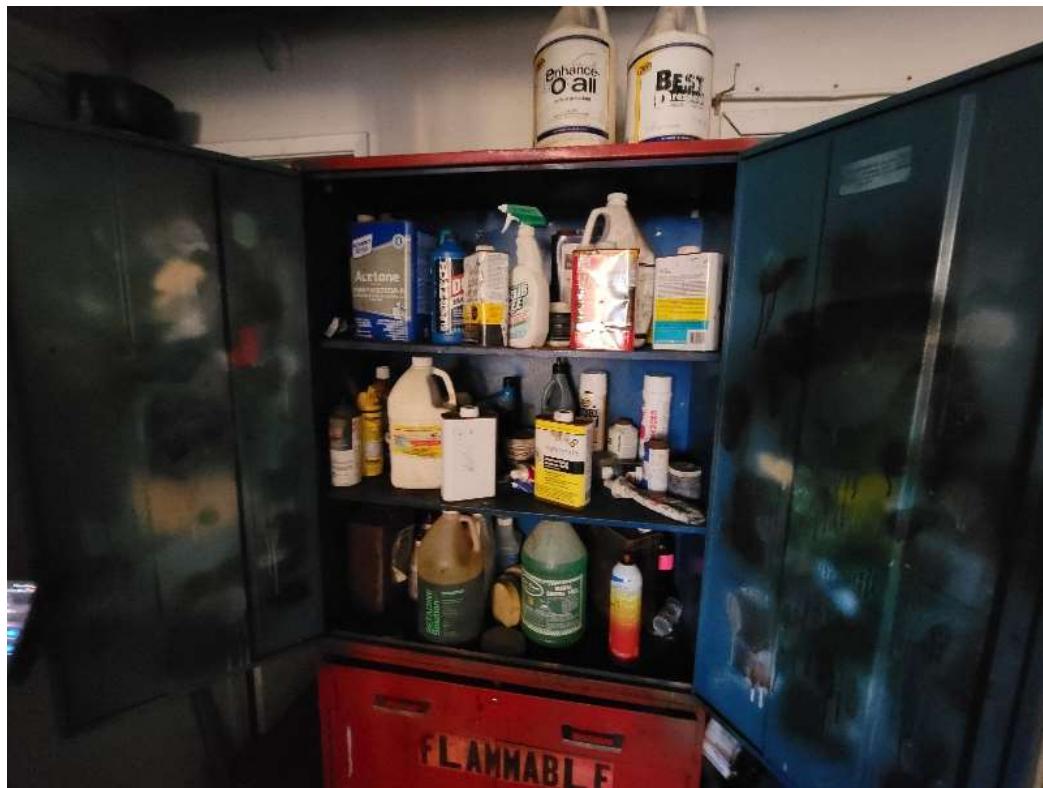
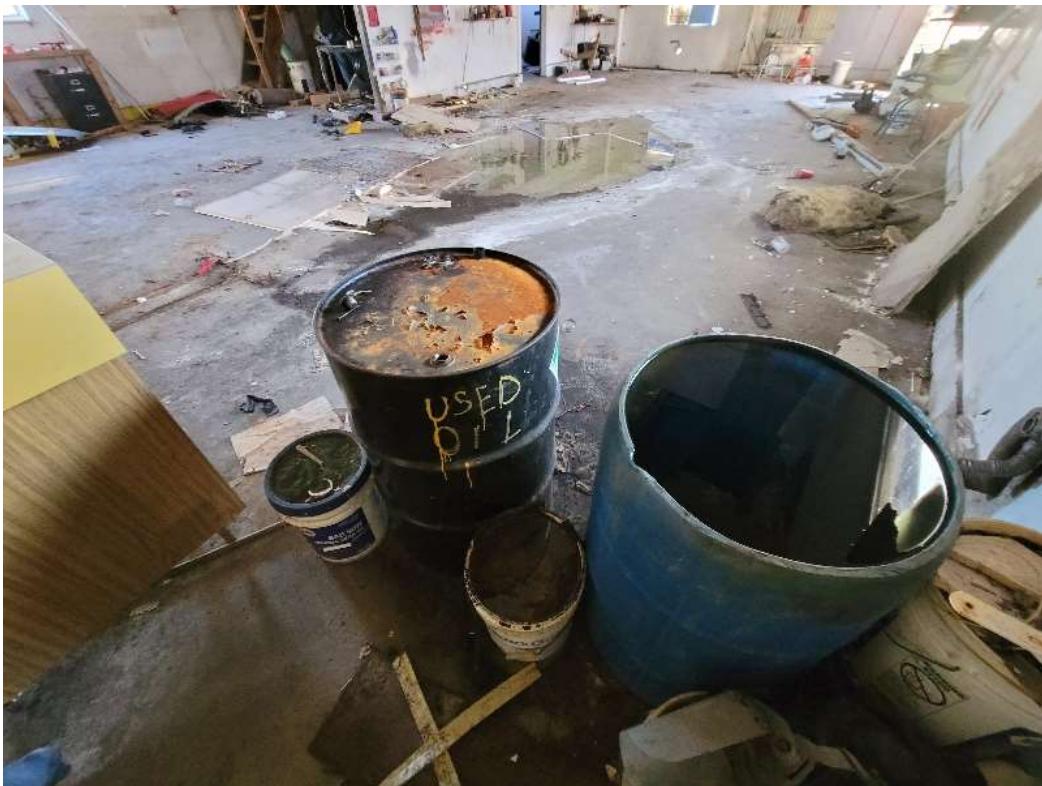
Photo 12: Example of chemicals, lubricants, and coolants located within the shop area of the main building of Lot 5A.

Photo 13: Example of used oil stored within the shop area of the main building on Lot 5A.

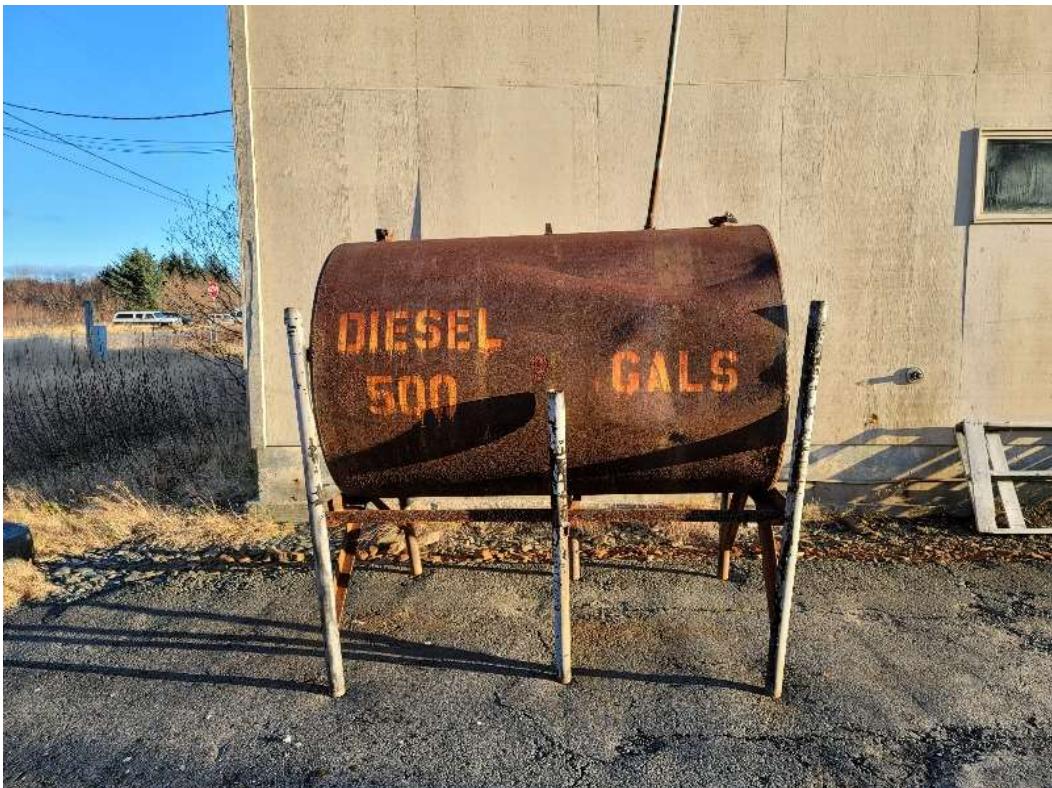
Photo 14: Example of a 500-gallon diesel fuel tank located on Lot 5A. The tank is in poor condition and should not be reused.

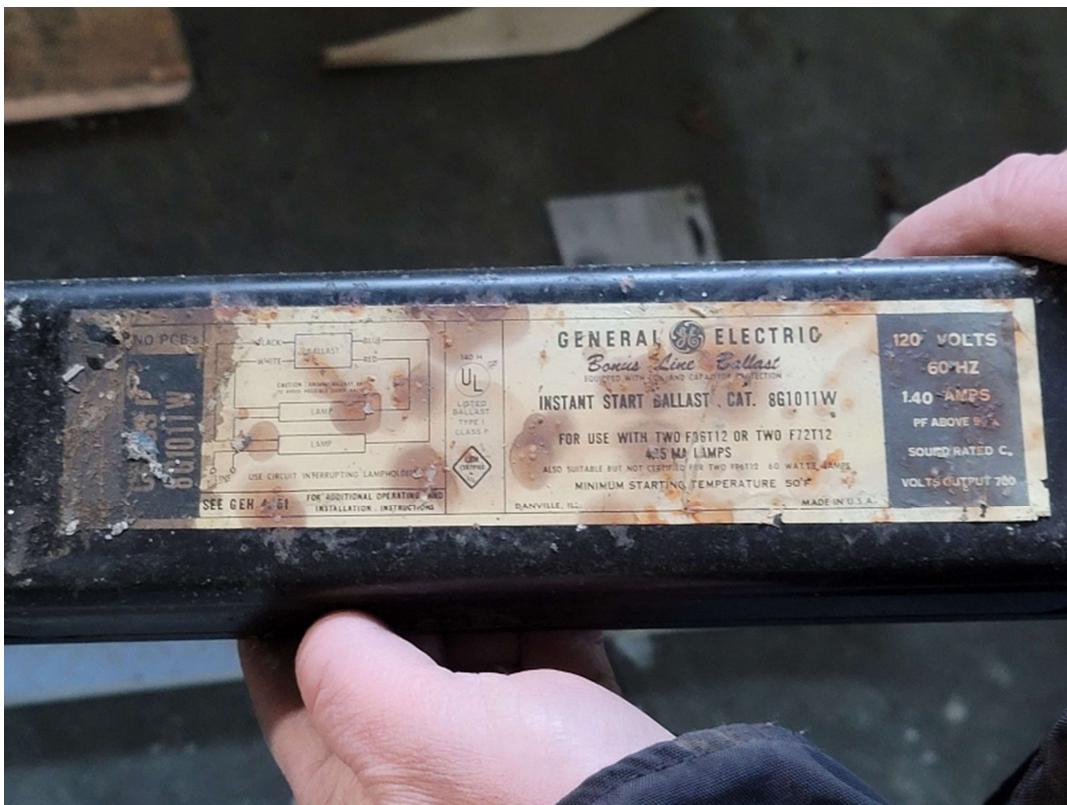
PCB investigation was limited to the assessment of fluorescent lighting ballasts. Lighting fixtures were spot-checked for markings indicating PCB containing components. Spot checks of two accessible fluorescent ballasts on Lot 3 did not reveal "No PCBs" statements on the ballasts. Spot checks of three ballasts on Lot 5A revealed two ballasts had "No PCBs" statements. A PCB statement was not observed on the third ballast.

Photo 15: Example of a “No PCBs” fluorescent ballast from Lot 5A.

If fluorescent light ballasts are removed as part of demolition activities and not reused in other buildings, each ballast should be inspected for stickers or wording that indicate the ballast is PCB free. If such documentation cannot be found, the fluorescent ballast should be assumed to contain PCBs and be disposed of in accordance with local, State, and Federal regulations. A spot check of one of the ballasts showed "No PCB" wording on two of the three ballasts inspected on Lot 5A (Photo 15, Appendix 2), but no "No PCBs" wording was observed on ballasts spot checked on Lot 3 (Photo 16, Appendix 2). If fluorescent lights and ballasts are in good condition, they can be removed and re-used in ballasts not affected by the project. If bulbs are not re-used, they should be disposed of in accordance with local, State, and Federal regulations.

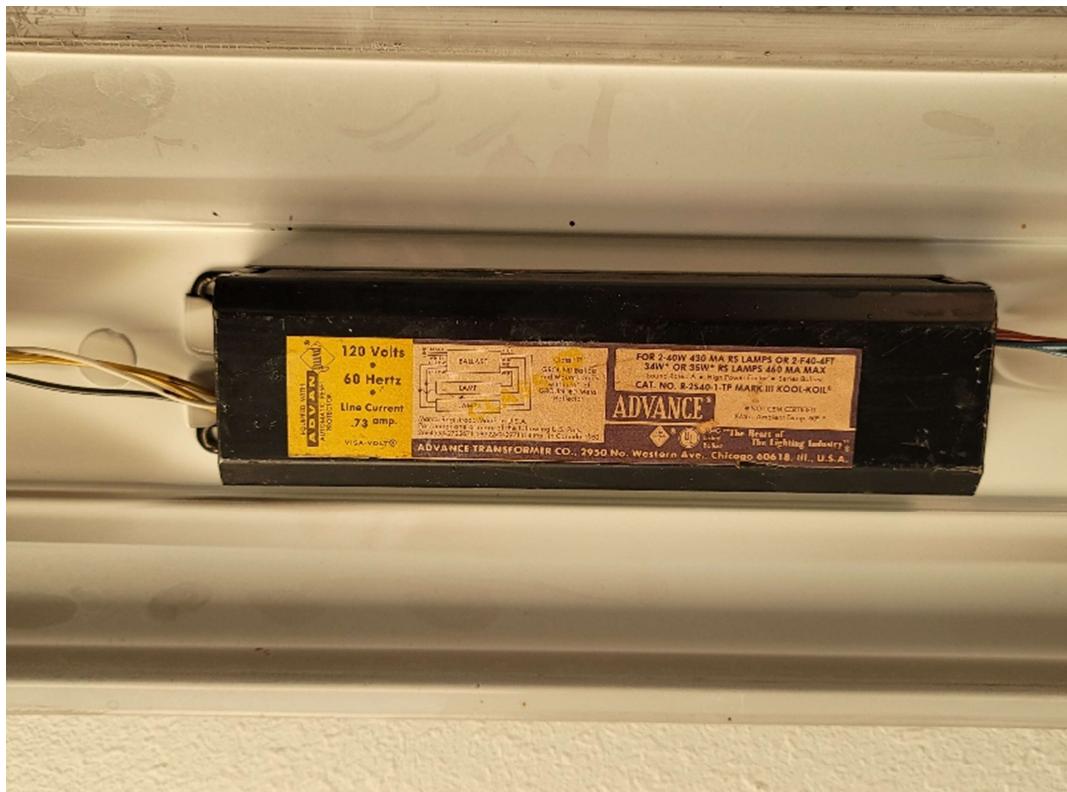
Photo 16: Example of a fluorescent ballast without a “No PCBs” indicator on the sticker from Lot 3.

- If affected by renovations, all PCB containing ballasts should be removed prior to demolition and disposed of properly
 - Fire extinguishers
 - If in good condition, fire extinguishers can be reused in other buildings
