RESTORATION OF SLOUGHS IN THE FAIRBANKS NORTH STAR BOROUGH (TANANA RIVER WATERSHED)

April 2006

Alaska Department of Natural Resources
Office of Habitat Management and Permitting

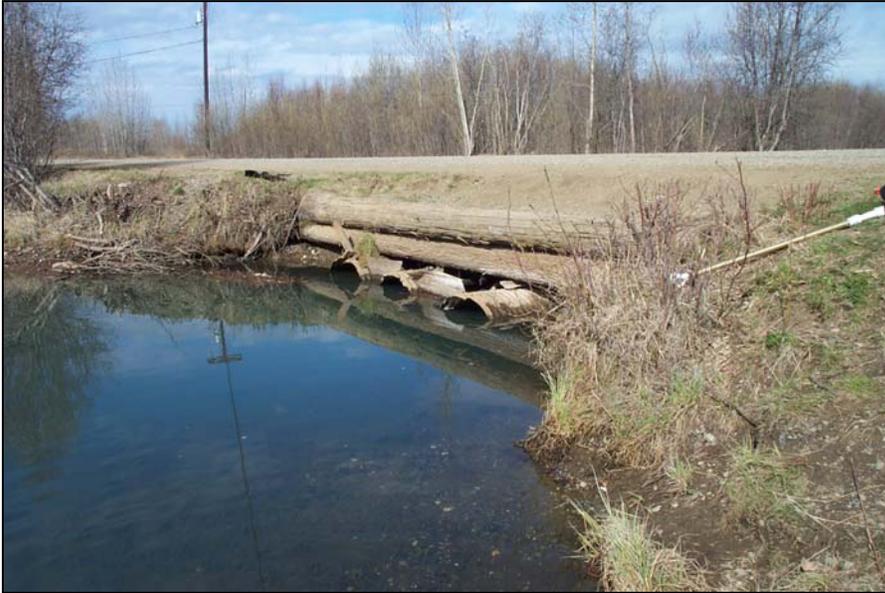
Before

In October 2001, 3-36” diameter culverts were removed from Airway Road crossing of Chena Slough and replaced with a free-span 40’ long steel bridge (originally used to access a timber sale on Montague Island) purchased and installed with a combination of funding and in-kind services from the NFWF Grant, Fairbanks Soil and Water Conservation District (FSWCD), ADNR-OHMP, ADOT/PF, USFWS, City of North Pole, and Airway Road Service District.

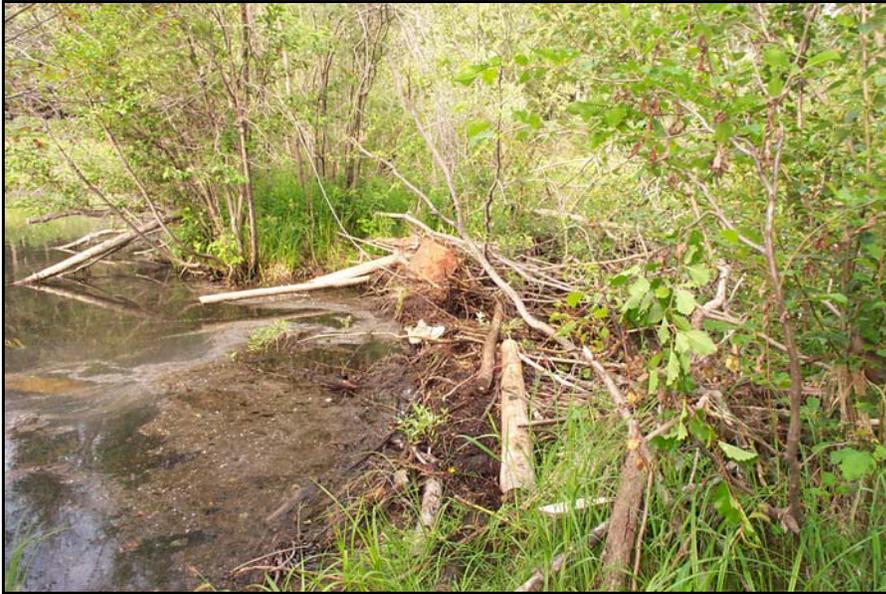
Before

In July 2001, a 25' section of an earth dam was breached to allow for fish passage. The dam was located just downstream from the Mission Road crossing of Chena Slough. Money from the NFWF Grant was used to hire the contractor.

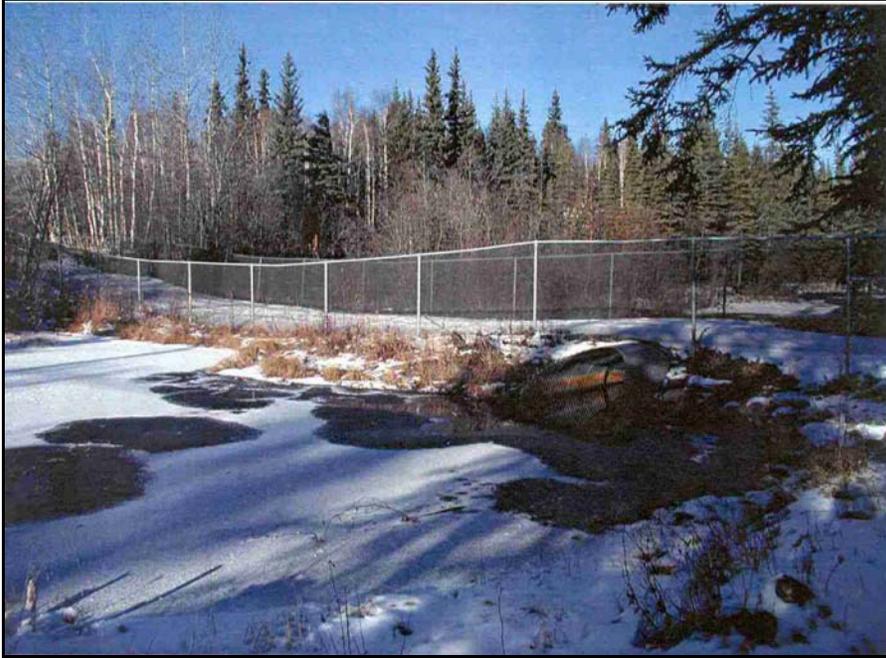
Before

In October 2001, to increase fish passage a causeway across Beaver Springs Slough that connected the elementary school to 5th Avenue Park was removed and replaced with a pedestrian footbridge. USFWS grant monies and the City of North Pole funded this project.

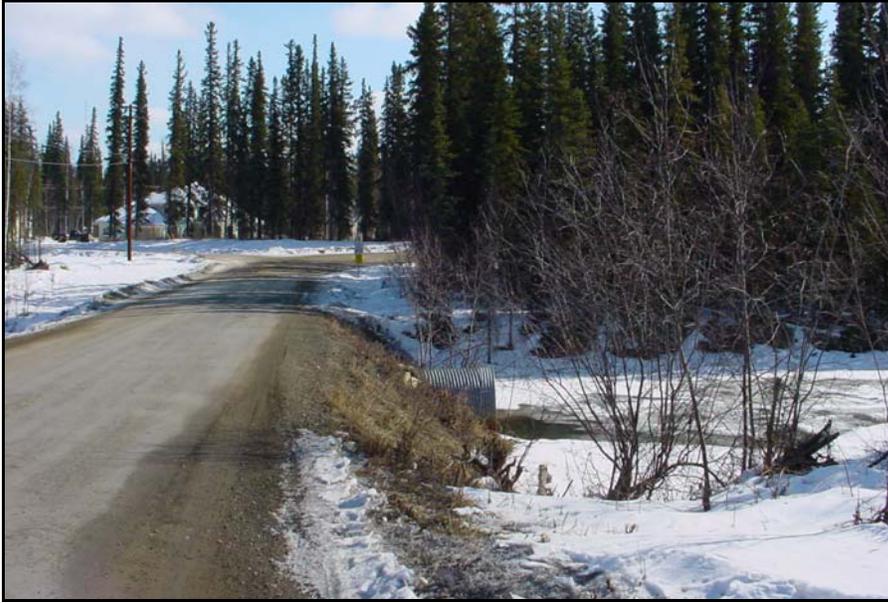
Before

In August 2003, one-5' diameter (extremely damaged) culvert was removed from the Doughchee Road crossing of Beaver Springs Slough and replaced with a free-span 40' long steel bridge (originally used to access a timber sale on Montague Island). Funding was generated from the USFWS grant program, City of North Pole, State grant monies, and NFWF Grant.

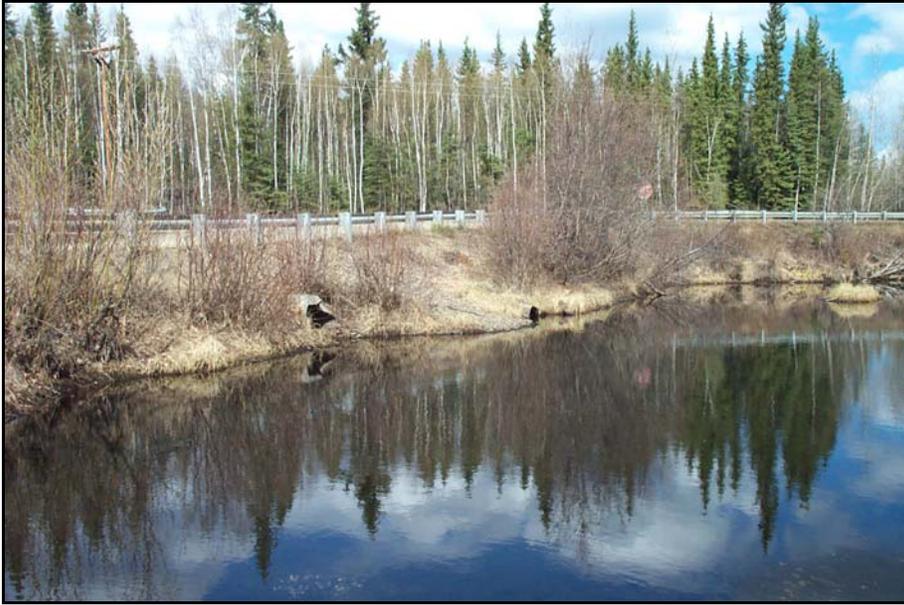
Before

In September 2004, 3-36" diameter culverts were removed at the Outside Hurst Road crossing of Chena Slough and replaced with a free-span 40' long steel bridge (originally used as a temporary bridge on the Pogo Mine Road). Funding was from USFWS grants and State grant monies.
