Piledriver Slough at Ingrid Road crossing

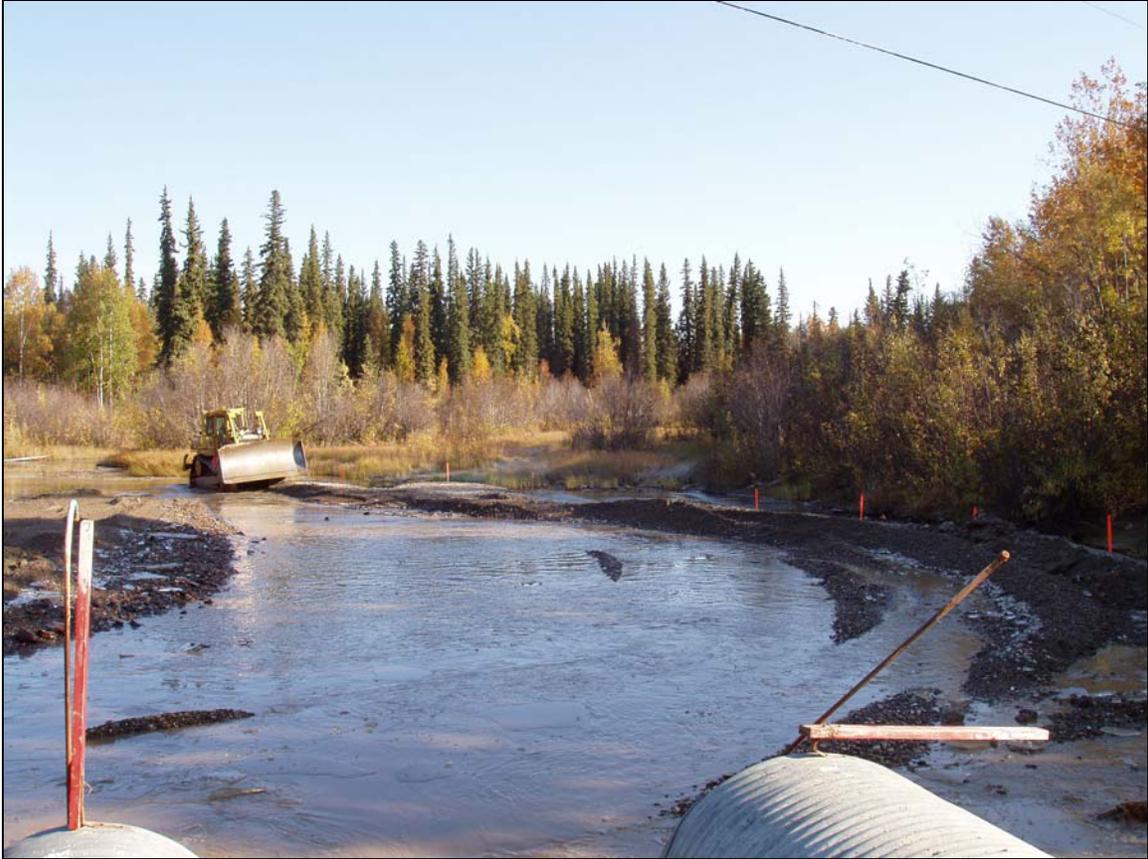
Constructing the permanent 30' wide by 3' deep channel downstream of the culverts and the bankfull bench on the left limit of the channel.

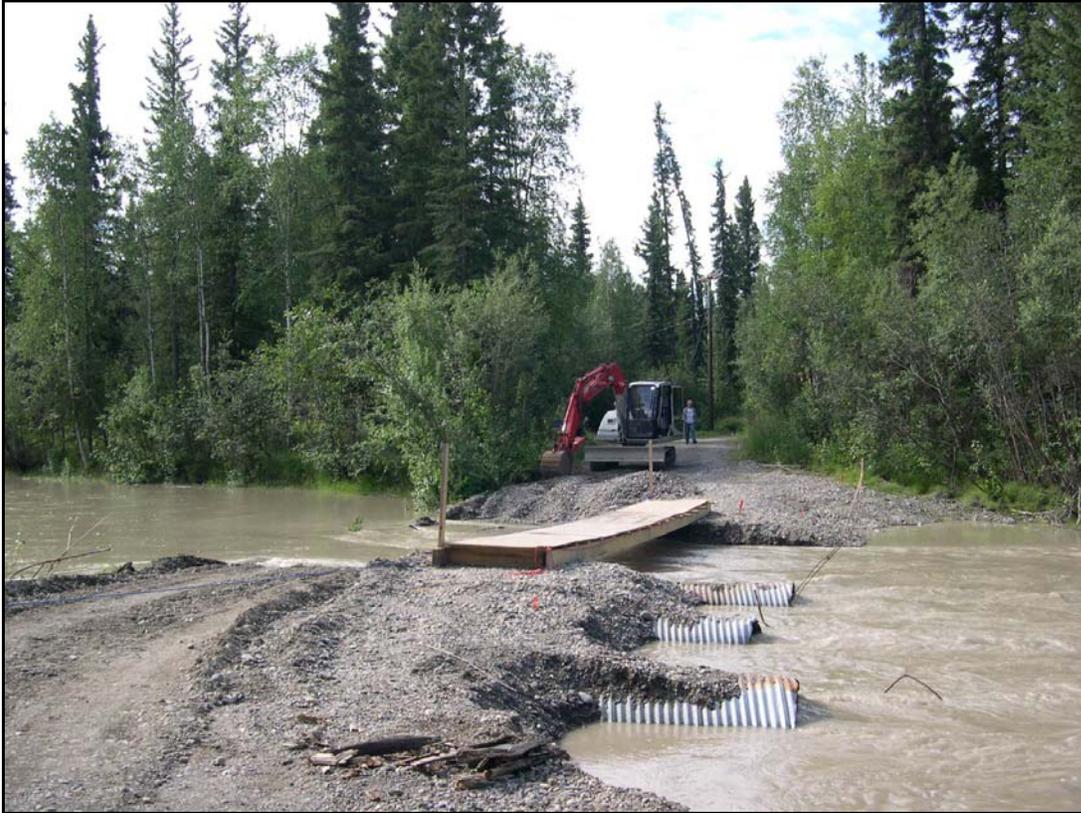
In July 2003, the Ingrid Road crossing of Piledriver Slough was washed out when water from the Tanana River inundated the slough. The subdivision was accessible only by foot for several days.

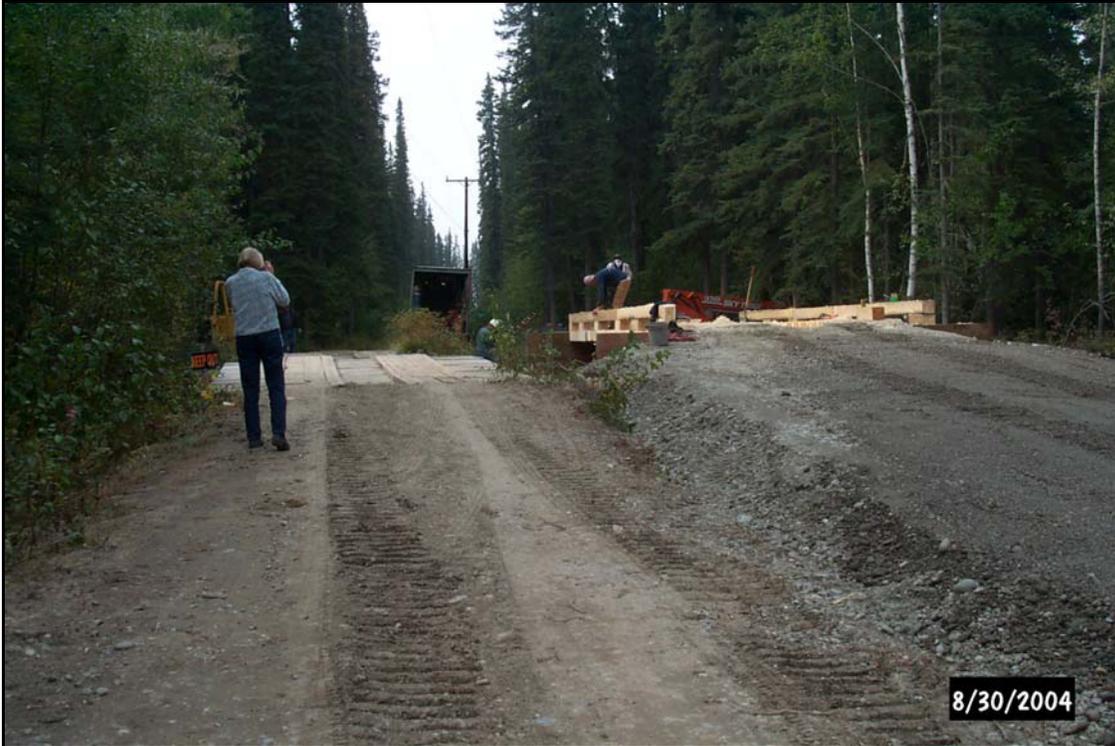
Old bridge on left, new bridge on right (over the top of the low water crossing)

In August 2004, an old (unsafe) bridge with abutments in the stream bed was removed and replaced with a free-span 40' long steel bridge (flatbed railcar) at the Bradbury Road crossing of Piledriver Slough. The residents had created a low water crossing in the stream immediately downstream of the old bridge. The new bridge was purchased and installed using USFWS grant monies.

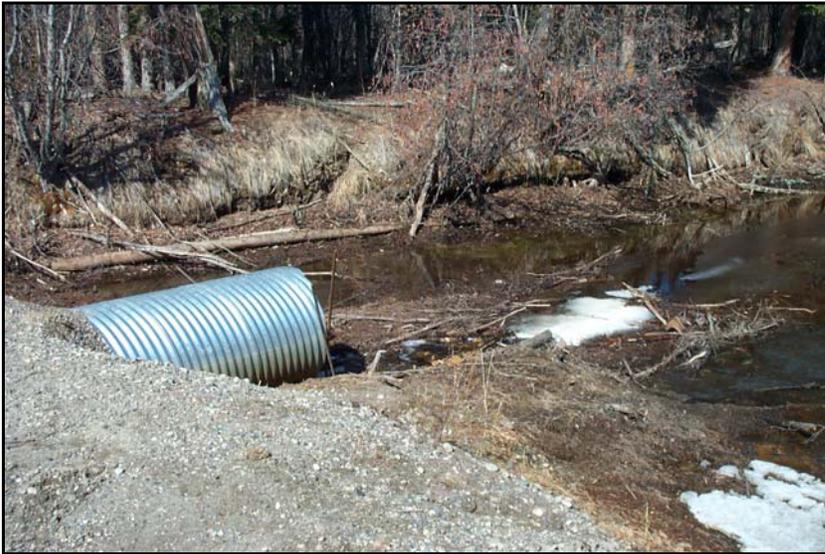
Before

In August 2004, one 36” diameter perched culvert was removed from Twentythree Mile Slough. This culverted crossing completely blocked the upstream and downstream passage of fish for 15 years. The ADNR-OHMP, ADNR Lands and US COE had all issued notices of violation and requested that this culvert be removed. This crossing provided access to a private agriculture lot. Once the culverted crossing was removed, a free-span 40’ long steel bridge (flatbed railcar) was installed downstream from this site. Funding for the installation of the bridge was provided by the USFWS and the property owner.

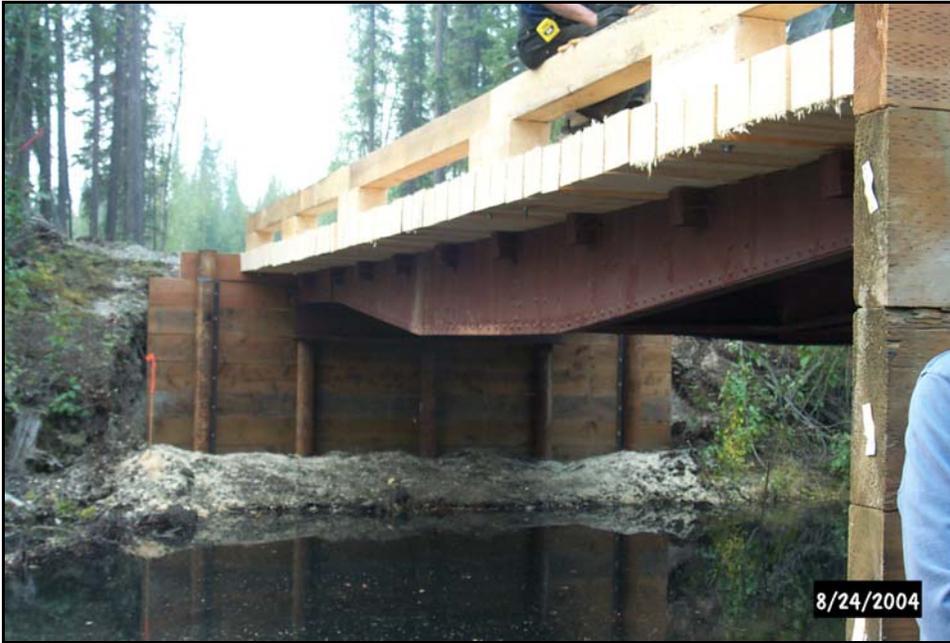
New bridge downstream from original crossing
