**HOMER HERC BUILDINGS
450 STERLING HIGHWAY
HOMER, ALASKA**

ANALYSIS OF BROWNFIELD CLEANUP ALTERNATIVES

SEPTEMBER 2025

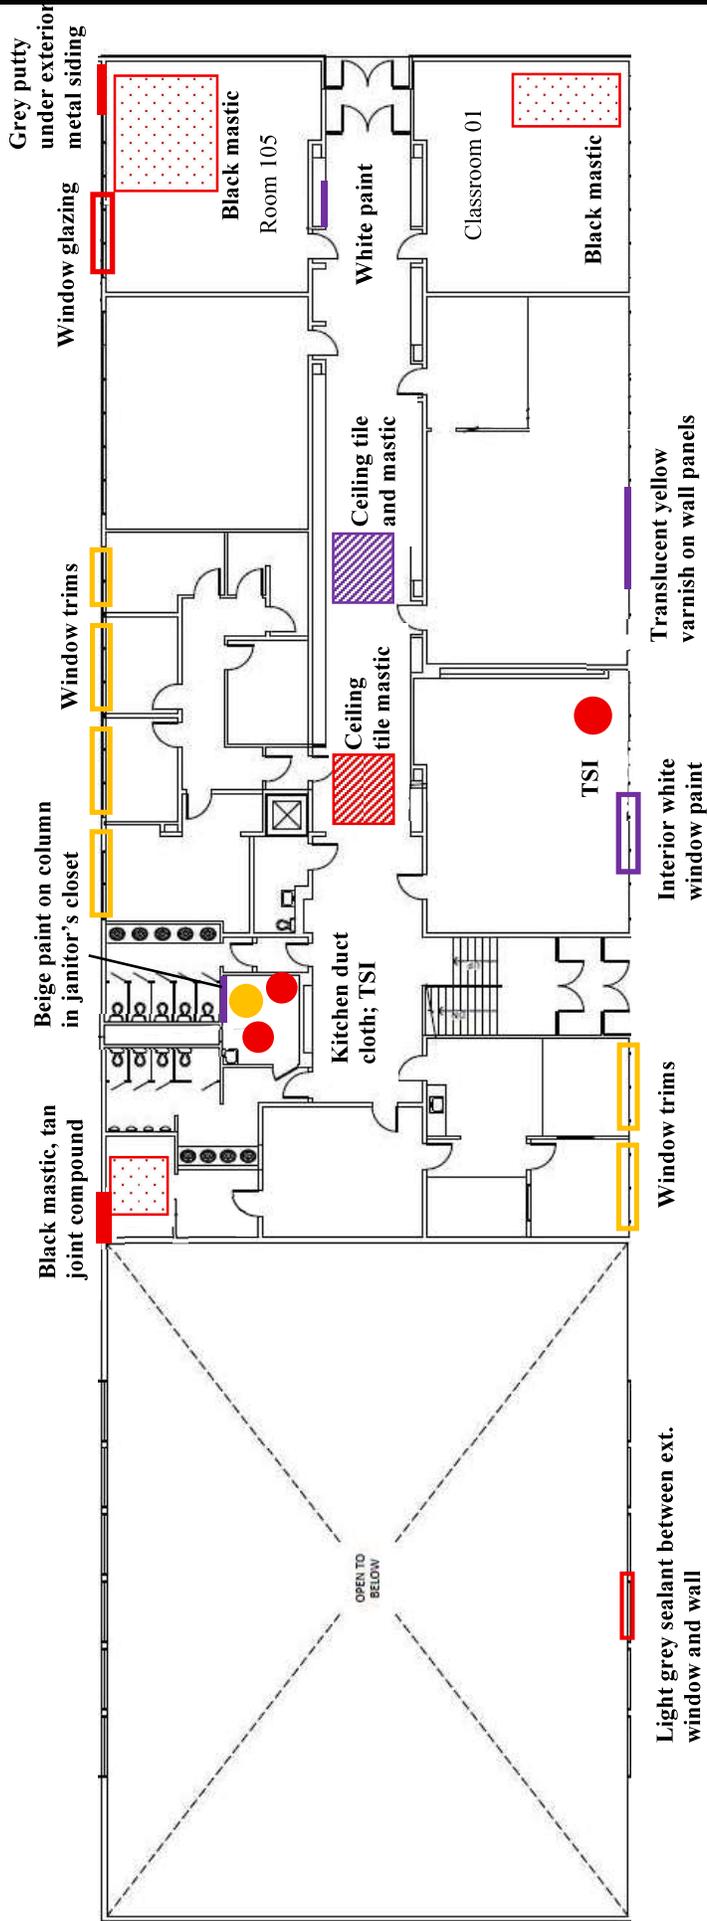
Homer HERC Buildings
 Homer, Alaska
HERC 1 – 2nd Floor
Hazardous Building Materials

A 2023 HBMI of HERC 1 identified ACBMs such as the putty used in the exterior seams of the metal siding, window glazing compound, and a cloth within the duct system in the kitchen; and PCBs in the wall and window paints, varnish, ceiling tiles, and mastic. A LBP-survey of HERC 1 was not performed in 2023.

evaluated using an XRF field-screening instrument. A total of 440 XRF readings were taken and 45 of those readings exceeded the Environmental Protection Agency (EPA) regulatory limit of 1.0 milligram of lead per square centimeter, or 1.0 mg/cm². Specifically, all windows in HERC 1 have LBP on one or more of their components.

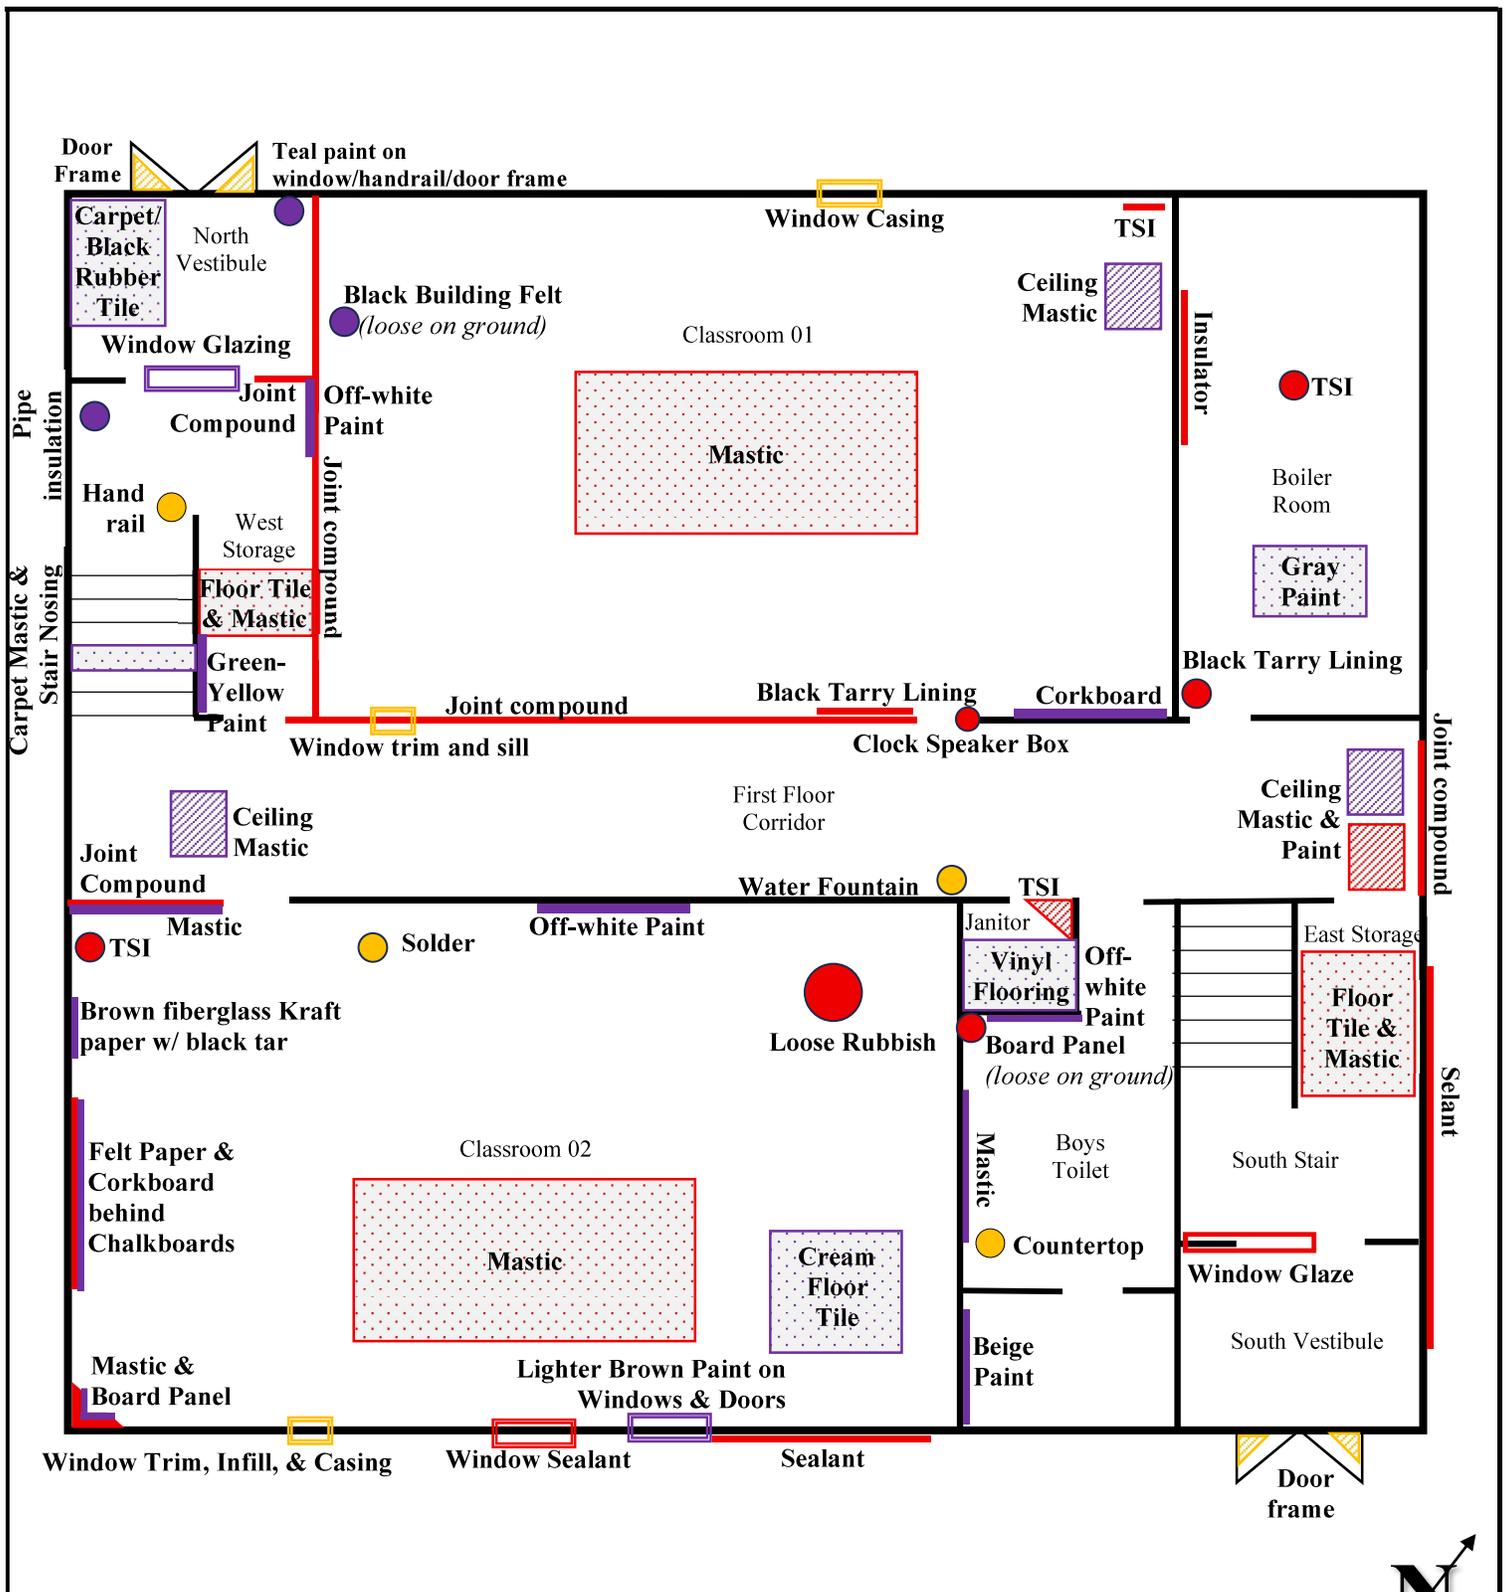
Homer HERC Buildings
Homer, Alaska
HERC 2 – 1st Floor
Hazardous Building Materials

A 2020 HBMI of both buildings identified ACBMs such as floor tile mastic, pipe insulation, and joint compound in both buildings; LBP on the windows in both buildings; and visually assessed building materials for PCBs, concluding that light ballasts may contain PCBs, but samples for analysis were not collected.

A 2022 and 2023 HBMI of HERC 2 identified ACBMs such as floor tile and mastic, ceiling mastic, pipe insulation, joint compound, sealant and putty, and other miscellaneous building materials; LBP in windows, door frames, handrails, and other miscellaneous building materials; and PCBs in wall, door, and window paints, window glazing compounds, ceiling and floor tiles, mastic, cove base, and fiberglass insulation.
