**State of Alaska**  
**Department of Transportation & Public Facilities**  
**Request for Information (RFI): 2526001CA**

**Disposition of the M/V Matanuska**

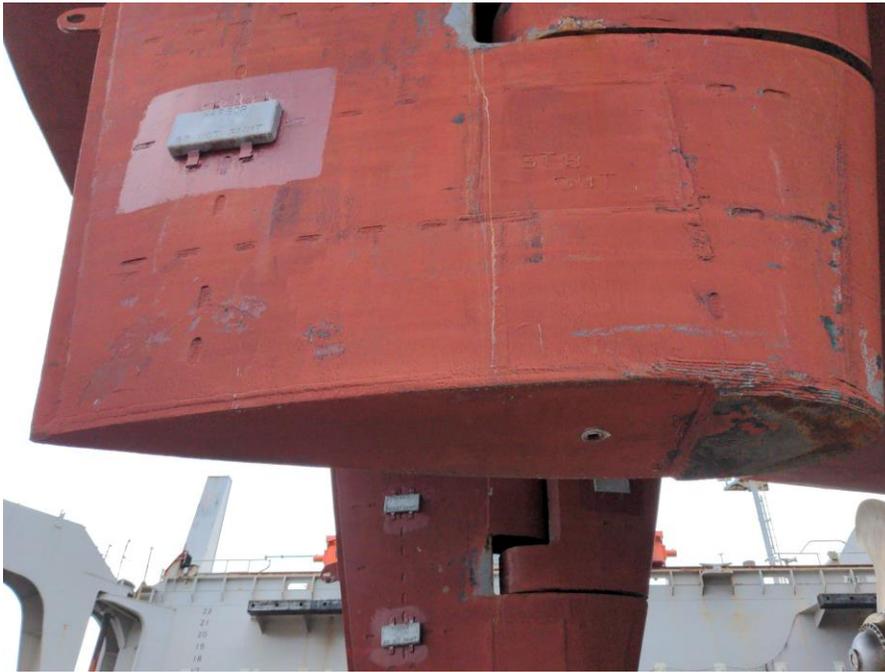
Historically, the crew frequently raised concerns about the perceived sluggishness of the steering on Matanuska. However, no issues have been reported since the repower.

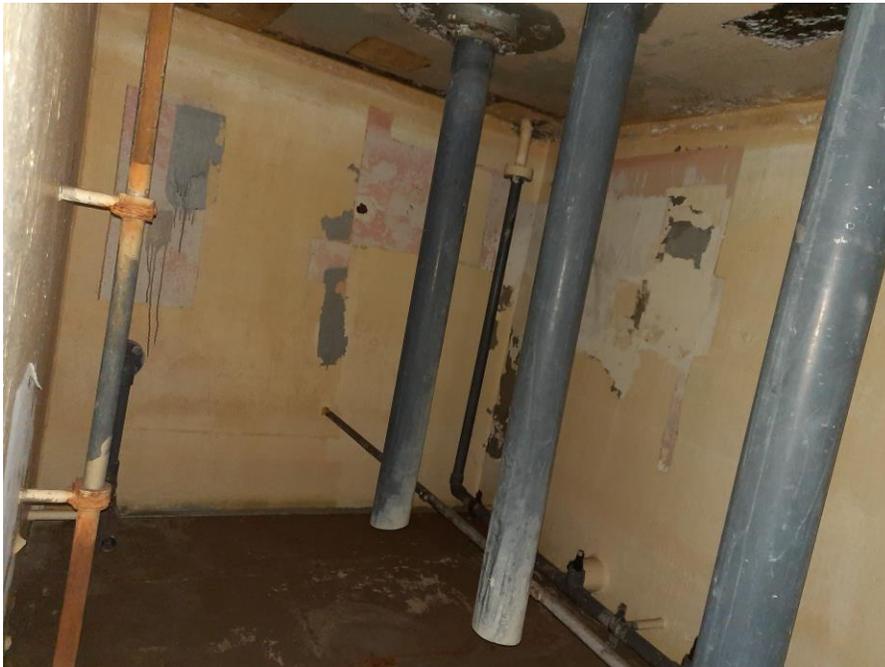
**Figure 45 V2 tank suction lines**

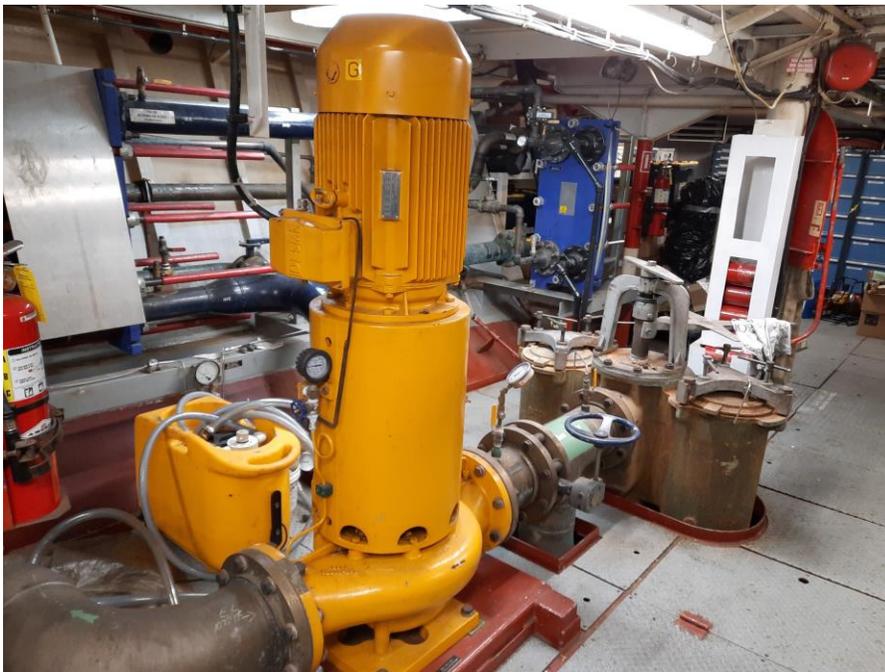
Figure 47 Seawater pump and piping

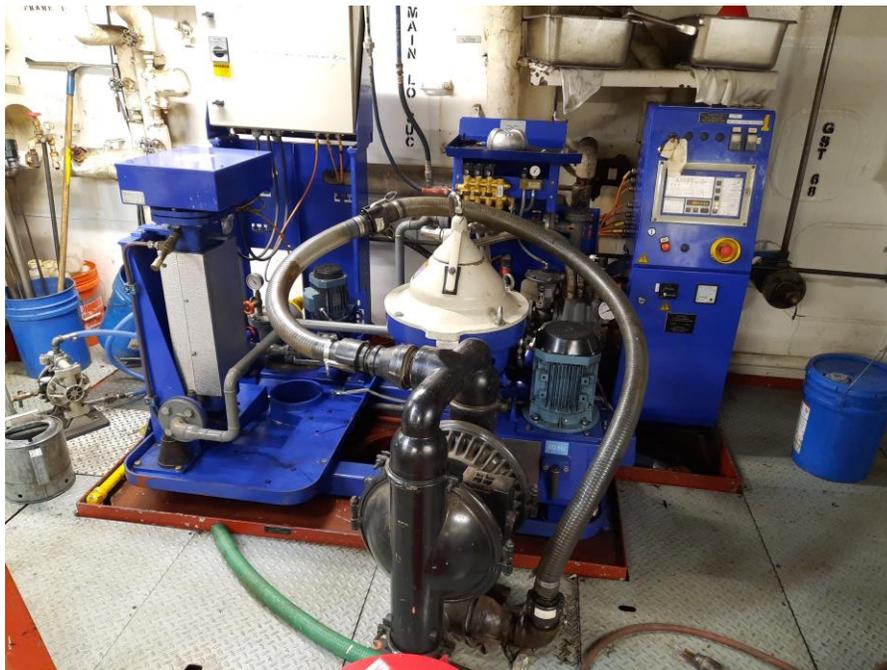
**Figure 48 Lube oil purifier**

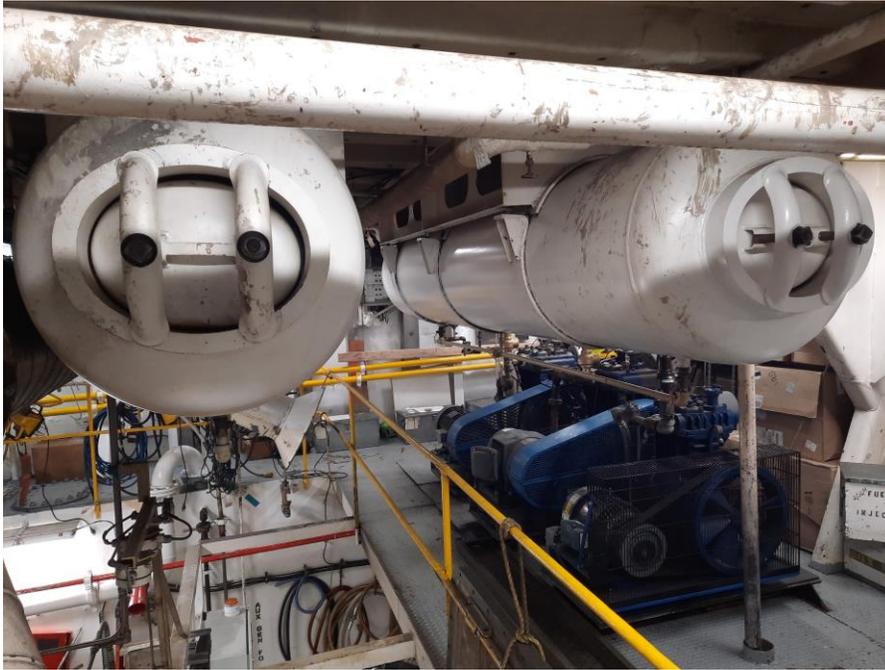
**Figure 49 Compressed air receiver tanks**

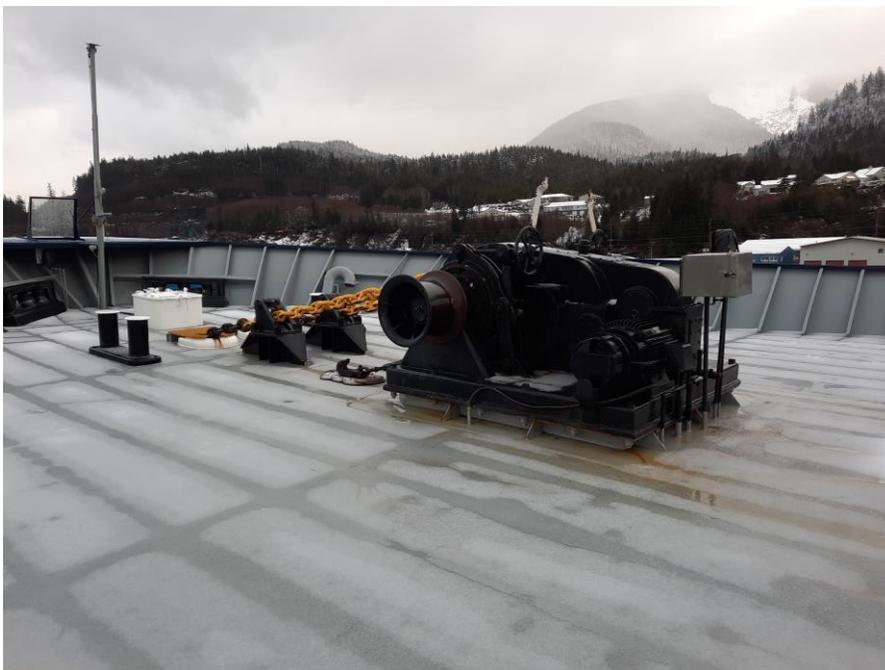
Figure 50 Anchor windlass

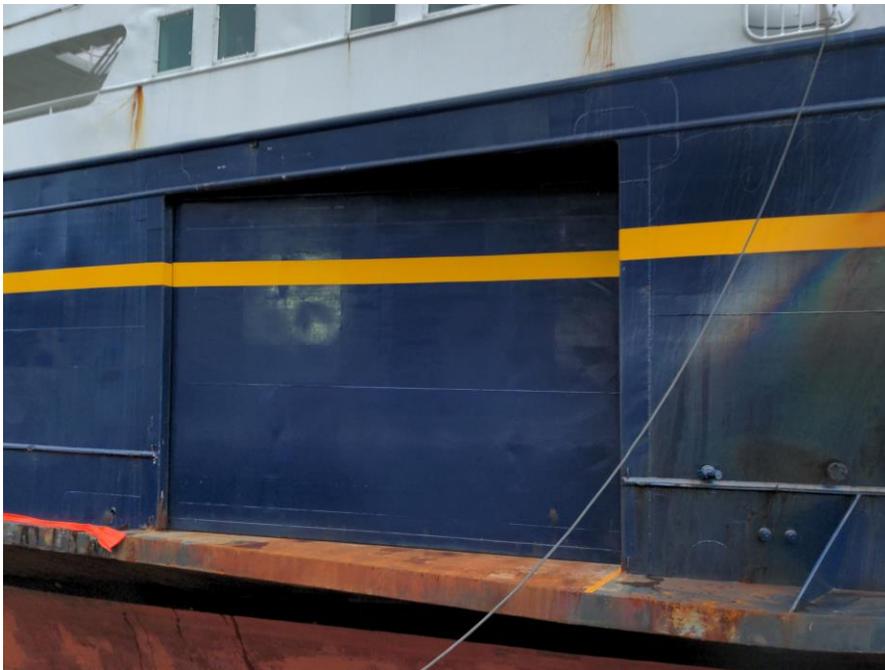
Figure 51 Starboard side door

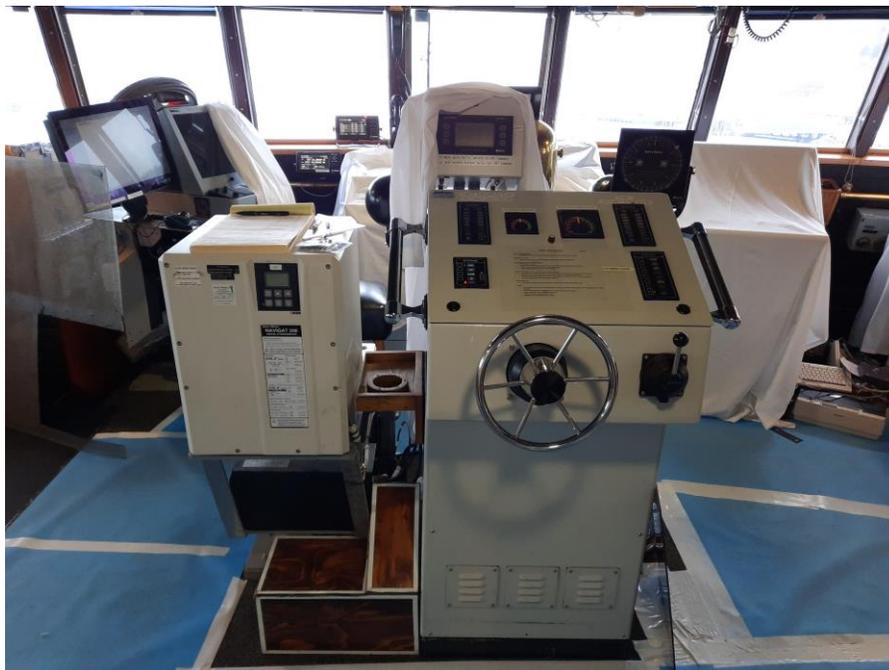
Figure 52 Gyrocompass unit in Pilothouse

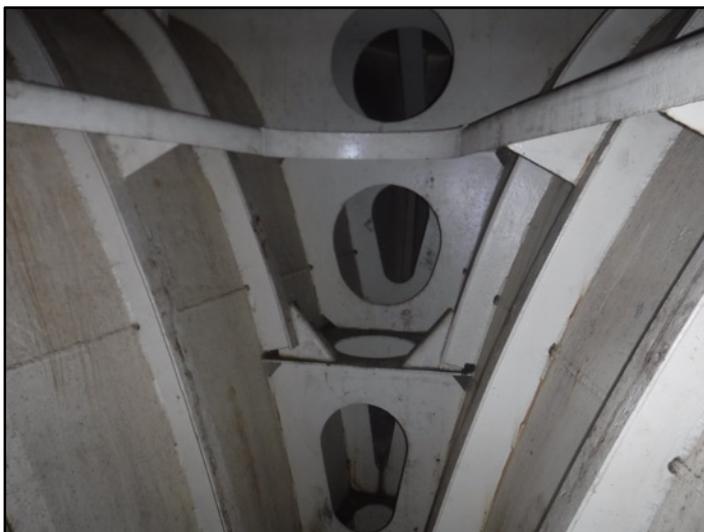
**General Remarks:** Overall, the coatings in the Forepeak remain in satisfactory condition. There is some minor corrosion on the skip welds and sharp edges in the lower forward section (see Photo 2).

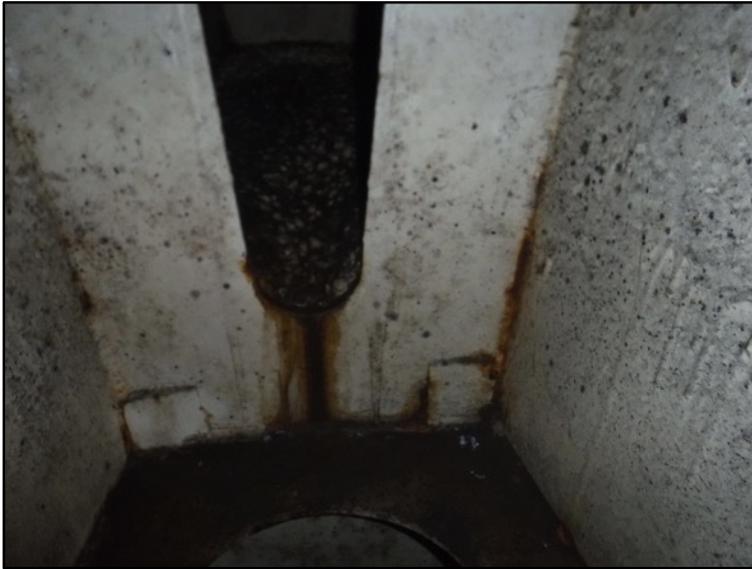
**Recommendations for Future:** No touch up is currently needed. Continue to inspect the Forepeak on an annual basis with special attention the welds in the forward section.

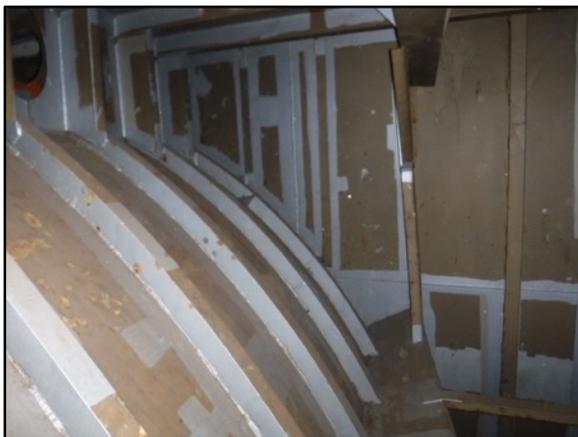
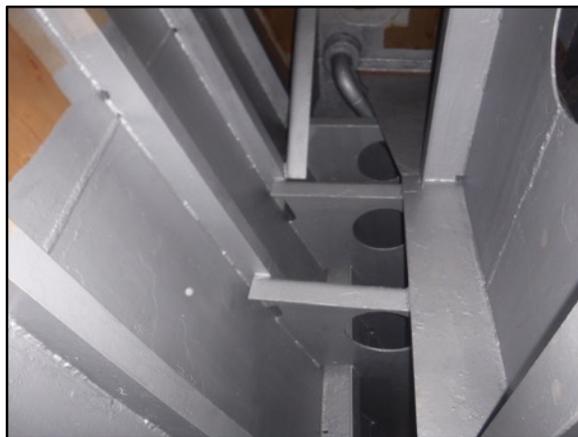
**General Remarks:** There is corrosion on the forward bulkhead on the starboard side (see Photo 5) and on the aft bulkhead, under the aft ladder (see Photo 6). In addition, there is minor corrosion on welds in the port side upper section, near the aft bulkhead (see Photo 7). Coatings in the remainder of the void remain in satisfactory condition.

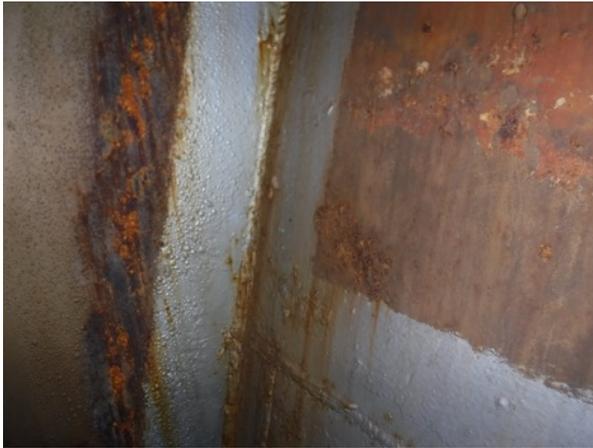
**Photo 6: Corrosion on Aft Bulkhead**

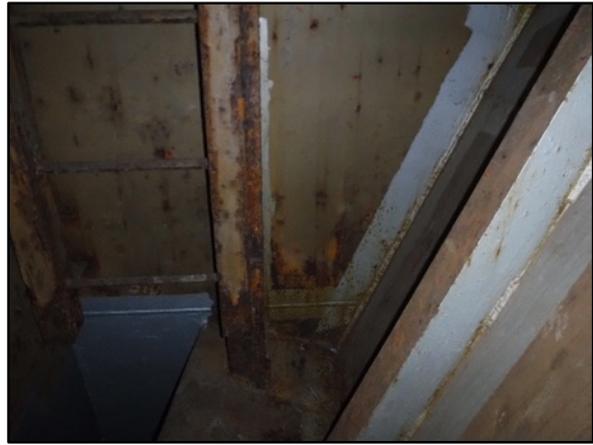
**Photo 7: Minor Corrosion on Welds in Upper Section**

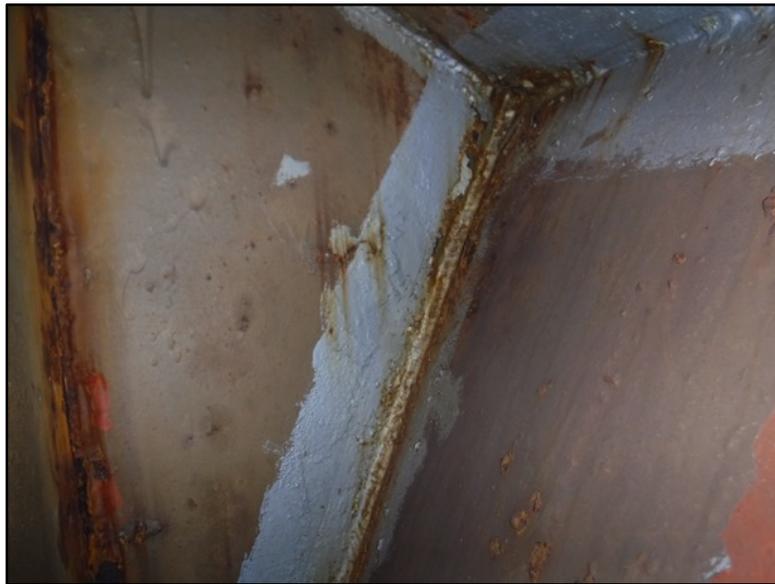
**Recommendations for Future:** No touch up currently needed. The corrosion areas on the forward and aft bulkheads will most likely need to be touched up in the next 1-2 years. Continue to inspect the No. 1 Deep Ballast on an annual basis.

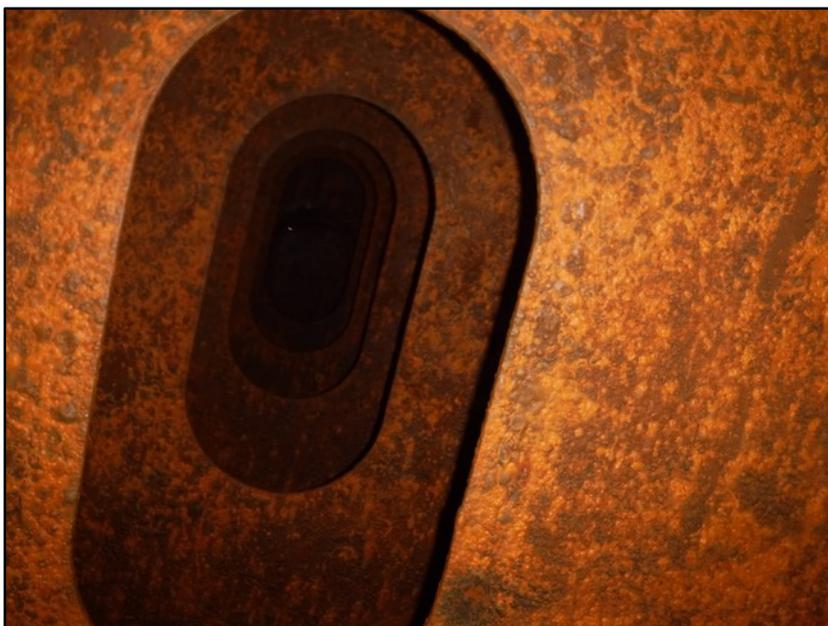
**General Remarks:** The No. 2 Double Bottom Ballast is extremely dirty and caked in mud, so it is difficult to assess the condition of the coatings. The coatings appear to remain intact underneath the mud.

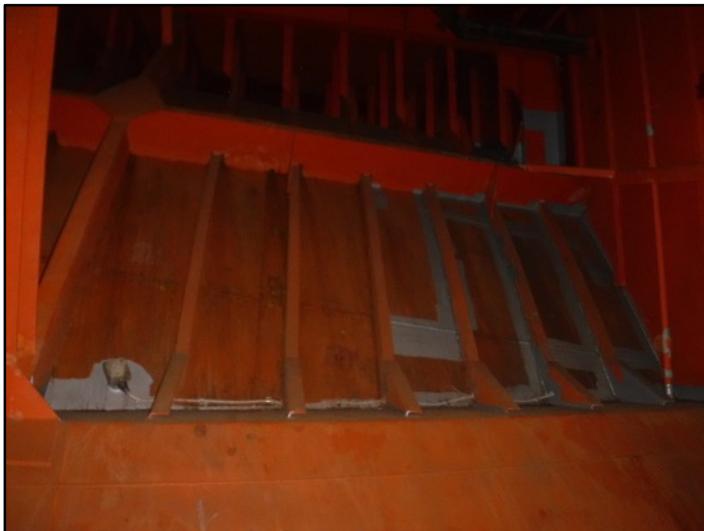
**General Remarks:** There is corrosion on the deck of the void near the forward and aft bulkheads, (see Photos 10 and 11). Coatings in the remainder of the void remain in satisfactory condition.

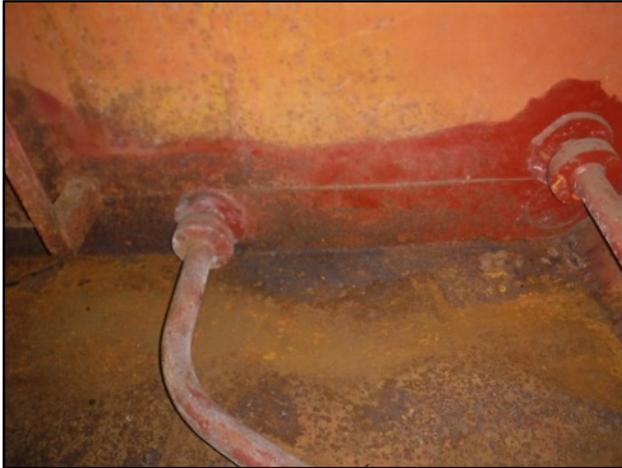
**Photo 11: Corrosion on Deck near Aft Bulkhead**

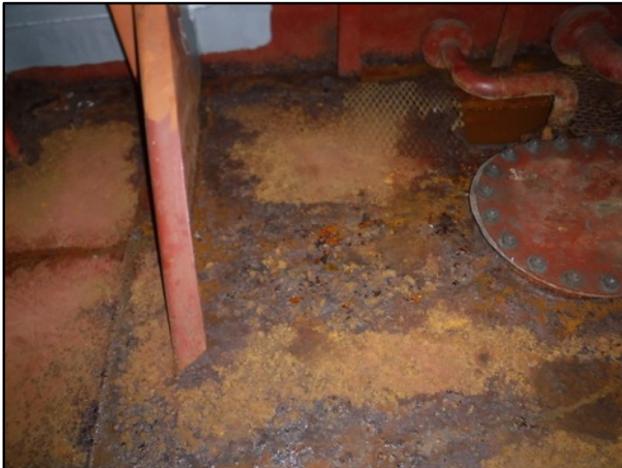
**Recommendations for Future:** No touch up currently needed. The corrosion on the deck near the forward and aft bulkheads will most likely need to be touched up in the next 1-2 years. Continue to inspect the No. 3 Void on an annual basis.

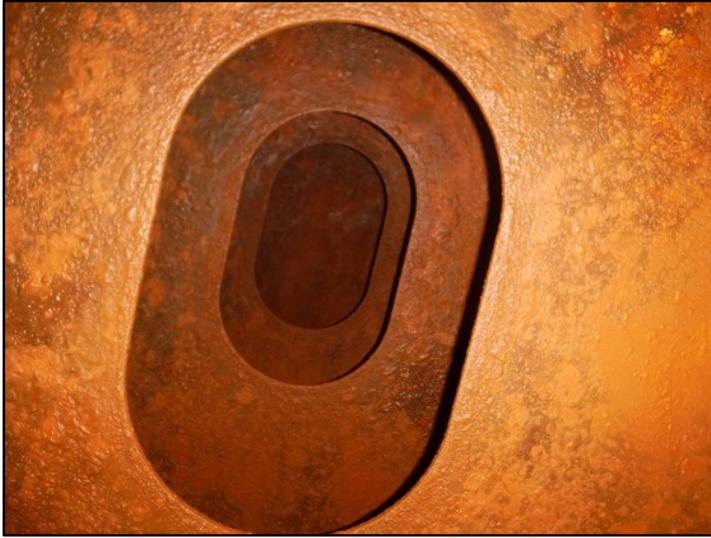
**General Remarks:** The No. 3 Wing Ballasts and Center Line Double Bottom Ballast are extremely dirty and caked in mud. However, the coatings appear to remain intact underneath.

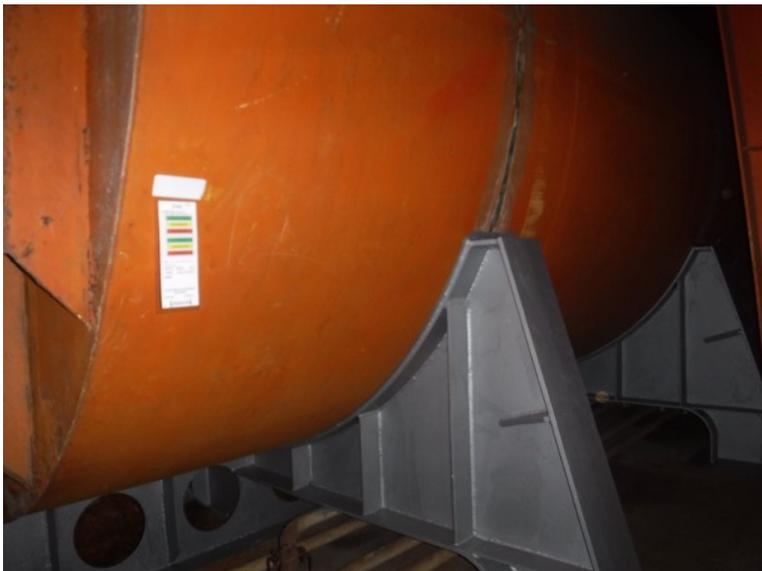
**General Remarks:** There is corrosion on welds and the skin plate on the starboard side above the wing ballast, mostly near the aft bulkhead (see Photos 16 and 17). There is also corrosion on the sides of the pipe alley (see Photo 18). Finally, there is corrosion on the deck near the forward and aft bulkheads (see Photo 19) The coatings in the remainder of the void remain in satisfactory condition.

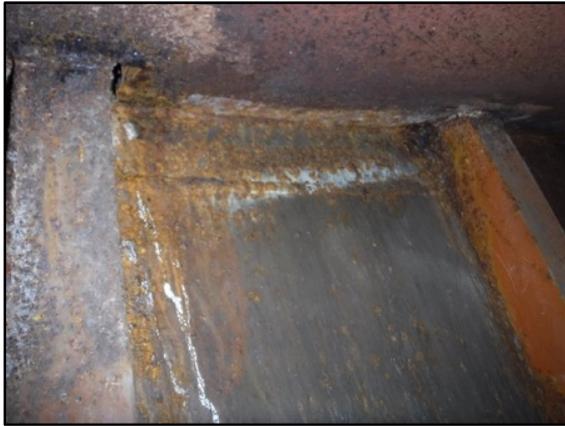
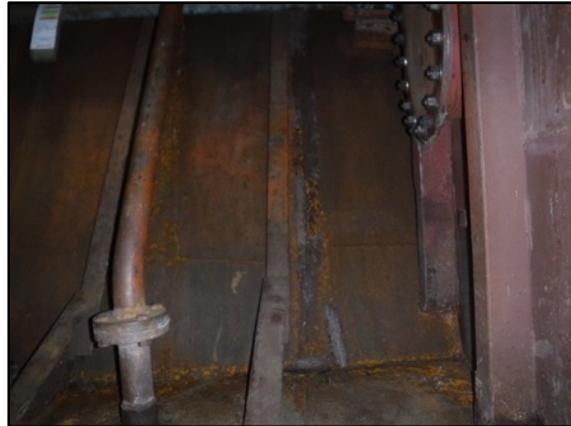
**Photo 18: Corrosion on Sides of Pipe Alley**

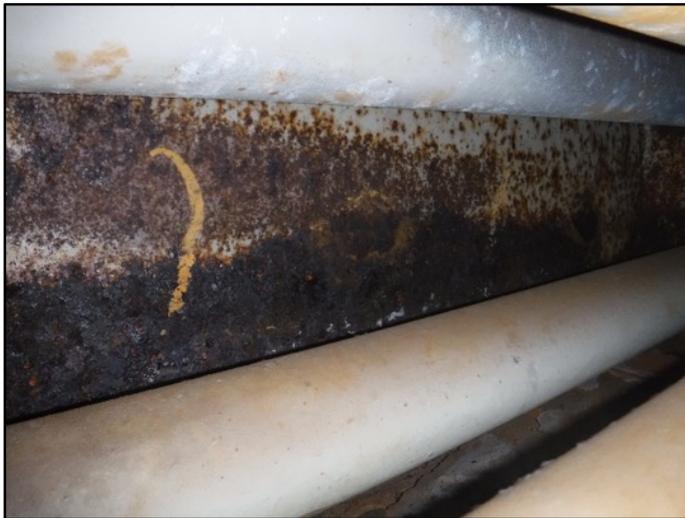
**Photo 19: Corrosion on Deck Near Forward Bulkhead**

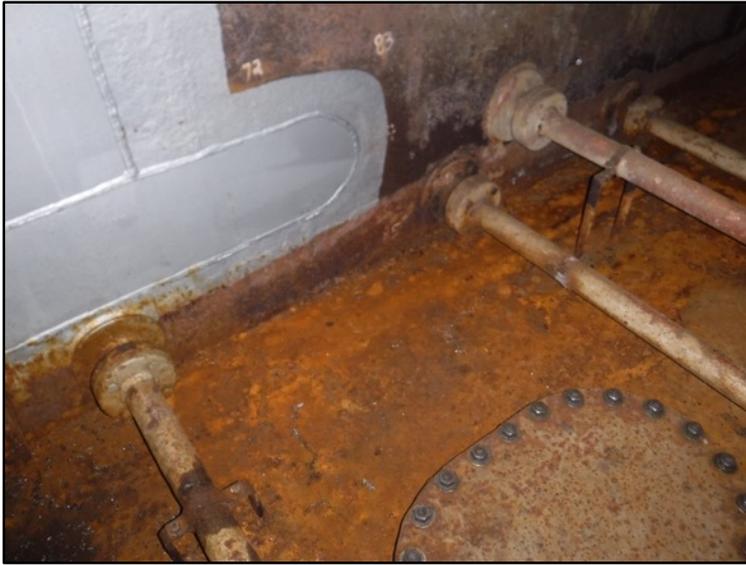
**Recommendations for Future:** At next availability, we recommend power tool cleaning (as per SSPC-SP 15) the corrosion areas on the welds and skin plate above the starboard wing ballast and applying 2 coats and a stripe coat of Intershield 300 epoxy. We also recommend power tool cleaning the walls of the pipe alley and coating with 2 coats of Intershield 300. This area is difficult to access, so if power tool cleaning is not possible, Interbond 600 could be used to seal up the corrosion areas. The corrosion on the deck, near the forward and aft bulkheads, will also most likely need to be touched up in the next 1-2 years. Continue to inspect the No. 4 Void on an annual basis.

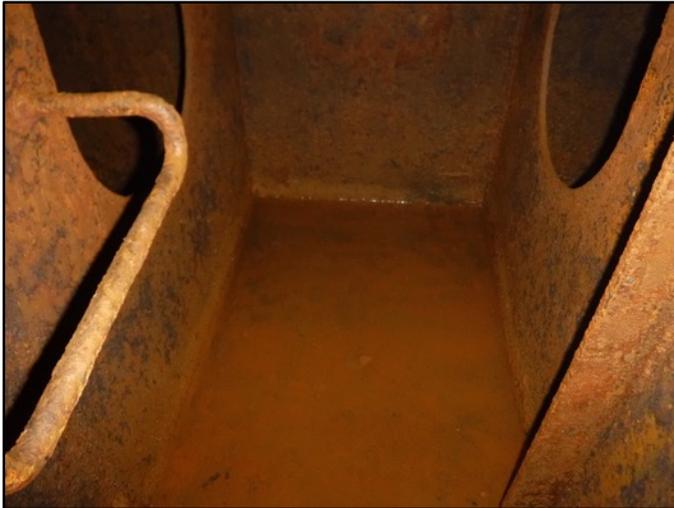
**General Remarks:** The No. 4 Port Wing Ballast is not as dirty as the others, which are coated in dirt and mud. The coatings appear to remain intact underneath the mud.

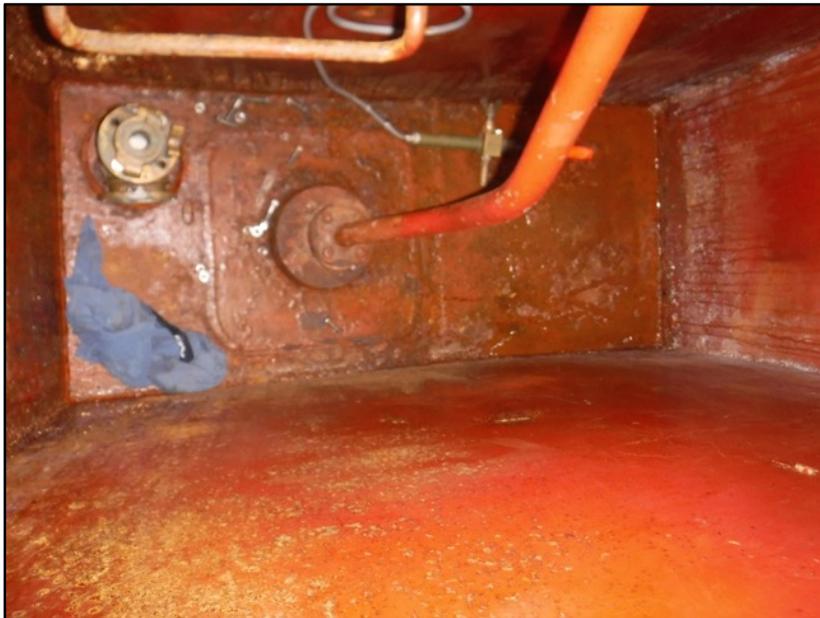
**General Remarks:** The deck of the Transducer Void is dirty, but the coatings remain in satisfactory condition.

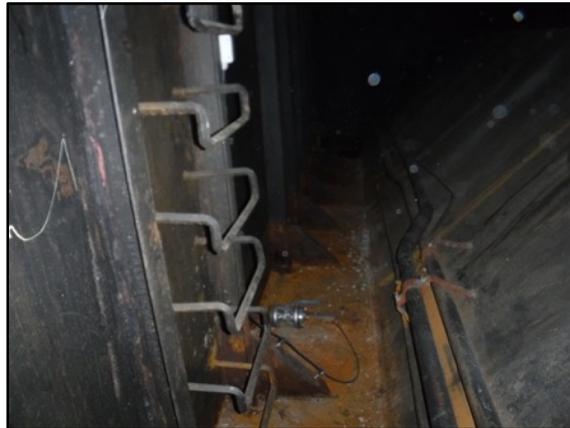
**General Remarks:** There is corrosion on the deck of the No. 5 Starboard Void, near the center line bulkhead (see Photo 26). The coatings in the Wing Voids remains in satisfactory condition (see Photos 27 and 28). In the No. 5 Double Bottom, there is minor corrosion on the welds on the deck (see Photo 29).

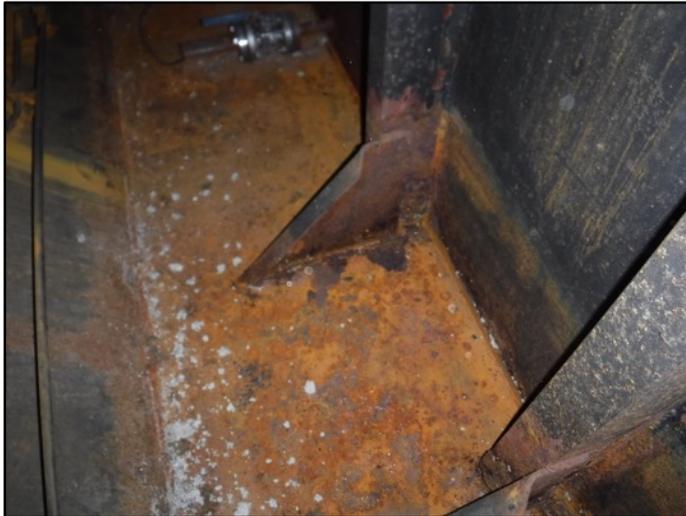
**Photo 27: No. 5 Port Wing Void**

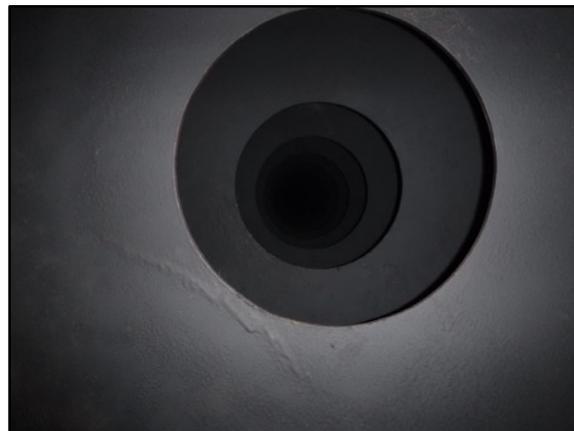
**Photo 29: Minor Corrosion on Welds on Deck of No. 5 Double Bottom**

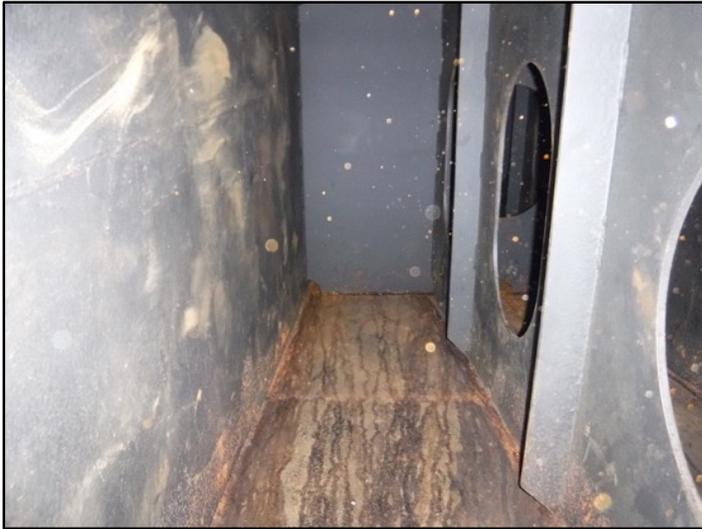
**Recommendations for Future:** No touch up currently needed. The deck of the No. 5 Starboard Void, near the center line bulkhead, should be touched up in the next 1-2 years. The welds on the deck of the No. 5 Double Bottom will also most likely need to be touched up in the next 2-3 years. Continue to inspect the No. 5 Voids, Wing Voids, and Double Bottom on an annual basis.

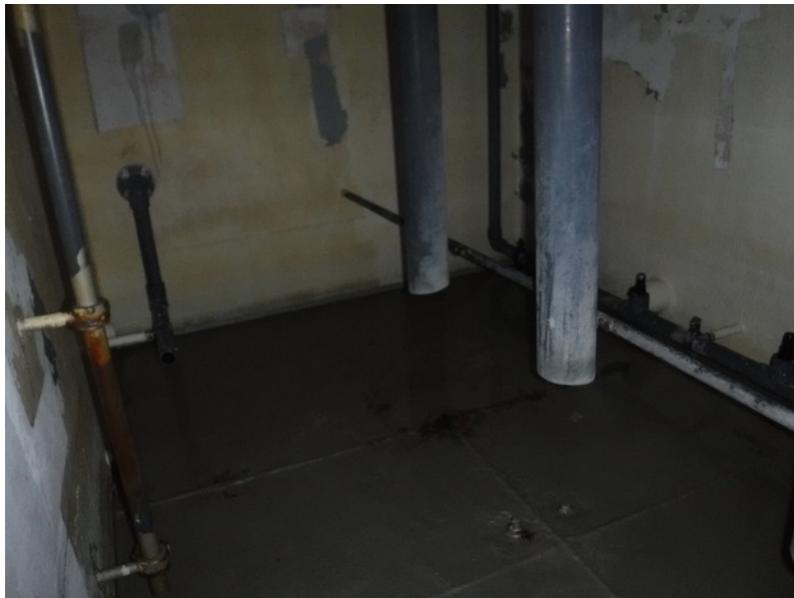
**General Remarks:** Overall, the coatings in the V-1 Sewage Tank remains in satisfactory condition. There are two small delamination spots on welds on the deck of the of the tank (see Photo 31).

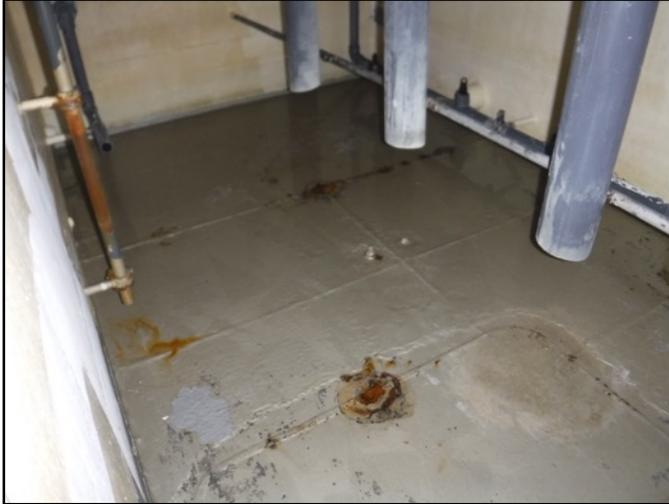
**Recommendations for Future:** No touch up and repair currently needed. The delamination spots on the deck of the V-1 Sewage Tank will most likely need to be touched up in the next 1-2 years. Continue to inspect the Sewage Tanks on an annual basis.

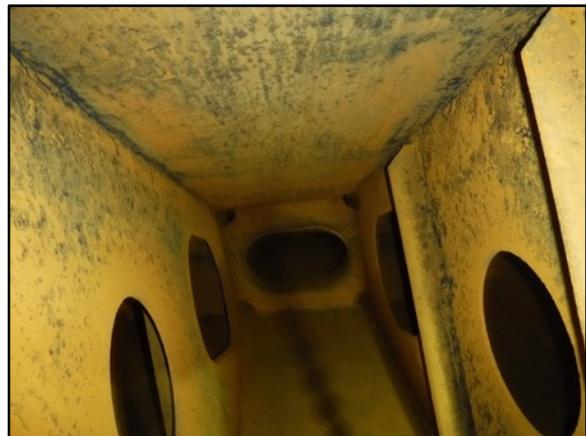
**General Remarks:** Both Wing Ballasts are coated in mud. Underneath the mud, the coatings appear to remain intact.

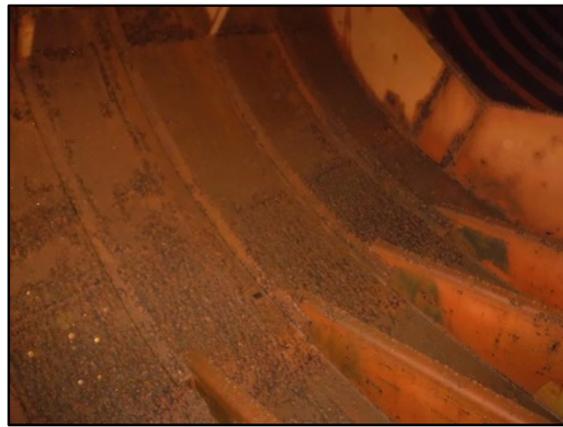
**General Remarks:** Both wing voids are very dirty, but coating appears to remain intact underneath.

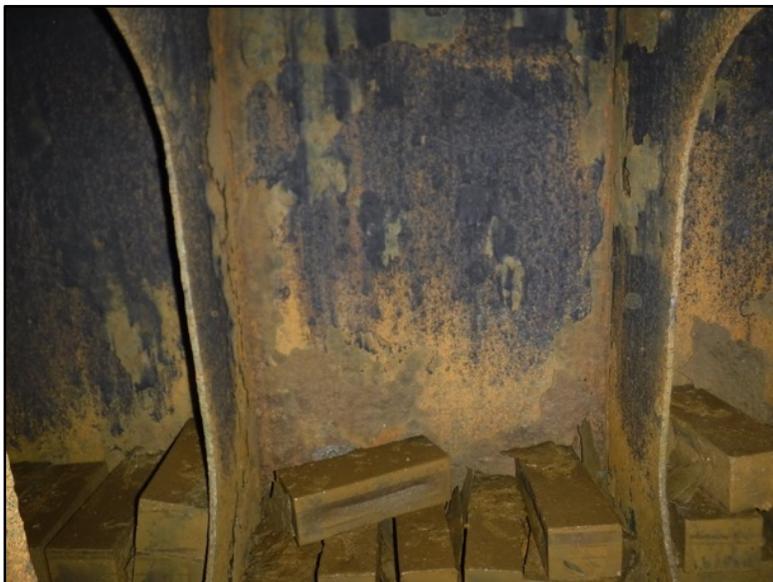
**General Remarks:** The No. 9 Double Bottom Ballast is extremely dirty and caked with mud. There are spots throughout the double bottom where the coating appears to be delaminating (see Photo 37). In order to get a good look at the condition of the coating, these areas would need to be cleaned.

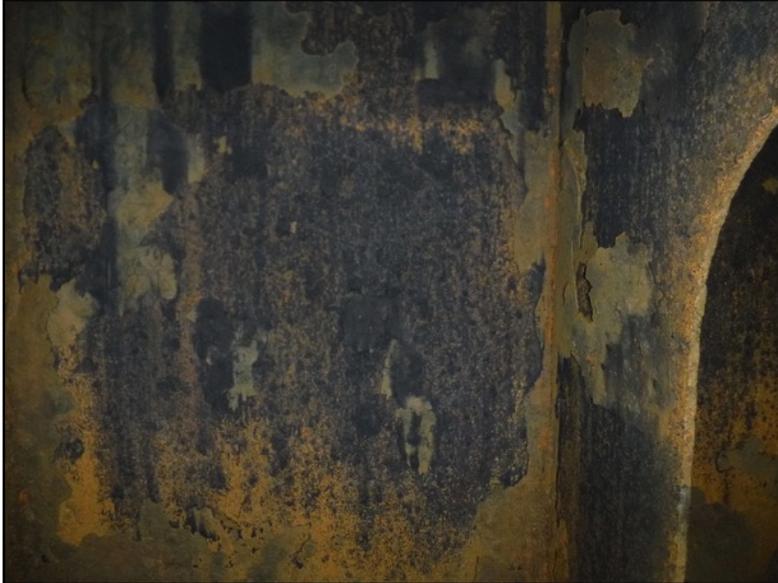
**Recommendations for Future:** We recommend cleaning the No. 9 Double Bottom Ballast in the near future, so that a better assessment of the coatings can be completed. Continue to inspect on an annual basis.

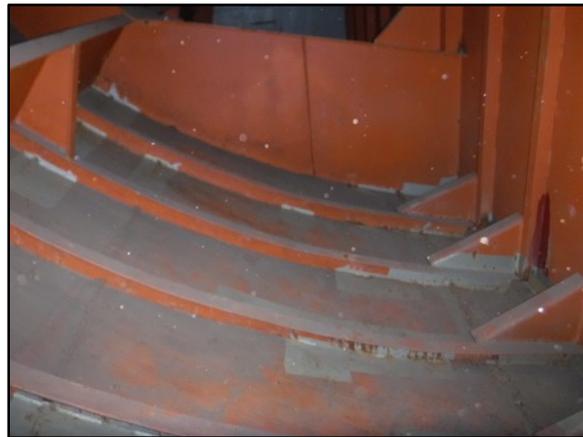
**General Remarks:** There is corrosion and delamination spots on the deck of the Cross Flood (see Photo 40). In addition, there is corrosion on the deck in the lower section of both voids, mostly near the forward bulkheads (see Photo 41). There is also a delamination spot in the lower

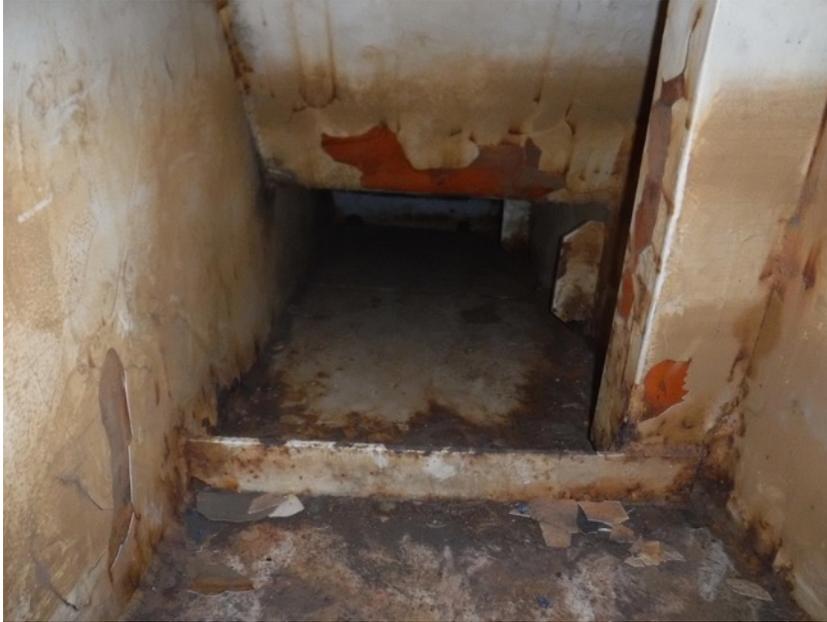
**Photo 41: Minor Corrosion in Lower Section of No. 10 Port Void**

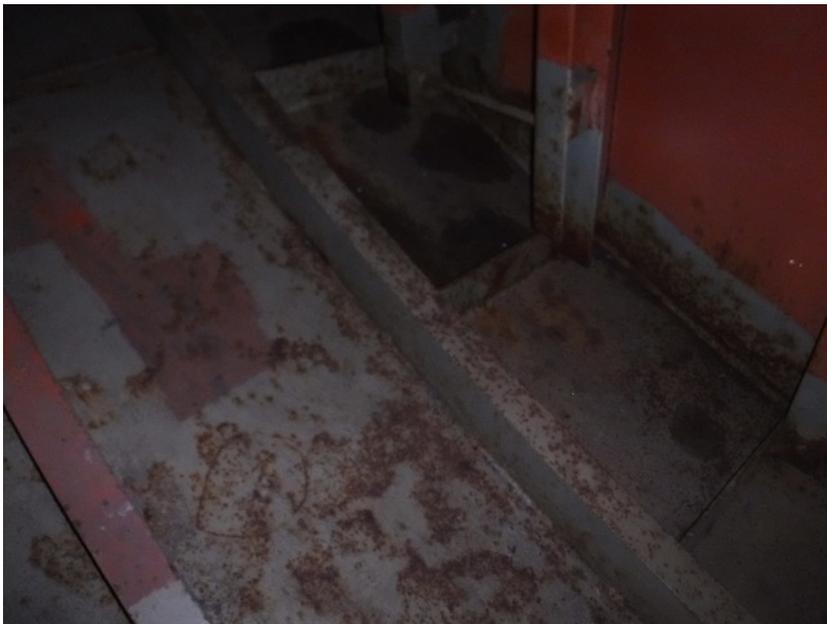
**Photo 42: Delamination Spot in Middle Lower Section of No. 10 Starboard Void**

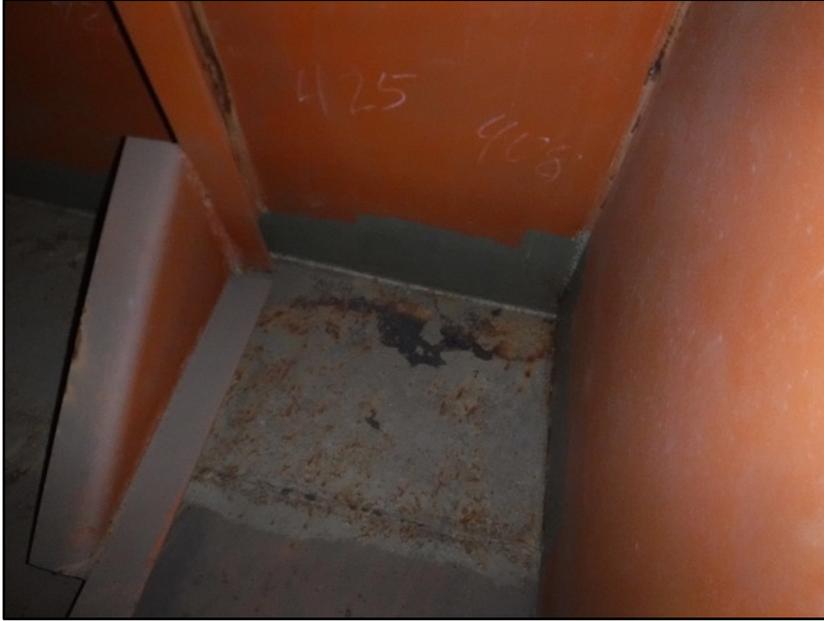
**Recommendations for Future:** At the next availability, we recommend power cleaning (as per SSPC-SP 15) the corrosion areas on the deck of Cross Flood and corrosion/delamination spots in the lower section of the No. 10 Port and Starboard Voids. We then recommend that these areas be coated with two coats and a stripe coat of Intershield 300. Continue to inspect the No. 10 Port and Starboard Voids on an annual basis.

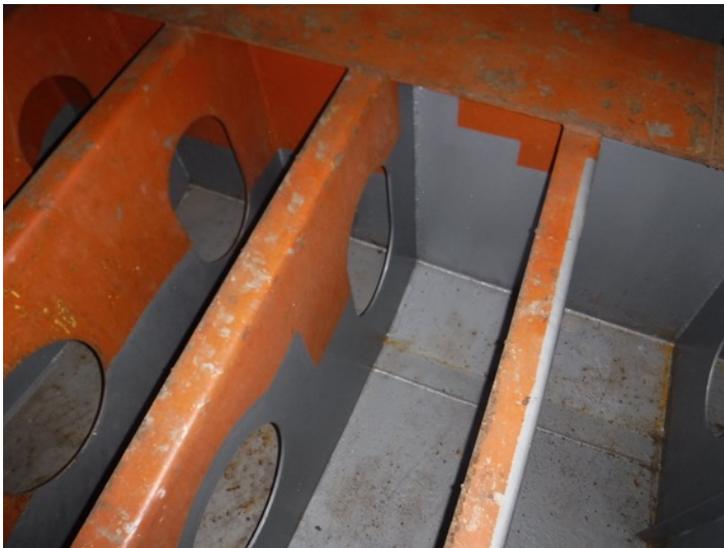
**General Remarks:** There are coating delamination spots and corrosion on the deck in the middle section (see Photo 44). There is also minor corrosion on the deck of the Cross Flood in

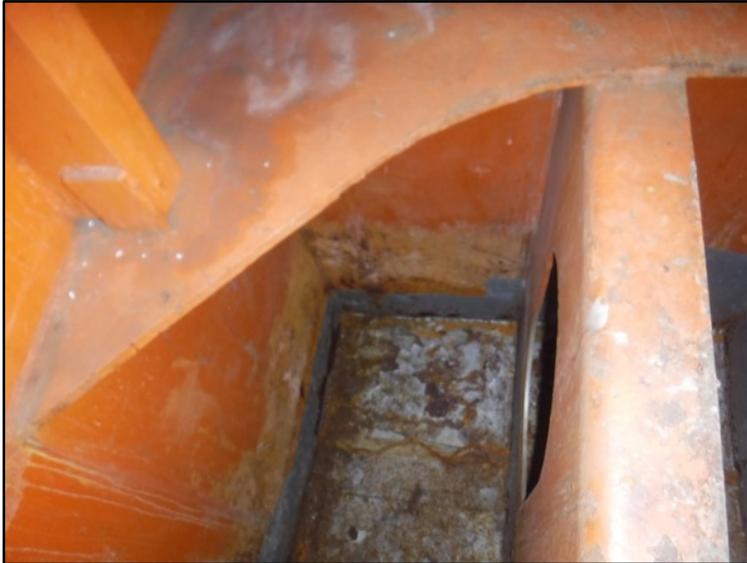
**Photo 45: Corrosion on Deck of Cross Flood**

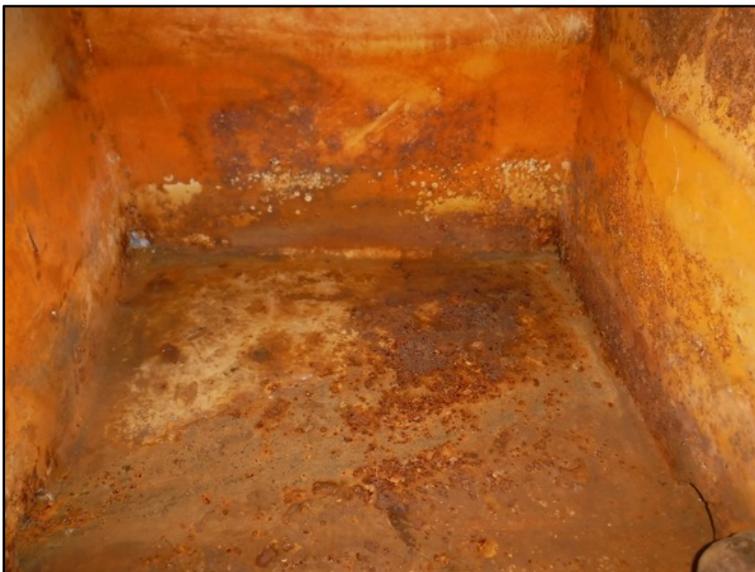
**Recommendations for Future:** At the next availability, we recommend power tool cleaning (as per SSPC-SP 15) the corrosion/delamination areas on the deck in the middle section and corrosion areas on the deck of the Cross Flood in the forward section. The recommended coating system in these areas would be two coats and a stripe coat of Intershield 300. Continue to inspect the No. 10 Center Line Void on an annual basis.

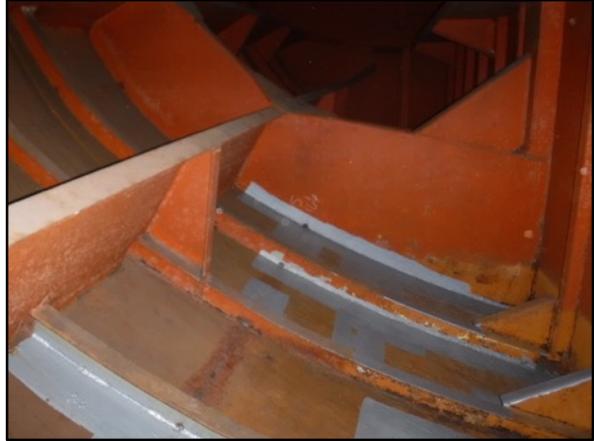
**General Remarks:** There is corrosion on the welds of the skin plate in both voids, above the touch up areas in the forward sections (see Photos 48 and 49). In addition, there is corrosion in the lowest section of both voids, in the middle and aft sections (see Photos 50 and 51). Finally, there is corrosion on the deck of the Cross Flood (see Photo 52).

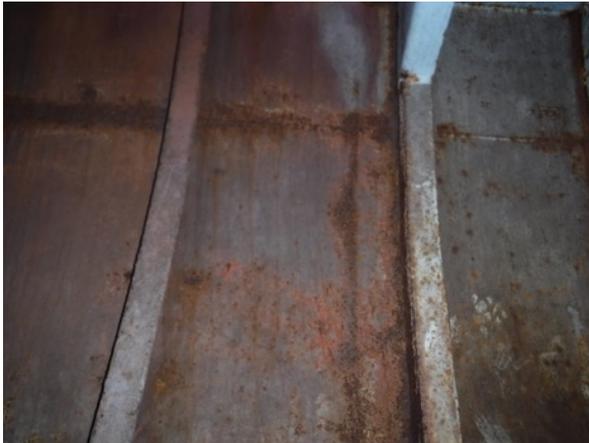
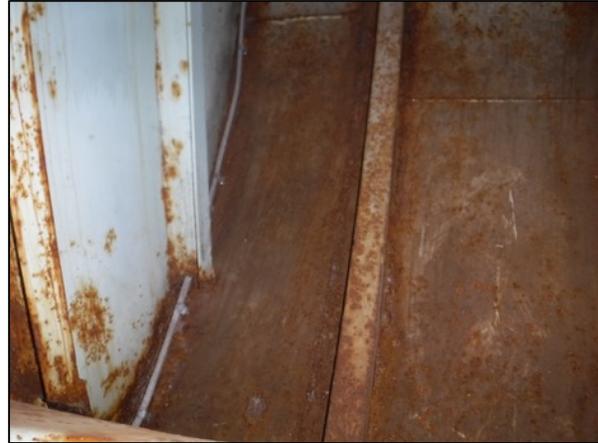
**Photo 50: Corrosion in Lower Aft Section of No. 10 Port Void**

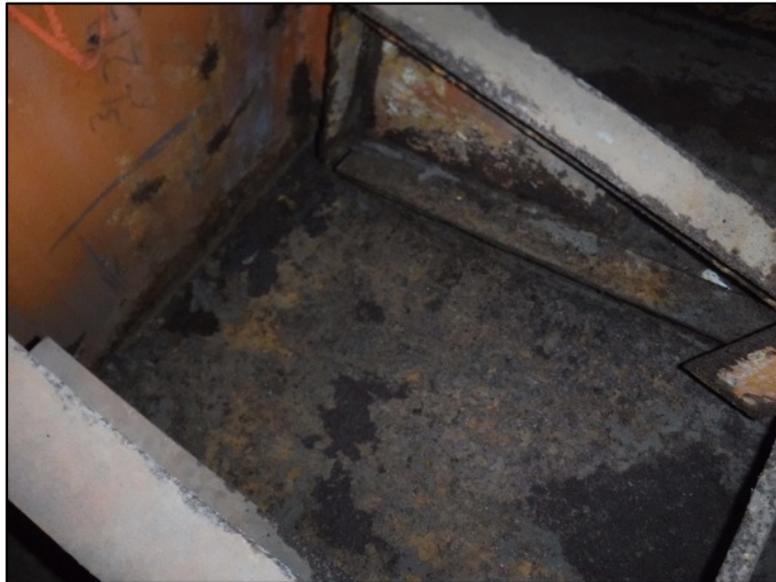
**Photo 51: Corrosion in Lower Middle Section of No. 11 Starboard Void**

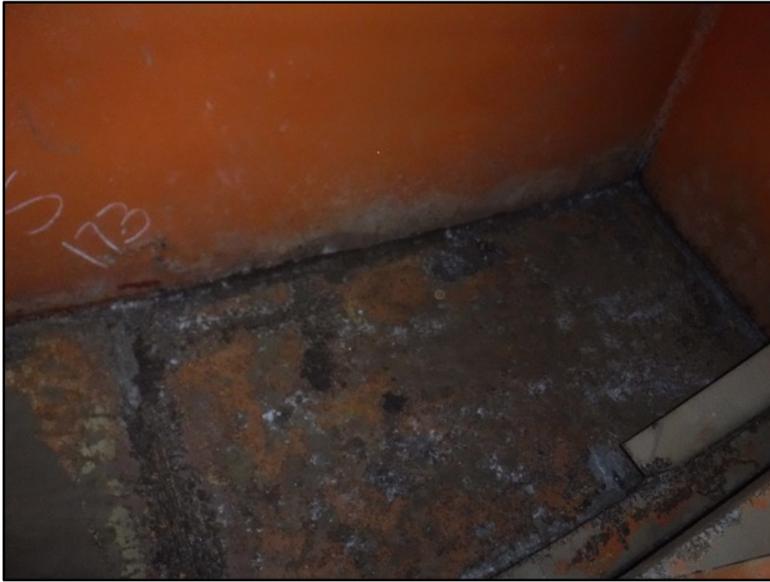
**Photo 52: Corrosion on Deck of Cross Flood**

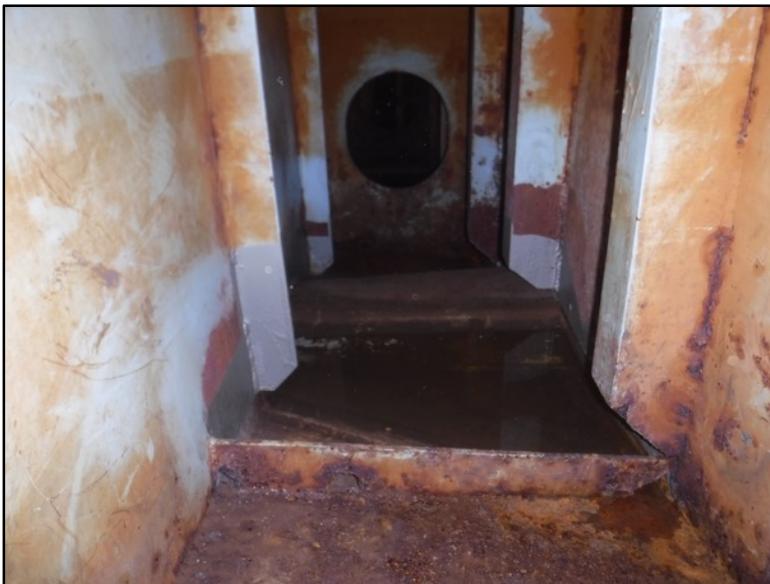
**Recommendations for Future:** At next availability, we recommend power tool cleaning (as per SSPC-SP 15) corrosion areas on the skin plate in the forward section of the No. 11 Port & Starboard Voids and coating with two coats and a stripe coat of Intershield 300 epoxy. We also recommend that corrosion areas in the lower aft and middle sections of both voids, near the center line bulkhead, and corrosion areas on the deck of the Cross Flood be power tool cleaned (as per SSPC-SP 15) and touched up with two coats and a stripe coat of Intershield 300 at the next availability. Continue to inspect the No. 11 Port and Starboard Voids on an annual basis.

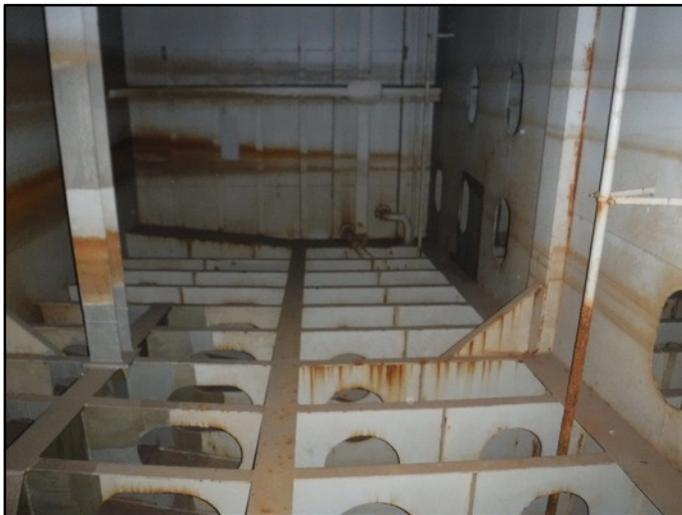
**General Remarks:** Overall, the coatings in the No. 11 Center Line Ballast remain in satisfactory condition. It is dirty on the deck and there is some minor corrosion on skip welds in the lower section (see Photo 54).
