**State of Alaska**  
**Department of Transportation & Public Facilities**  
**Request for Information (RFI): 2526001CA**

**Disposition of the M/V Matanuska**

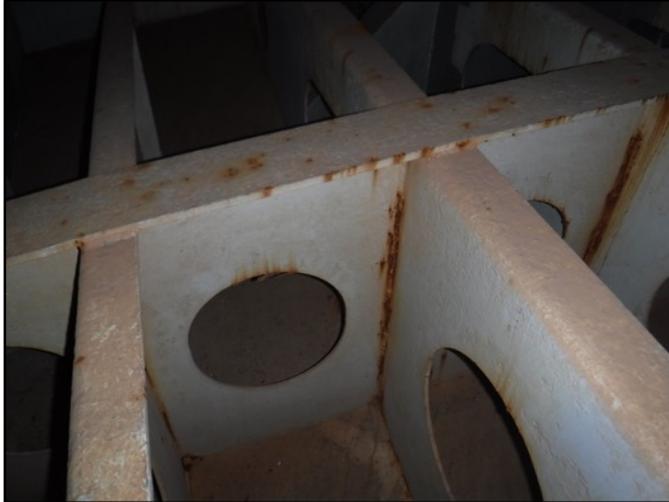
**Recommendations for Future:** No touch up currently needed. Continue to inspect the No. 11 Center Line Ballast on an annual basis with special attention on the welds in the lower section.

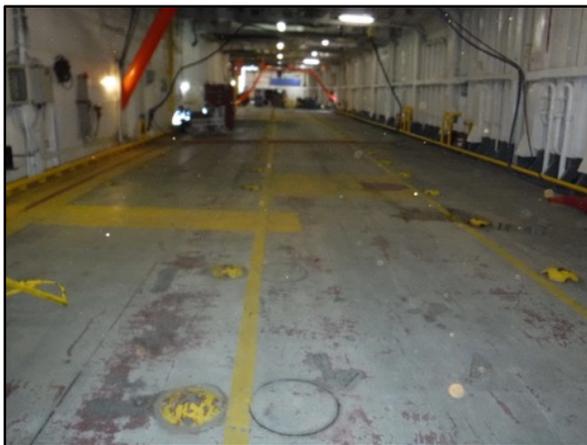
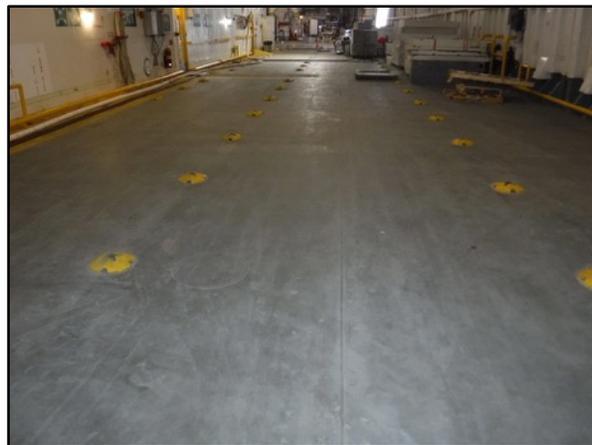
**General Remarks:** Coatings have worn down on many areas of the Car Deck. The coatings on the superstructure have been well maintained by the crew (see Photos 57-60). As is common,

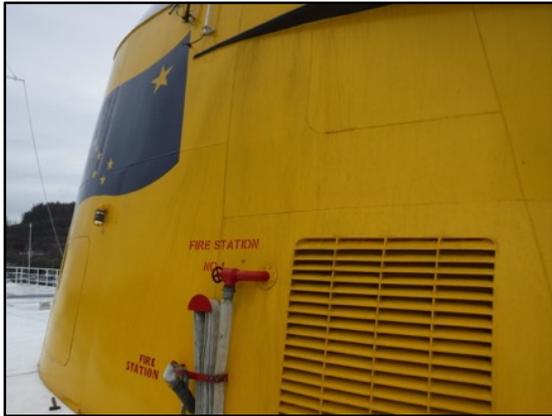
**Photo 58: Solarium**

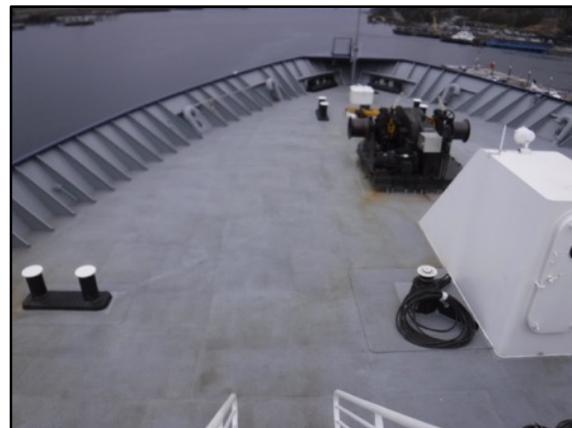
**Photo 61: Corrosion on Handrail**

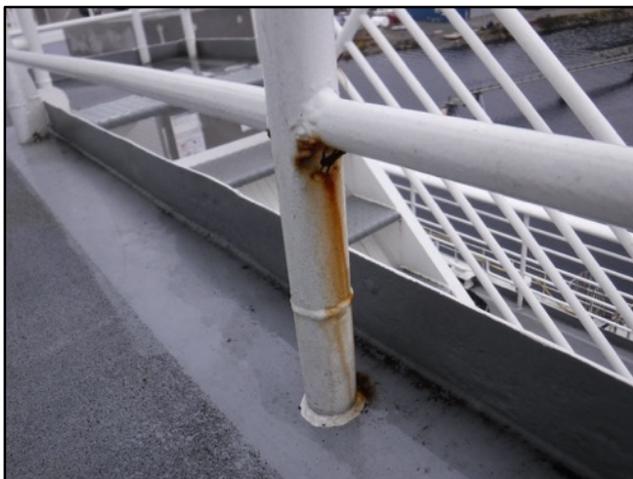
**Recommendations for Future:** No touch up currently needed. Crew should continue to maintain areas on the Car Deck and Superstructure.

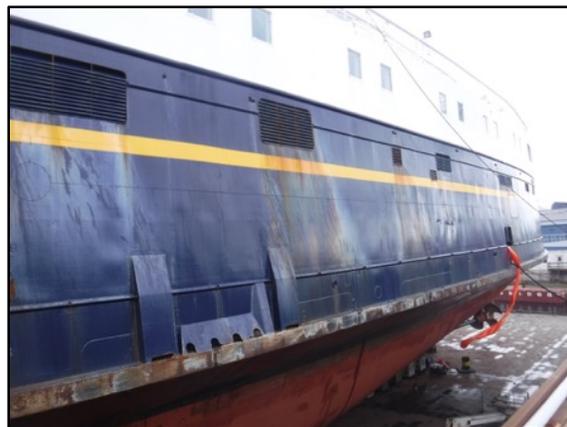
**General Remarks:** The coatings on the rub rails have worn down and there is some minor corrosion (see Photo 64). As is common, there is some rust bleeding under the vents and drains (see Photo 65), and corrosion spots around the anchors. Otherwise, the coatings on the freeboard remain in satisfactory condition.

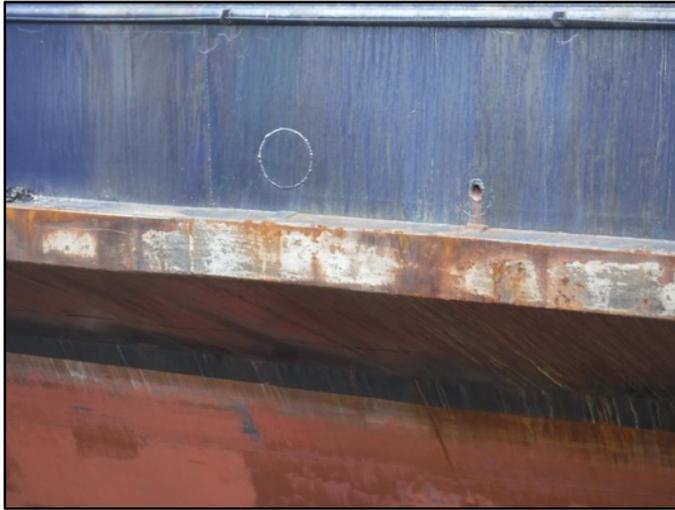
**Photo 65: Rust Bleed Under Vents & Drains**

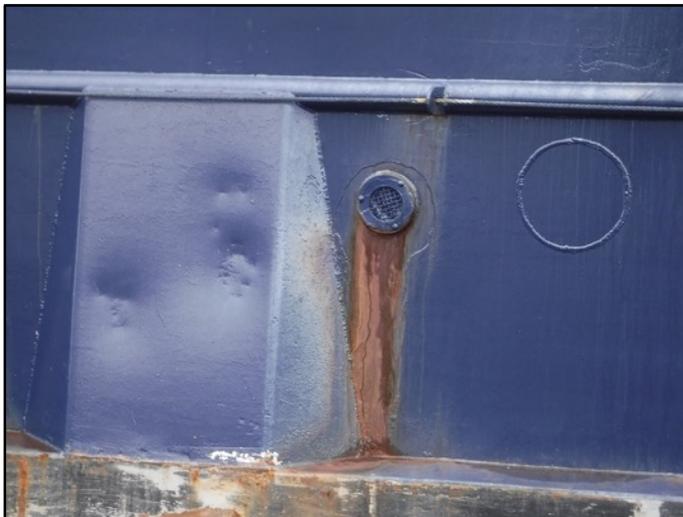
**Recommendations for Future:** No touch up currently needed. The rub rails will most likely need to be touched up in the next 1-2 years. Continue to inspect the Freeboard on an annual basis.

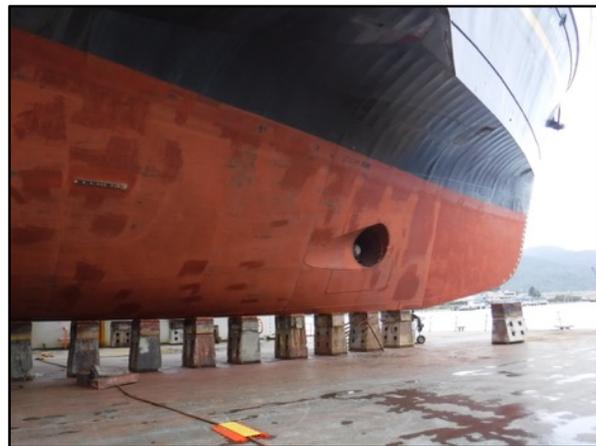
**General Remarks:** Overall, the coatings on the Underwater Hull remain in satisfactory condition. The Black AF is showing through on less than 5 percent of the total area. There are

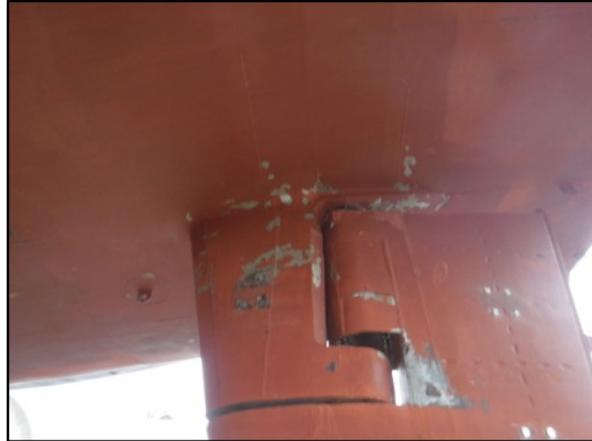
**Recommendations for Future:** At the next availability, we recommend that AF delamination areas are power tool cleaned as per SSPC-SP 3 and coated with one spot coat of Interhield 300 epoxy and two spot coat of Interspeed 640 AF. Continue to inspect the Underwater Hull on an annual basis.

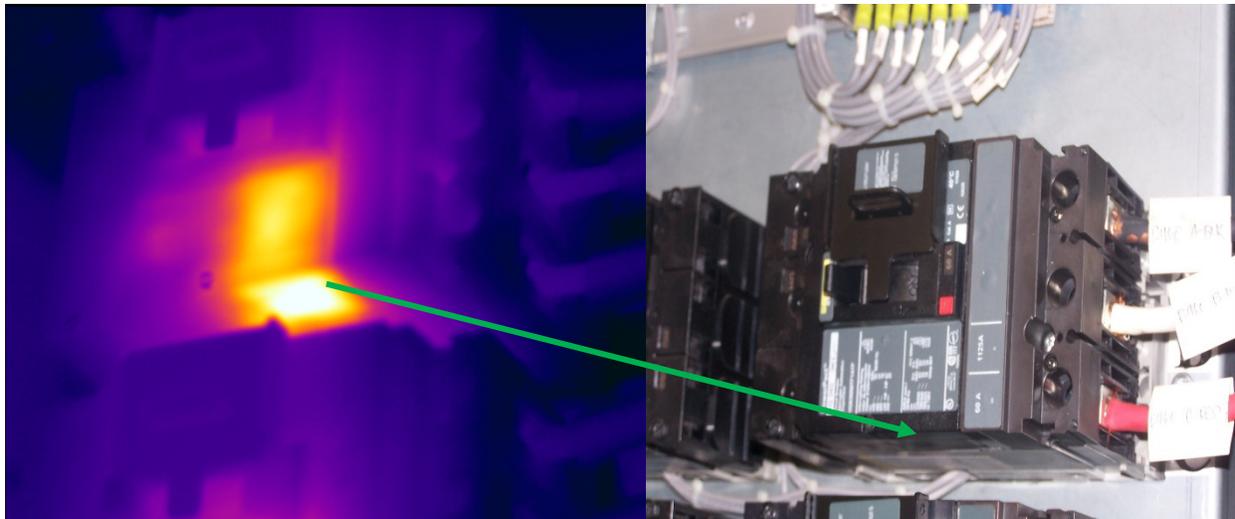
Vessel Name	M/V Matanuska
Location	Port Main Engine- 480V Distribution Panel
Equipment Name	Breaker- P-460 Vent- MCC-6 150 AF/ 60V AT
Problem:	Breaker is overheated internally
Recommendation:	Replace breaker.
Fault Classification	<b>Severe</b>

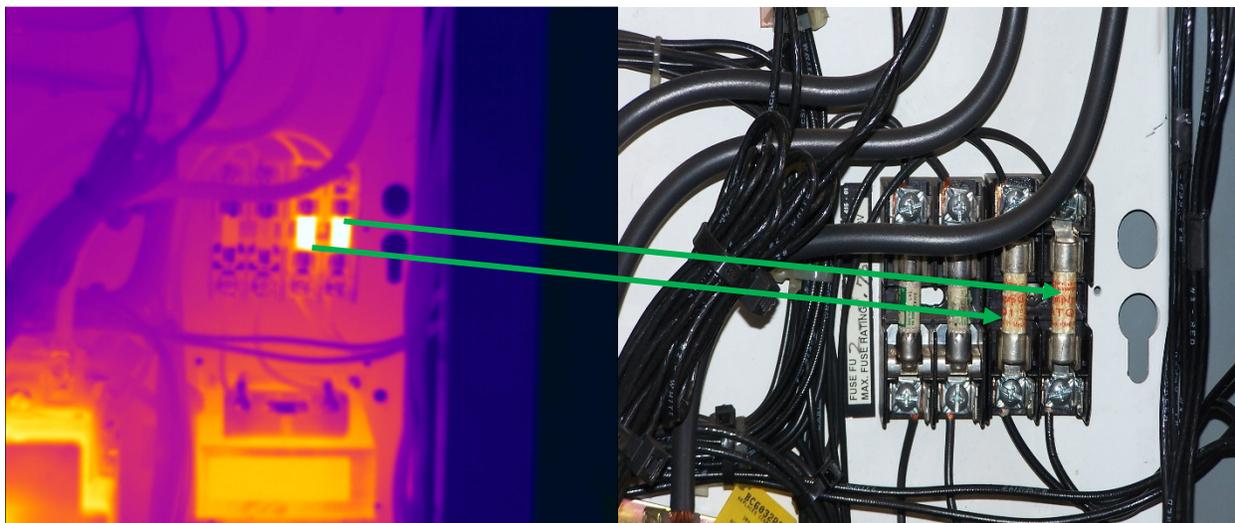
Vessel Name	M/V Matanuska
Location	Fidley Room
Equipment Name	Compressor Unit #2
Problem:	(Upper Right) First 2 fuses from the right are overheated
Recommendation:	Replace fuses, if possible replace the first two fuses from the right with higher amperage.
Fault Classification	<b>Severe</b>

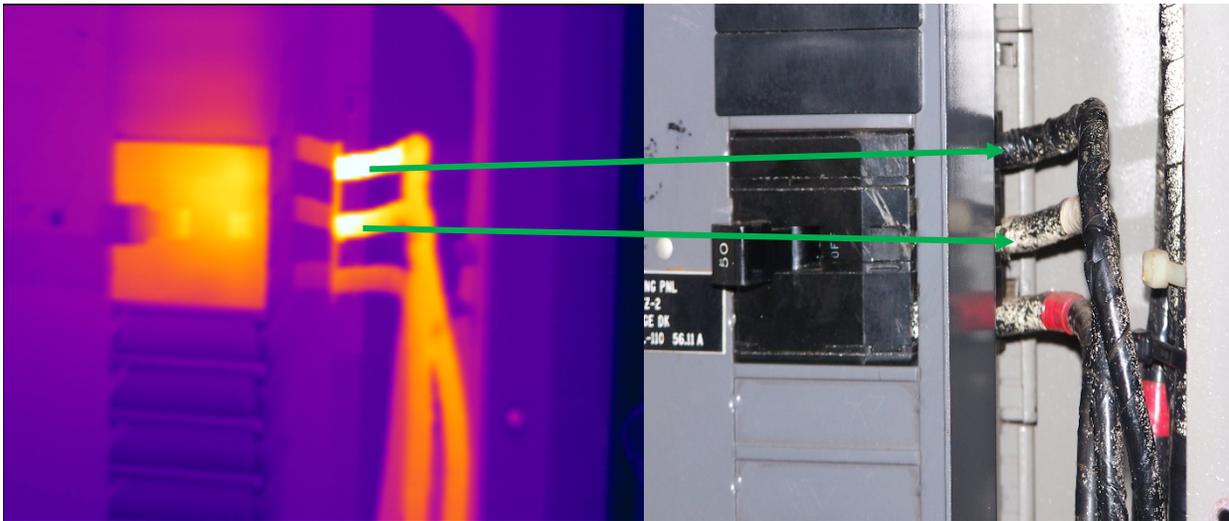
Vessel Name	M/V Matanuska
Location	Car deck 3- Forward Frame 61- Room FSD 14
Equipment Name	Lightning Panel MVZ-2 (EL-40A-4L-110) Breaker –wire terminals
Problem:	Wire terminals overheated
Recommendation:	Inspect the wire terminals for looseness dirt, and tightened.
Fault Classification	<b>Medium</b>

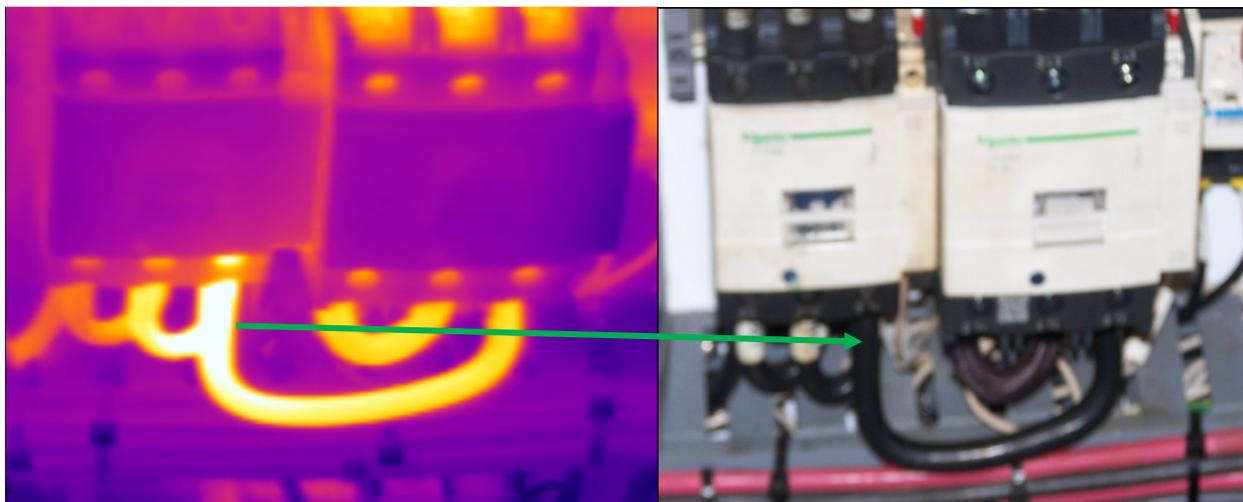
Vessel Name	M/V Matanuska
Location	MSD Room
Equipment Name	#3 MSD Control Panel- BC1 Bottom wire
Problem:	#3 MSD Control Panel- BC1 Bottom wire terminal 6T3 overheated.
Recommendation:	Inspect Book Contactor bottom wire terminals for corrosion and looseness, then tightened wire terminals.
Fault Classification	<b>Severe</b>

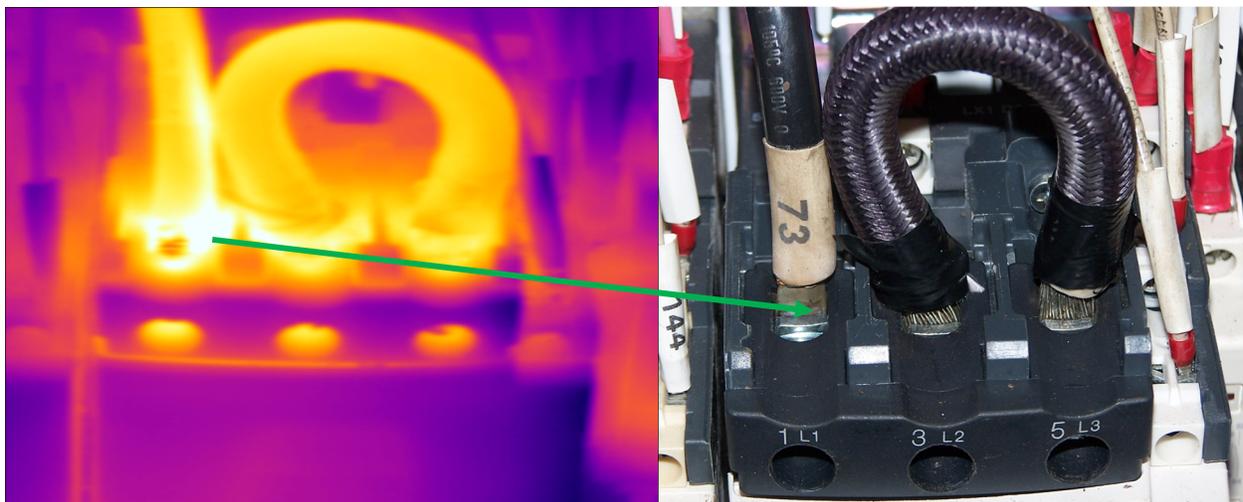
Vessel Name	M/V Matanuska
Location	MSD Room
Equipment Name	#2 MSD Control Panel Contactor Cell #2
Problem:	Top Schneider Book Contactor Cell #2 – wire terminal (#73) overheated.
Recommendation:	Inspect Book Contactor wire terminal for looseness, dirt, then tightened wire.
Fault Classification	<b>Severe</b>

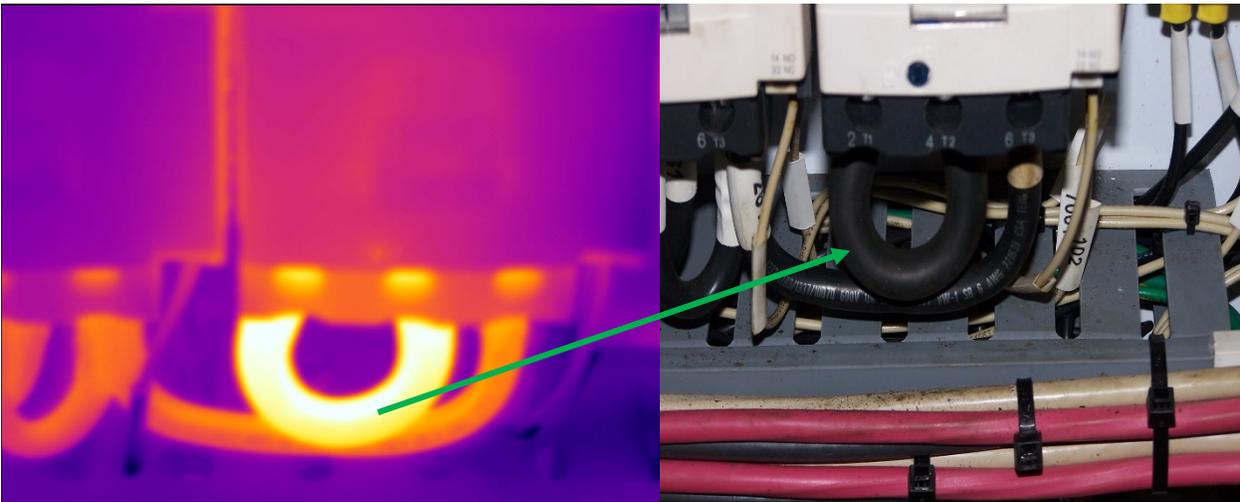
Vessel Name	M/V Matanuska
Location	MSD Room
Equipment Name	#2 MSD Control Panel Contactor Cell #2
Problem:	Bottom Schneider Book Contactor Cell #2 – Loop wire 2T1 to 4T2 overheated
Recommendation:	Inspect Book Contactor wire terminals for looseness, dirt, then tightened wire.
Fault Classification	<b>Severe</b>

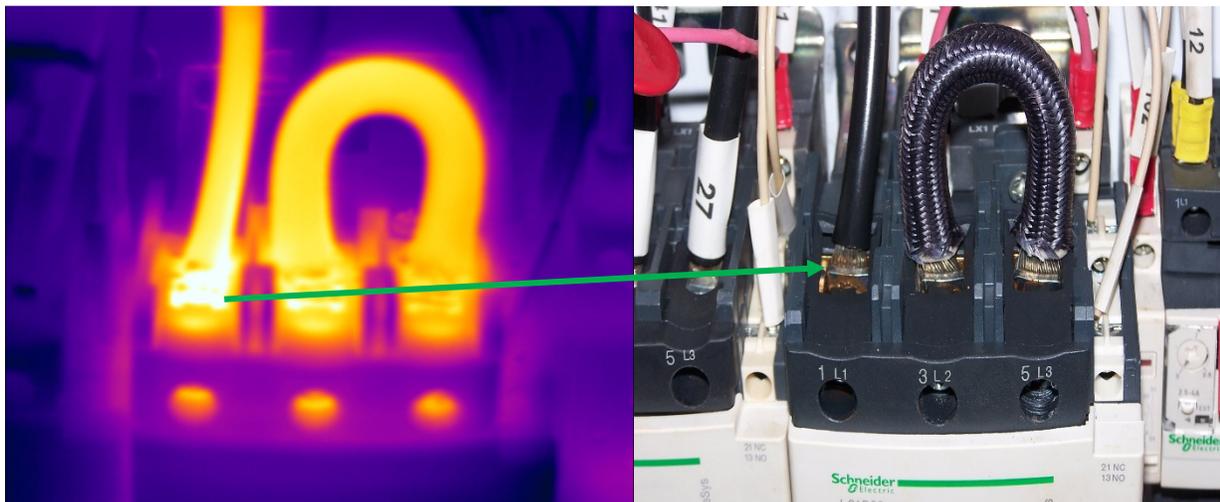
Vessel Name	M/V Matanuska
Location	MSD Room
Equipment Name	#1 MSD Control Panel
Problem:	Top Schneider Book Contactor Cell #1 – 1L1 Wire terminal overheated.
Recommendation:	Inspect Book Contactor wire for looseness, dirt, then tightened wire.
Fault Classification	Medium

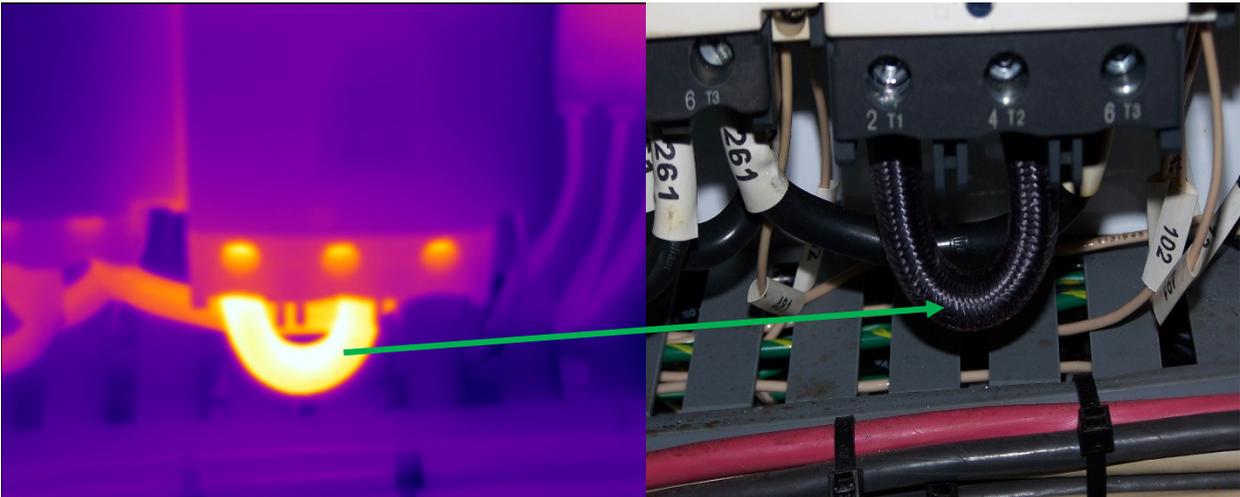
Vessel Name	M/V Matanuska
Location	MSD Room
Equipment Name	#1 MSD Control Panel
Problem:	Bottom Schneider Book Contactor Cell #1 – 2T1 to 4T2 Wire terminals overheated.
Recommendation:	Inspect Book Contactor wire for looseness, dirt, then tightened wire.
Fault Classification	Medium
