Hazardous Building Materials Survey

DOT Ferry HBMS & Management Plan
MV Matanuska
3801 Tongass Avenue
Ketchikan, Alaska 99901

State of Alaska Department of Transportation & Public Facilities
Mr. John Clendenin
2301 Peger Road
Fairbanks, Alaska 99709

December 1, 2023

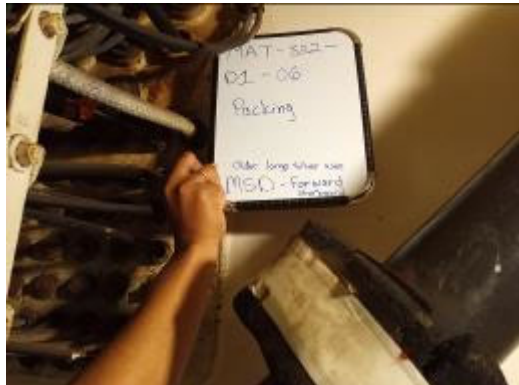
Sample #	Date	Time	Location
Mat-822-D1-06	8.22.23	9:01	Hold Deck 1—MSD Room—Forward Starboard

Description of Photo: Picture of sample location for bulk sample Mat-822-D1-06, Black Packing from large silver wire

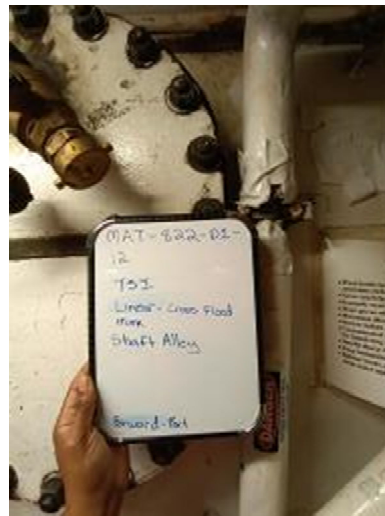
Sample #	Date	Time	Location
Mat-822-D1-12	8.22.23	13:37	Hold Deck 1—Shaft Alley—Forward Port

Bulk Sample#	Sample Location	Material Description	Friable (Y/ N)	Material Condition	Appx. Quantity	Asbestos Content
MAT-822-D1-11-Coating 2	Shaft Alley – TSI Elbow (Fwd/Port)	White Coating	N/A	Good	N/A	ND
MAT-822-D1-11-TSI	Shaft Alley – TSI Elbow (Fwd/Port)	White TSI	N/A	Good	N/A	ND
MAT-822-D1-12-Wrap	Shaft Alley – TSI Linear (Fwd/Port)	White/Green Wrap	N/A	Good	N/A	ND
MAT-822-D1-12-TSI	Shaft Alley – TSI Linear (Fwd/Port)	Gray TSI	Y	Good	N/A	10% Amosite, 5% Chrysotile

Description of Photo: Picture of sample location for bulk sample Mat-822-D1-12, Gray TSI Linear

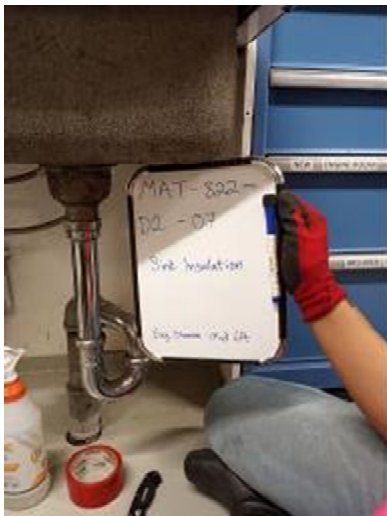
Sample #	Date	Time	Location
Mat-822-D2-07	8.22.23	10:42	Second Deck 2—Engineer Stores—Mid Aft

Bulk Sample#	Sample Location	Material Description	Friable (Y/ N)	Material Condition	Appx. Quantity	Asbestos Content
MAT-822-D2-07	Engineer Stores – Sink Undercoating	Gray Insulation	N	Good	N/A	7% Chrysotile
MAT-822-D2-08	Engineer Stores – Sink Caulking	Gray Caulking	N/A	Good	N/A	ND
MAT-822-D2-09-Vinyl	Engine Room Upper Level – Condensation Pipe TSI Elbow (Aft/Port)	White Vinyl	N/A	Good	N/A	ND
MAT-822-D2-09-Wrap	Engine Room Upper Level – Condensation Pipe TSI Elbow (Aft/Port)	White/Beige Wrap	N/A	Good	N/A	ND
MAT-822-D2-09-TSI	Engine Room Upper Level – Condensation Pipe TSI Elbow (Aft/Port)	White TSI	N/A	Good	N/A	ND
MAT-822-D2-10	Engine Room Upper Level – Ceiling & Wall Insulation (Aft/Port)	White/Yellow Insulation	N/A	Good	N/A	ND
MAT-822-D2-11-Pegboard	Engine Room Upper Level – Wall Pegboard & Insulation (Fwd)	Beige Pegboard	N/A	Good	N/A	ND
MAT-822-D2-11-Insulation	Engine Room Upper Level – Wall Pegboard & Insulation (Fwd)	Black/Yellow Insulation	N/A	Good	N/A	ND

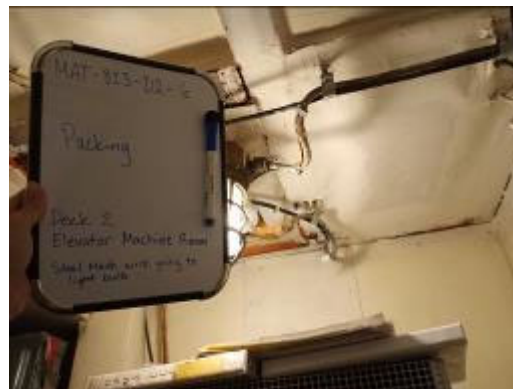
Sample #	Date	Time	Location
Mat-823-D2-16	8.23.23	9:27	Second Deck 2—Forward Quarters Elevator Machine Room

Bulk Sample#	Sample Location	Material Description	Friable (Y/ N)	Material Condition	Appx. Quantity	Asbestos Content
MAT-823-D2-16	Elevator Machine Room – Light Fixture Steel Mesh Wire	Black Packing	N	Good	N/A	50% Chrysotile
MAT-823-D2-17	Steward SR 2 – Baseboard Below Telephone	White Adhesive	N/A	Damaged	N/A	ND
MAT-823-D2-18-Foam	Steward SR 1 – Floor (Fwd/Port)	Black Foam	N/A	Damaged	N/A	ND
MAT-823-D2-18-Adhesive	Steward SR 1 – Floor (Fwd/Port)	Yellow Adhesive	N/A	Damaged	N/A	ND
MAT-823-D2-18-Flooring	Steward SR 1 – Floor (Fwd/Port)	Black/Green Flooring	N/A	Damaged	N/A	ND
MAT-823-D2-19-Flooring	Steward SR 7 – Floor (Fwd/Port)	Brown/Gray/Red Flooring	N/A	Damaged	N/A	ND
MAT-823-D2-19-Adhesive	Steward SR 7 – Floor (Fwd/Port)	Black/Yellow Adhesive	N/A	Damaged	N/A	ND
MAT-823-D2-20-Adhesive 1	Outside of Steward SR 7 – Baseboard (Aft/Stbd)	Tan Adhesive	N/A	Damaged	N/A	ND
MAT-823-D2-20-Adhesive 2	Outside of Steward SR 7 – Baseboard (Aft/Stbd)	Brown Adhesive	N	Damaged	N/A	2% Chrysotile

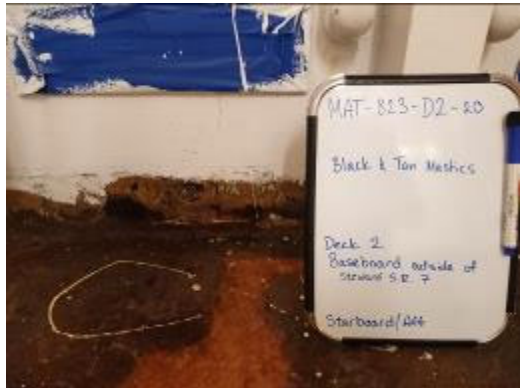
Sample #	Date	Time	Location
Mat-823-D2-20	8.23.23	9:50	Second Deck 2—Steward Stateroom 7—Starboard Aft

Description of Photo: Picture of sample location for bulk sample Mat-823-D2-20, Brown Adhesive from previously removed baseboard outside of Stateroom 7

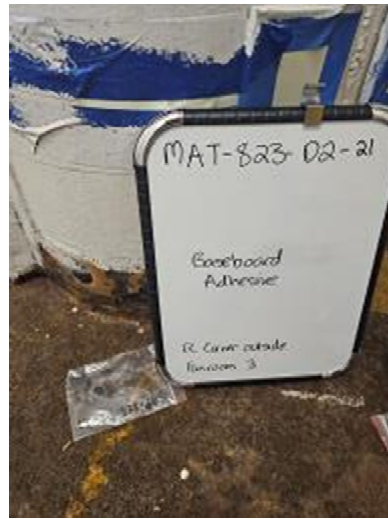
Sample #	Date	Time	Location
Mat-823-D2-21	8.23.23	9:53	Second Deck 2—Outside of Fan Room No. 3—Forward Starboard

MAT-823-D2-21-Adhesive 1	Outside of Fan Room No. 3 – Baseboard (Fwd/Stbd Corner)	Yellow Adhesive	N/A	Damaged	N/A	ND
MAT-823-D2-21-Adhesive 2	Outside of Fan Room No. 3 – Baseboard (Fwd/Stbd Corner)	Brown Adhesive	N/A	Damaged	N/A	ND
MAT-823-D2-21-Adhesive 3	Outside of Fan Room No. 3 – Baseboard (Fwd/Stbd Corner)	Brown Adhesive	N	Damaged	N/A	2% Chrysotile

Description of Photo: Picture of sample location for bulk sample Mat-823-D2-21, Brown Adhesive from previously removed baseboard forward of Fan Room No. 3

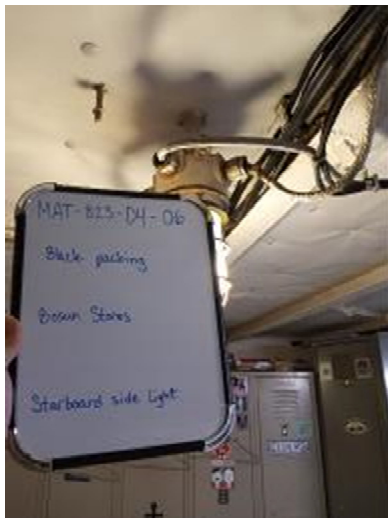
Sample #	Date	Time	Location
Mat-823-D4-06	8.23.23	12:08	Gallery Deck 4—Bosun Stores—Starboard

Description of Photo: Picture of sample location for bulk sample Mat-823-D4-06, Black Packing on incandescent light fixture

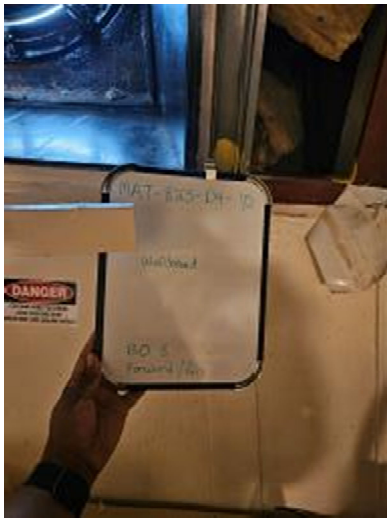
Sample #	Date	Time	Location
Mat-823-D4-10	8.23.23	12:33	Gallery Deck 4—Crew Stateroom BO 8—Forward Port

Description of Photo: Picture of sample location for bulk sample Mat-823-D4-10, Gray Wallboard

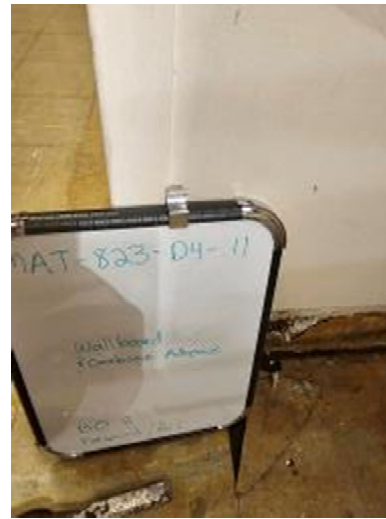
Sample #	Date	Time	Location
Mat-823-D4-11	8.23.23	13:49	Gallery Deck 4—Crew Stateroom BO 8—Forward Port

Bulk Sample#	Sample Location	Material Description	Friable (Y/ N)	Material Condition	Appx. Quantity	Asbestos Content
MAT-823-D4-11-Wallboard	Crew SR BO 8 – Wall/Baseboard (Fwd)	Gray Wallboard	N	Good	N/A	15% Amosite, 2% Chrysotile
MAT-823-D4-11-Adhesive 1	Crew SR BO 8 – Wall/Baseboard (Fwd)	Brown Adhesive	N/A	Damaged	N/A	ND
MAT-823-D4-11-Adhesive 2	Crew SR BO 8 – Wall/Baseboard (Fwd)	Beige Adhesive	N/A	Damaged	N/A	ND
MAT-823-D4-12	Crew SR BO 8 – HVAC Ducting	Gray Caulking	N/A	Good	N/A	ND
MAT-823-D4-13-Mastic 1	Crew SR 1 – Layered Flooring (In Front of Lockers)	Brown Mastic	N/A	Good	N/A	ND
MAT-823-D4-13-Mastic 2	Crew SR 1 – Layered Flooring (In Front of Lockers)	Yellow Mastic	N/A	Good	N/A	ND
MAT-823-D4-13-Floor Tile	Crew SR 1 – Layered Flooring (In Front of Lockers)	Gray Floor Tile	N	Good	N/A	2% Chrysotile
MAT-823-D4-13-Mastic 3	Crew SR 1 – Layered Flooring (In Front of Lockers)	Black Mastic	N	Good	N/A	2% Chrysotile

Description of Photo: Picture of sample location for bulk sample Mat-823-D4-11, Gray Wallboard

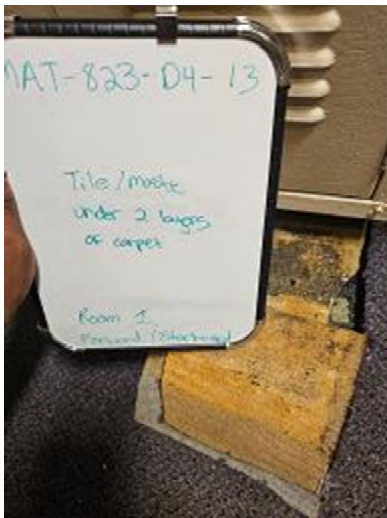
Sample #	Date	Time	Location
Mat-823-D4-13	8.23.23	14:14	Gallery Deck 4—Crew Stateroom 1—Forward Starboard

Description of Photo: Picture of sample location for bulk sample Mat-823-D4-13, Gray Floor Tile and Black Mastic beneath two layers of carpet

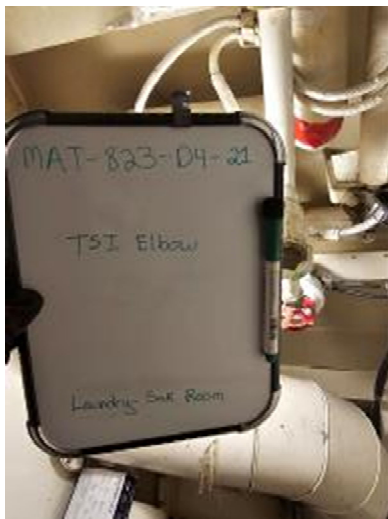
Sample #	Date	Time	Location
Mat-823-D4-21	8.23.23	14:58	Gallery Deck 4—Cleaning Gear Locker—Above Sink

Description of Photo: Picture of sample location for bulk sample Mat-823-D4-21, Gray TSI Elbow

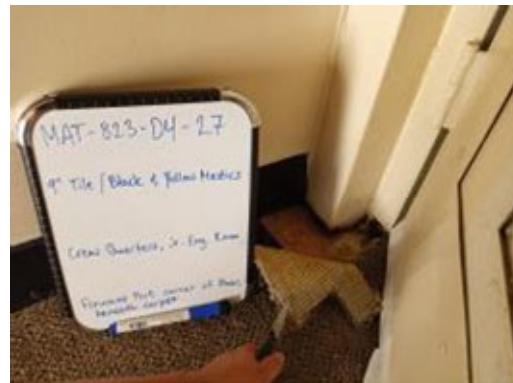
Sample #	Date	Time	Location
Mat-823-D4-27	8.23.23	15:18	Gallery Deck 4—Crew Stateroom Jr. Engineer—Forward Port Corner

Description of Photo: Picture of sample location for bulk sample Mat-823-D4-27, Gray/White/Green 9" x 9" Floor Tile and Black Mastic beneath carpet

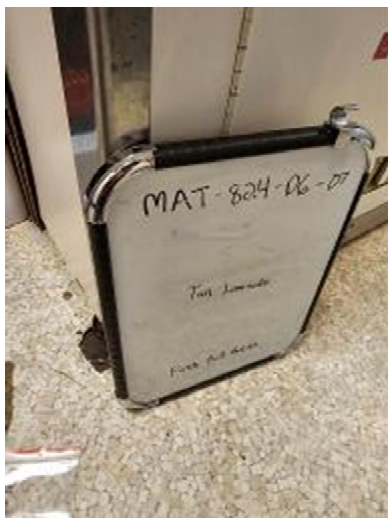
Sample #	Date	Time	Location
Mat-824-D5-07	8.24.23	11:25	Cabin Deck 5—First Aid Room

Description of Photo: Picture of sample location for bulk sample Mat-824-D6-07, Tan Laminate Flooring

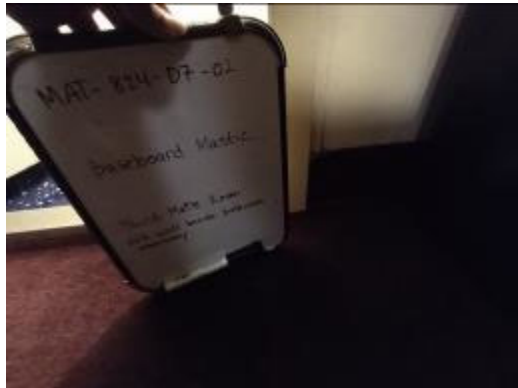
Sample #	Date	Time	Location
Mat-824-D7-02	8.24.23	18:33	Bridge Deck 7—Third Mate Stateroom—Right Side of Restroom Entrance

Description of Photo: Picture of sample location of bulk sample Mat-824-D7-02, Brown Mastic from baseboard

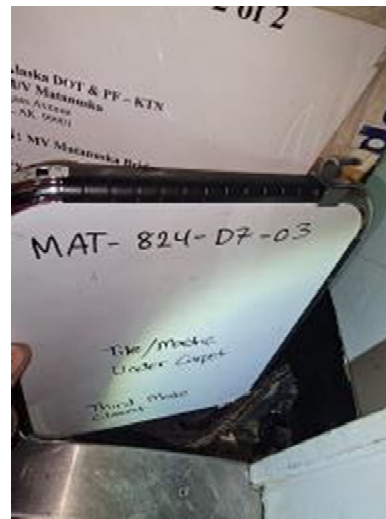
Sample #	Date	Time	Location
Mat-824-D7-03	8.24.23	18:23	Bridge Deck 7—Third Mate Stateroom Closet

Description of Photo: Picture of sample location of bulk sample Mat-824-D7-03, Tan Floor Tile and Black Mastic beneath carpet
