March 6, 2023  
1136.90097.01  
Area 9  
Report 6063b

**Subject: Coal Creek Crossing- Access Road Slope Stability, Healy, Alaska  
Final Geotechnical Exploration and Mitigation Recommendations**

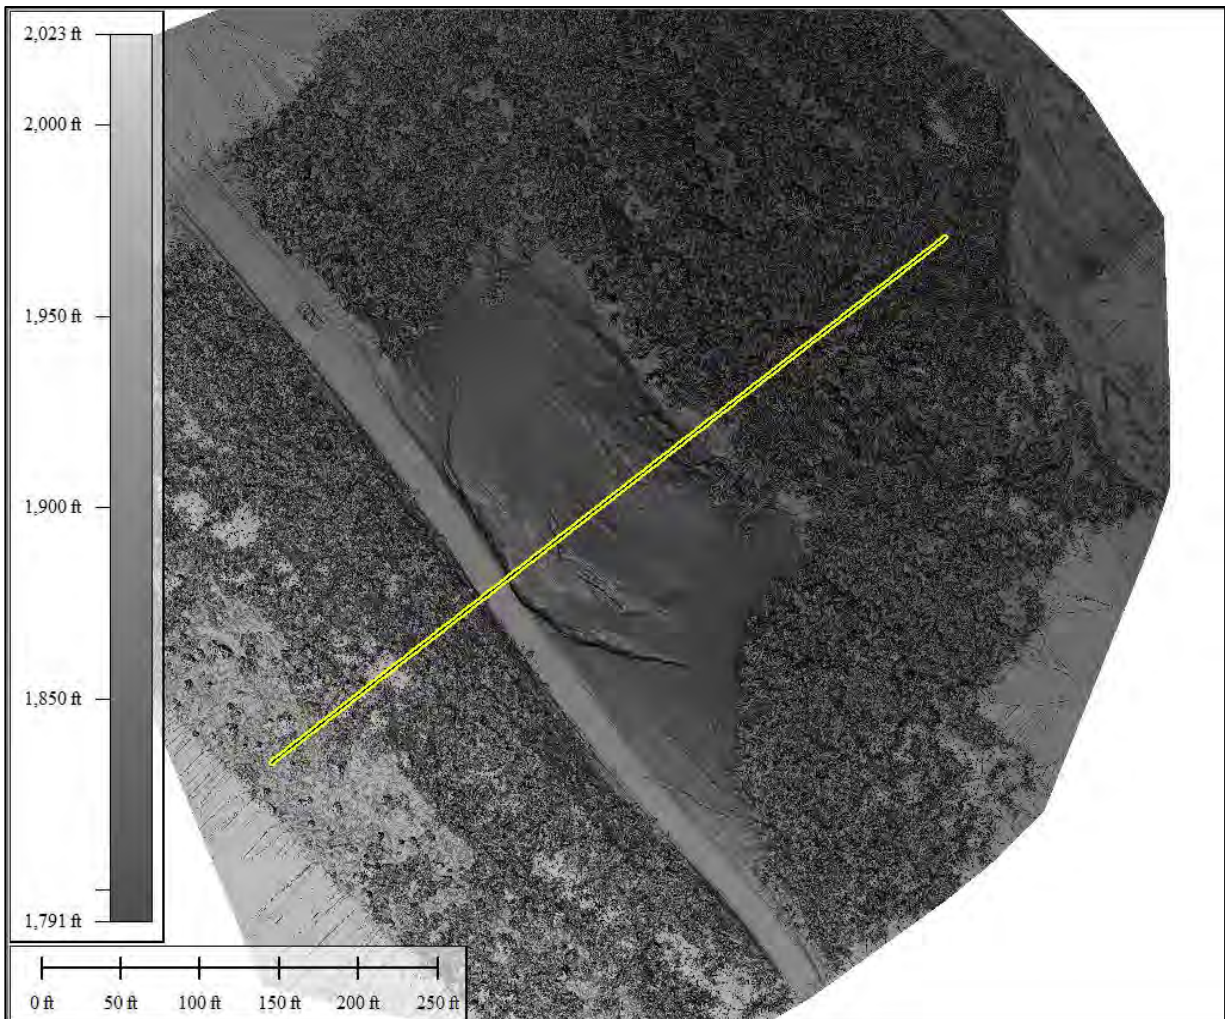
**Figure 1:** Photogrammetric Surface and Slope Stability Modeling Cross Section

The terrestrial survey points of the existing failed slope surface were used to best fit the various data sets to create a two-dimensional cross section for slope stability modeling. The drone photogrammetric surface was initially processed without control points and was then reoptimized using the terrestrial survey points to recalibrate the location of the surface and orthomosaics. This back-calibration method is inherently less accurate than using RTK correction or ground control points located by survey at the time of the drone image acquisition. However, comparison of the resultant surface with the terrestrial survey points indicates an estimated general accuracy of approximately +/- one-foot horizontally and vertically but portions of the surface may be off up to approximately four feet. The two-dimensional reference cross section location used for slope modeling is shown overlying the resultant photogrammetric surface in Figure 1.

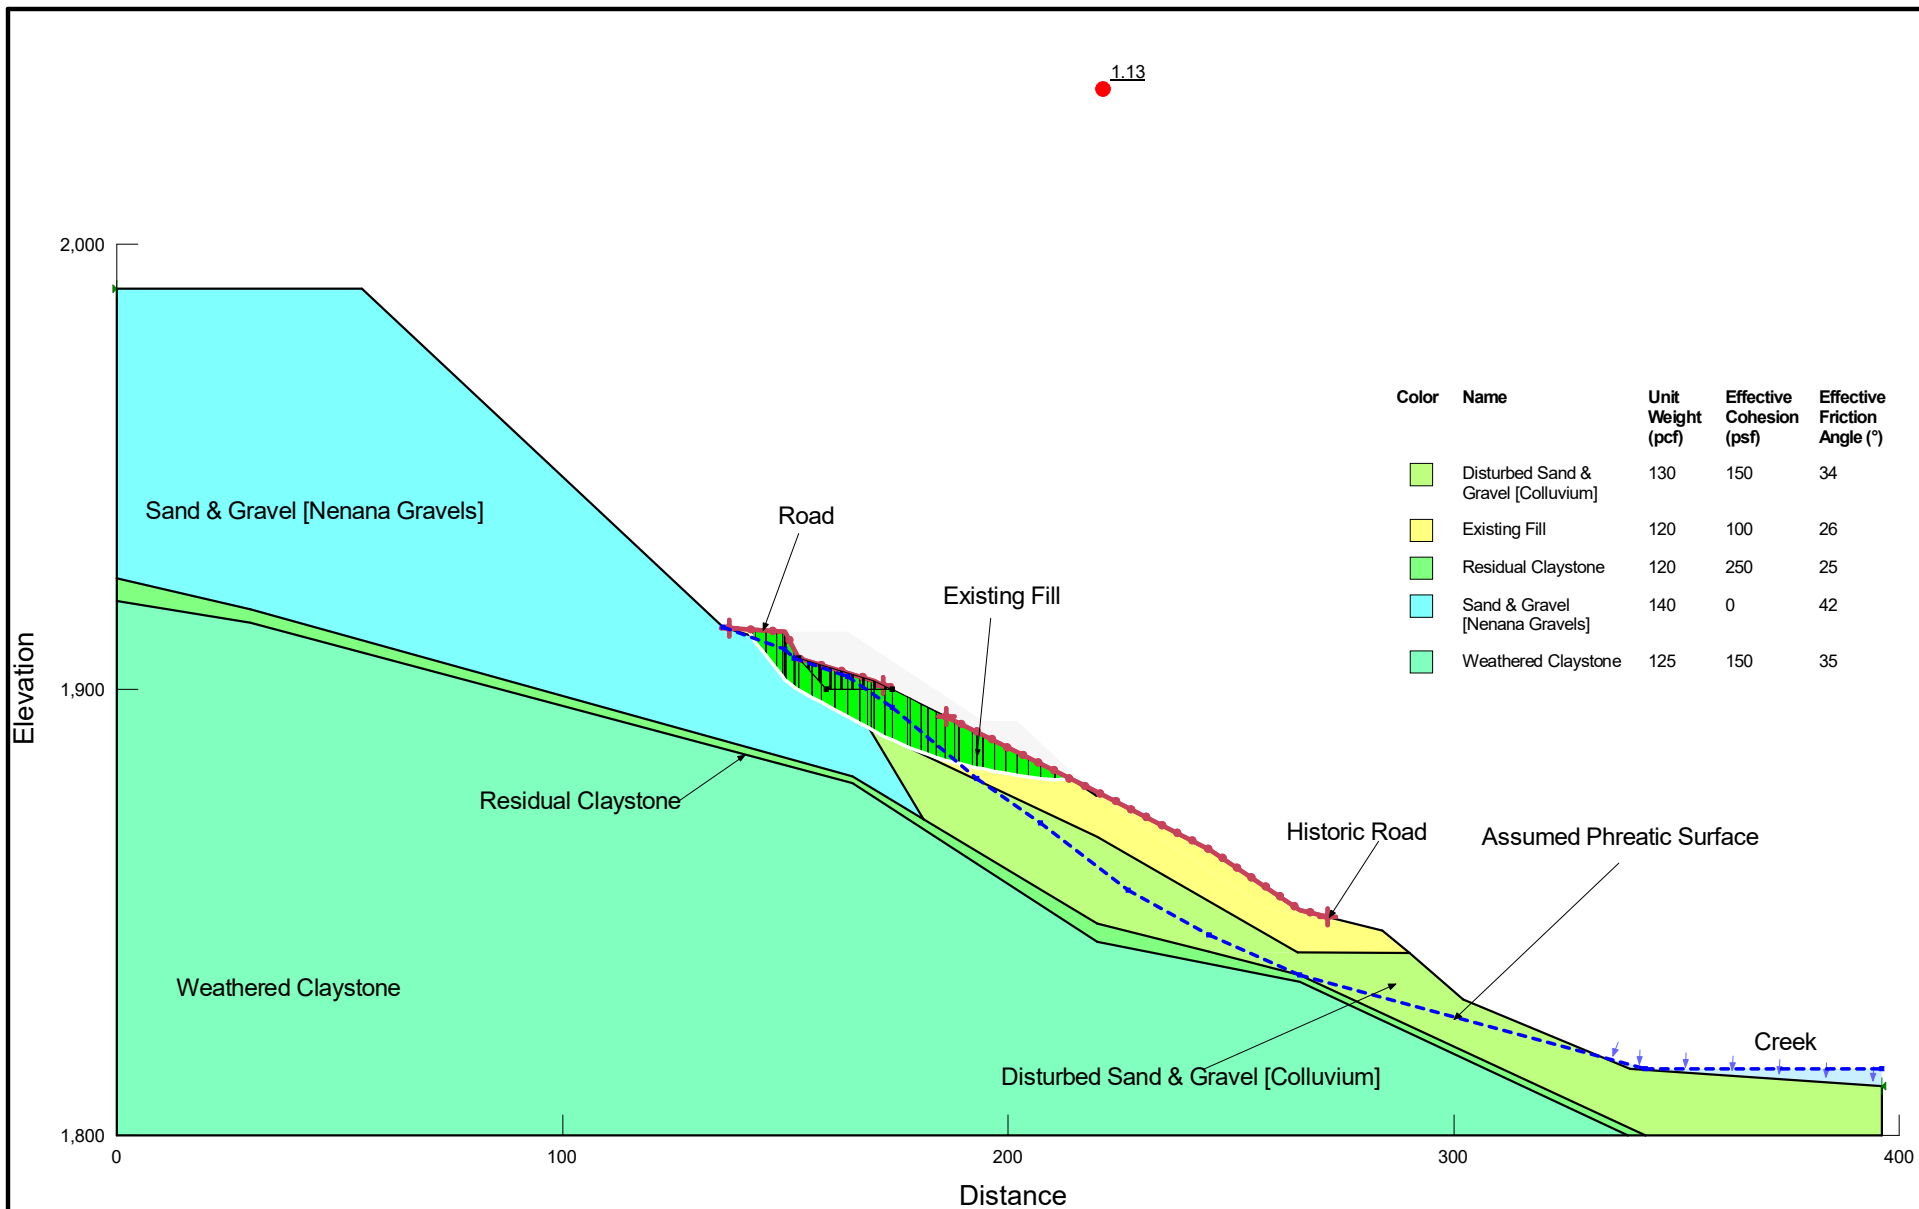
Slope Stability - Existing

An analysis was performed to evaluate the static slope stability of the existing slope. To complete the analysis, a wide range of failure surfaces were examined ranging from deep seated circular failure surfaces to shallow failure surfaces. Utilizing this approach, calculated minimum Factors of Safety of the existing slope are 1.13, which is less than typically recommended factors of safety (1.30). Furthermore, tension cracks currently present in the hillside, will likely result in a lower factor of safety, especially during times of surface water infiltration.

Model failure surfaces indicate the critical failure surface is located almost entirely within the previously placed fill. With regards to the road, the predicted failure surface will likely result in a progressive failure moving upslope if not mitigated.

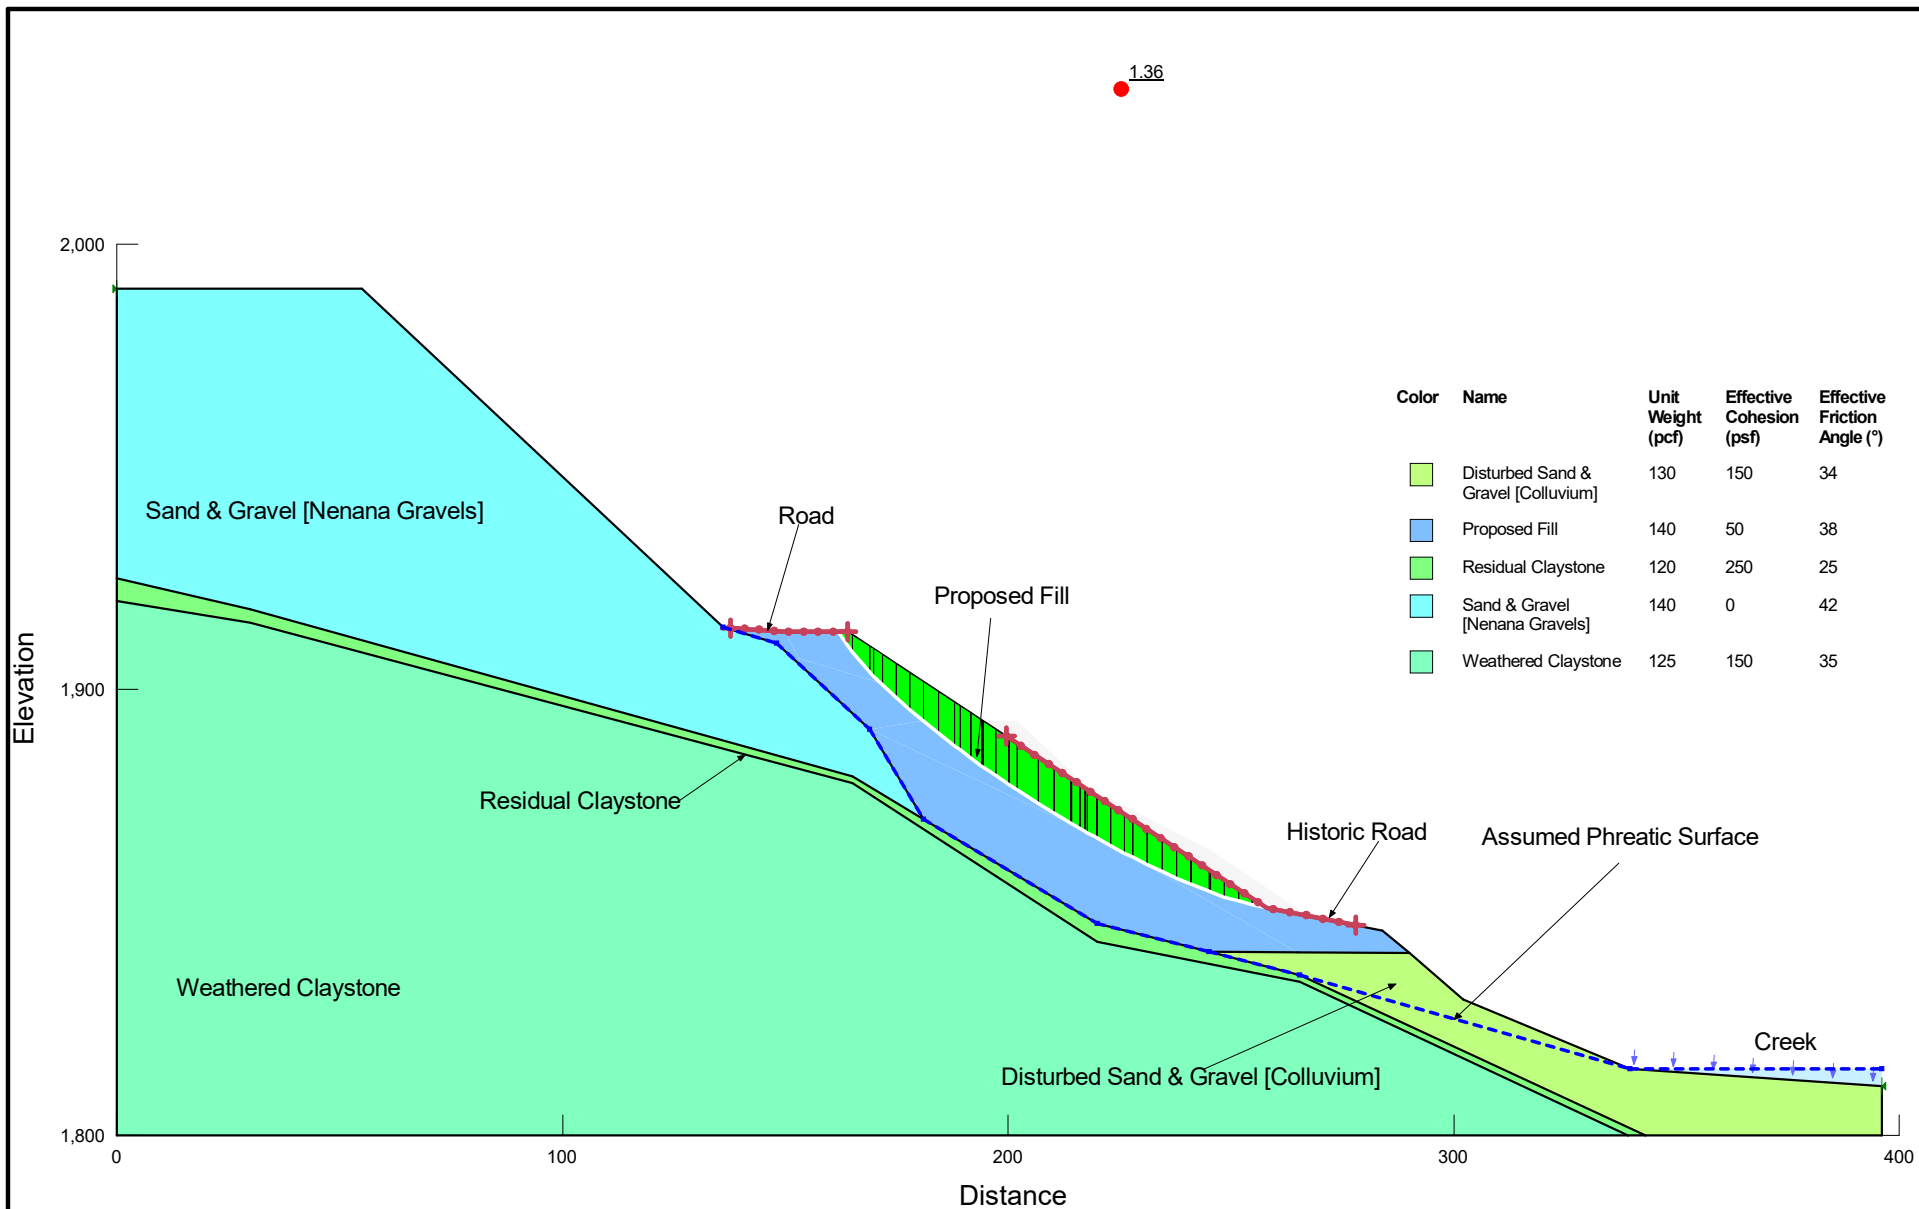
| Slope Stability - Recommended Mitigation | Kind: SLOPE/W |

Model failure surfaces of the recommended slope with drainage indicate the critical failure surface is relatively shallow (within the fill) and starts near the edge of road and daylights near the old two-track road downslope.

Based on our findings, site observations, and historical slope failures at the subject site, we recommend mitigating the slope by removing all previously placed fill, disturbed colluvium, and residual claystone to firm weathered claystone and replacing the material with compacted sand and gravel fill sourced from the Nenana Gravels formation.

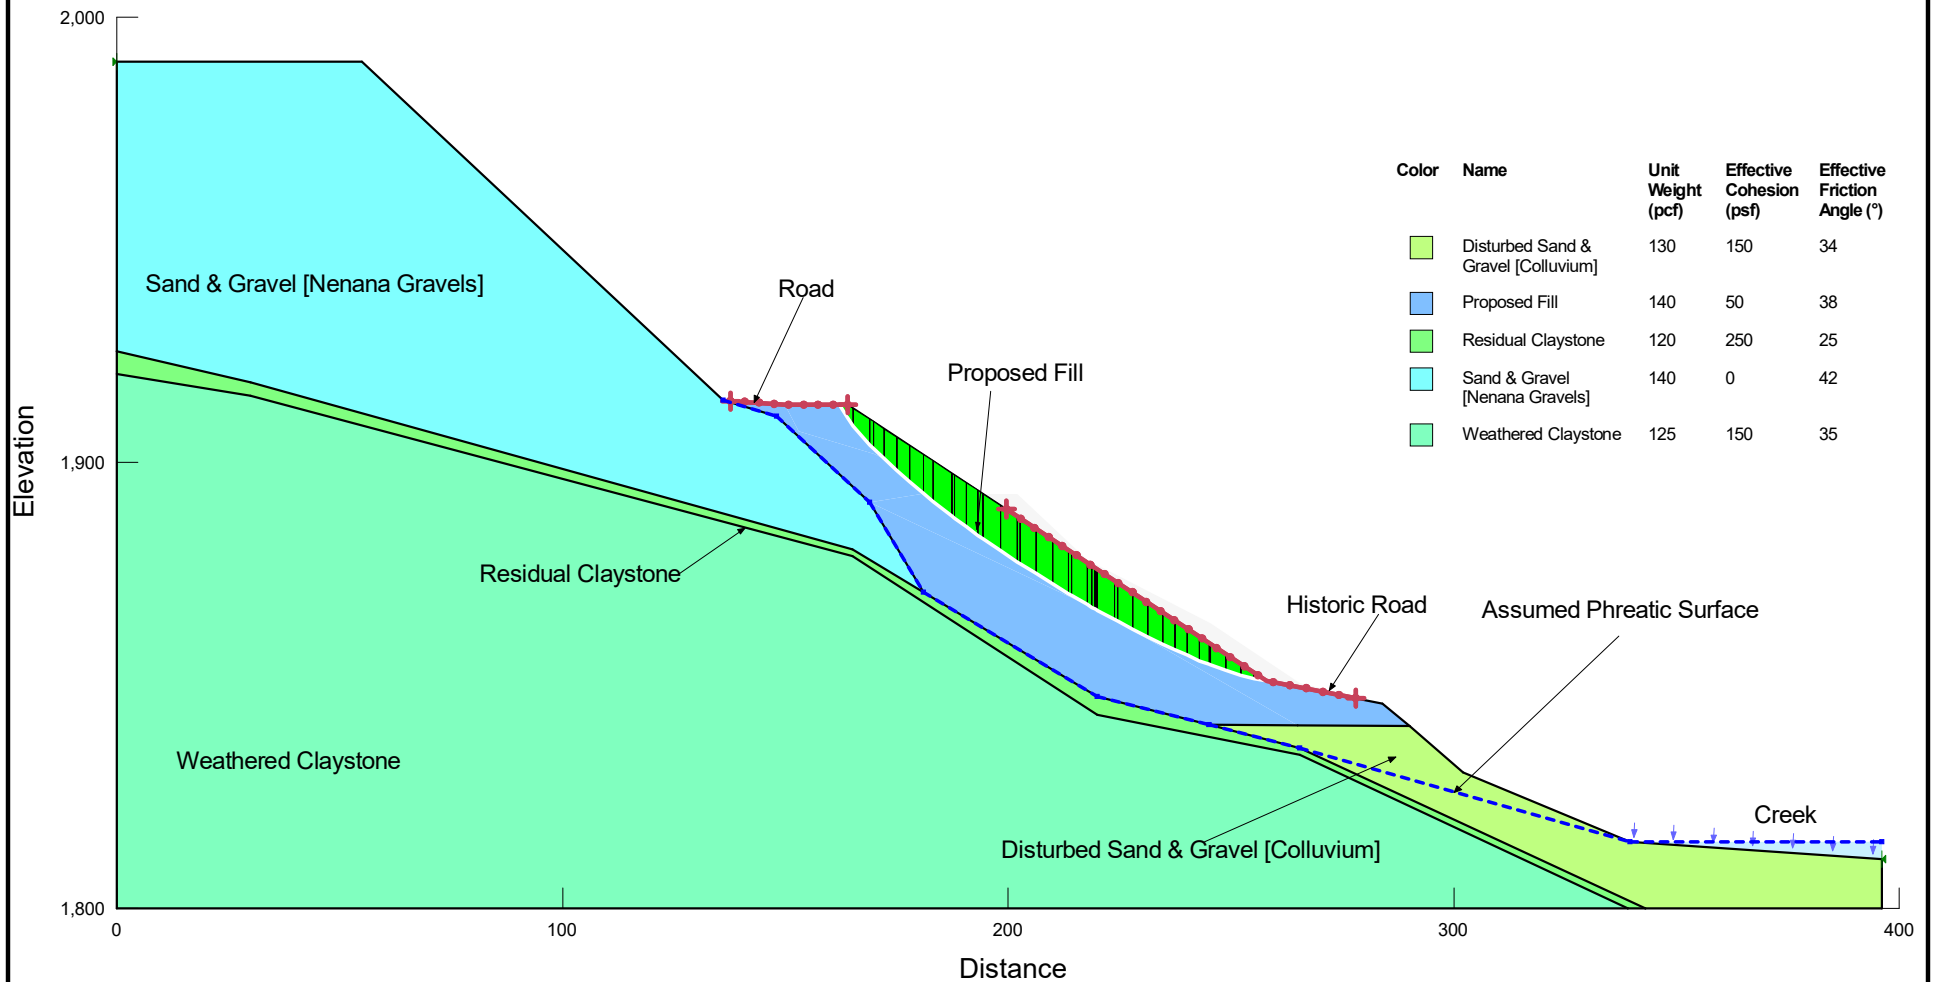
Slope Stability - Recommended Mitigation - Probability

The analysis resulted in a Factor of Safety ranging between 1.15 and 1.57 with a mean value of 1.36. The probability of failure (iterations resulting in  $FS < 1.0$ ) was calculated to be 0%.

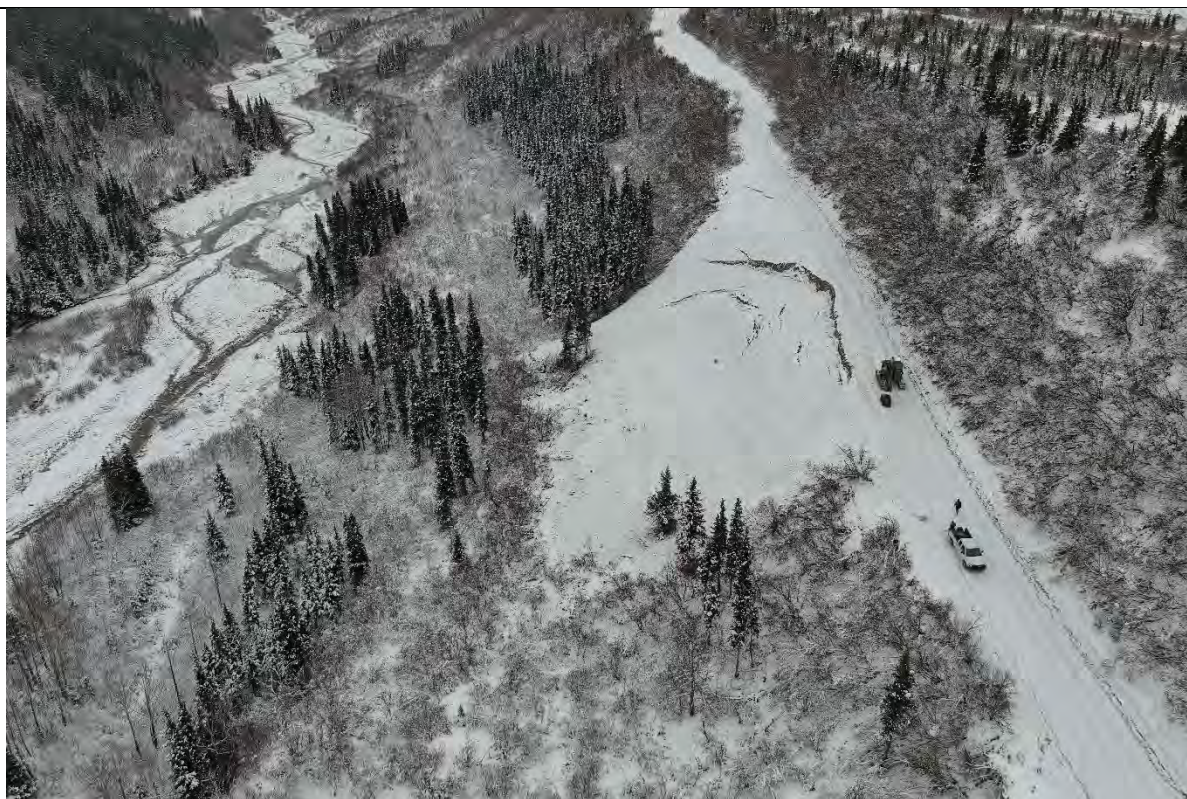
Photo 1. Unstable Slope – Aerial View Southeast

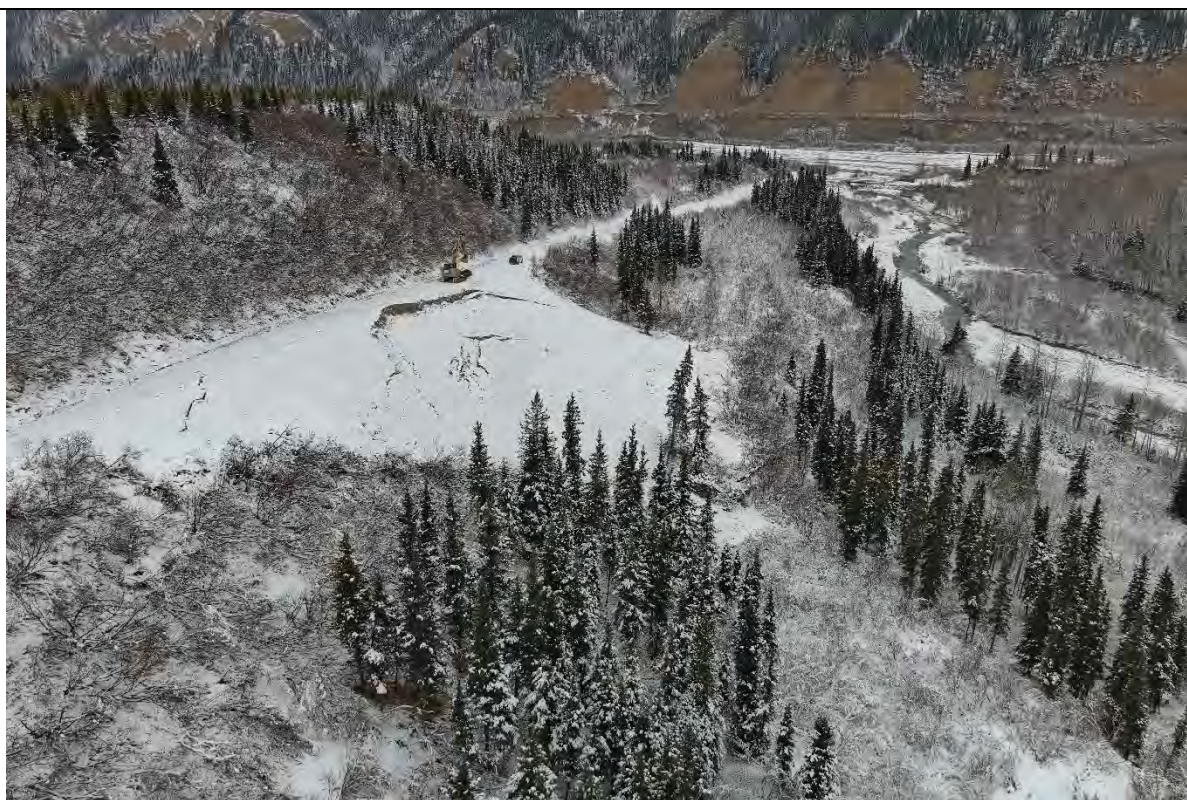
Photo 2. Unstable Slope – Aerial View North-Northwest

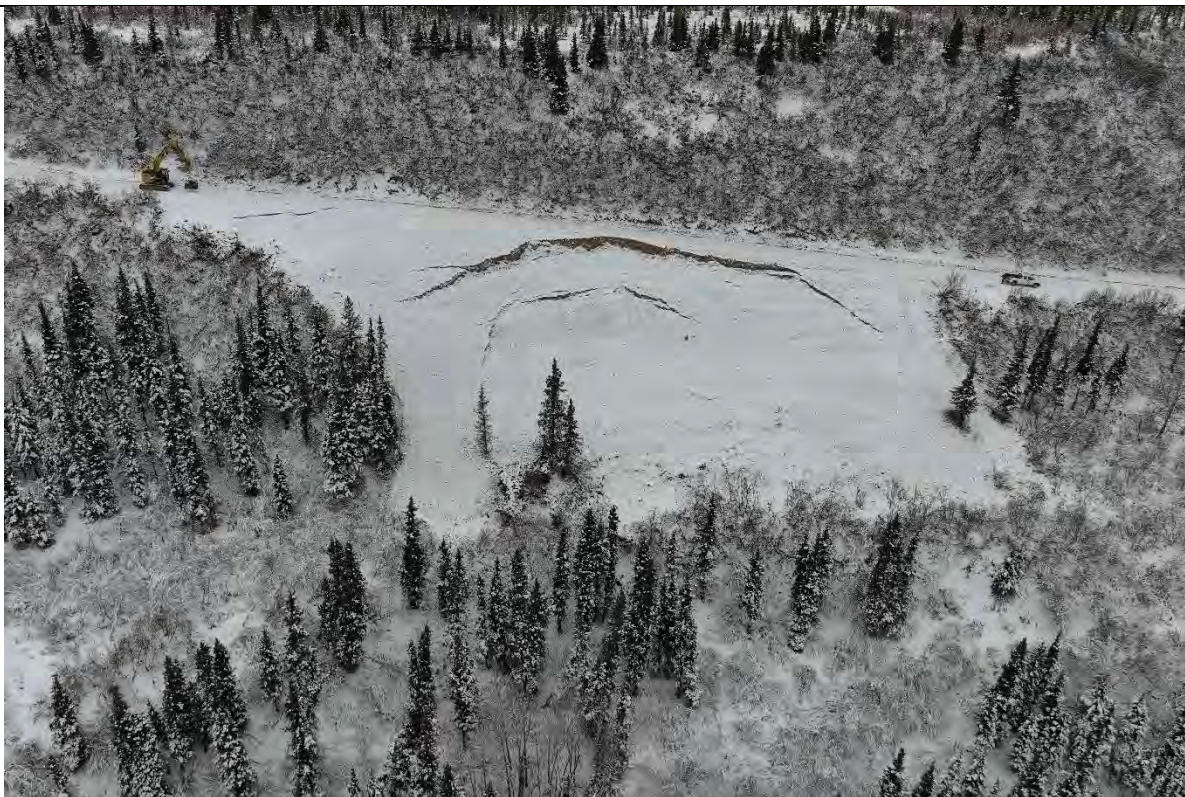
Photo 3. Unstable Slope – Aerial View West

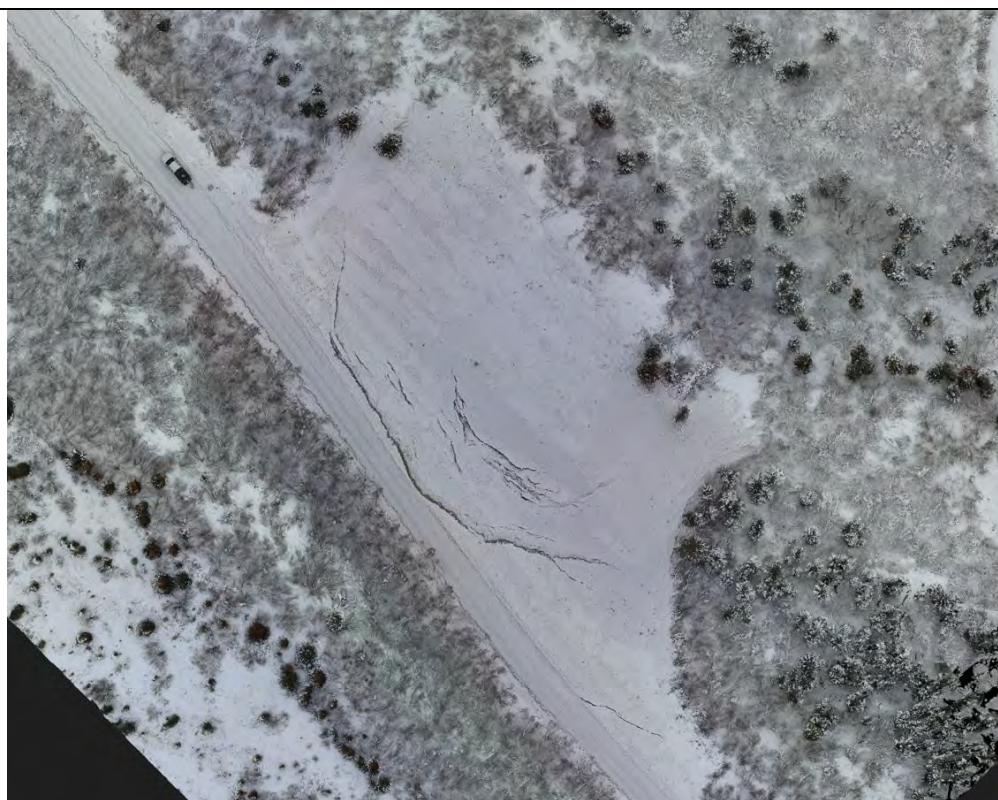
Photo 4. Unstable Slope – Aerial Nadir View

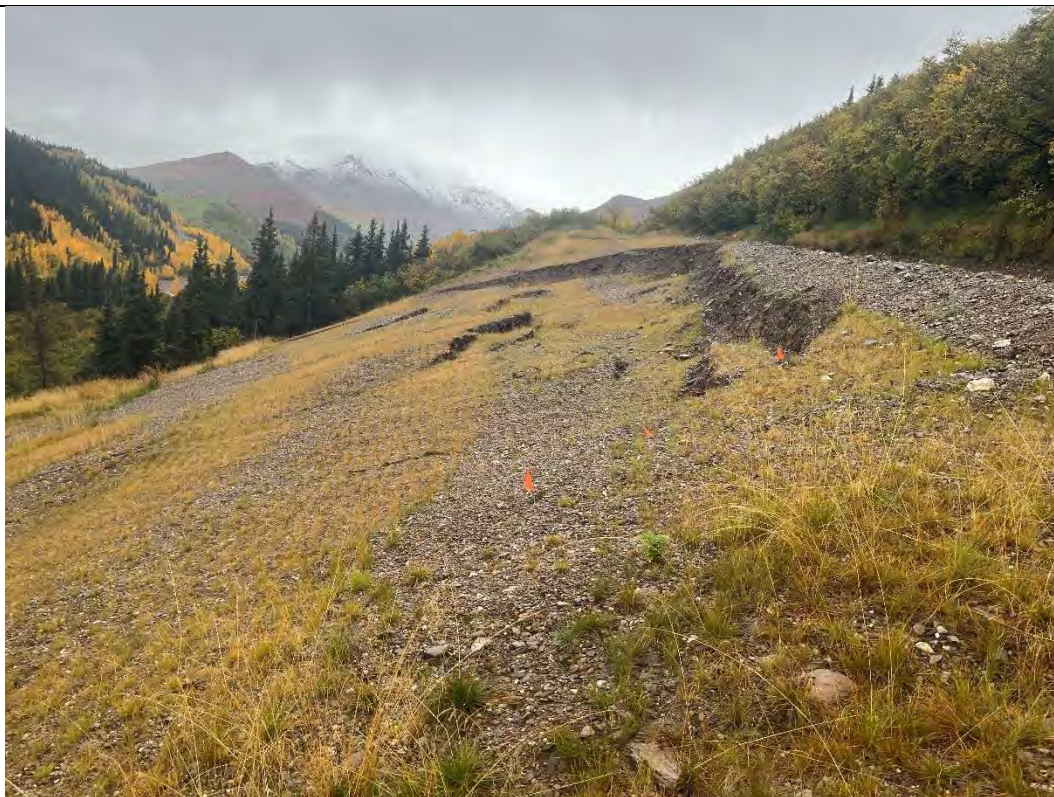
Photo 5. Unstable Slope – Site Visit – View Southeast

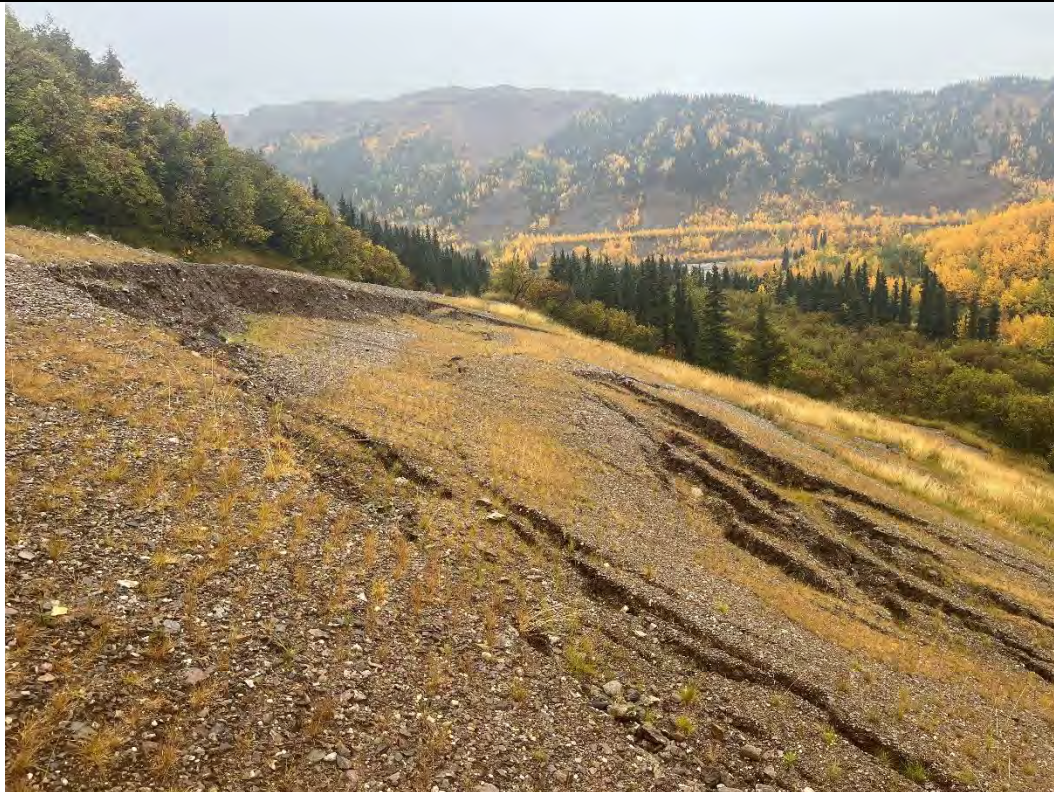
Photo 6. Unstable Slope – Site Visit – View Northwest

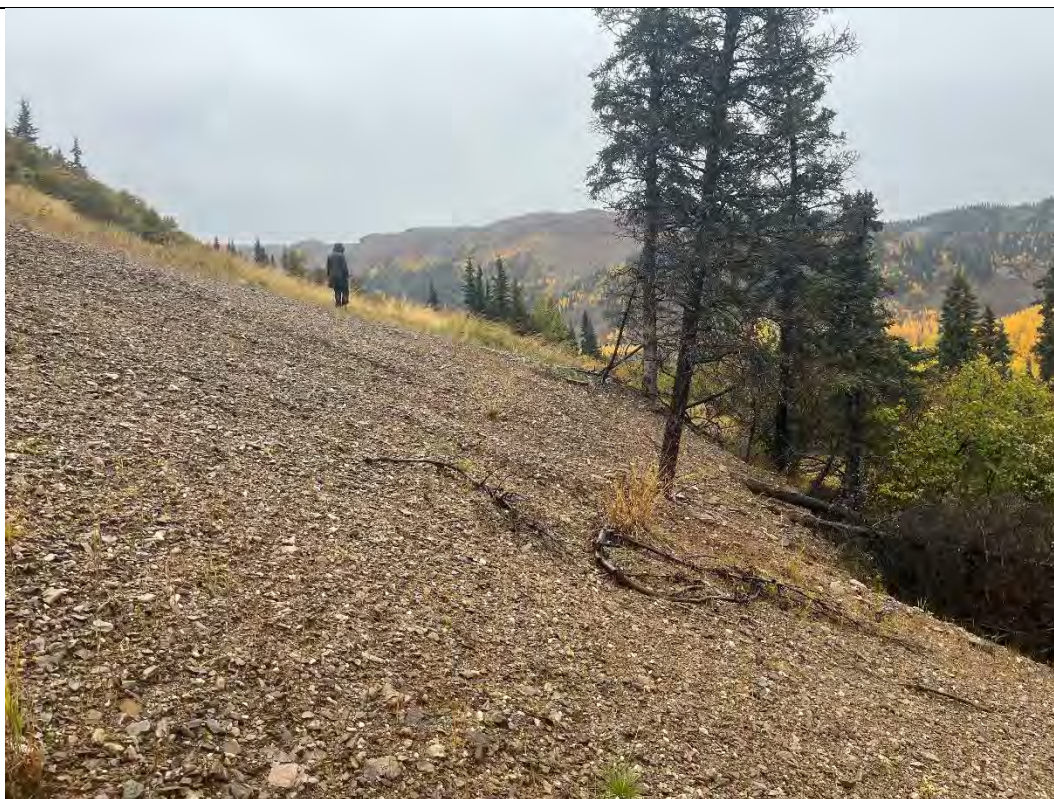
Photo 7. Unstable Slope – Site Visit – View Northwest from Southeast Toe

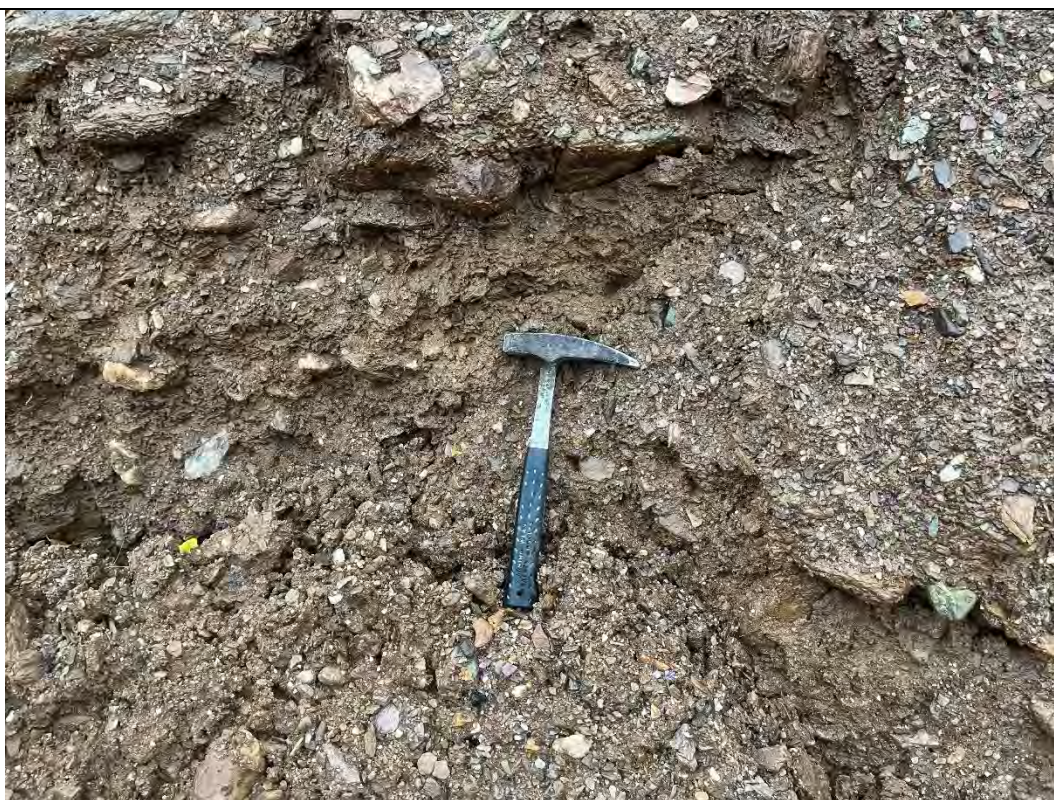
Photo 8. Unstable Slope – Material Exposed in Scarp

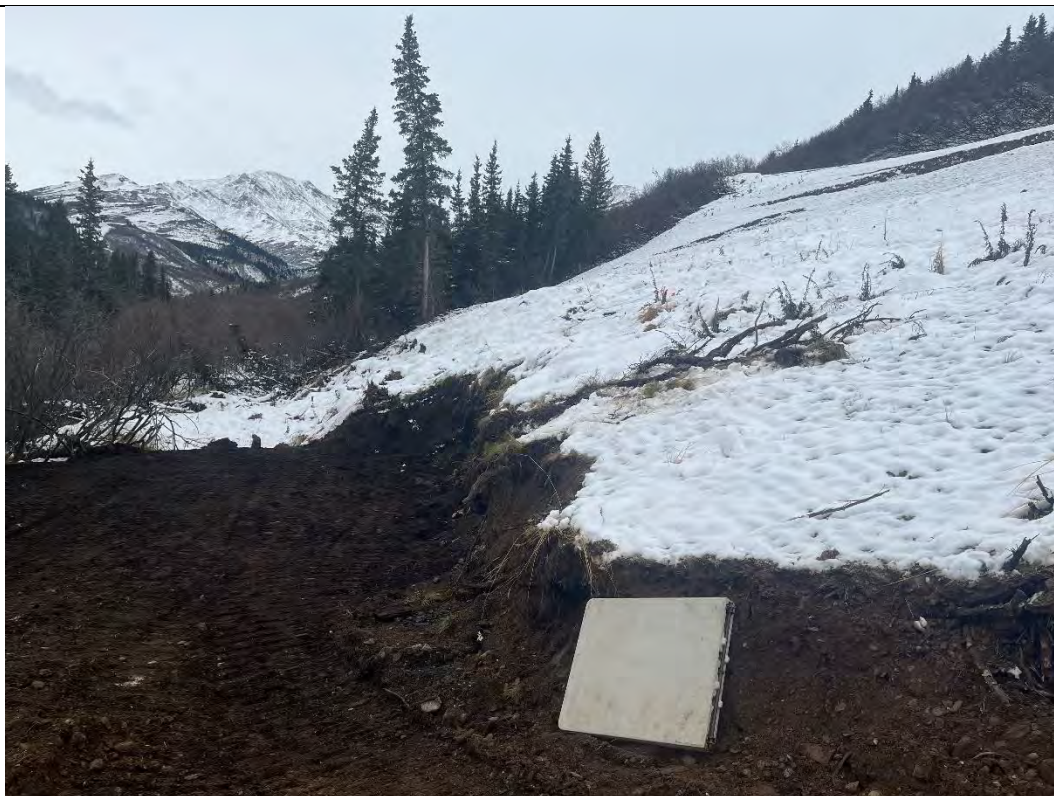
Disturbed Sand and Gravel (Colluvium or Older Fill). The surficial existing fill is underlain by disturbed sand and gravel originating as colluvium, older fill, and/or landslide deposits. This material has similar properties as the existing fill in portions of the slope and is observed near the toe of the slope. In the upper portions of the failed slope, the material may be present below recently placed fill, but isn't distinguishable in the samples. At the toe of the unstable slope, the disturbed sand and gravel extends from the ground surface to depth of about 15 feet. Additionally, the portion of the toe exposed by the excavator to create a drill pad contains visually displaced layers containing organics, organic mat layers, and stumps (see photos 14 through 17 in Appendix E).

Photo 14. Slope Investigation – View Southeast at Toe of Fill and Leaning Trees

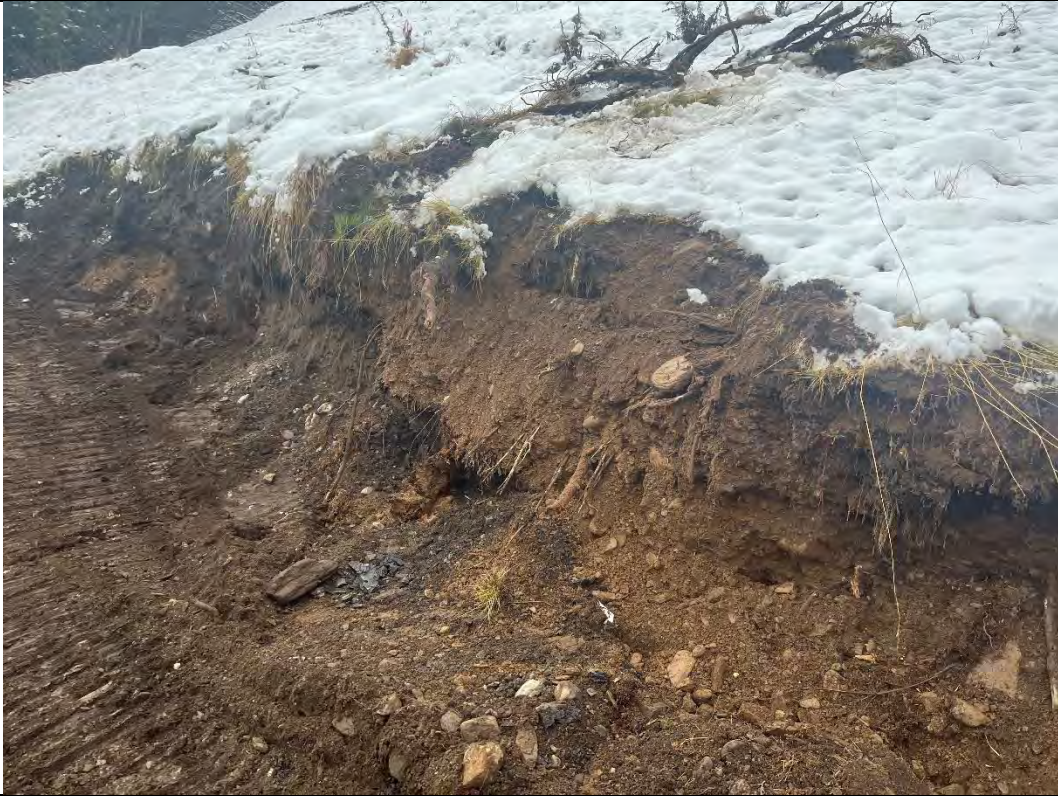
Photo 15. Slope Investigation – Photo #1 of Toe Material Exposed Upslope of Test Boring 2

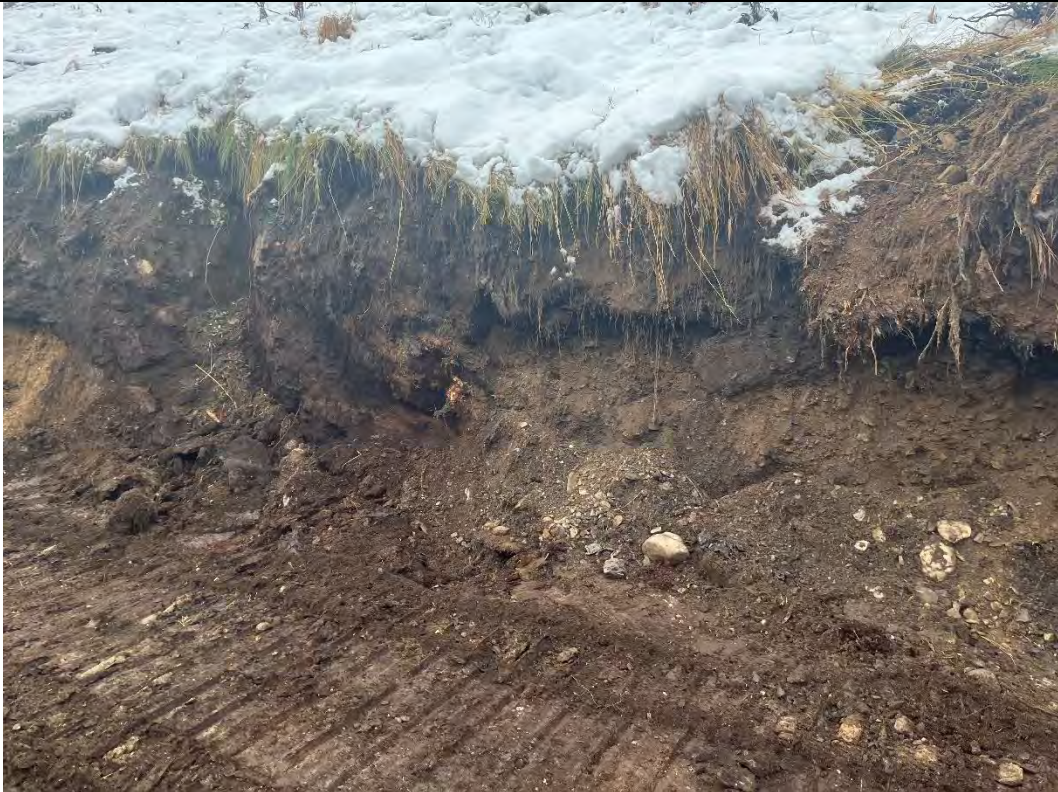
Photo 16. Slope Investigation – Photo #2 of Toe Material Exposed Upslope of Test Boring 2

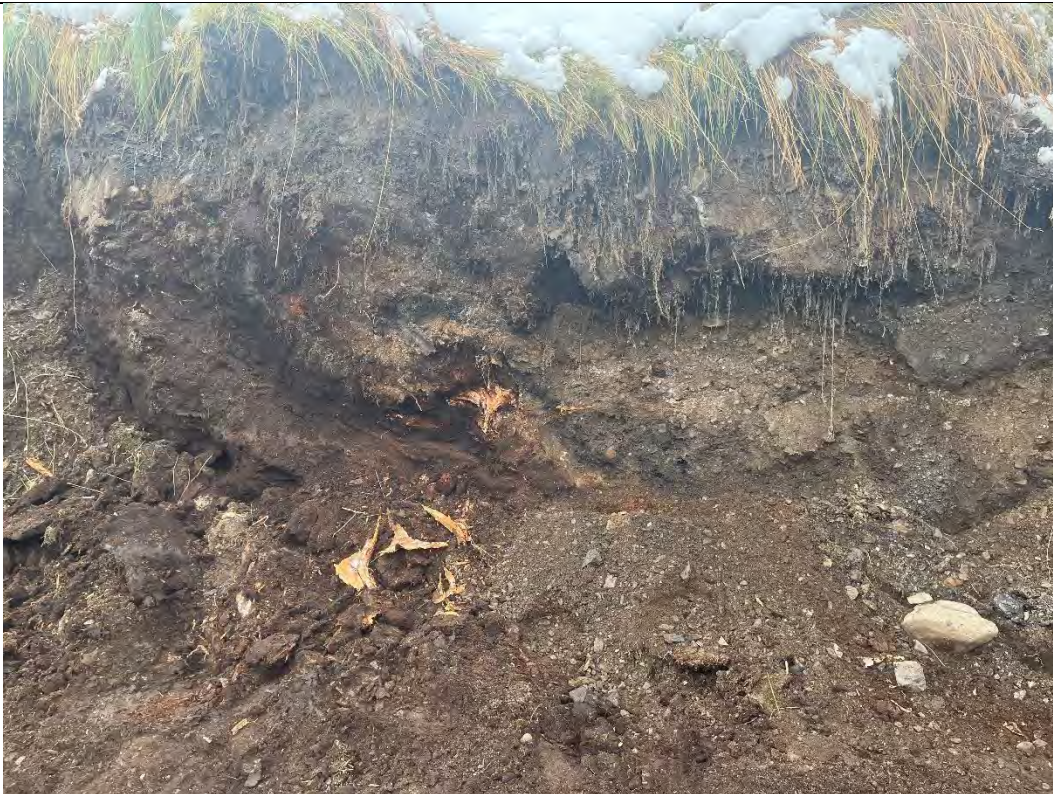
Photo 17. Slope Investigation – Photo #3 of Toe Material Exposed Upslope of Test Boring 2

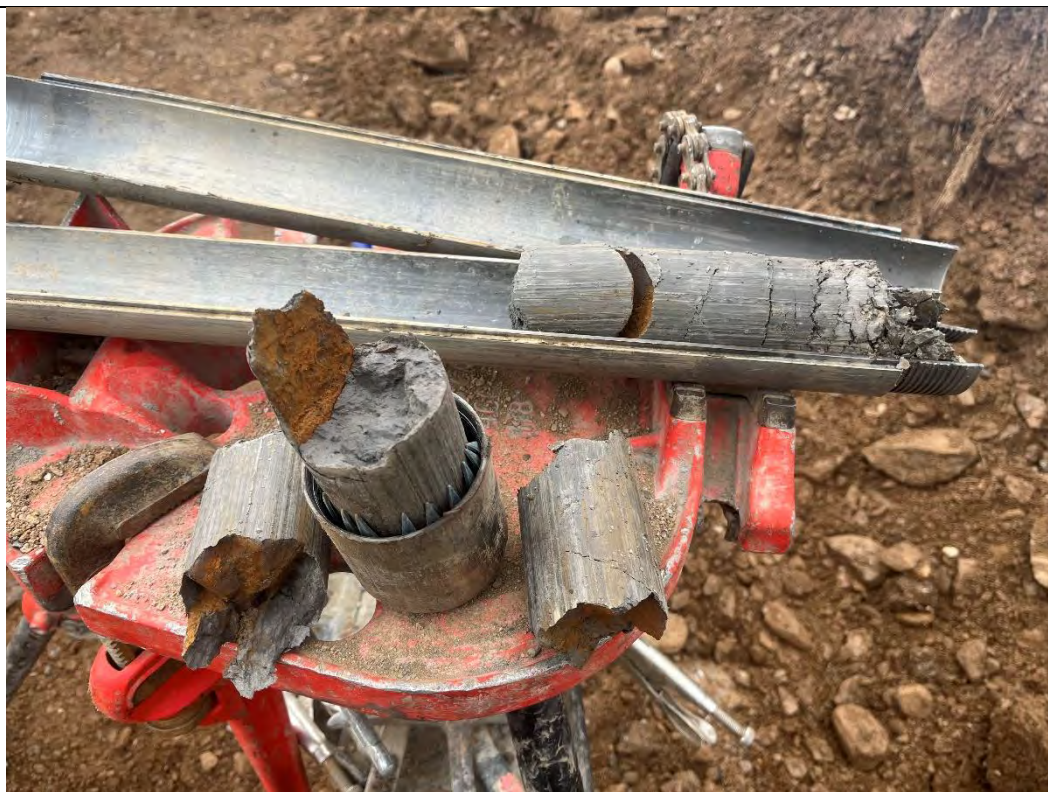
Photo 17. Slope Investigation – Claystone Material with Planar and Curved Discontinuities
