**REPORT OF ULTRASONIC EXAMINATION**

**PROJECT NO:** E11-018-004  
**REPORT DATE:** March 18, 2011  
**TEST DATE:** March 17, 2011  
**P.O. NO:** 1953  
**CLIENT'S NO:**  
**REPORT NO:** R01  
**CODE:** See below  
**PAGE:** 1 of 11

**PROJECT:** R.V. Medeia – Piping Survey

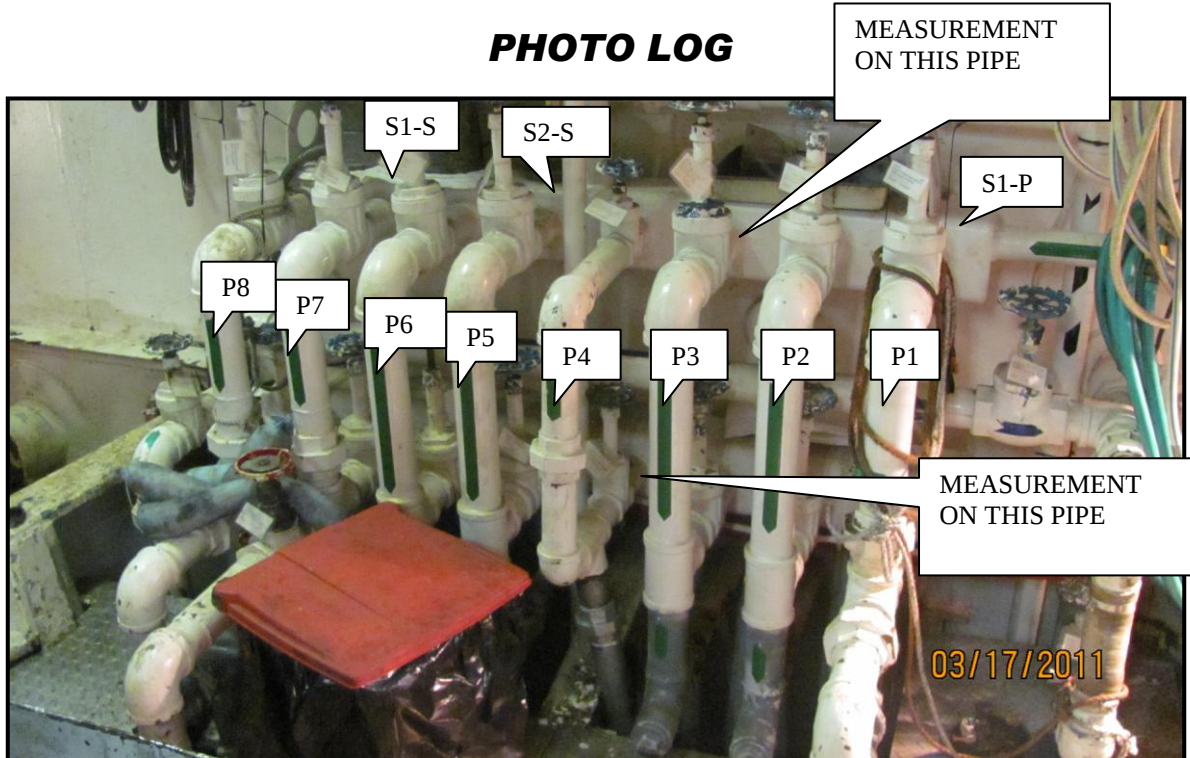
**Figure 1** General view of the Suction and Discharge manifold and associated piping. Suction and discharge pipes were tested at the same locations.

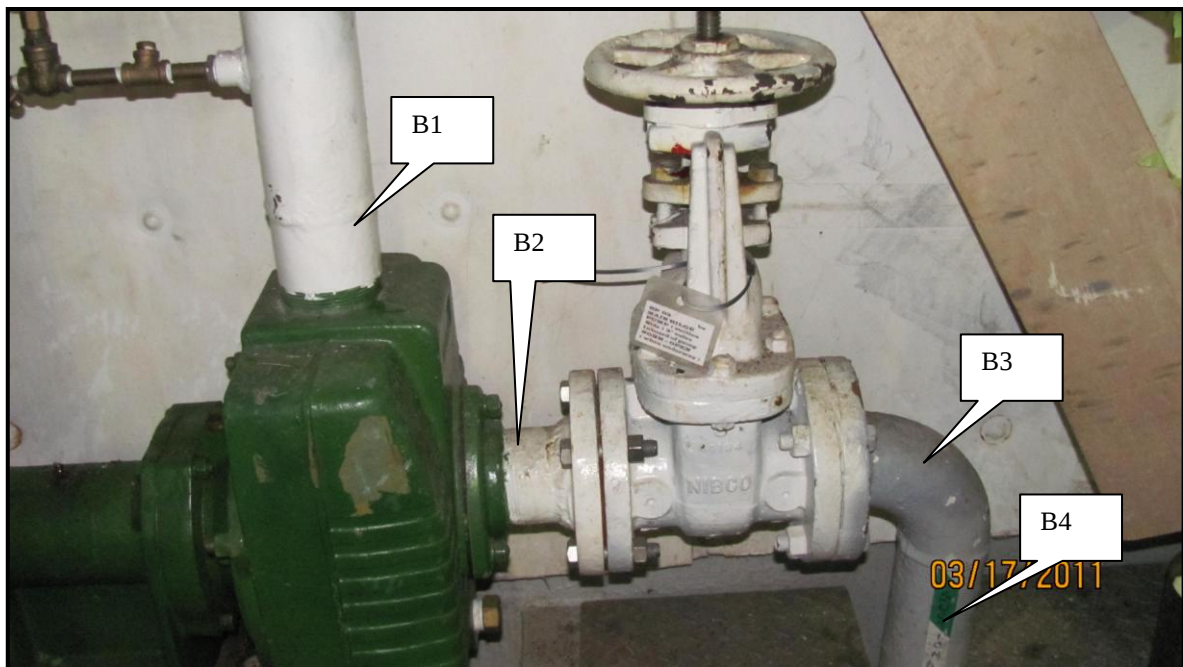
**Figure 2** General view of the bilge pump and associated piping.

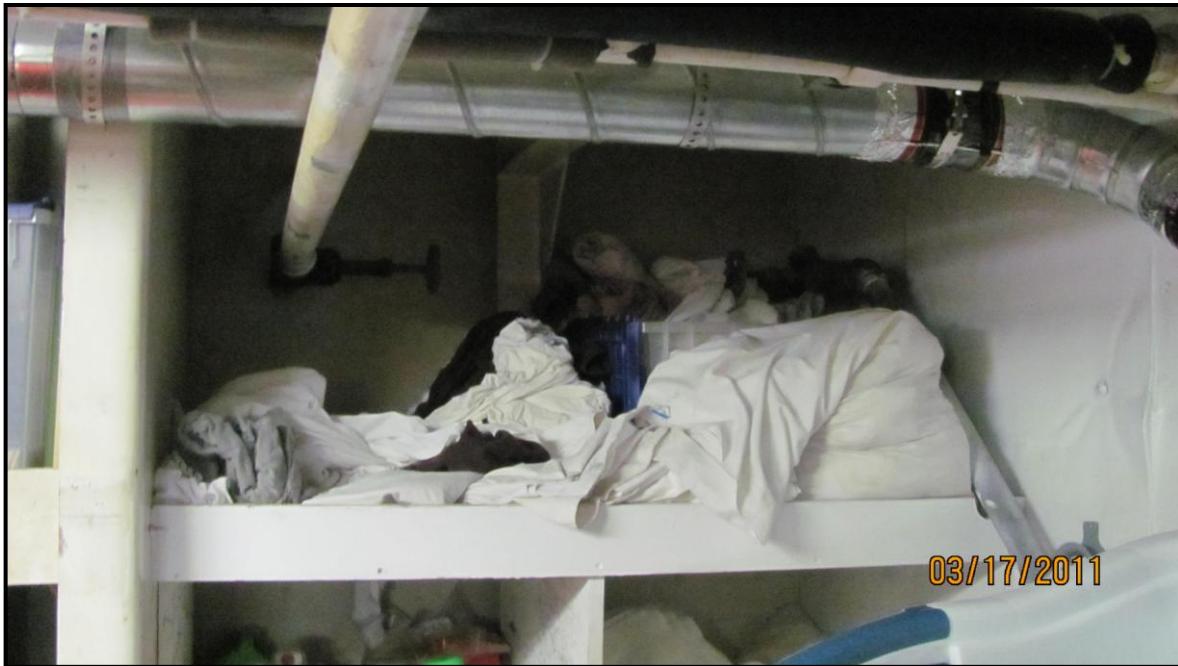
**Figure 3** General view of the Fwd. Void Space through-hull penetration, Port Side.

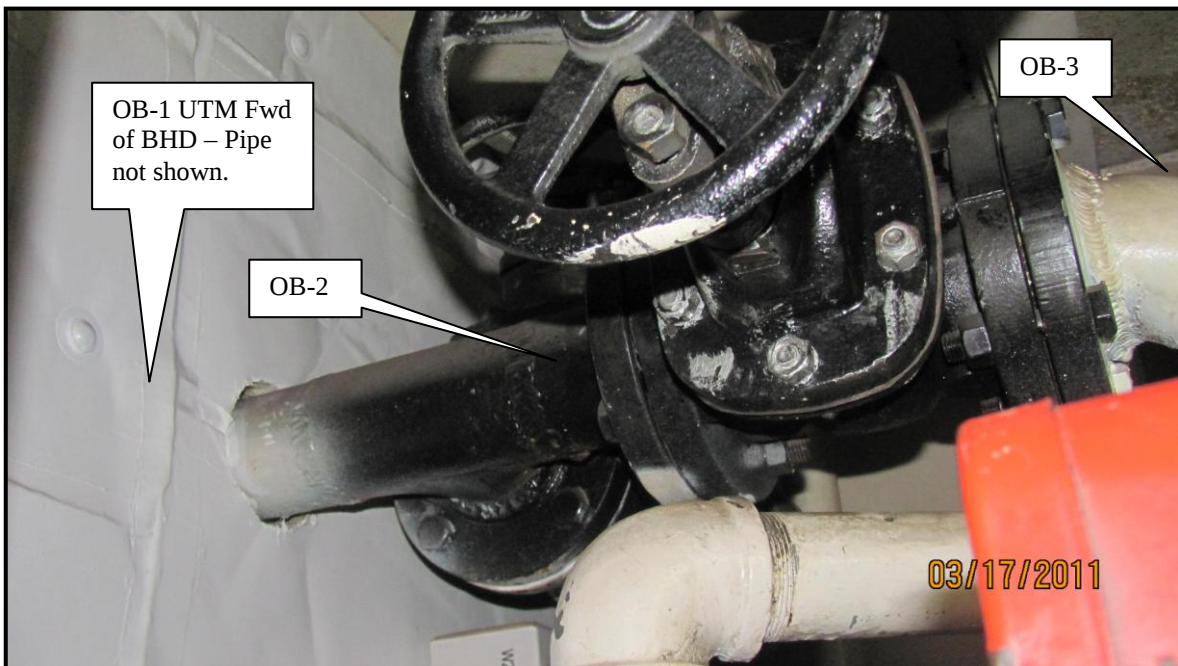
**Figure 4** General view of the waste water to tank piping, Stbd. side showing the pipe coming from the Fwd. heads.

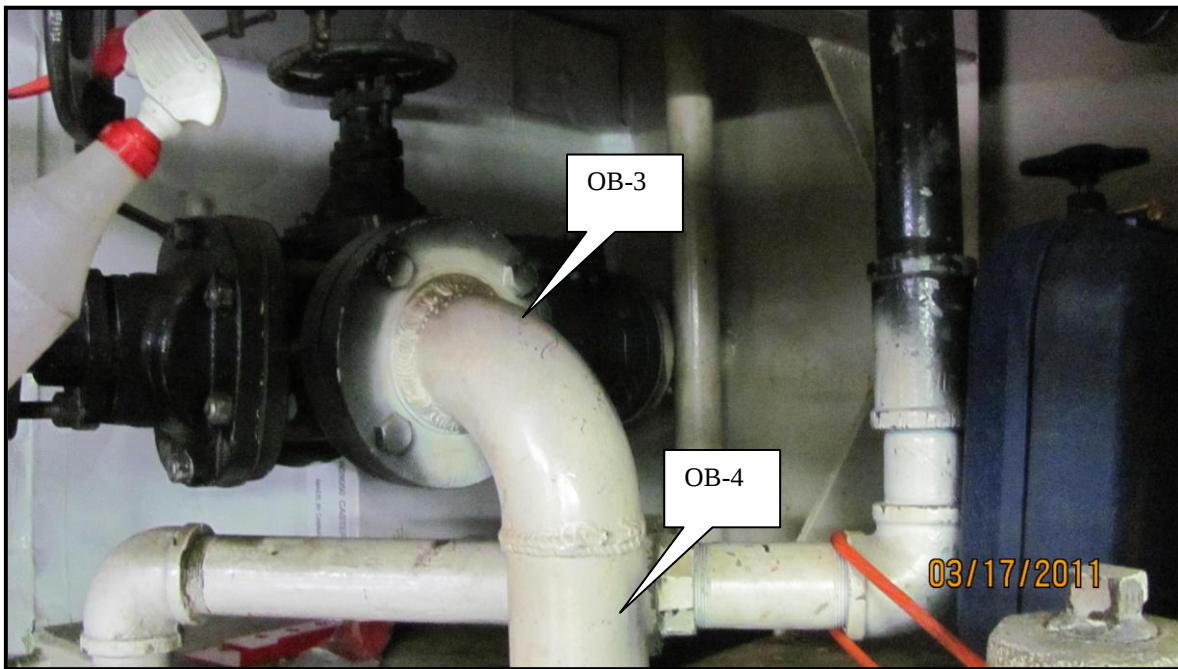
**Figure 5** General view of the waste water to tank piping, Stbd. side showing the pipe Aft of the valve.

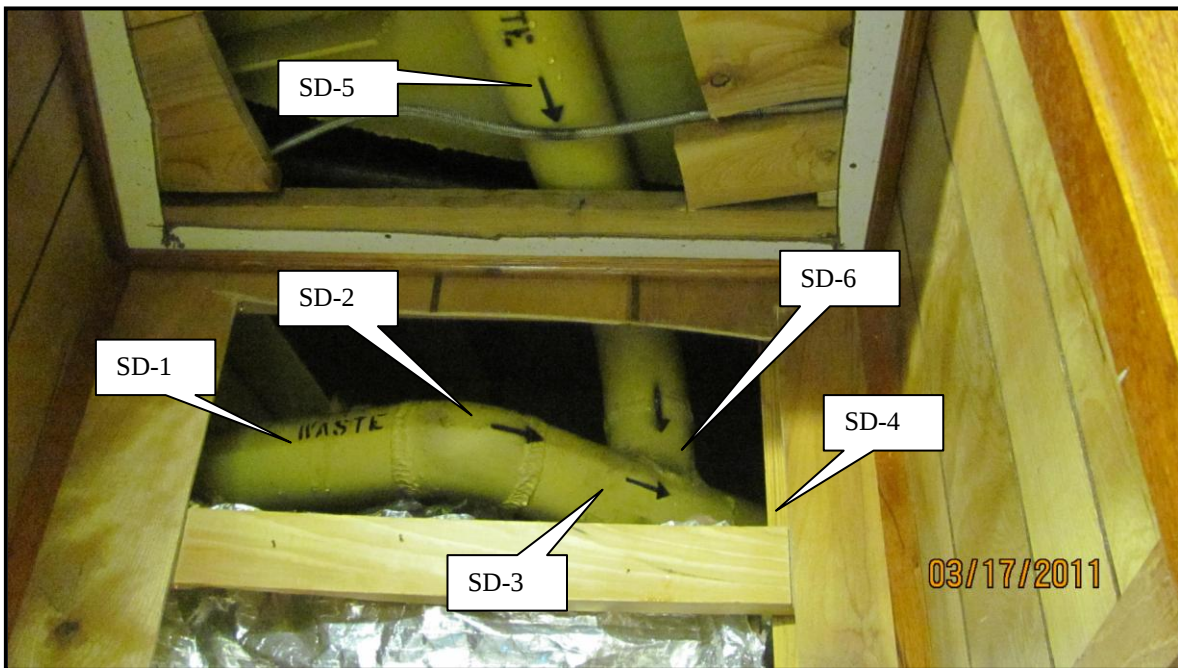
**Figure 6** General view of the waste water to tank piping in closet, Stbd. Side
