MARTIN ENGINEERING, INC.
1985 Gilmore Trail
Fairbanks, AK 99712

24 March 2026

Re: Alaska Army National Guard Readiness Center –
Structural Evaluation of Fire Damaged Concrete Walls
202 Wien Street
Fairbanks, Alaska 99701

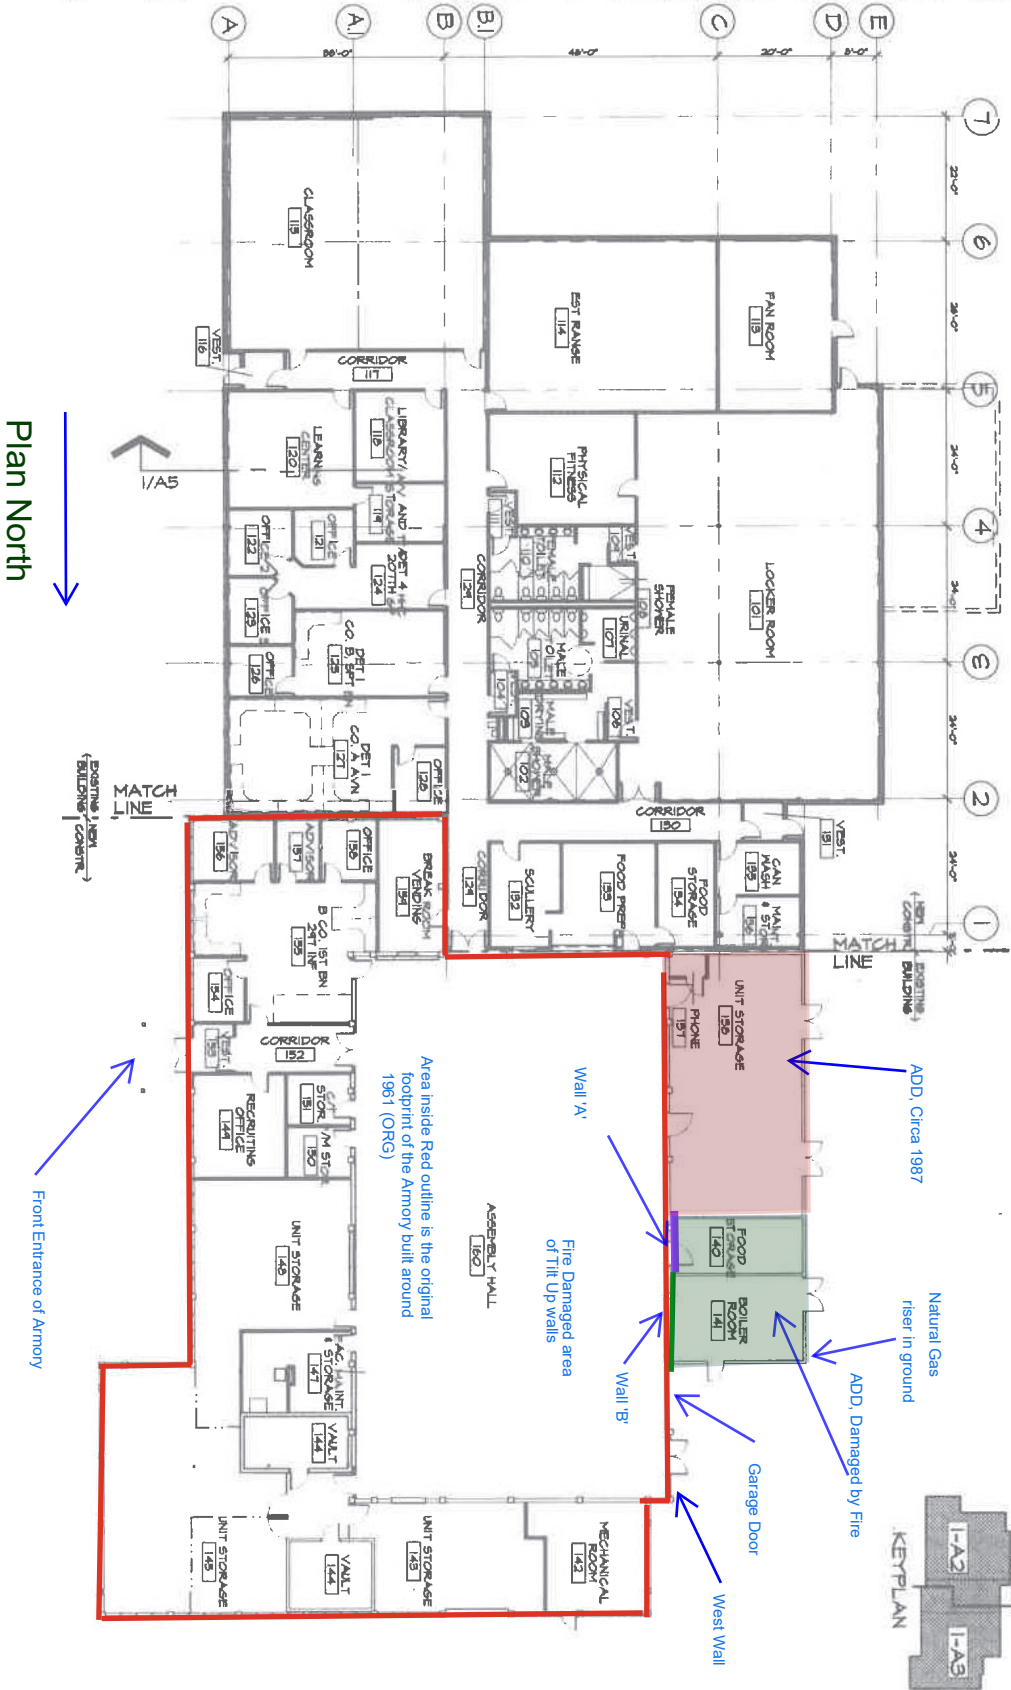
Located in the north end of the ADD is the boiler room. The explosion and resulting fire caused the GLB in that room and an adjacent room to burn with enough intensity to damage the exterior face of two sections of concrete wall on the west face of the ORG. These walls will be referred to as Wall 'A' and Wall 'B'. Please see the attached annotated plan view of the ORG and ADD that reference the walls and shows the areas affected by the explosion/fire.

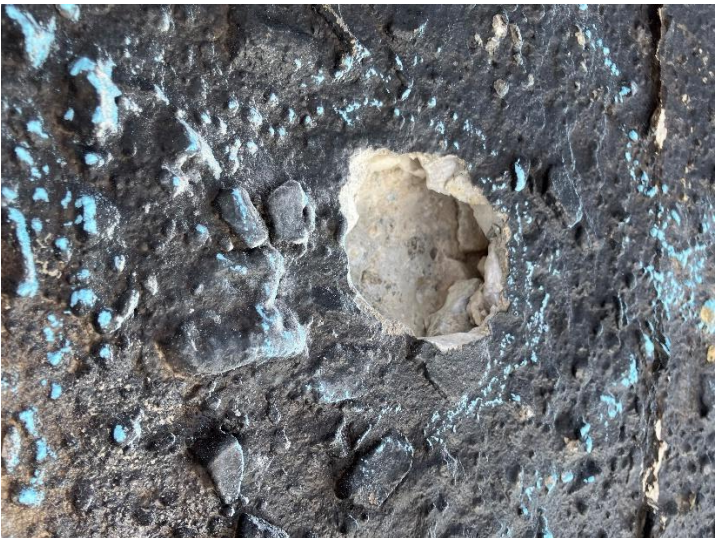
Test Hole – Wall 'B'

MEI directed TCI to drill into a section of Wall 'B' that appeared to have sustained the most severe fire damage as indicated by the heavy charring on the exterior face of that wall. Application of a mechanical rotor hammer and drill bit cut through the first 1/2" of concrete. After passing through the initial concrete a void was discovered behind this veneer. The void was measured to be approximately 1.5 inches deep and consisted of loose rock and cement powder. The loose rock and cement powder are evidence that the temperature experienced by the concrete was sufficient to remove all of the moisture from the concrete and return it to its original elements of cement and aggregate (rock).

TCI did not encounter any reinforcing bar with this initial drilling into the fire damaged wall 'B'. TCI expanded the hole to approximately 3 inches in diameter. MEI tested the sound concrete found approximately 2" from the outside face of the concrete wall with the Schmidt Hammer and recorded an average result of approximately 42 units.

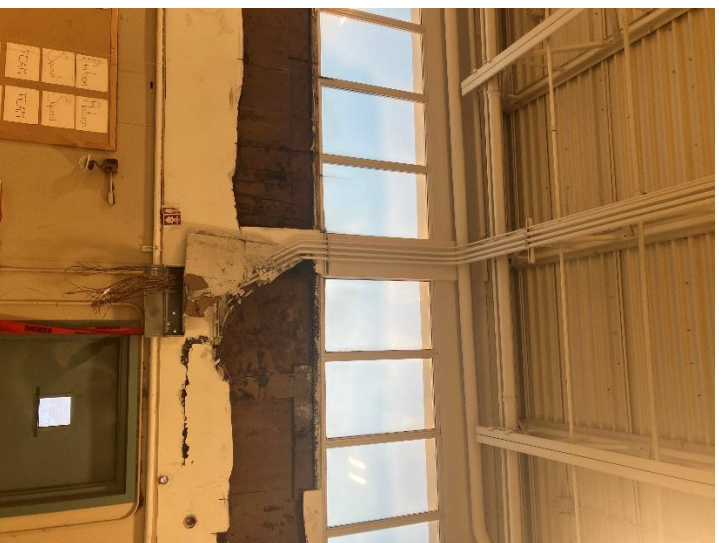
Inside Face Wall 'A'

A portion of the inside face of Wall 'A' (as well as an adjacent wall panel that was not affected by the fire) was removed during fire-fighting operations on 23 January 2026. MEI recommends that the inside wall finishes be repaired as close as practicable to match the adjacent wall finishes. The contractor who performs the repairs to the inside face of the finishes on these walls shall leave all of the existing insulation in place, replace the damaged insulation with rock wool insulation and only remove the plaster finish as needed to make square cuts over existing wood framing. The square cuts will facilitate installation of a Cementitious coated gypsum wall board and paint to match the existing wall color as close as practicable. Before removing any of the existing plaster, the contractor shall employ a company that is certified to test for Asbestos and then sample the existing plaster for Asbestos. If Asbestos is present in the existing wall plaster, the contractor shall follow the testing company's recommendations for removal of the plaster that contains Asbestos before implementing the remainder of the interior wall finish repair.

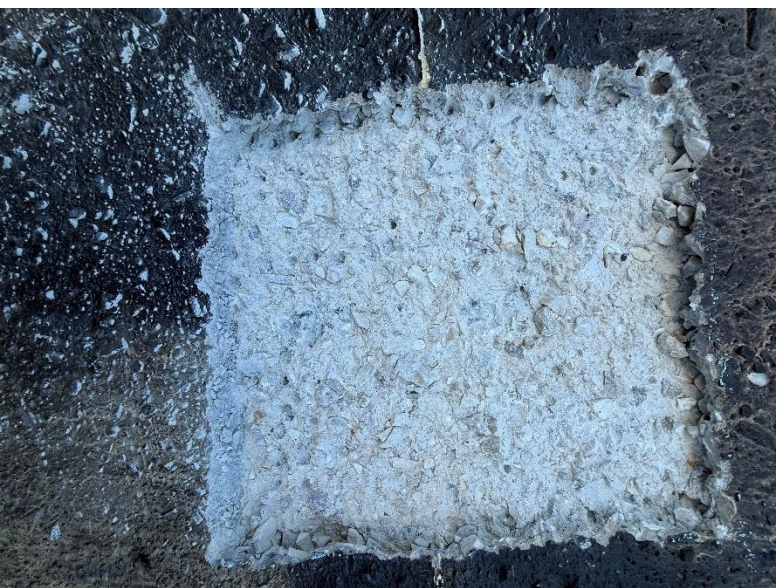
Test Patch – Wall 'B'

MEI directed TCI to expand the size of the test patch on Wall 'B' to a 2 foot by 2 foot area. TCI used power hand tools to remove the damaged concrete on the exterior face of Wall 'B' down to sound concrete. No reinforcing was encountered inside this 2 foot by 2 foot patch. MEI returned on-site for a fourth time and the surface of the exposed sound concrete was tested with a Schmidt Hammer and provided an average reading of 42 units. MEI can conclude from these results that the fire damage extends a maximum of 2 inches from the outside face of Wall 'B' towards the center of the original 5 inch thick concrete tilt-up wall panel. The 6 inch thick concrete shear wall remains undamaged from the fire.

The damaged exterior face of Wall 'B' may be left in-place as it currently exists. MEI recommends filling in the 2 ft x 2 ft test patch with Terrafuse TF Structural Repair Concrete Mortar or an approved equal. The patch repair will need to wait until ambient exterior temperatures exceed 50 degrees Fahrenheit or the installation temperature recommended by the manufacturer of the concrete repair mortar.

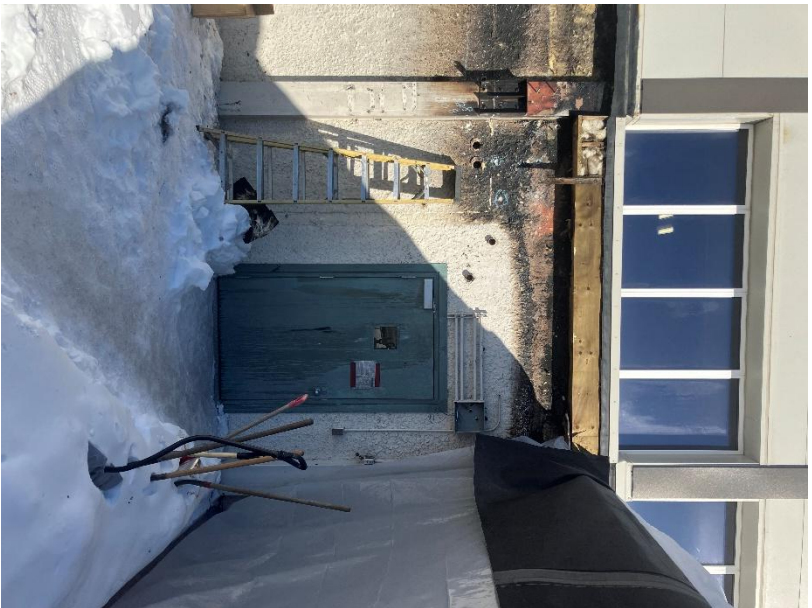
During our final site visit, MEI had TCI drill several holes along the column to wall interface of wall 'A' and its adjacent column. Most of the holes that were drilled revealed a depth of approximately 1 inch of fire damaged concrete. Only about a 1 foot length of the wall (adjacent to the column) had damaged concrete that was 1 1/2" deep. MEI was able to ascertain from the drilling performed by TCI that this wall only had significant damage to the exterior face for approximately 2 feet horizontally from the 1 foot tall section of roof for a total of about 2 square feet of damaged wall adjacent to the column.

MEI determined from our site visits that Wall 'A' has only about 3% of its total wall area affected from fire damage. MEI's concludes that Wall 'A' is not in need of any structural repair or reinforcement. From a structural perspective, Wall 'A' may be left in its As-Is condition and no structural reinforcement or improvements are needed.

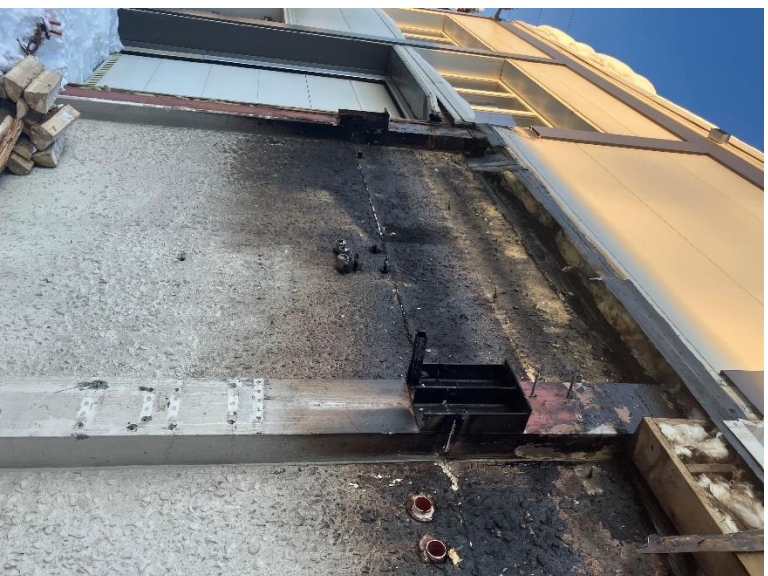
Wall 'B' Looking North with Garage Door

MEI's on-site tests show that only the original concrete tilt-up Wall 'B' was damaged in the fire of January 2026. The shear wall added in 1997 was not damaged by the fire. MEI states that the damage done to the original Wall 'B' does not affect the overall structural integrity of the capacity of the ORG to develop the original design gravity loads or lateral shear loads in the area of Wall 'B'. No further structural reinforcement or repairs are required at this time to Wall 'B'.
