**LEGISLATIVE AFFAIRS AGENCY  
RFP NUMBER 625  
AMENDMENT NUMBER 3**

**RFP TITLE: Terry Miller Legislative Office Building Windows and Exterior Renovation**

Re: Hazardous materials sampling results from Capital School/TMLOB in Juneau, AK

# TMLOR INTERIOR WINDOW SAMPLING

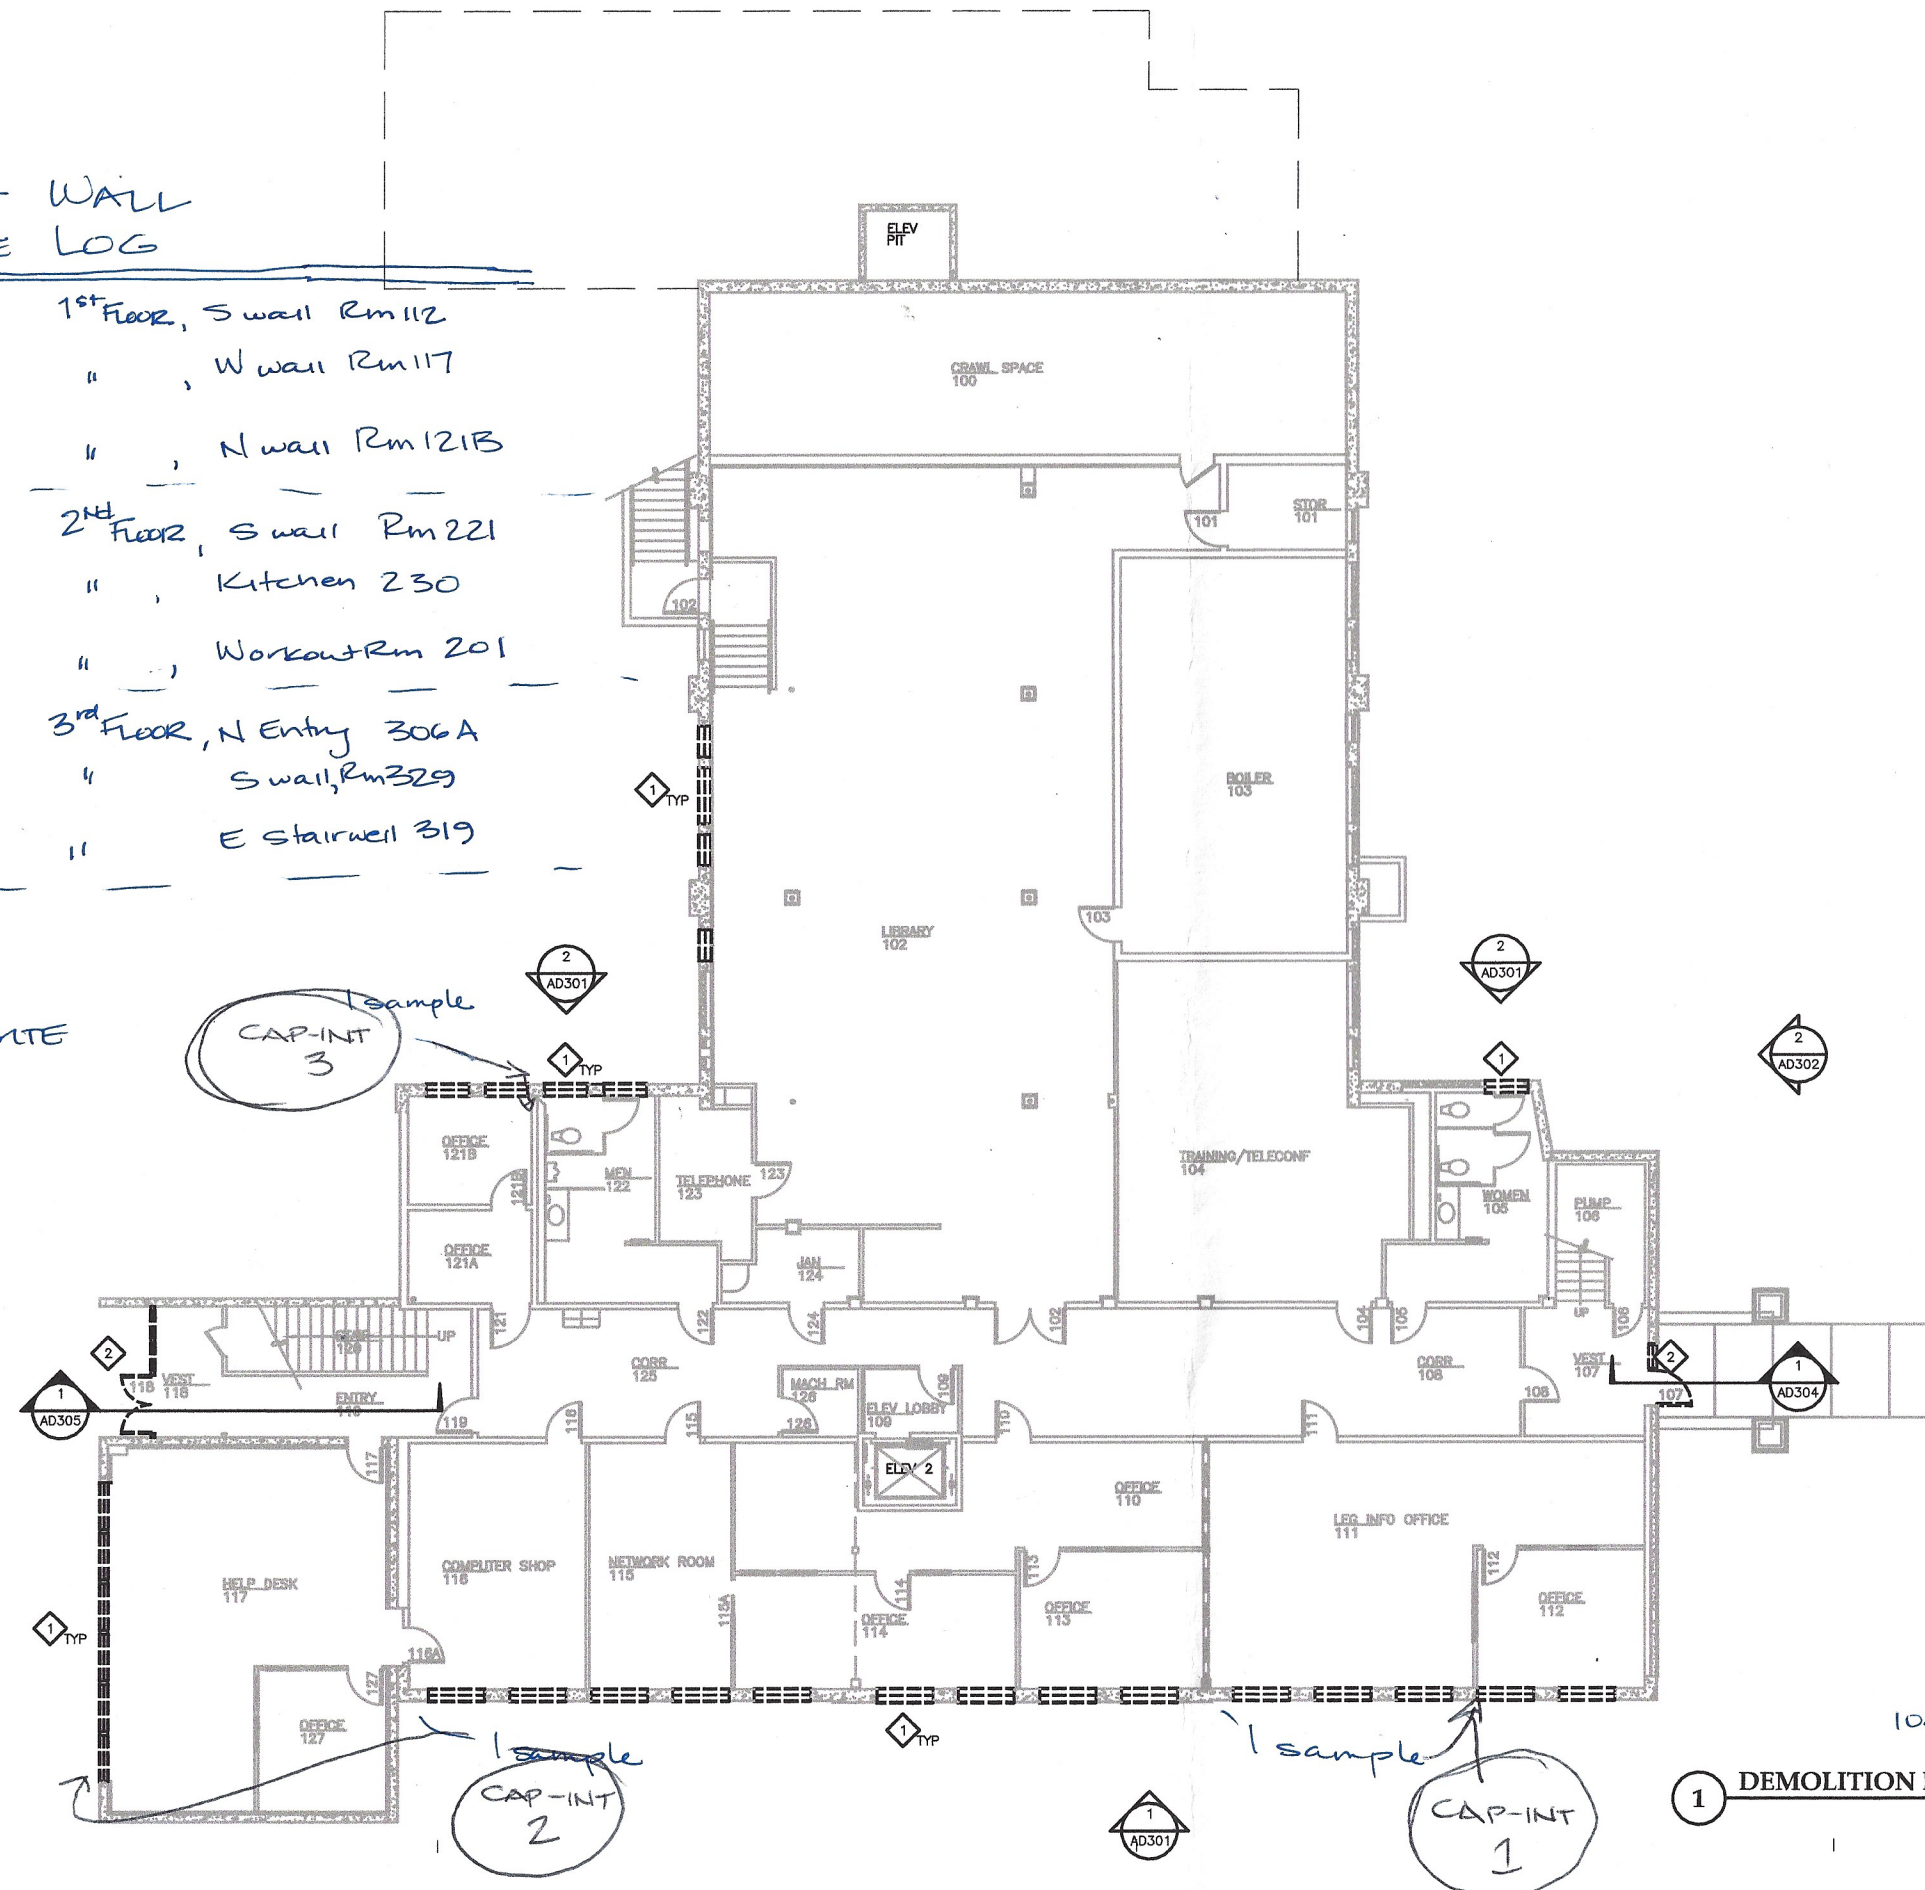
**AD201**

104 LF windows - 2 samples  
**1 DEMOLITION FIRST FLOOR PLAN**  
SCALE: 0 4' 8' 16'

INT. SAMPLING 2019

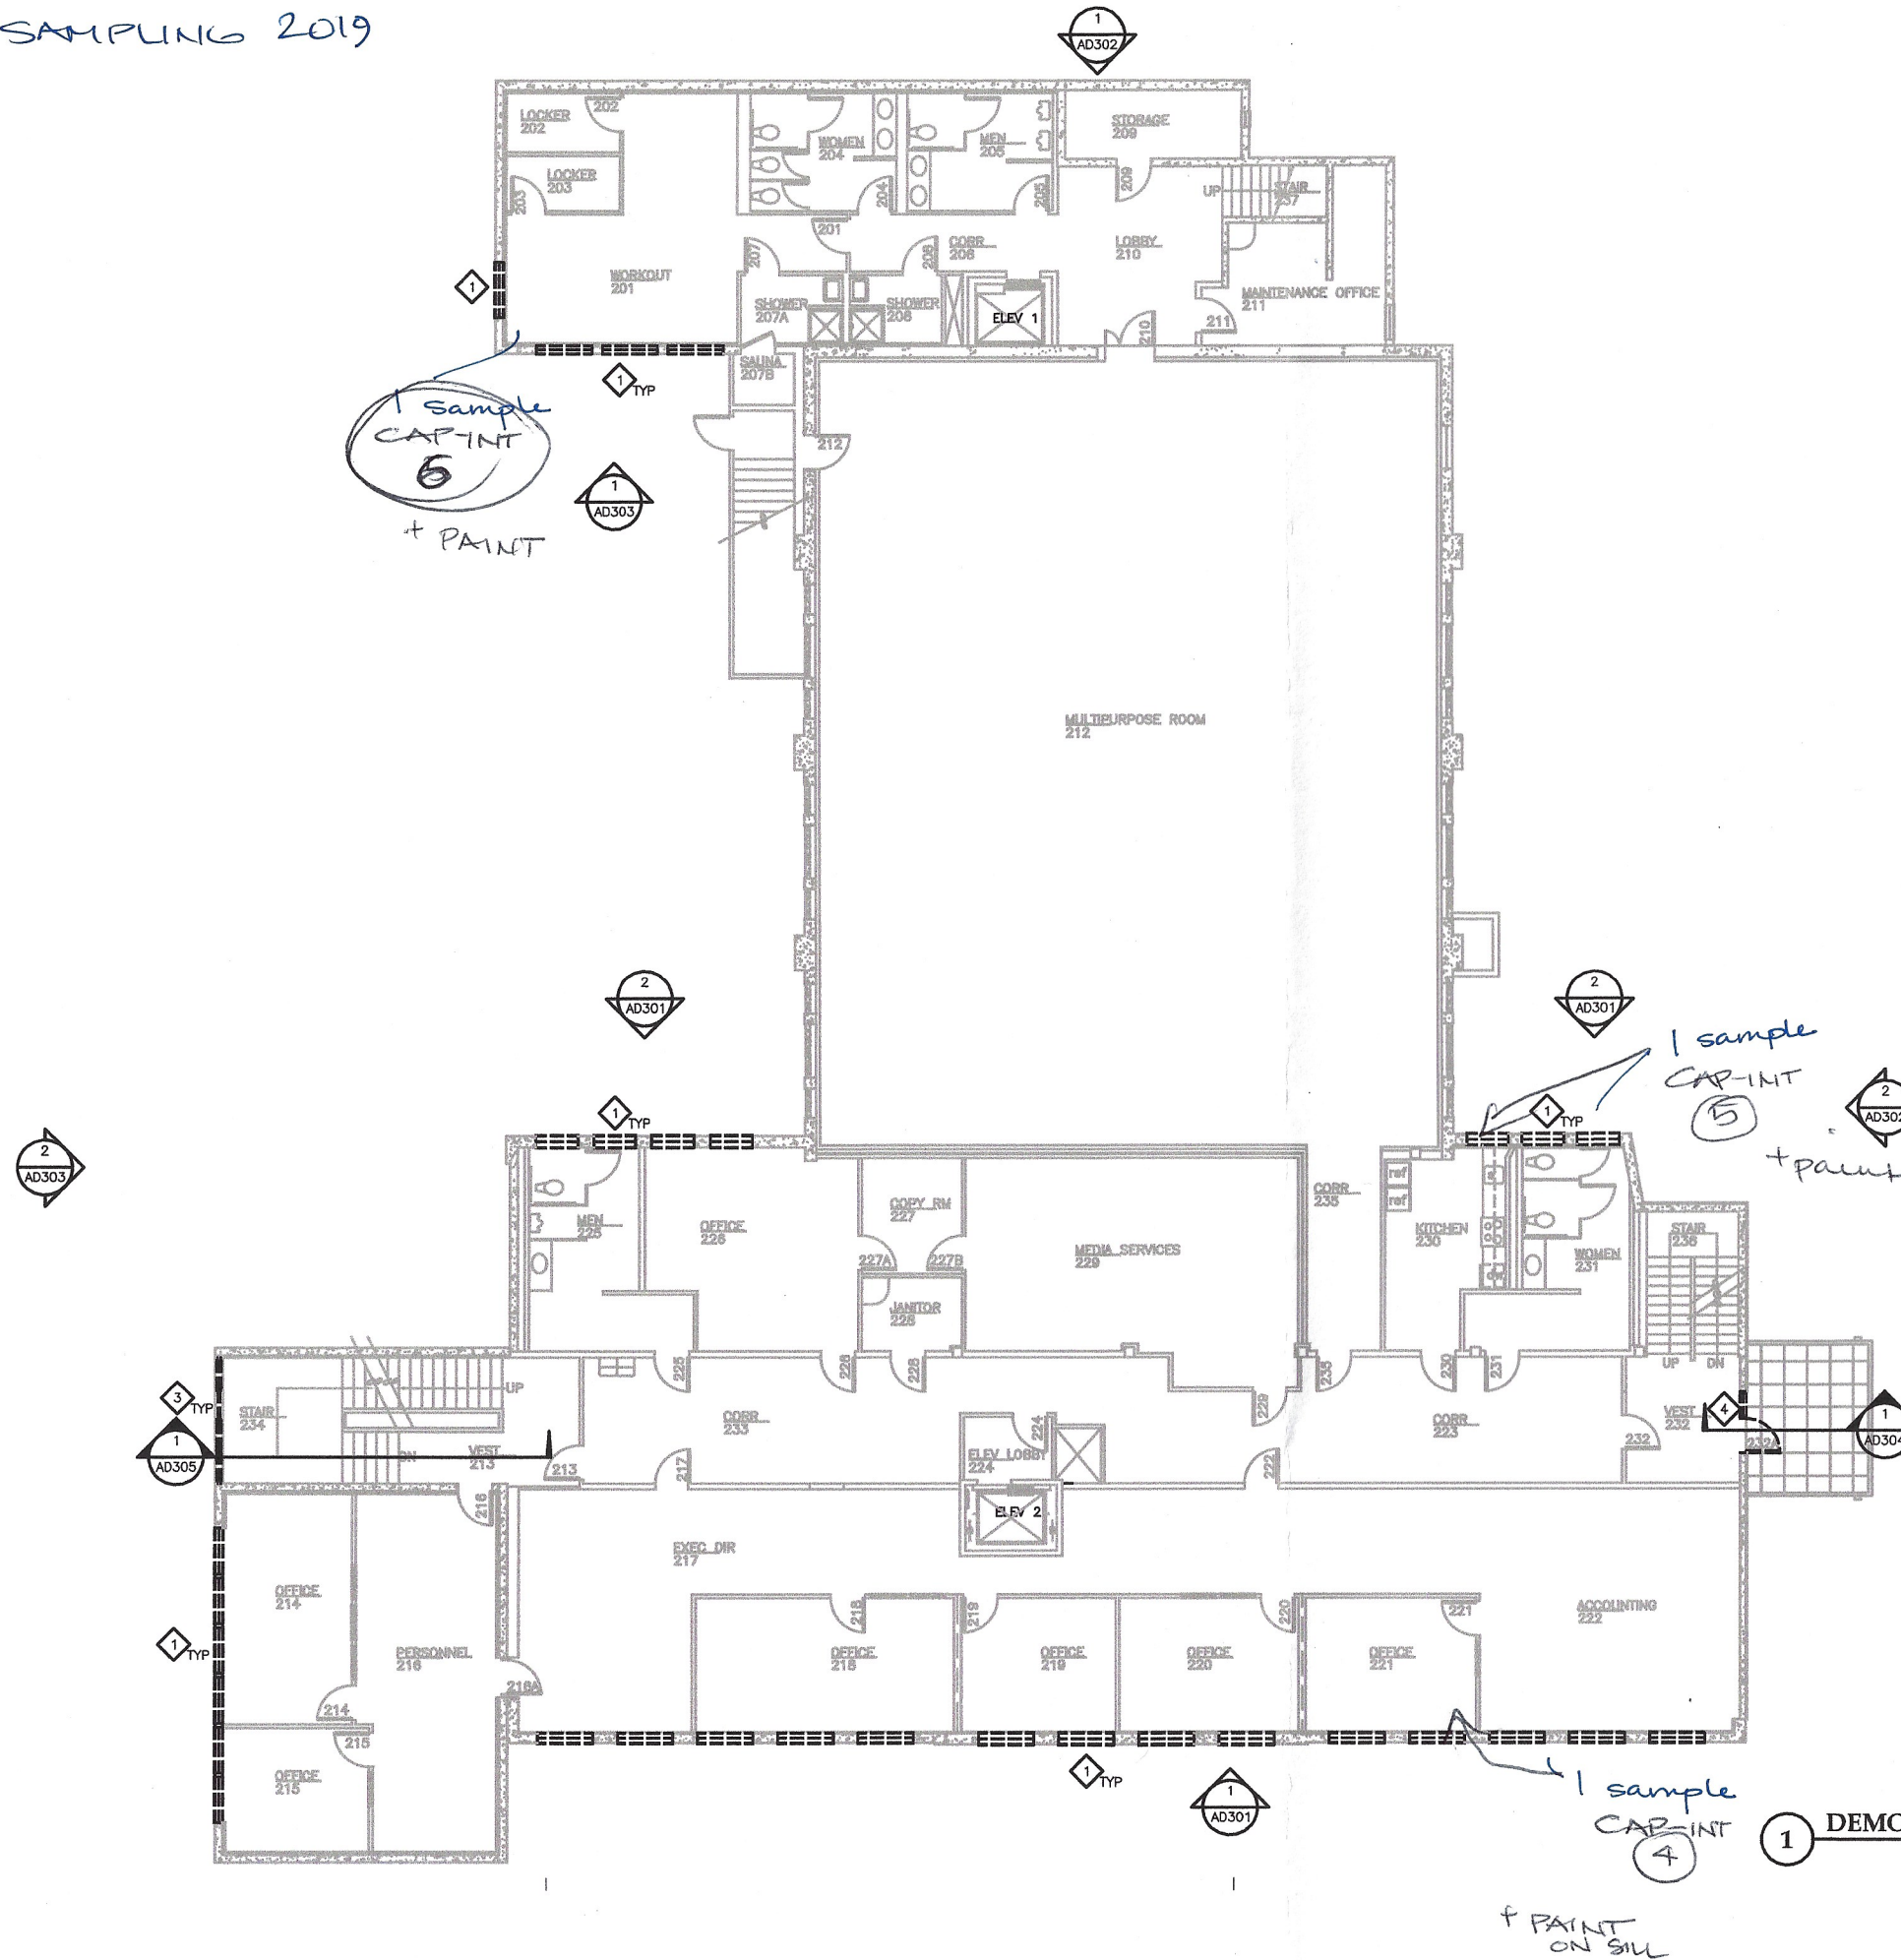
**AD202**

INT. SAMPLING 2019
