RE: Project Name: Hooper Bay Interior Restoration
Project Number: 0252123012
Project Location: Hooper Bay, Alaska

Addendum Two (2)

**ASBESTOS SURVEY
ALASKA ARMY NATIONAL GUARD
HOOPER BAY FEDERAL SCOUT ARMORY
HOOPER BAY, ALASKA
APRIL 1996**

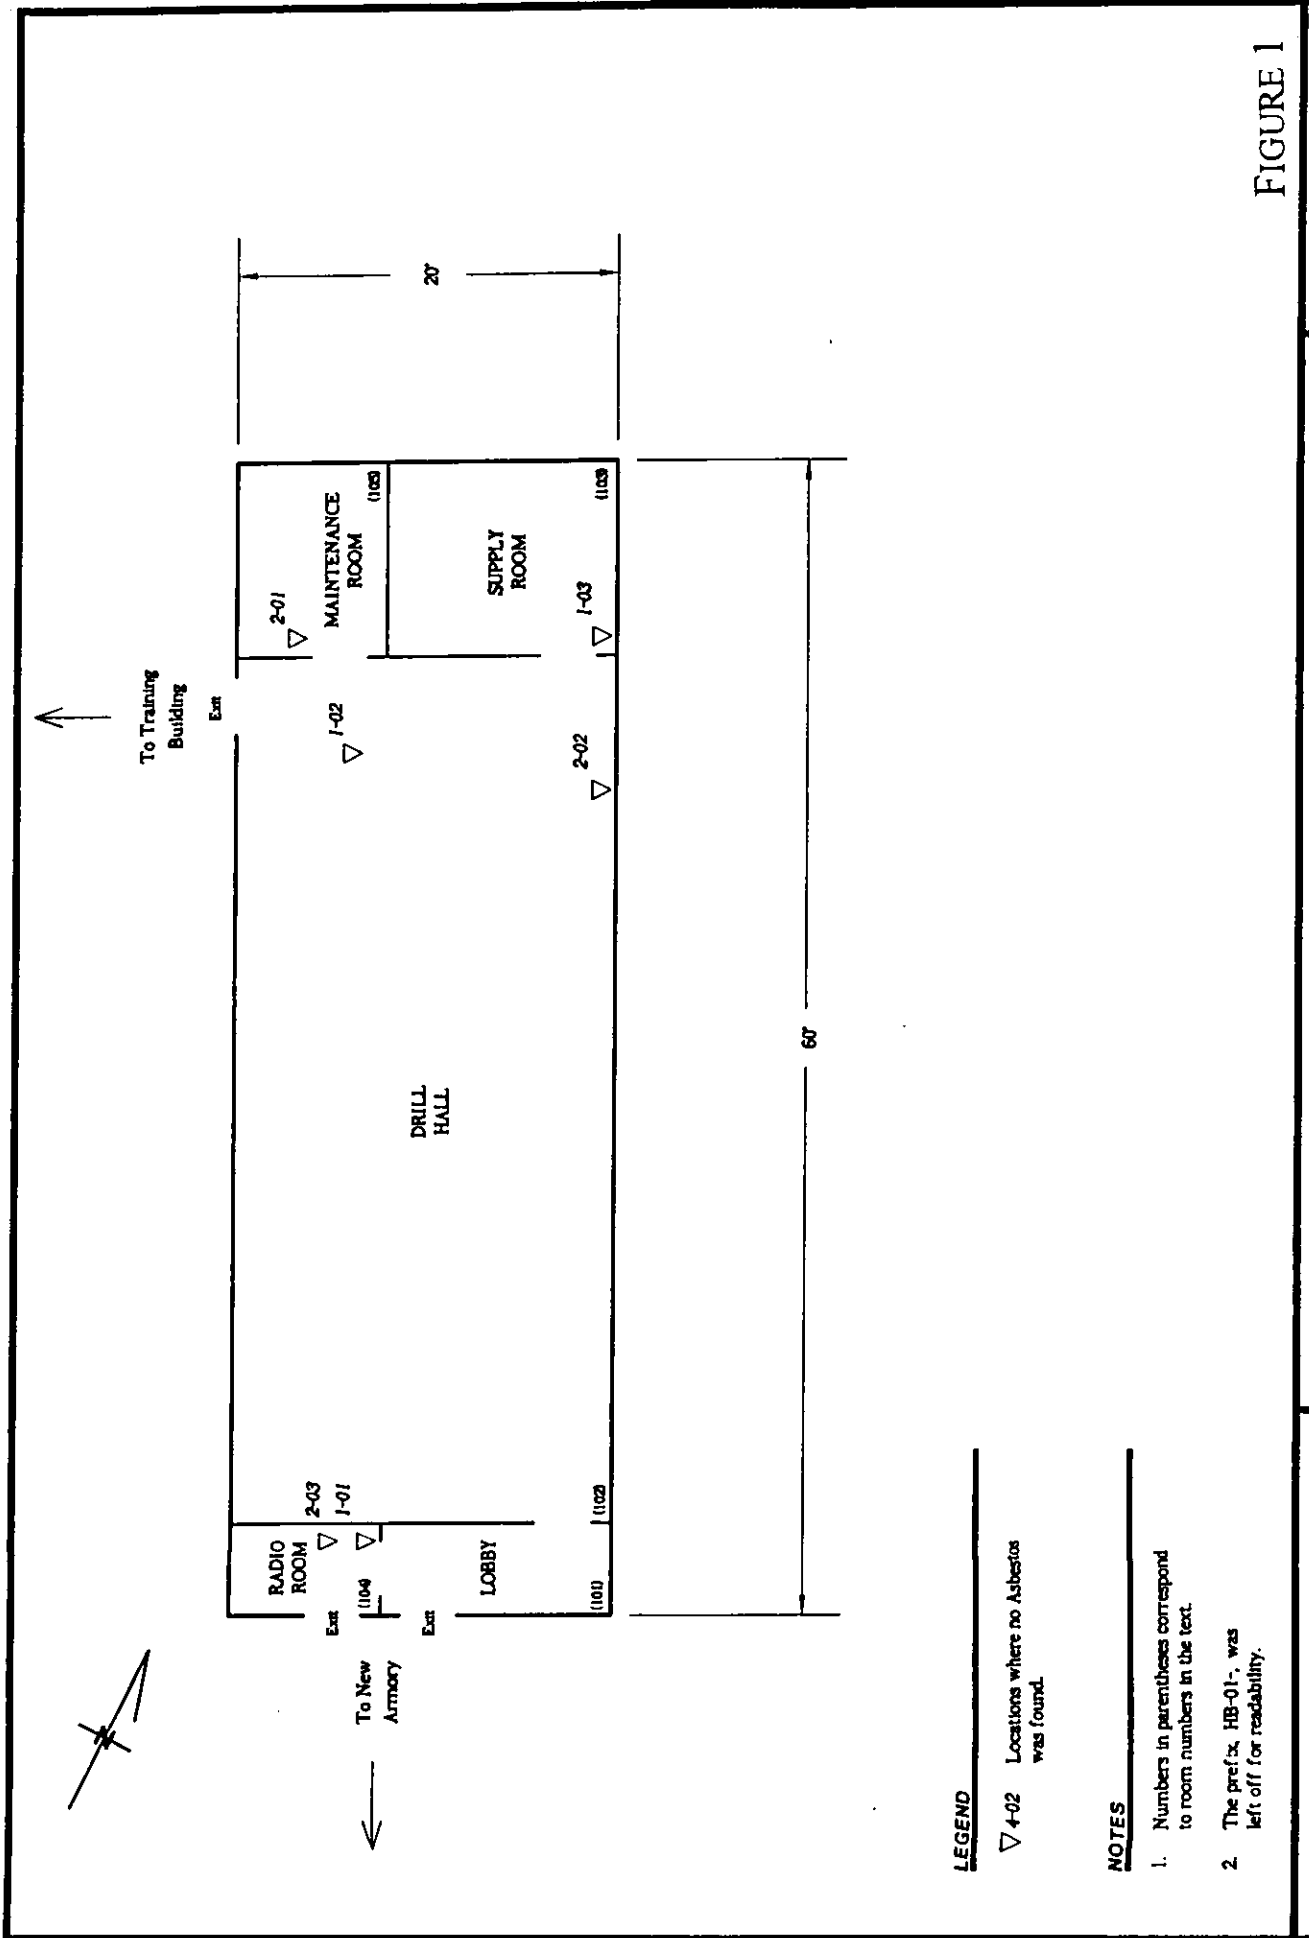
FIGURE 1

In the Old Armory, six samples were collected from two homogeneous areas (HA) identified during the inspection. No HAs were assumed to contain asbestos, and, as indicated by the materials bulk sample analysis results, none of the sampled materials were found to contain asbestos:

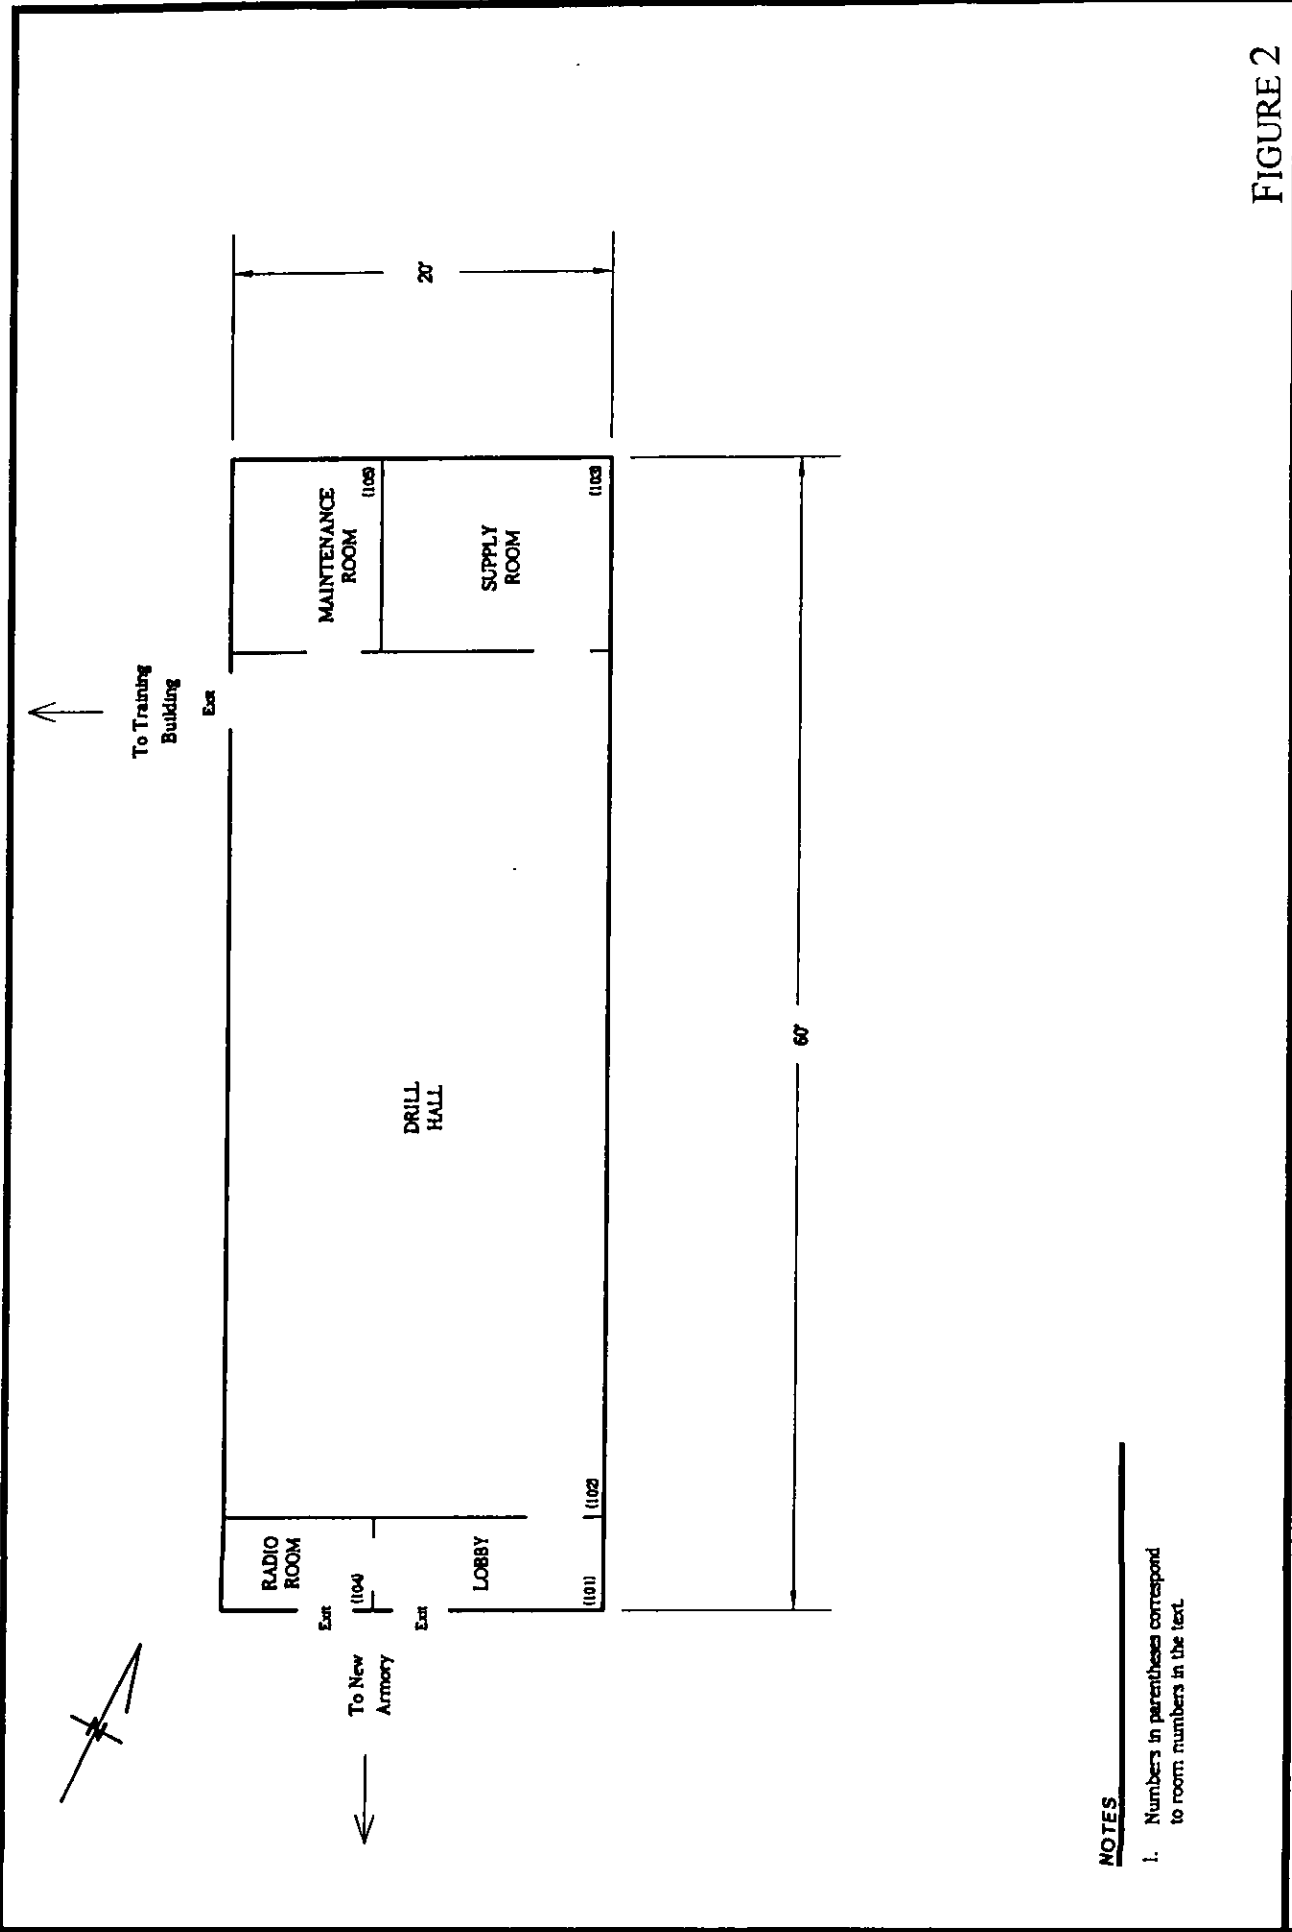
FIGURE 2

No Asbestos Detected
