## Lidar Quality Assurance Report Version 1.0

Project Summary:

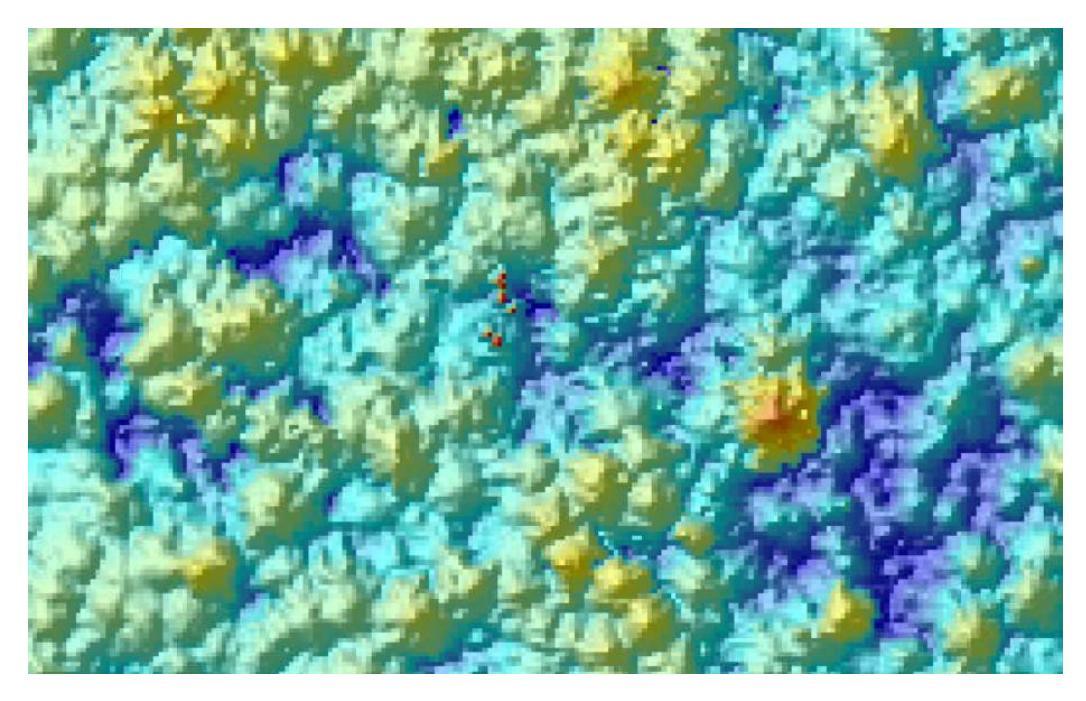
DSM spikes and noise examples:

- -121.745666, 47.488263 Decimal Degrees, single pixel pit in the DSM, 61 feet deep
- -121.463974, 47.199829 Decimal Degrees, 9 pixels, 371 to 320 feet high

Figure 2: red pixels in the center of the image represent spikes, where noise was misclassified and included in the surface model.

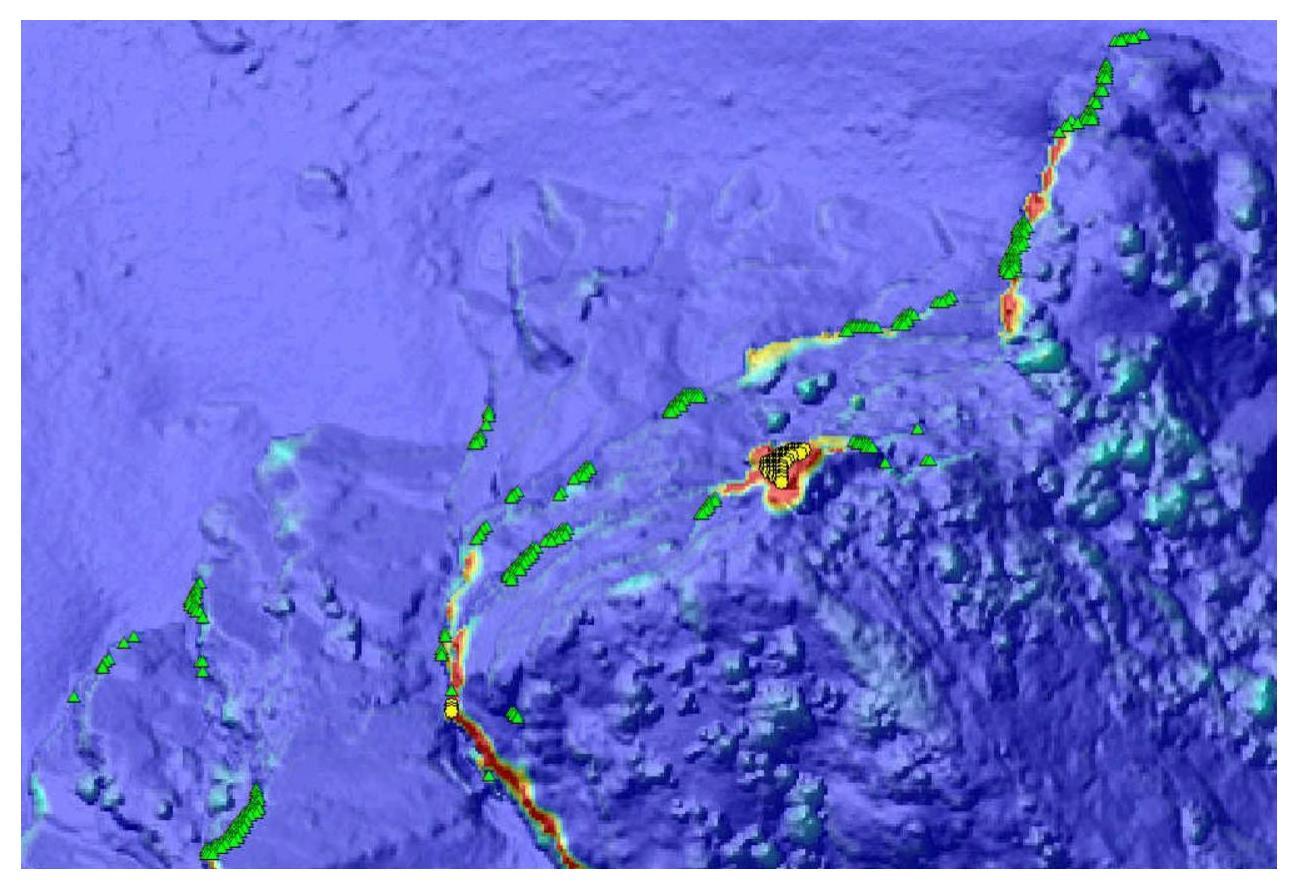
Across the project there were 43,721 pixels identified as height anomalies on cliffs. Height differences ranged from -253 to 663 feet high. 18,588 of these points were less than -30 feet deep, while 25,133 were taller than 300 feet. The total number of points, and that so many were negative values, is significantly different than previous lidar projects. WGS has determined that this is due to the higher resolution of the dataset. At 1.5 ft resolution rather than the previous standard of 3 ft resolution, the number of anomalies increases when comparing the DTM to the DSM.

The example below is located at: -143.420313, 60.458846 Decimal Degrees. Green triangles are height points less than -30 feet. Yellow are points greater than 300 feet. The image below shows how these anomaly points are closely correlated to the terrain and are a result of how the DSM and DTM are generated.

Figure 3: Height model over the DSM shaded Relief map
