MEMORANDUM

DEPARTMENT OF NATURAL RESOURCES DIVISION OF GEOLOGICAL AND GEOPHYSICAL SURVEYS

SUBJECT: Chilkat River (Schnabel Fill & Culvert Installation) hazard area designation

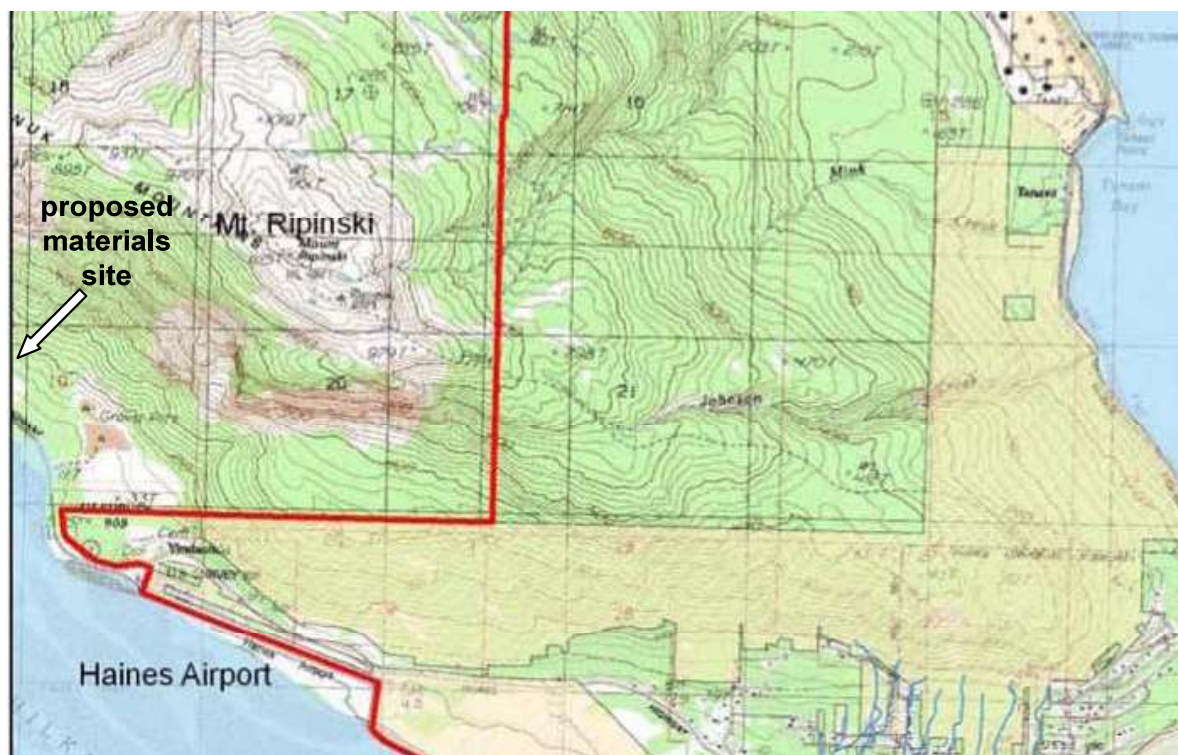
2. The proposed materials site is approximately 1 mile outside the boundary of the Haines Coastal Management Area and slope conditions are equivalent to or more extreme than those comprising designated slope hazard areas within the management area (fig. 1). The Haines Coastal Management Plan (2007) notes that small landslide and snow avalanche debris accumulations occur along the steep mountain front north and northwest of Haines and along the fjord walls of the Chilkoot and Lutak inlets. The Plan (2007) goes on to point out that numerous landslides of considerable extent occur frequently in the Haines borough, and that a landslide in the late 1890's virtually destroyed a Native village at 19-mile Haines Highway.

Figure1. Location of proposed materials site in relation to designated slope hazard areas of the Haines Coastal Management Plan. Red line is Management Area boundary, yellow shading is designated slope hazard area. Source: Haines Coastal Management Plan (2007).

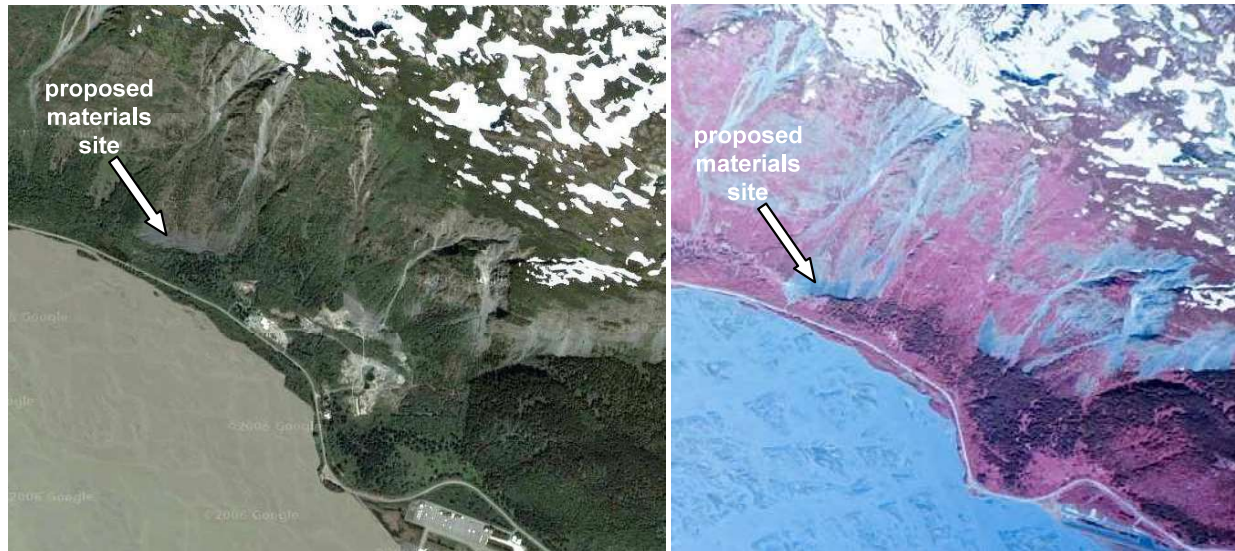
3. The site is located at the base of a debris fan formed by snow and rock avalanches, debris flows, and rock falls (fig. 2a,b). The limited and/or lack of vegetation at the site demonstrate that these processes are still active. Landslides and mixed mud and snow debris avalanches can occur in this type of setting during or after periods of extreme precipitation. Large rain events may cause massive amounts of water and debris to

rapidly flush down the tributary gullies from sources high up the mountain, and snow avalanches may catastrophically deposit snow and rock debris at and beyond the toe of the slope. Steep rock walls above the site may be sources of rock falls that could shed boulders onto the extraction operation. Ground shaking due to earthquakes may exacerbate the potential slope hazards.

4. Based on measurements made on USGS topographic maps, the current slope angle is approximately 36 degrees and represents the natural angle of repose of the constituent materials. Extraction of a sufficiently large amount of material to significantly increase the slope angle and/or undercut the toe of the deposit has the potential to trigger slope failure.

Figure 2. Recent true-color satellite image (a) and 1971 color-infrared aerial photograph (b) of the proposed materials site. The debris fan is sourced in the steep slopes and rocky alpine gullies above the site. Vegetation appears pink and dark red in the color-infrared photograph (b); note lack of vegetation on the fan surface, indicating ongoing, active slope processes. Source: Google Maps (a) and USGS (b).

Consequently, I recommend that the areas described above on the west-southwest slopes of the Takshanuk Mountains be designated for the period of this consistency review.
