## Geotechnical Findings Report

November 3, 2025

Re: Geotechnical Findings Report – Healy, Center Pit

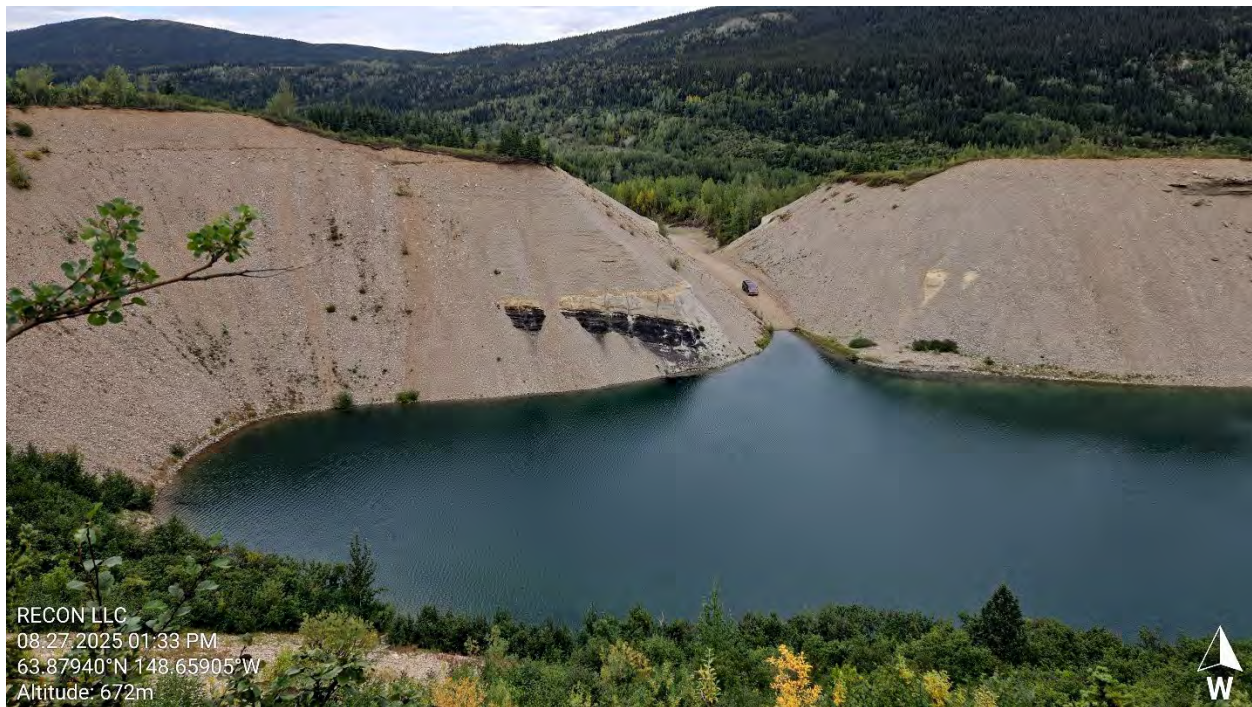
Center Pit is part of a northeast-southwest trending abandoned coal pit. The site is located 11 miles east of Healy and 500 feet south of Healy Creek. The overall pit complex consists of the connected Center Pit (southwest) and Apex Pit (northeast). Center Pit is partially filled with water. Pit sidewalls are steep with slope angles near 30 to 35°. Coal seams are visible in the pit walls on the north side (see Figure 1).

*Figure 1: Center Pit (view northwest, note coal seam and contact between sedimentary rocks and alluvial terrace gravel).*

A **coal seams** is visible in the slope on the north side of Center Pit (see Figure 1). The seam dips approximately 40° towards the northwest and was estimated at 20 feet thick.

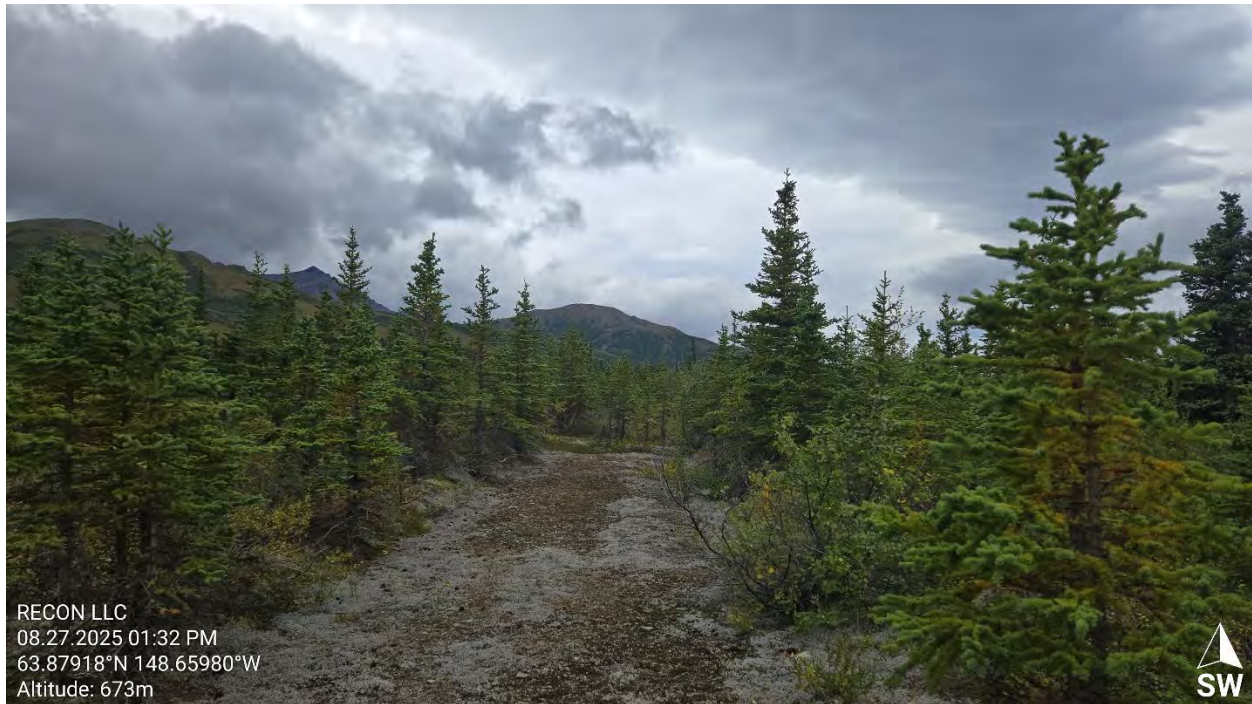
Overburden on the alluvial terrace consists of silt with organics and is relatively thin (generally less than 1 foot-thick). Figure 2 shows an abandoned road on the alluvial terrace south of Center Pit. Road construction on the alluvial terrace is expected to involve removal of overburden and minimal grading.

Figure 2: Old road south of Center Pit.

The elevated area surrounding the pit contains a network of old roads and trails (see Figure 2). These roads were likely accessed from the east via Apex and via a narrow road that followed the east slope of Coal Creek valley 0.5 mile west of Center Pit. This abandoned trail is steep with grades up to 30% and several sections that have been eroded by slope failures.

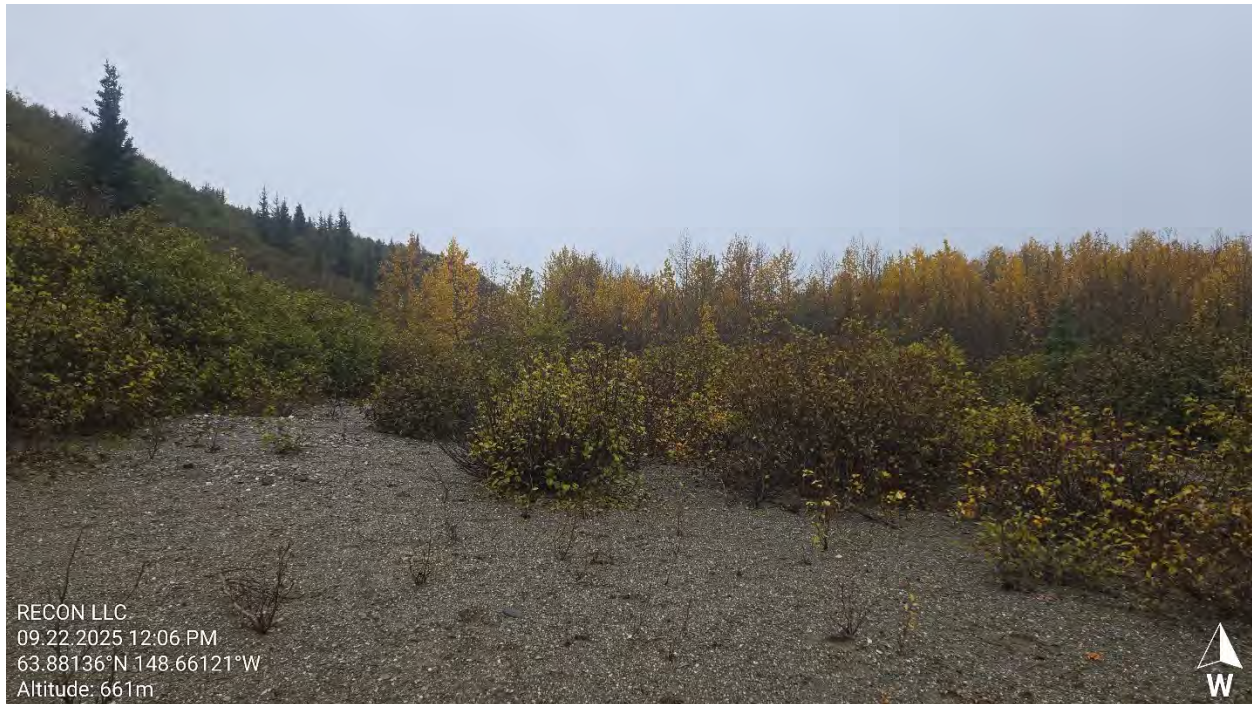
**Spoil piles** are visible in aerial imagery and elevation data north of the pit. Spoil pile surfaces are uneven and partially covered with alders and small trees (see Figure 3).

Figure 3: Surface of spoil pile north of Center Pit (view west).

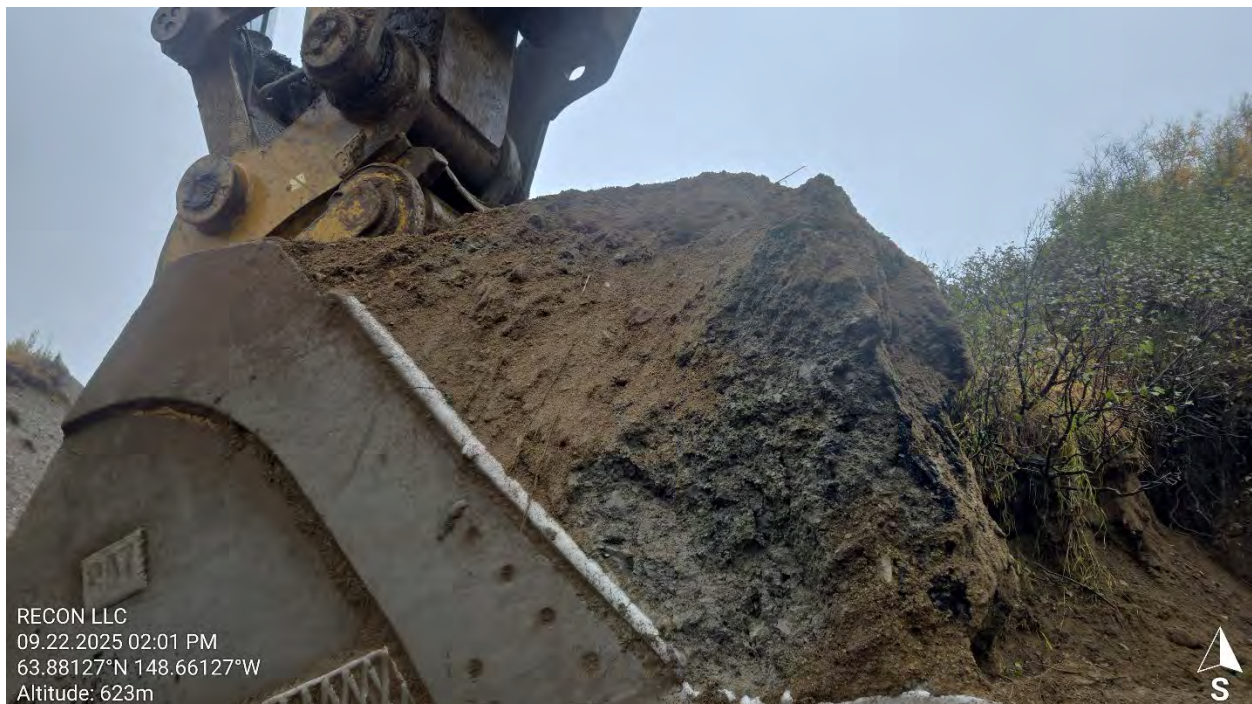
**Clay:** An approximately 3-foot thick layer of clay (see Figure 5) was encountered overlying highly weathered sandstone bedrock in TP-2. Clay was not noted in TP-3 between the sandstone bedrock and alluvial terrace deposits. Clay was also encountered in two borings performed by others near the Cripple Creek Crossing. It was unclear whether the clay layer is part of the sedimentary rock sequence and thus highly weathered claystone or clay that was deposited after erosion of the sedimentary rock and prior to the deposition of alluvial gravel.

Figure 5: Gray, moist to wet clay in excavator bucket.

- Optimize the proposed road route to avoid the coal and chert seams to the extent feasible.
- Remove any clay layers encountered and back-fill with compacted gravel.
- Over-excavate the road sections through friable sedimentary rock and replace with compacted gravel.
- Monitor construction through spoil piles for potentially deleterious material or sections with significantly elevated fines contents. Over-excavate deleterious material and material with elevated fines content and replace with compacted gravel.
- Establish proper drainage during and after construction.
- Minimize impact to the existing seep north of the pit. Do not excavate in or near the seep.
- Utilize the alluvial gravels for embankment construction.

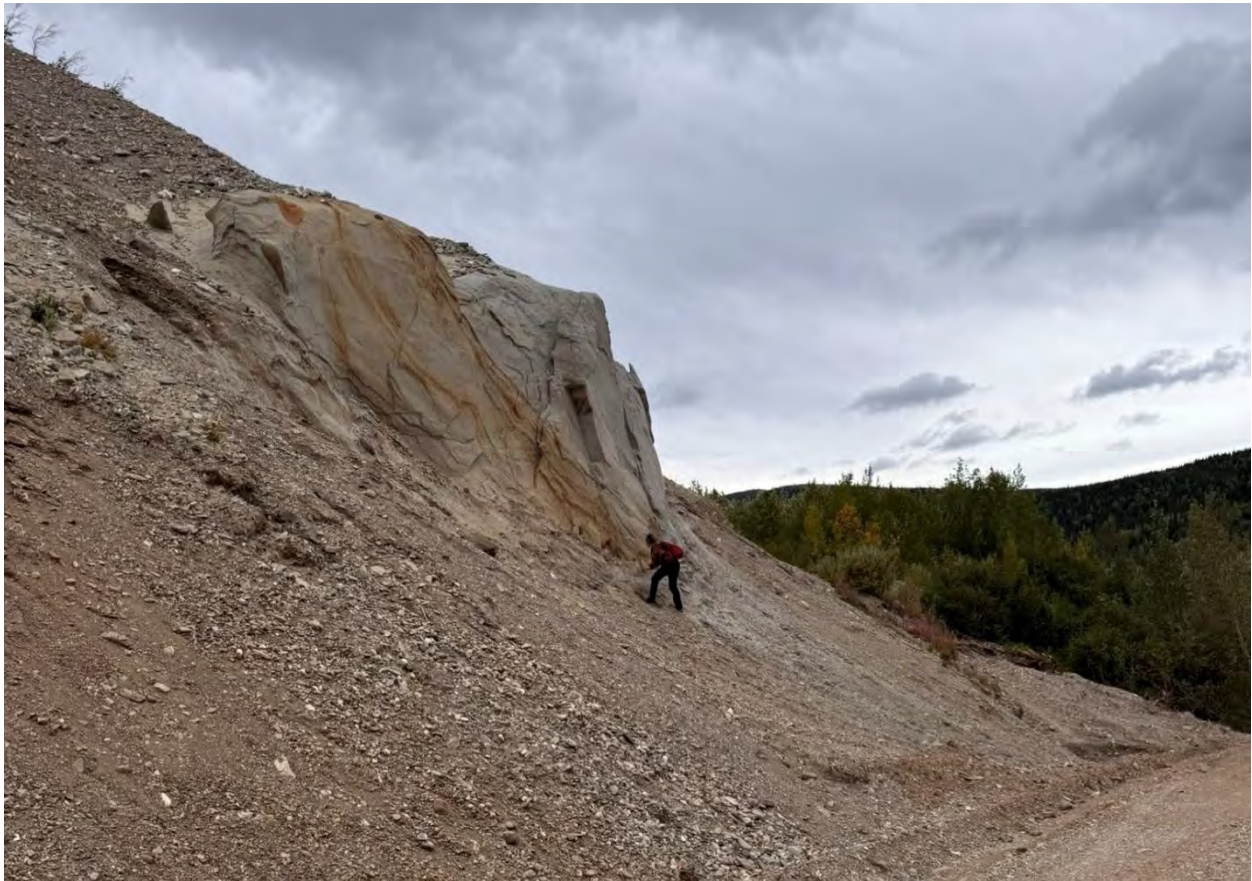
**Sandstone bedrock:** Light gray, extremely weathered and friable sandstone bedrock (Figure 6) consisting of fine- to medium-grained sand outcrops along the existing road cut and within Center Pit. Sandstone can be dislodged by hand and crumbles with little pressure. The top of sandstone appears to be nearly horizontal (likely due to glacial and fluvial erosion). Sandstone is overlain by approximately 50 to 70 feet of alluvial terrace deposits. Clay was encountered between the sandstone and alluvial terrace deposits in one test pit.

*Figure 6: Sandstone in road cut (view north). Note RECON field staff for scale.*

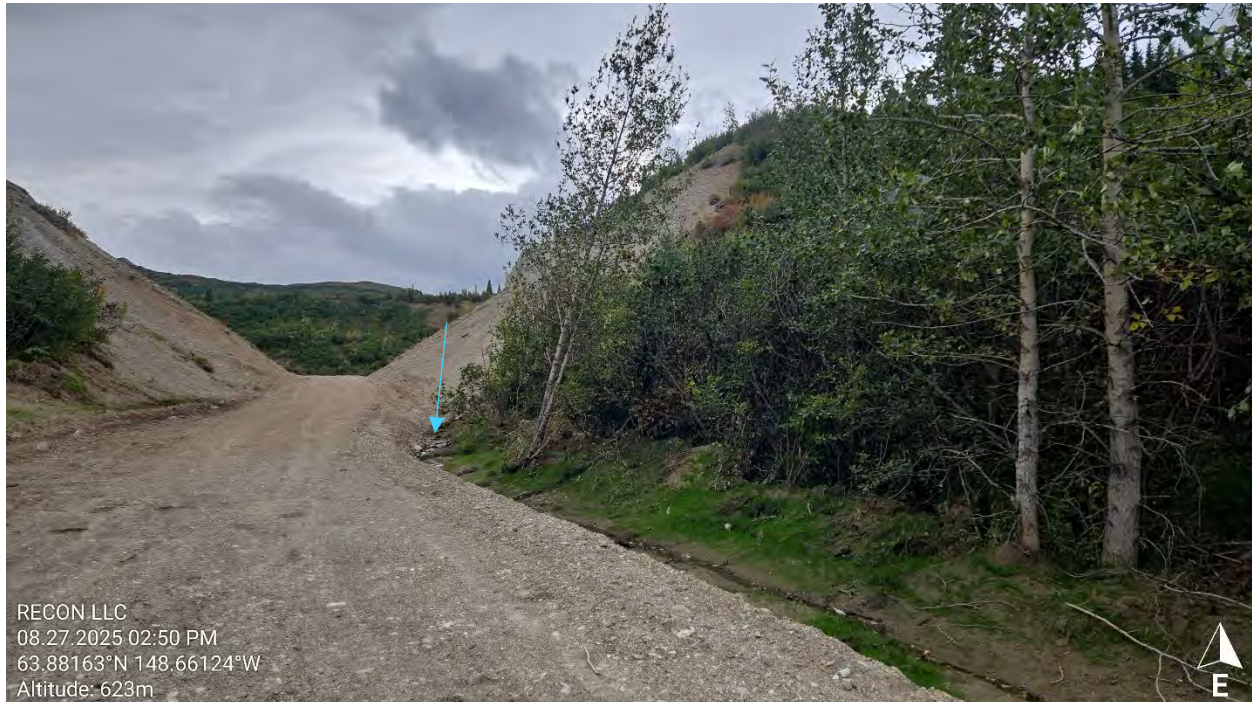
**Water** was not observed in any of the test pits. A seep was noted west of the access road near elevation 2,018 feet (see Figure 7). The seep is likely connected to the water in the pit which is near 2,020 feet elevation.

Figure 7: Seep (indicated by blue arrow) west of re-established access road to bottom of Center Pit (view south).

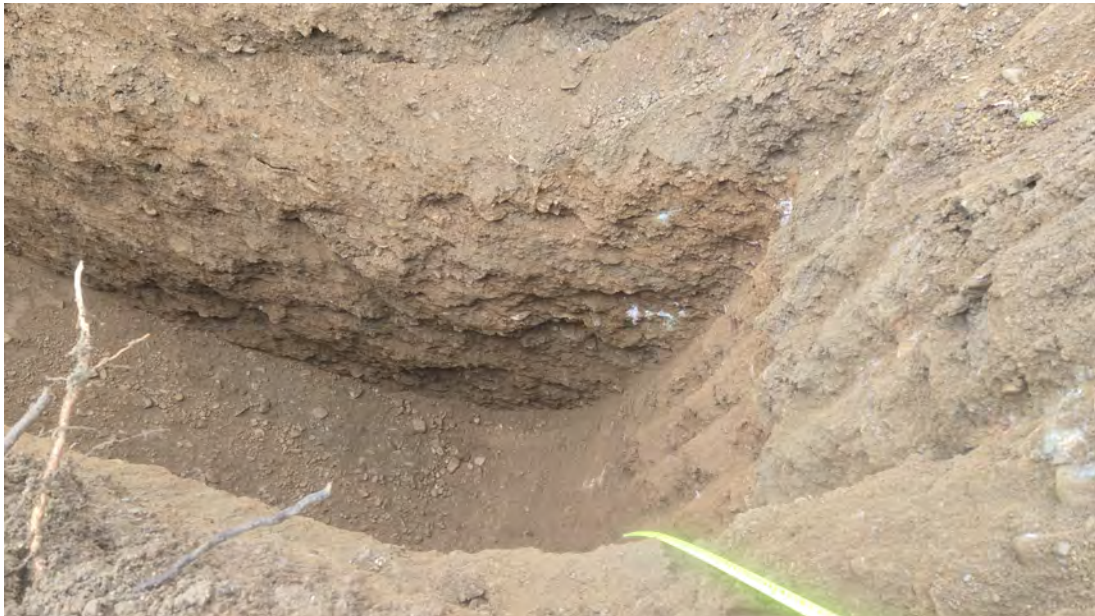
## TEST PIT: TP-1

**Comments** On spoil pile.

| Depth (ft) | Sample Number | Frozen= | Graphic Log | Material Description |
|---|---|---|---|---|
| 5 | S-1 | | | Light brown, loose, <i>Well-graded Sand with Silt and Gravel</i> (SW-SM); moist; with organics (roots) to 0.5 feet; fine to coarse, subangular to subrounded gravel and sand; few cobbles and coal fragments throughout. |
| 15 | | | | - Brown below about 8 feet. |

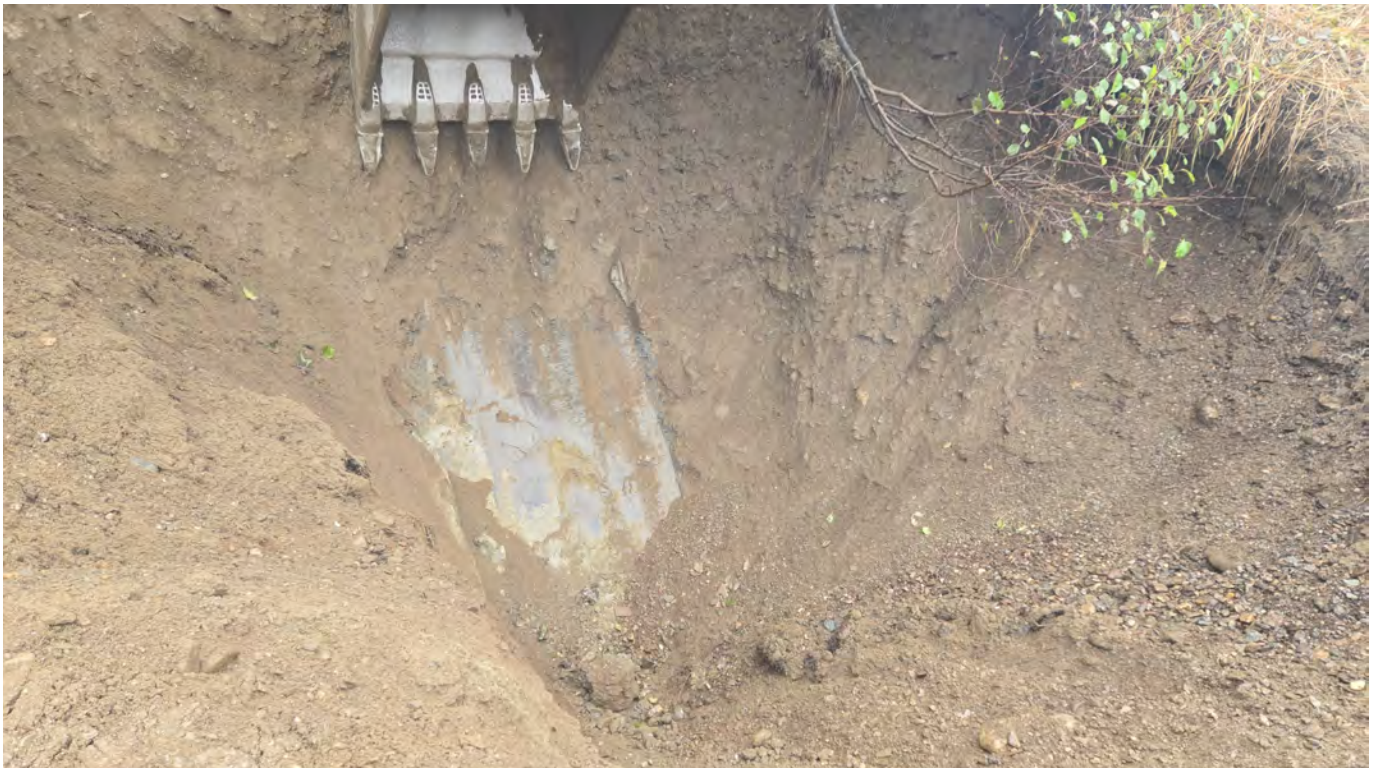
## TEST PIT: TP-2

**Comments** In natural slope south of spoil pile.

| Depth (ft) | Frozen=<br>Graphic Log | Material Description | |
|---|---|---|---|
| 10 | | Gray, soft to firm, <i>Lean Clay</i> (CL); moist to wet. | 12.0 |

Bottom of Test Pit near 14 feet due to sloughing.

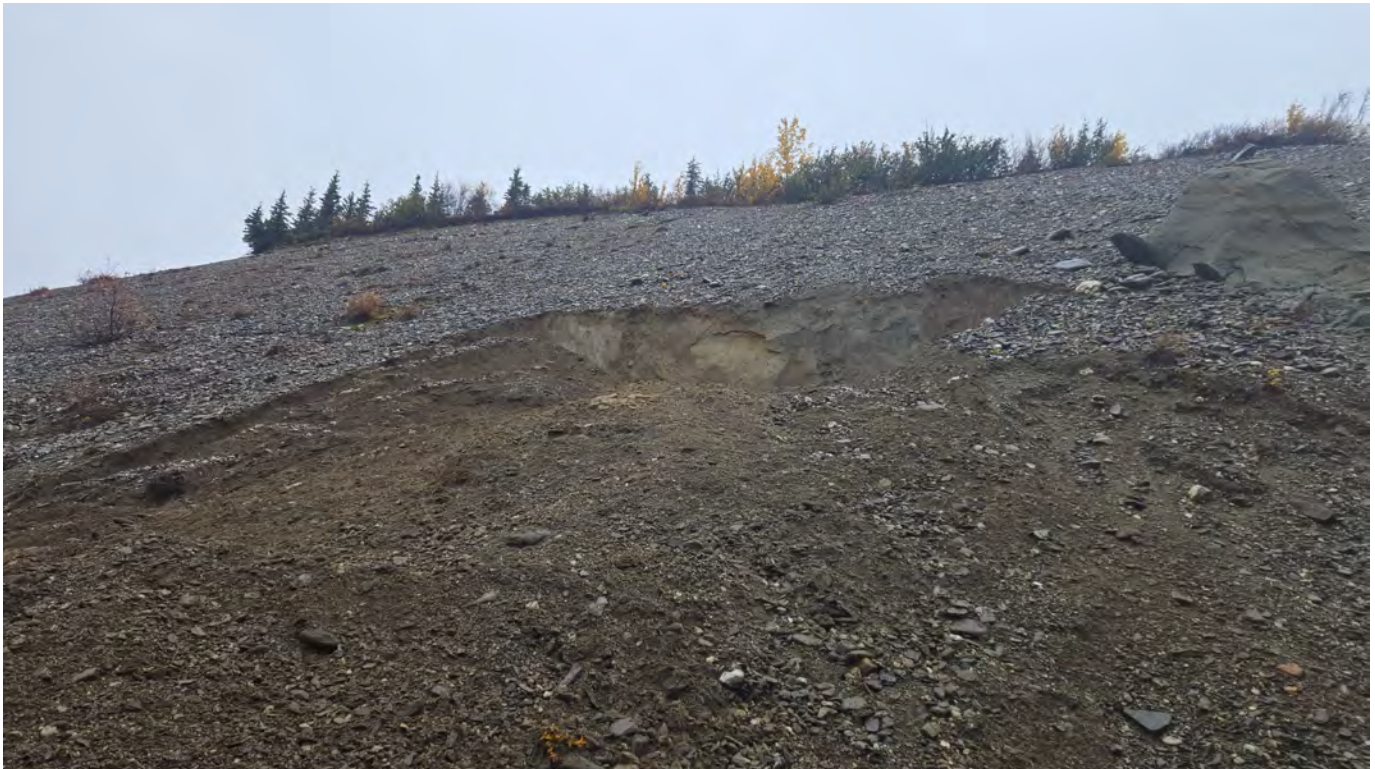
## TEST PIT: TP-3

**Comments** In west slope of road cut.

| Depth (ft) | Sample Number | Frozen= | Graphic Log | Material Description | |
|---|---|---|---|---|---|
| | S-1 | | | Light brown, very loose, <i>Well-graded Gravel with Sand</i> (GW); moist to wet; trace fines.<br>S-1: 65% Gravel; 35% Sand | 2.0 |
| 5 | | | | Light gray, fine to medium grained, <b>SANDSTONE</b> , highly weathered. | 8.0 |

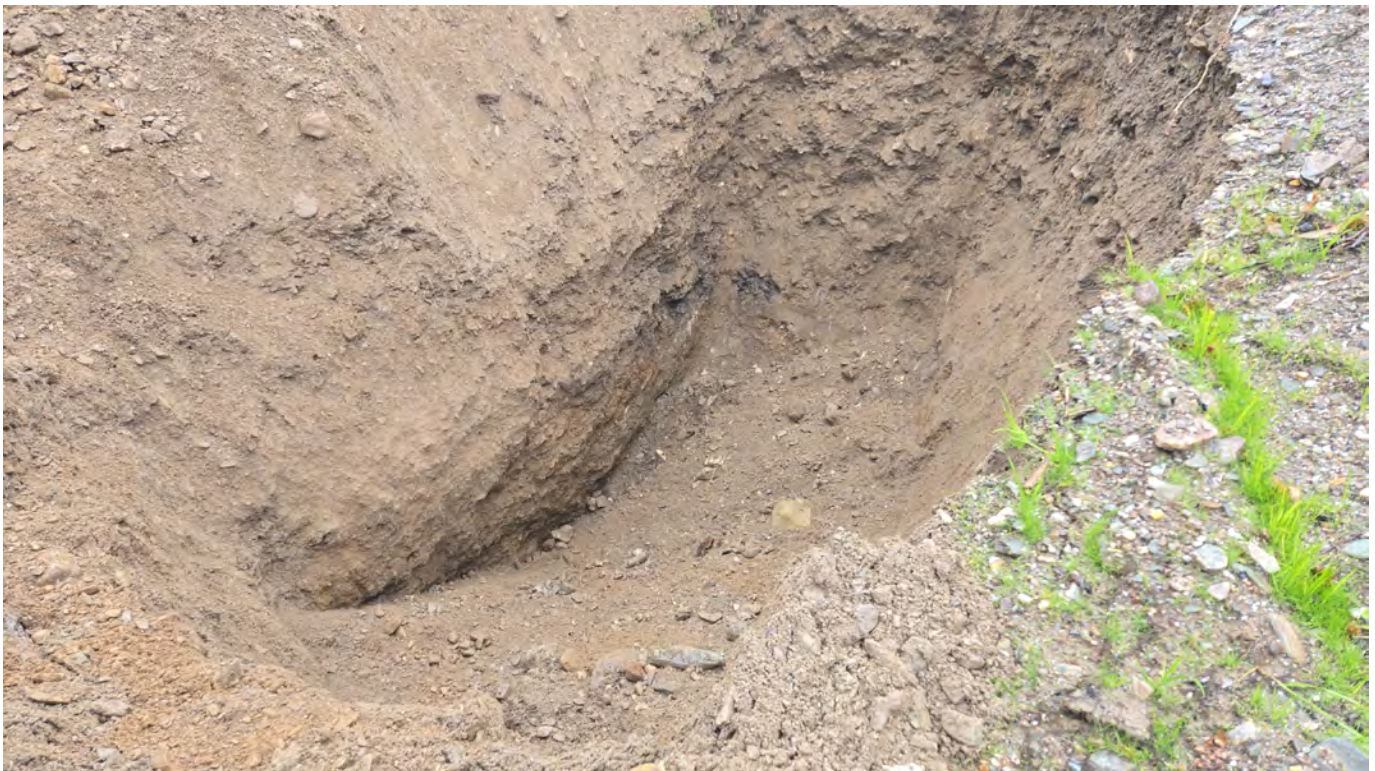
## TEST PIT: TP-4

**Comments** Along western shoulder of access road.

| Depth (ft) | Frozen= | Graphic Log | Material Description | |
|---|---|---|---|---|
| 5 | | | Light brown, <i>Well-graded Gravel with Silt and Sand</i> (GW-GM); moist; fine to coarse, subangular to subrounded gravel and sand; few cobbles and coal fragments throughout.<br><br>- Brown below about 6 feet. | 8.0 |
