DATE: July 10, 2007  
TO: LAS 13742 File  
FROM: Wendy Tatlow, Natural Resource Specialist II  
RE: Field Inspection, proposed creek water withdrawal, Pitchfork Ranch, Lazy Mountain, Palmer, Alaska.

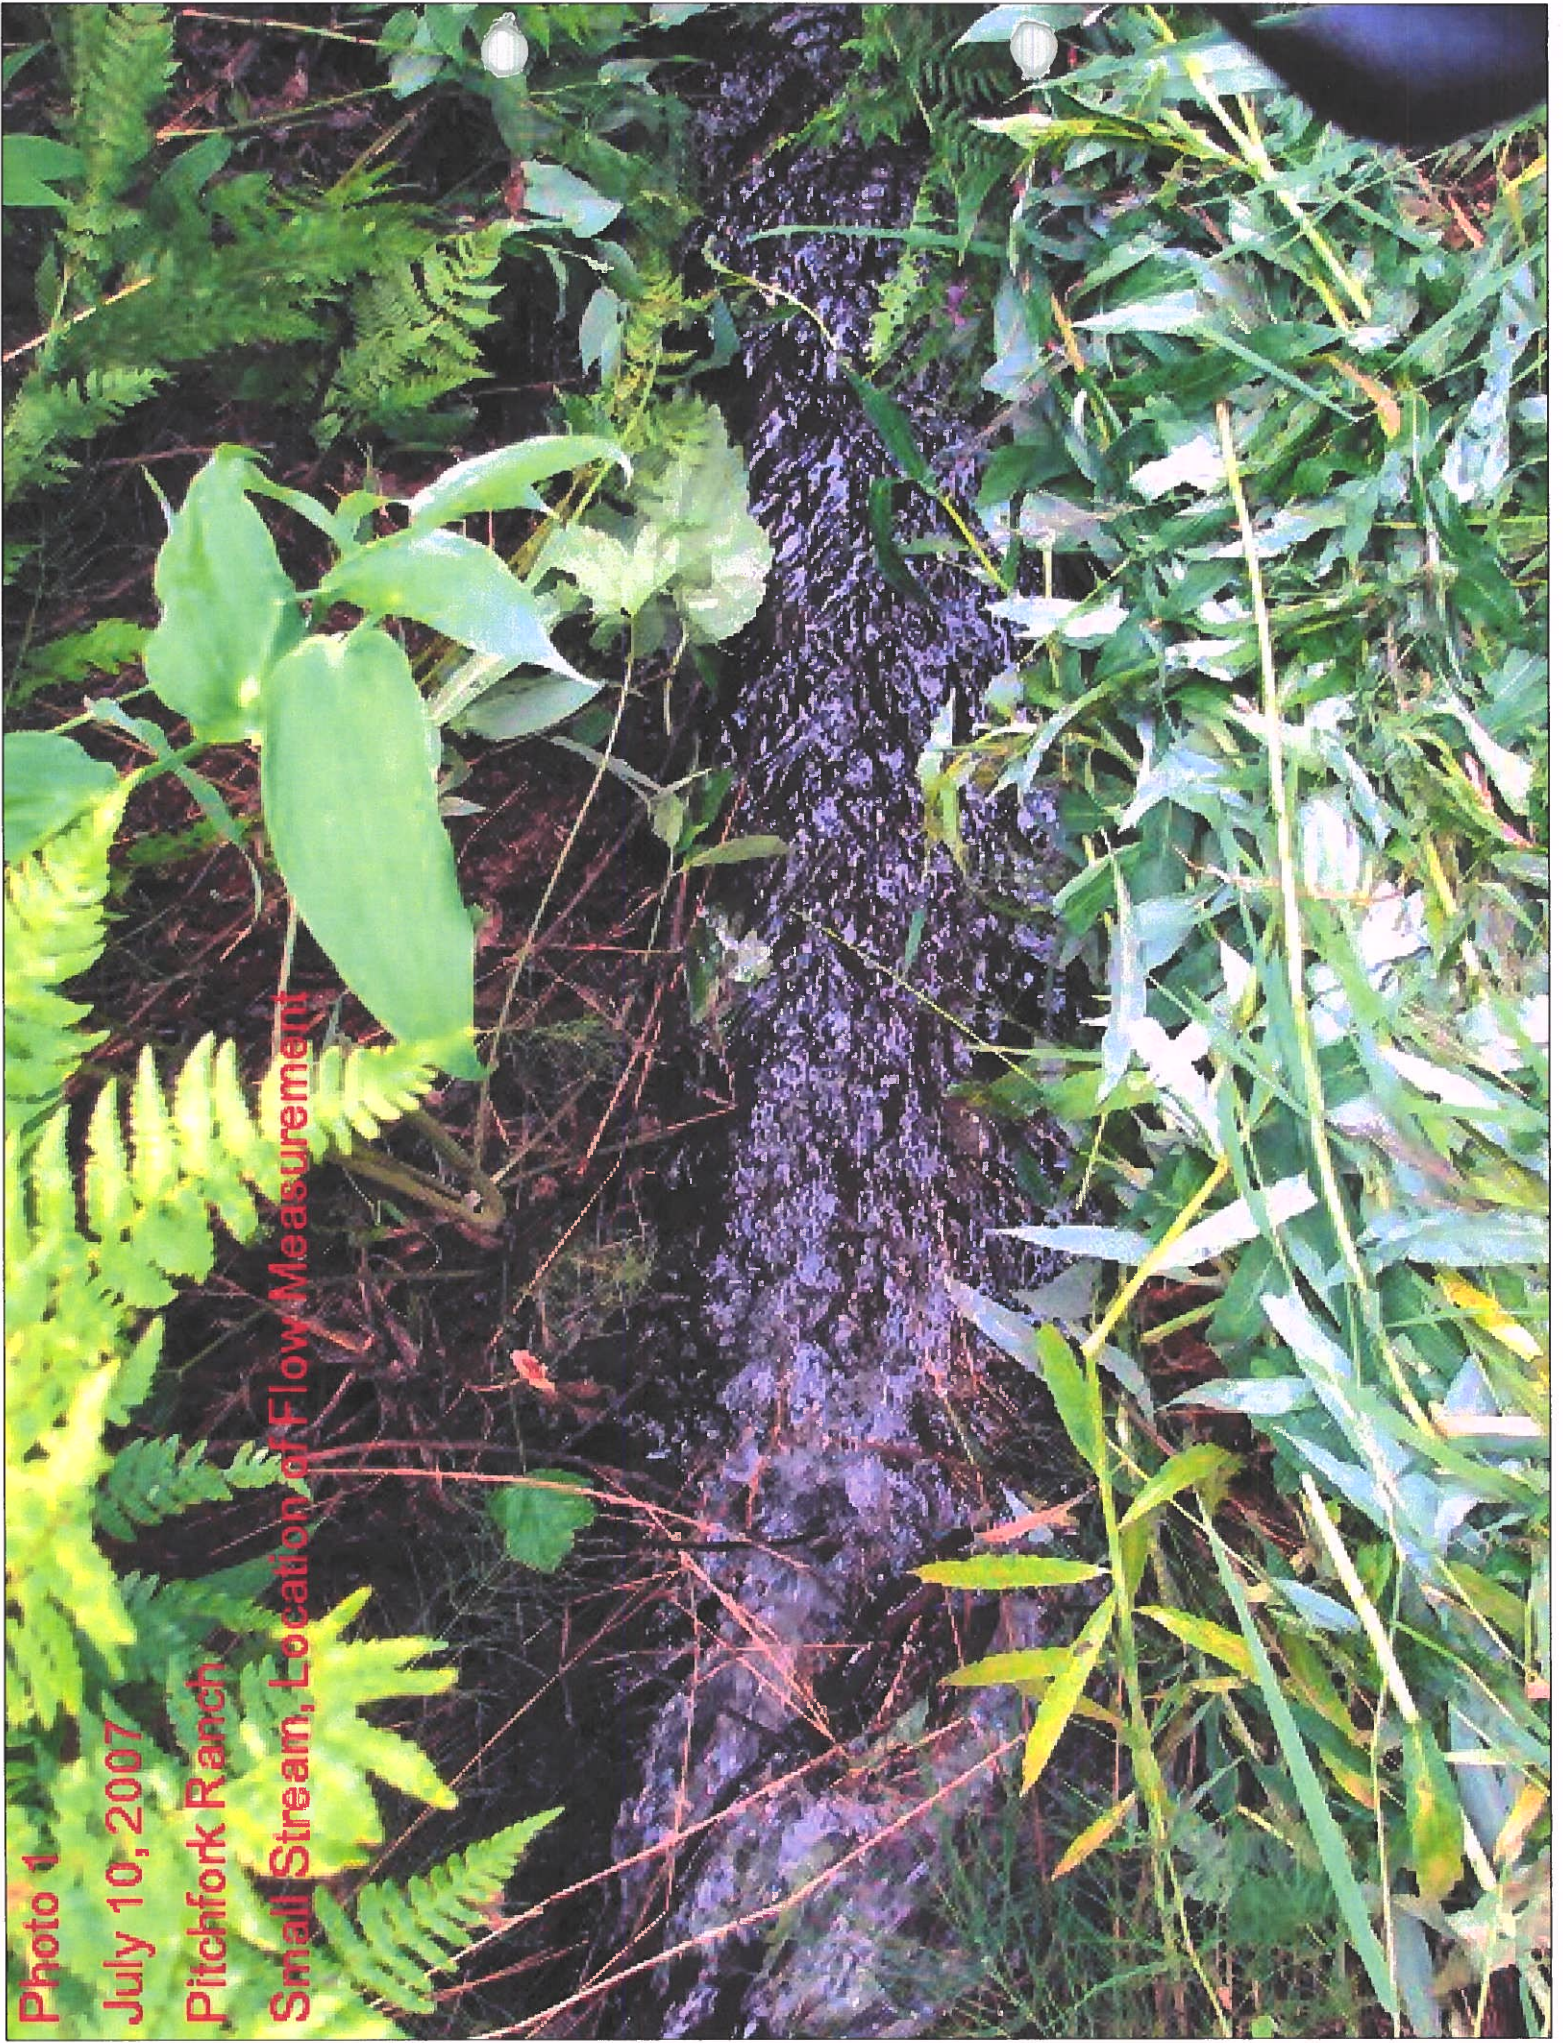
Photo 1

We then went to a gate approximately 150 feet from where we parked and went through to look at the creek. We walked on a trail around a bend in the creek and up to a point where the creek leaves a swampy area on the adjacent property in Section 24. We then went back downstream onto Pitchfork Ranch property and found an adequate location to take a flow reading, Photo 1.

Small Stream, Location of Flow Measurement

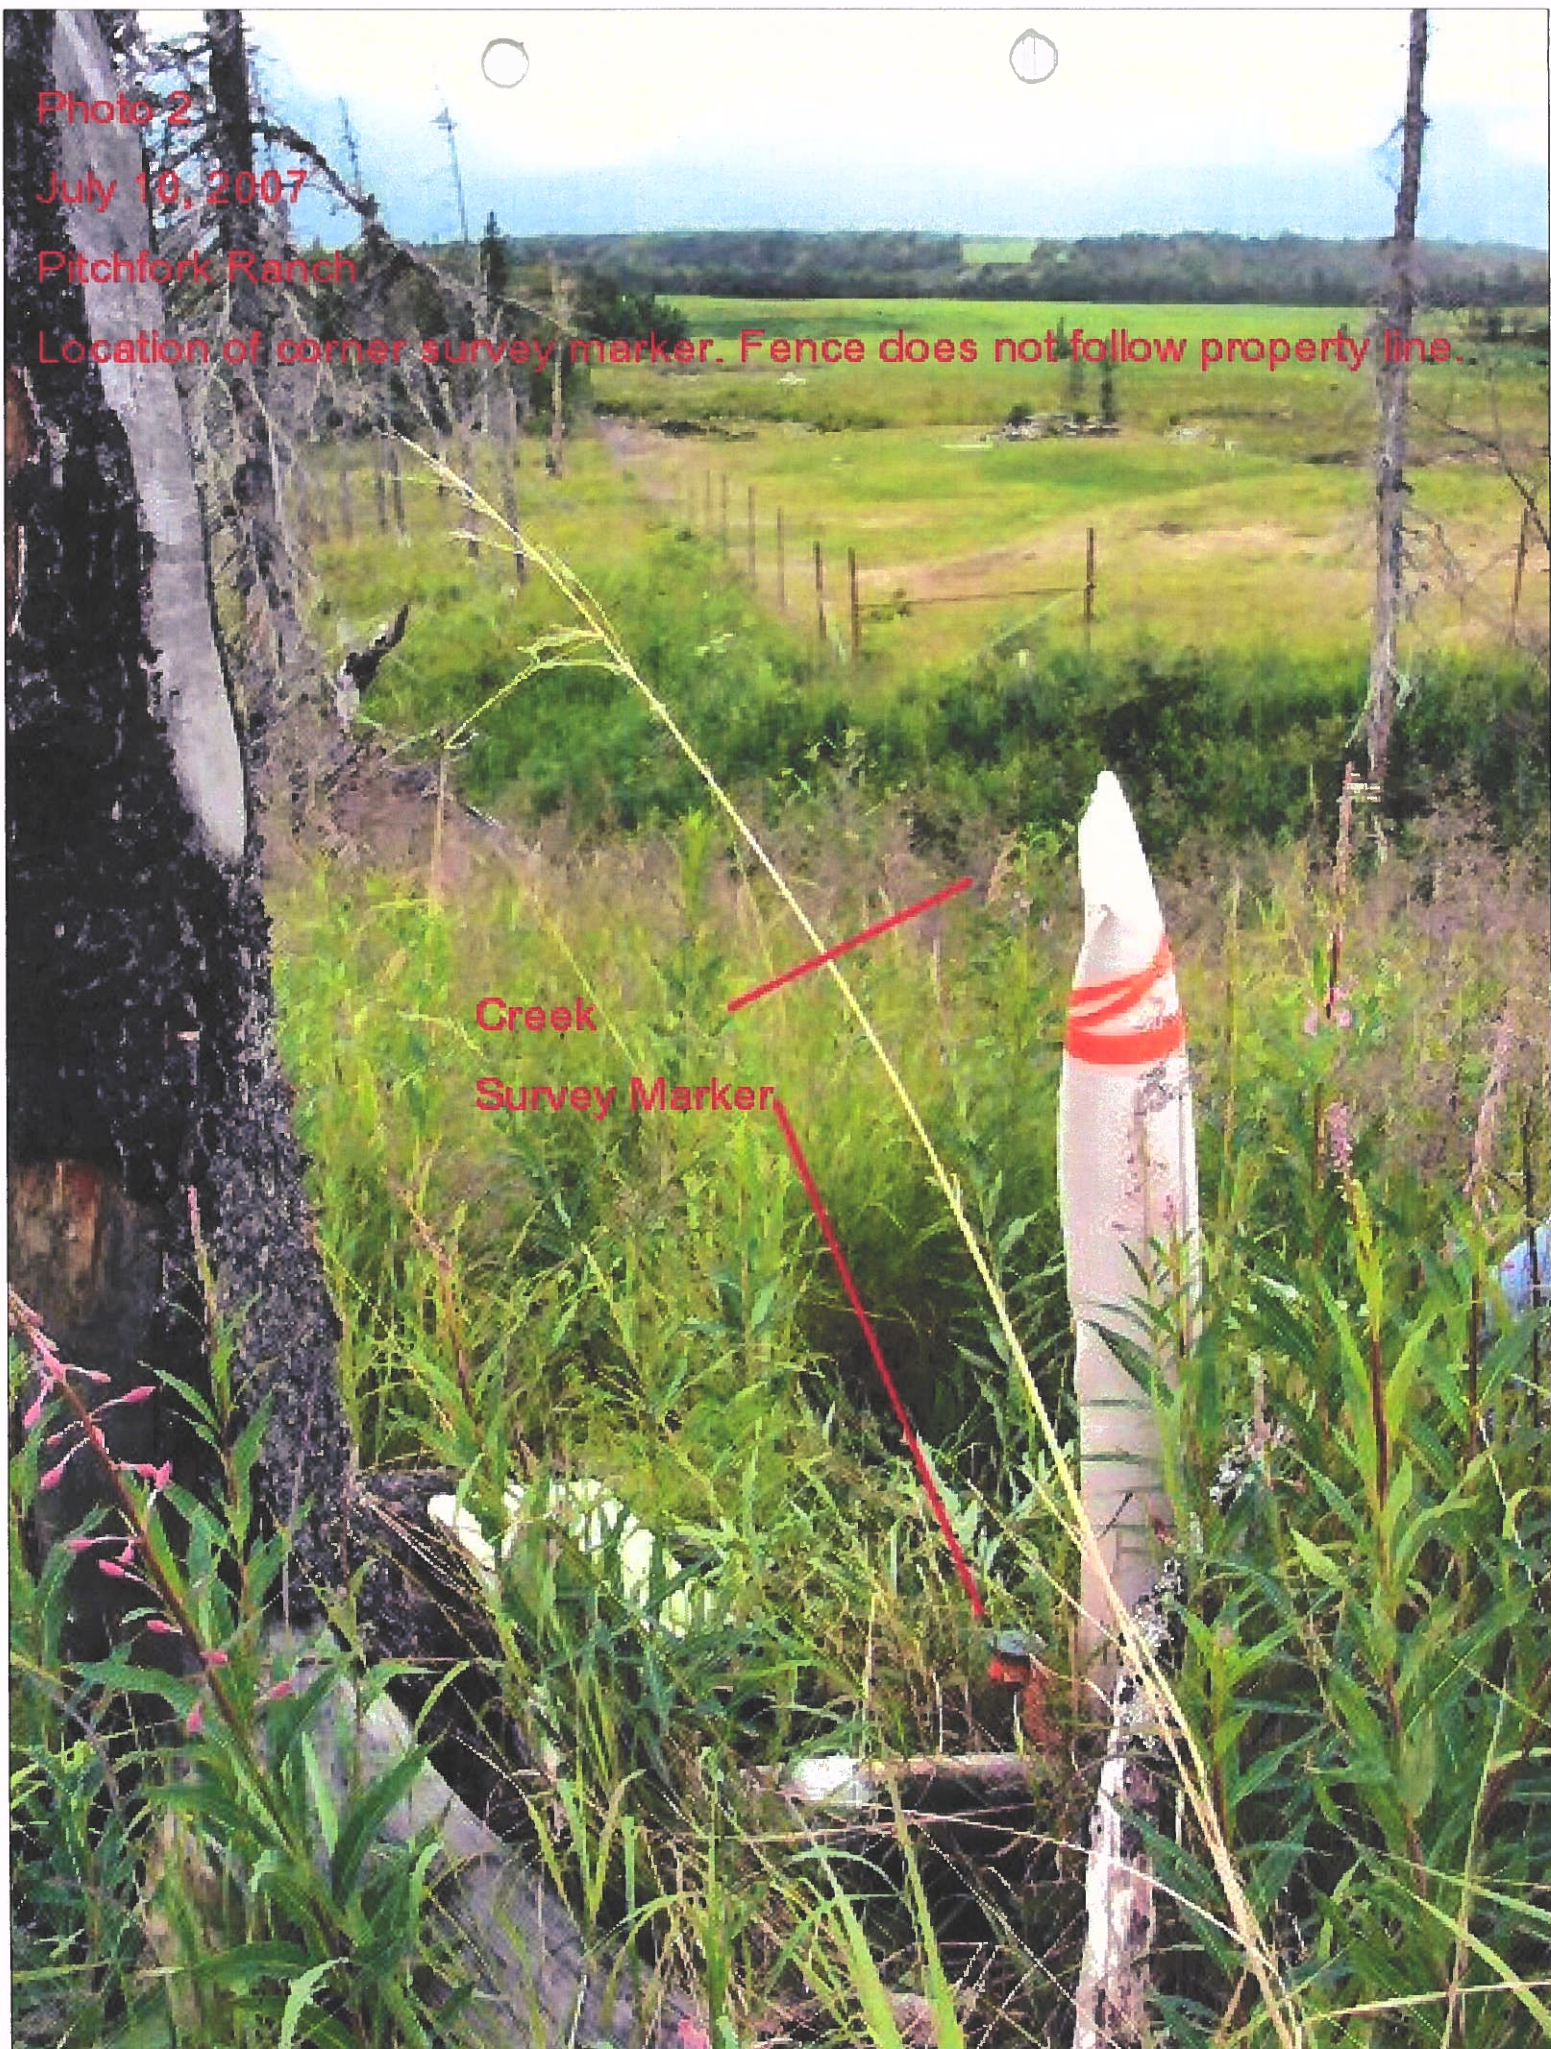
Photo 2

We then crossed the creek and walked to the survey marker. This survey marker designates the South Center ¼ Section point between Section 13 and Section 24. From Photos 2, 3, & 4, Pitchfork Ranch fencing is well within the property boundary. As well, these photos also show that the creek does flow within Pitchfork Ranch Lands and may be accessed as a water source.

Location of corner survey marker. Fence does not follow property line.

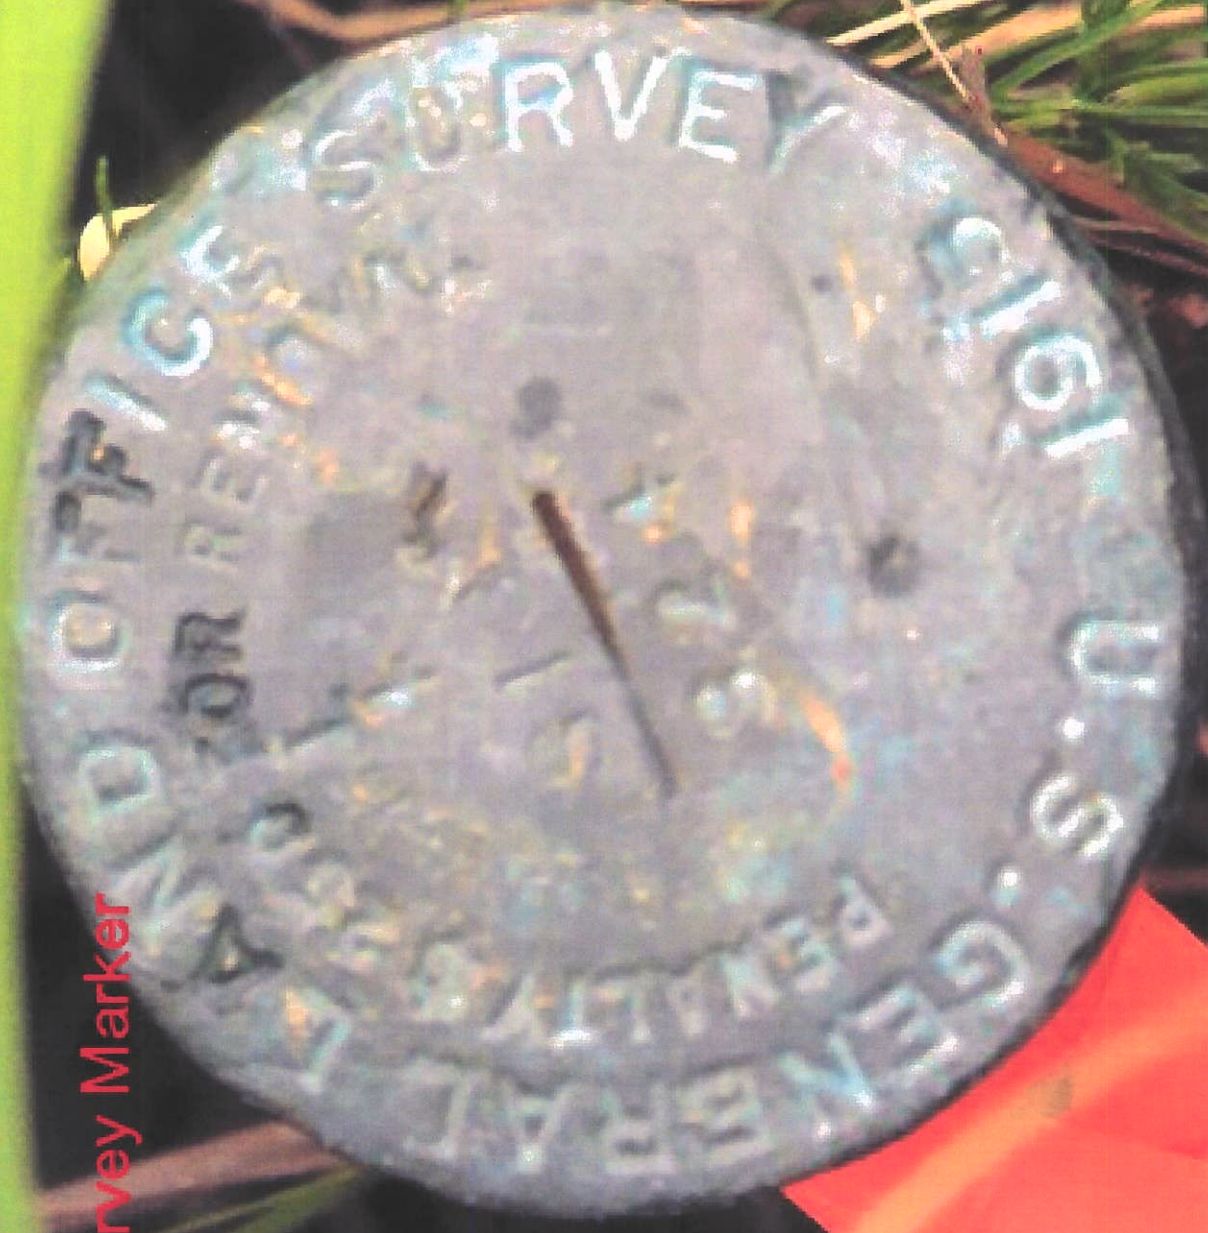
Photo 4

Close up of Survey Marker
