Re: Haines Ferry Terminal Public Water System 2023 Sanitary Survey Response Letter PWSID #: AK2110855 Class: Transient Non-Community; Source: Surface Water

Haines Ferry Terminal Public Water System PWSID: AK2110855

Sanitary Survey Inspection September 19, 2023

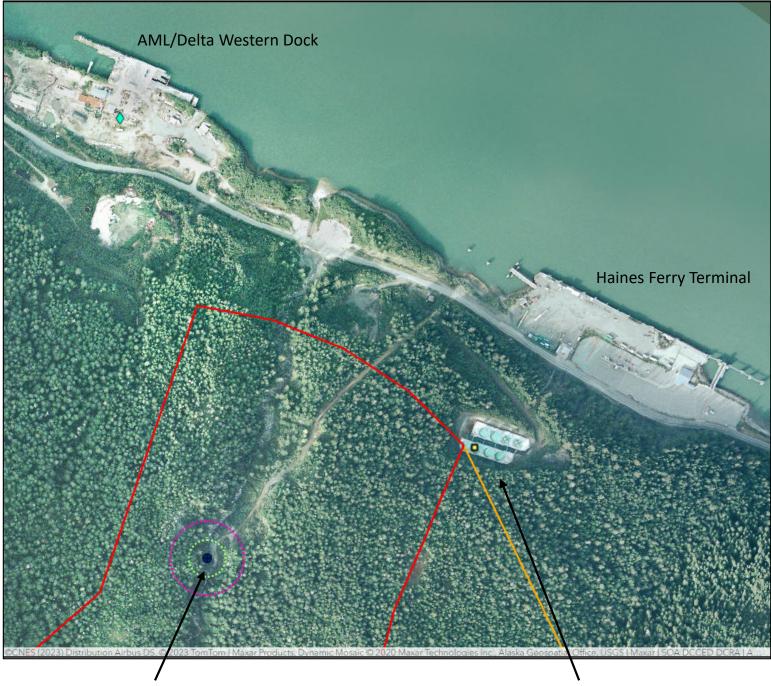
Intake

No known sources of contamination within 100 and 200-foot protective radii. Delta Western Tank Farm

Historic contaminated site, cleanup complete per ADEC Contaminated Sites.

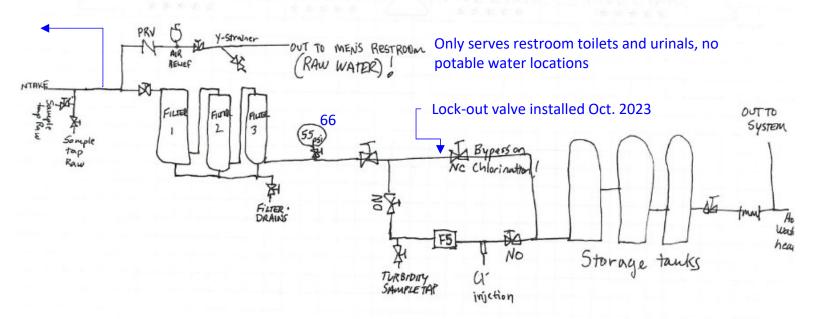
HAINES AMH 2110855 PROCESS SCHEMATIC 7/11/18 Jarah Ramon

E= Flow Switch 15 = value

M PRV - & Pressure Reducer Value

Additions in blue, verified 9/19/23. -T. Hakala

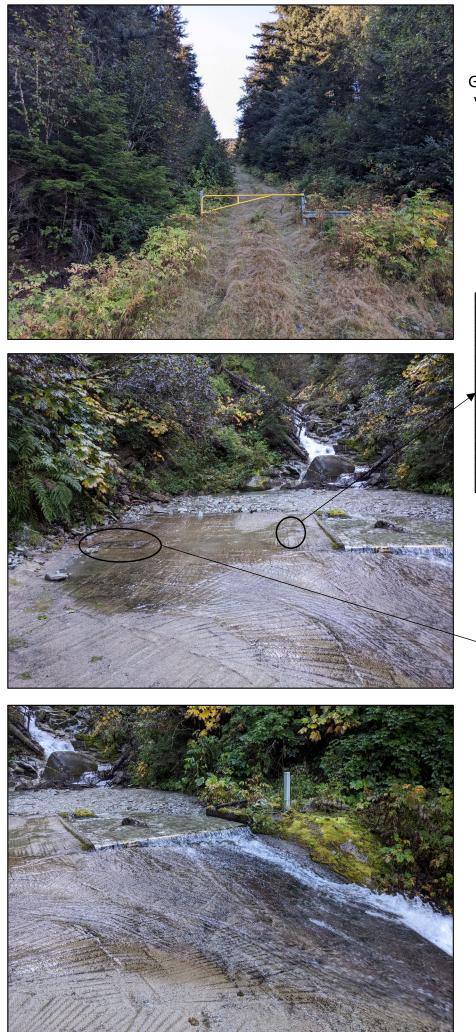
Gated road leading uphill to intake. Vehicles are not typically used for access due to steep grade.

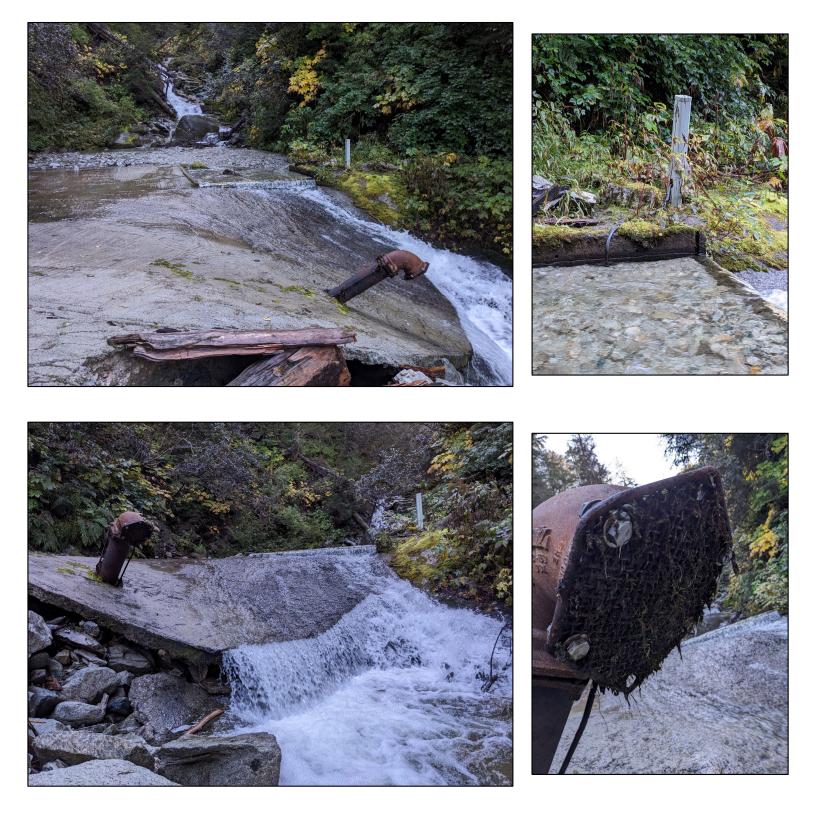
View of intake area; area has been modified, including installation of concrete within the last 3 years.

More views of intake area. Area has been modified and concreted installed within the last 3 years, per system operator. It was unclear where the intake piping is located, possibly buried or not visible in the stream. Ferry terminal personnel rarely come to the intake. It is owned by the Haines Borough, not AMHS.

- 2. Modifications have been made to the source intake that do not appear to have gone through the engineering plan approval process, including the installation of concrete to the surrounding area. It is estimated this work took place in the last 3 years. The Drinking Water Program understands the intake property and infrastructure is owned by the Haines Borough and not the Alaska Marine Highway System. Please coordinate with the Haines Borough to determine if engineered plans or design drawings are available documenting the modifications. Depending on the documents the Haines Borough has, it may be possible to include these modifications in the approval of the new treatment system or it may have to be handled separately. Either way, intake modifications must be approved by DEC engineering. Please contact Charity Bare at the above contact information with questions on the approval process.

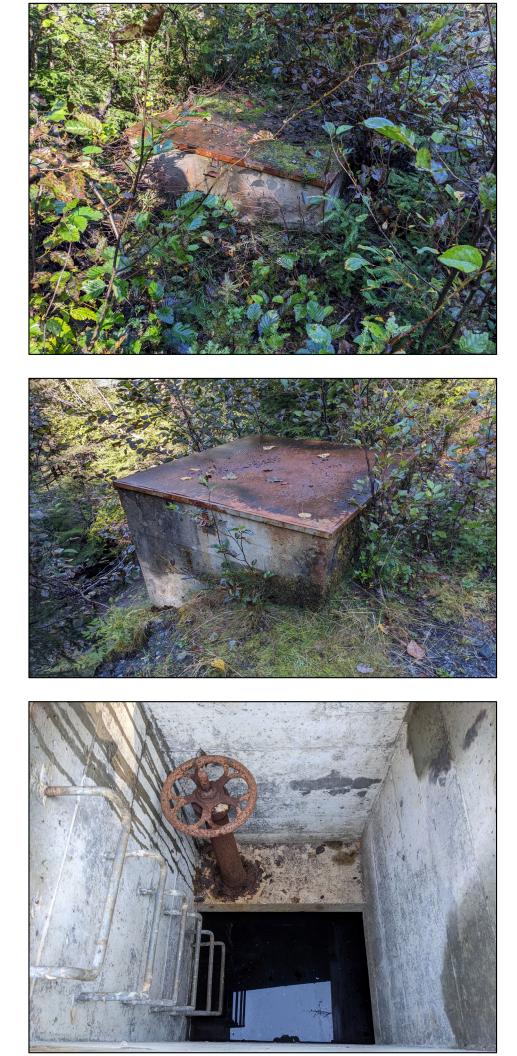
Valve and settling vault #1, down road from intake on hillside; lock was broken.

Valve and settling vault #2, close to #1; unlocked.

Inside of vault #2, water was 7 ½ feet deep, vault is 14 feet deep.

2. It's recommended both raw water settling vaults near the source intake be locked to prevent unauthorized users from accessing them.

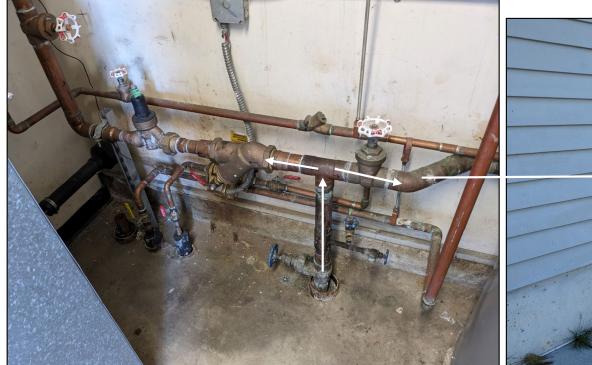
Raw water enters terminal, tees, right pipe runs outside and discharges year-round for freeze protection.

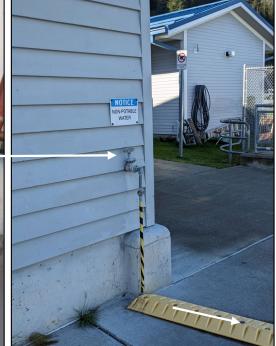
Non-potable sign has been added following 2018 survey.

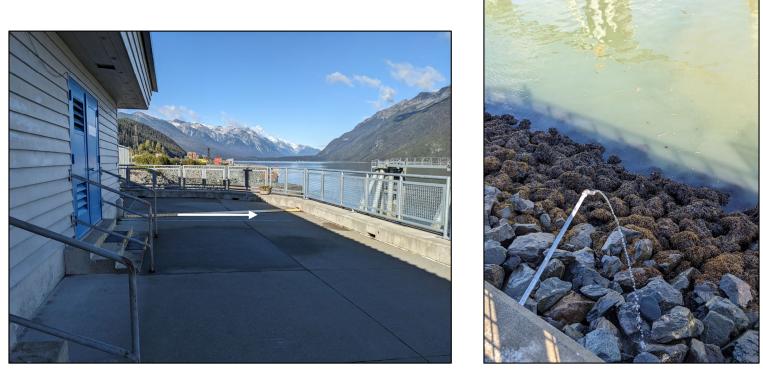
Pipe runs to breakwater wall and discharges. Discharge point is located above high tide line.

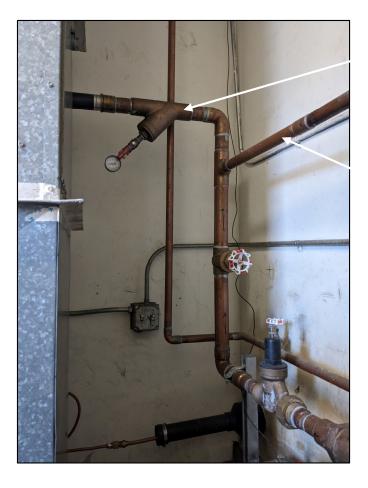
Reliance hot water heater.

Raw water to bathrooms. Only serves urinals and toilets, not sinks.

Raw water to treatment.

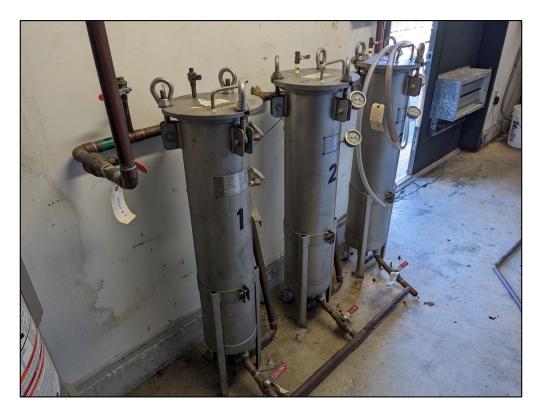
Strainrite filtration system, 3 stages of filtration.

Replacement instructions are posted on the wall, see page 12.

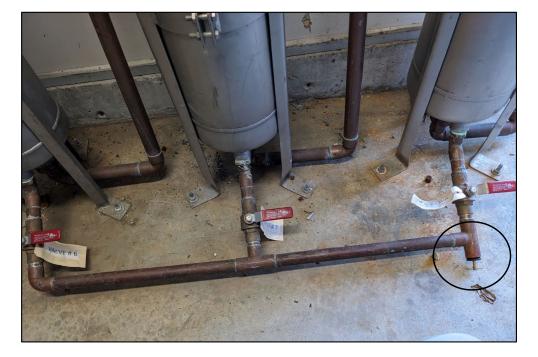
Filter drain capped following 2018 sanitary survey.

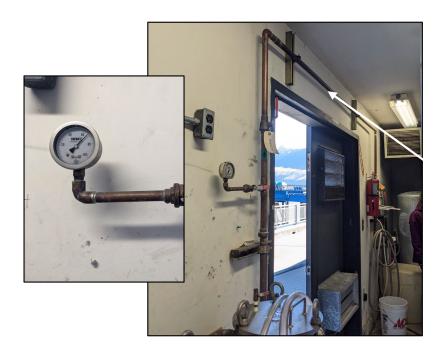
Line running from filters to chlorination and pressure tanks; pressure reading 66 psi.

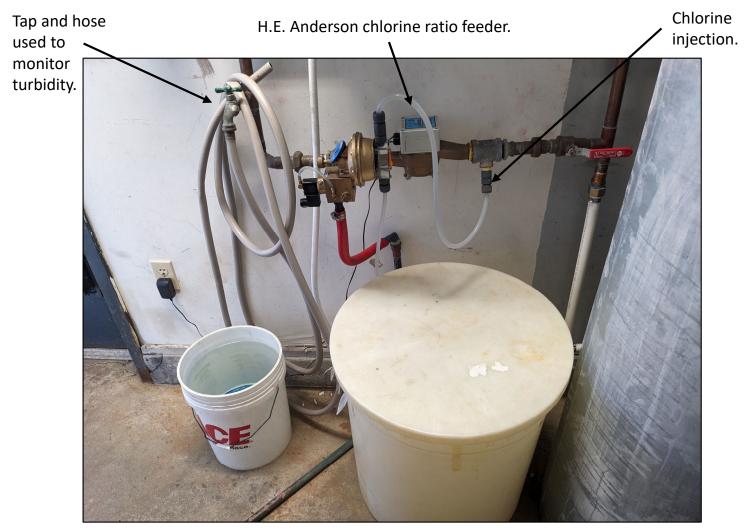
Turbidity monitoring tap followed by chlorine injection system; inside vat is 5-gallon bucket of solution, new batch made every 2-3 weeks as needed.

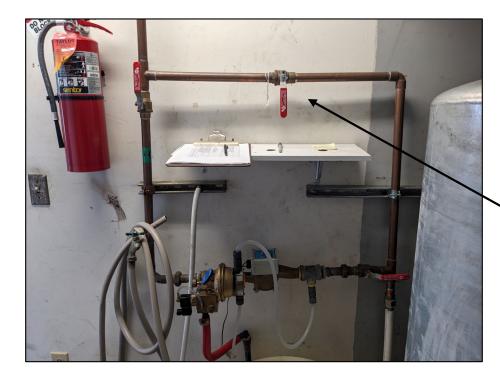
Bypass of chlorination system; system ordered a lock-out tag-out valve that was installed after the inspection (see page 15).

- 1. At the time of the inspection a bypass existed on the chlorination system. This was an outstanding deficiency from the 2018 sanitary survey. A lock-out valve was ordered, and documentation of its installation provided October 27, 2023. This item is considered addressed, and no further action is required.
- 2. All three hydropneumatic pressure tanks were replaced in August 2023 following the failure of one in July 2023. These tanks have a liner certified to NSF-Standard 61 and nothing further is required at this time. Hydropneumatic tank function should be evaluated in addressing deficiency #1.

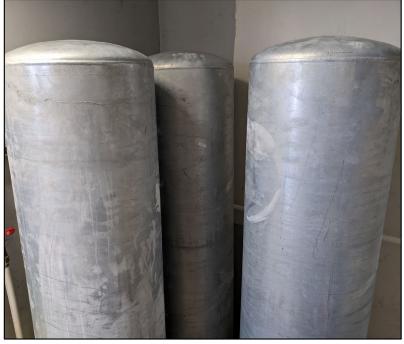
All 3 tanks were replaced in August 2023 with Quick Tanks, Inc. Q82V 82-gallon galvanized vertical tanks with NSF standard 61 lining.

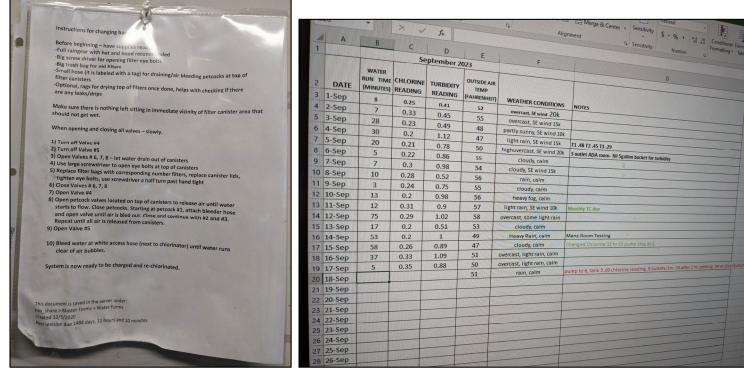
Filter replacement instructions posted on wall by filters. Written so inexperienced personnel can follow. Excel spreadsheet Haines AMHS personnel have created to track daily readings, maintenance activities, weather, and other notable comments related to the water system.

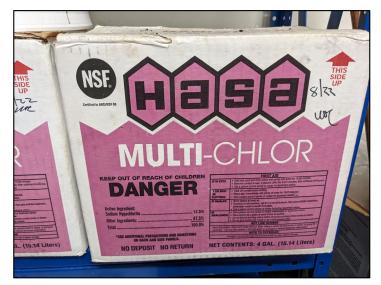
Chlorine, NSF-60.

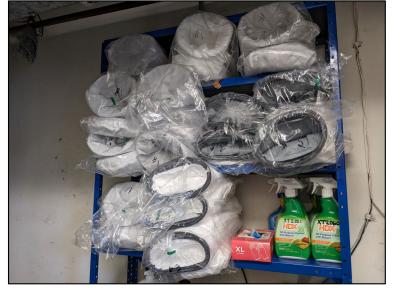
Spare filters onsite.

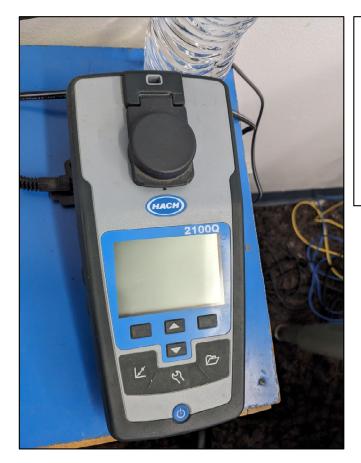
Monitoring equipment includes Hach 2100Q turbidimeter with StablCal calibration standards, and Hach Pocket Colorimeter II with unexpired DPD free chlorine reagent packets.

- Verification of calibration for the Pocket Colorimeter II is not routinely occurring. Calibration should be verified quarterly to ensure the unit is maintaining calibration within acceptable range. HACH sells secondary standards that can be purchased to verify calibration (<u>https://www.hach.com/p-speccheck-secondary-gel-standards-set-dpd-chlorinelr/2635300#overview</u>). It may also be possible to coordinate with other local water systems who already have these standards.

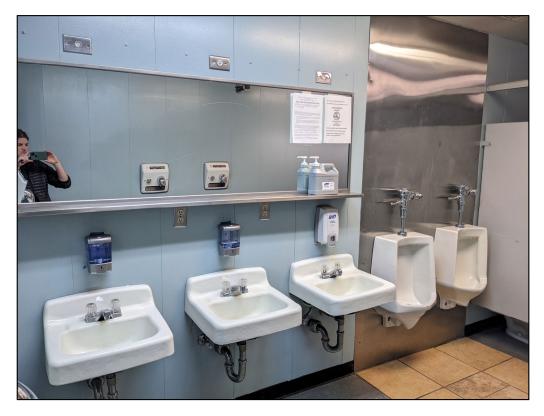
Men's bathroom, used left tap to measure chlorine residual during the inspection.

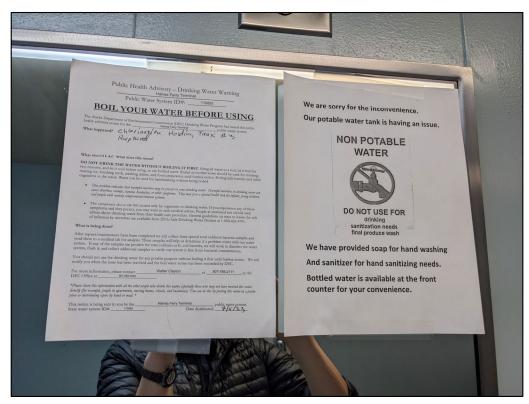
Boil water notice posted in bathrooms and water fountain.

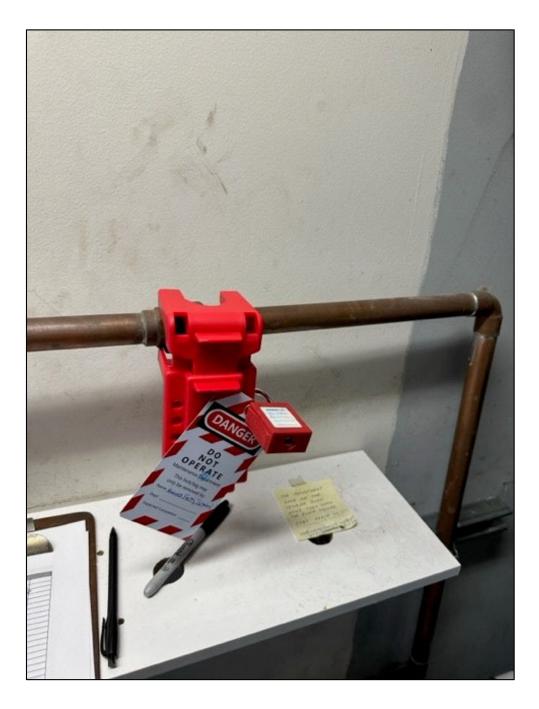
A lock-out valve was installed on the chlorine bypass following the inspection. System provided photo documentation on 10/27/2023, which resolves related deficiency.
