Guide for School Facility Condition Surveys

ABC ELEMENTARY MECHANICAL CONDITION SURVEY

Mid-Alaska School District**School Facility Condition Survey ABC Elementary****August 2019**

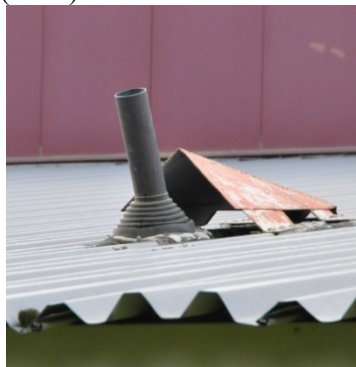
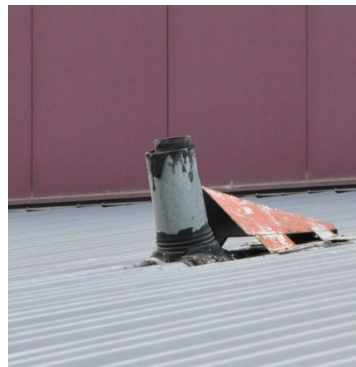
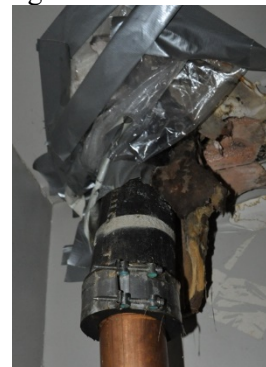
The sanitary waste piping and venting was not generally visible for inspection with the exception of short runs within the mechanical room. However, there was no ancillary evidence that the waste and vent piping was not performing adequately except as noted below. There are two plumbing vent through roof (VTR) extensions on the north sloped roof that have been bent over by sliding snow.

The waste piping is buried and was not available for inspection. The underground piping could be flushed and inspected with a camera to review the condition of the piping.

Consider repair of VTRs as O&M work.

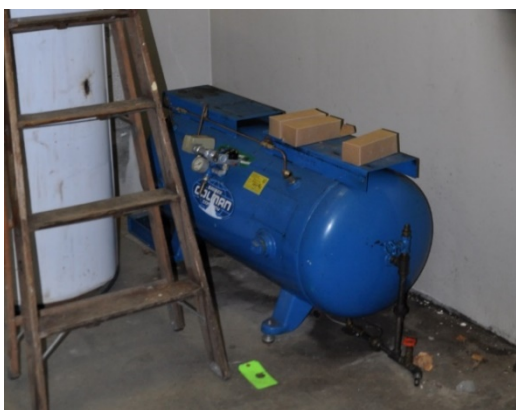
Mechanical controls installed in the original construction (a pneumatic system) are in disrepair, all are non-functional due to the absence of head end equipment (i.e., the compressor). The operating system and main controllers of this system are suspect even if the system was charged and pressurized and should be replaced or upgraded. In addition, approximately 40% of the room temperature sensors on the west side of the facility are missing. The remaining room temperature sensors indicated a reasonably accurate room temperature. The control air compressor storage tank in Mechanical room was not in working condition; only the tank remains.

Remove all elements of the non-functioning pneumatic control system and install a DDC control system.
