KASAAN LIBRARY TECHNICAL SERVICE SUPPORT RFP 18-326-21 Issued October 13, 2020

The Department of Environmental Conservation (DEC), Division of Spill Prevention and Response, is soliciting proposals from qualified professionals to provide technical support associated with the abatement, transportation, and disposal of asbestos-containing materials (ACM) from the Kasaan Library in Kasaan, Alaska.

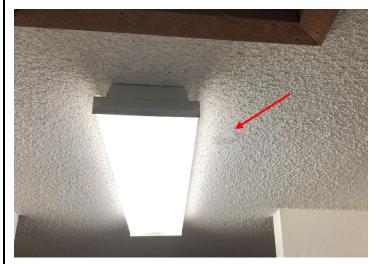
Photo 17. Sample A-5, Hallway, Ceiling, Ceiling Texture

Site activities were conducted on October 31, 2019. No LBP was identified on the subject property. ACMs were identified in the joint compound and ceiling texture in the hallway and main room of the building on the subject property. The items containing ACMs are in good condition. Prior to building renovations, it is recommended that any ACMs that may be disturbed during renovations be abated by appropriately trained professionals to reduce the potential for human and ecological contact and to comply with applicable regulations.

It is recommended that the ACMs identified during preparation of this PACP and during previous asbestos inspections on the subject property be abated, packaged appropriately for shipping, and transported to an appropriate disposal facility, or encapsulated. It is also recommended that the AST be equipped with secondary containment.

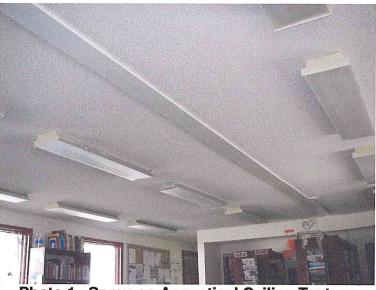
Photo 1. Spray-on Acoustical Ceiling Texture

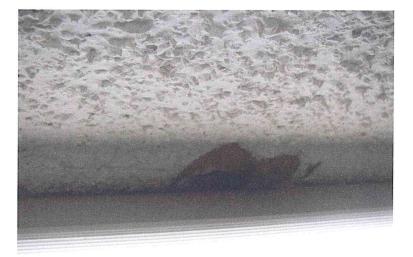
Photo 2. Damage to Spray-on Acoustical Ceiling Texture

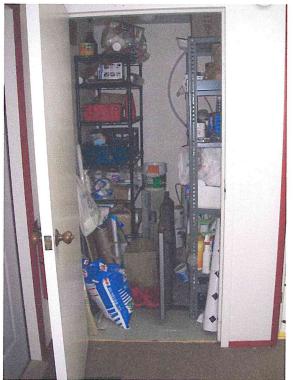
Photo 3. Plywood Painted Grey Covering Asbestos Sheet Vinyl and Mastic

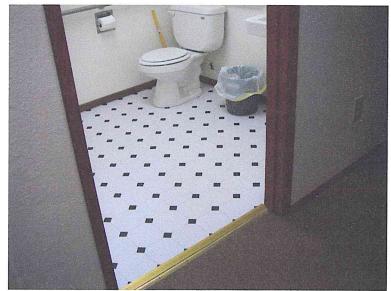
Photo 4. Linoleum on top of plywood Covering Asbestos Sheet Vinyl and Mastic
