## Temporary Land Use Permit Application Supplemental Information

Foggy Island Bay State No. 1 Corrective  
Action Project

October 2022

## Site Rehabilitation Plan

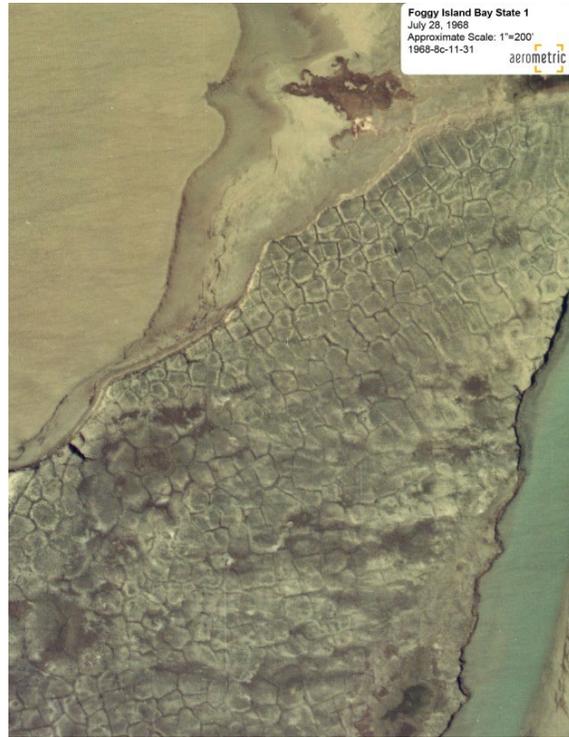
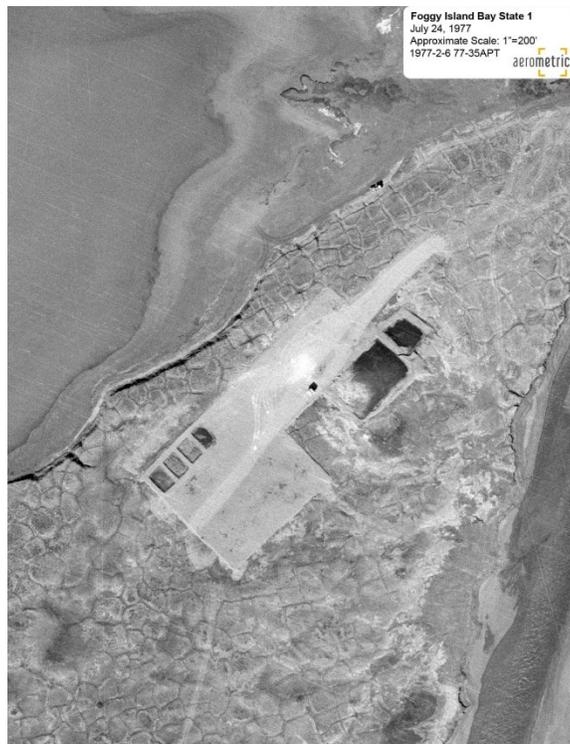
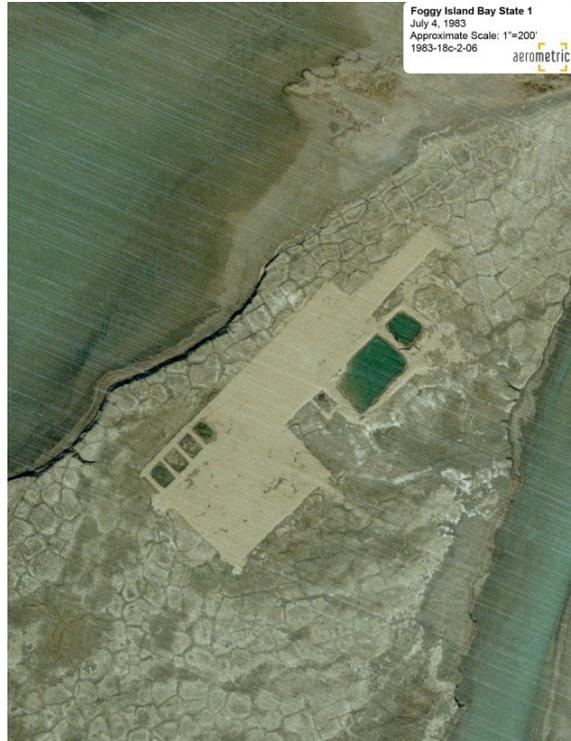
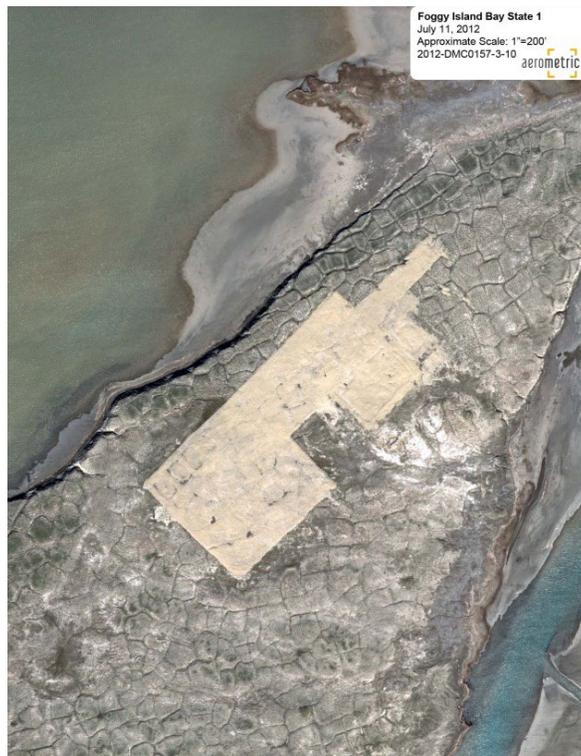
**PHOTOGRAPH 1: AERIAL PHOTOGRAPH; AEROMETRIC. 28 JULY 1968.**

**PHOTOGRAPH 2: AERIAL PHOTOGRAPH; AEROMETRIC. 24 JULY 1977.**

**PHOTOGRAPH 3: AERIAL PHOTOGRAPH; AEROMETRIC. 4 JULY 1983.**

**PHOTOGRAPH 4: AERIAL PHOTOGRAPH; AEROMETRIC. 11 JULY 2012.**

Review of historical aerial photographs from various years between 1977 and 2012 and on-site observations during the 2013 Phase II assessment indicate that only slight-to-moderate thermokarsting has developed in the gravel pad over the past 35 years. Comparing aerial photographs between 1984 and 2012 (Appendix B), the majority of the gravel pad perimeter remained well-defined during this time relative to the surrounding tundra.

gravel pad surface. Pieces of the foam board, approximately 5 inches thick, were observed during the Phase II assessment near the northeastern edge of the gravel pad (see Appendix B). Borings taken during the Phase II assessment show that the foam has compressed to approximately 1 to 2 inches thick.

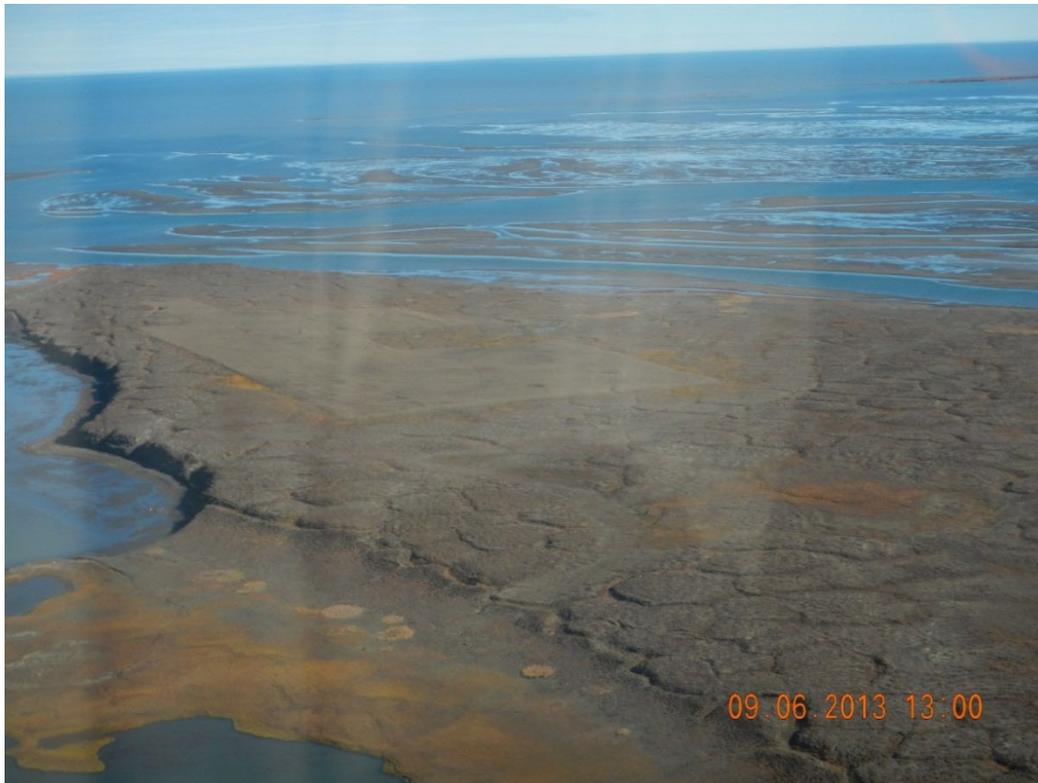
**PHOTOGRAPH 1: AERIAL VIEW LOOKING EAST, 6 SEPTEMBER 2013**

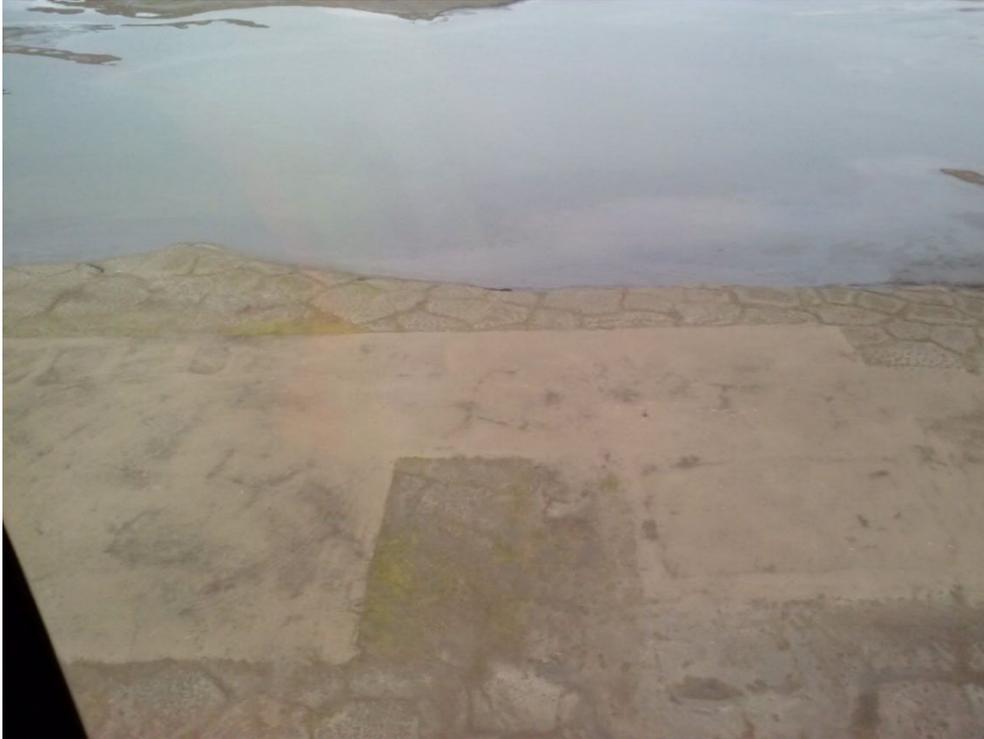
**PHOTOGRAPH 2: AERIAL VIEW LOOKING NORTHWEST, WITH BURN PIT NEAR LOWER RIGHT-HAND CORNER OF PHOTOGRAPH, 26 AUGUST 2013**

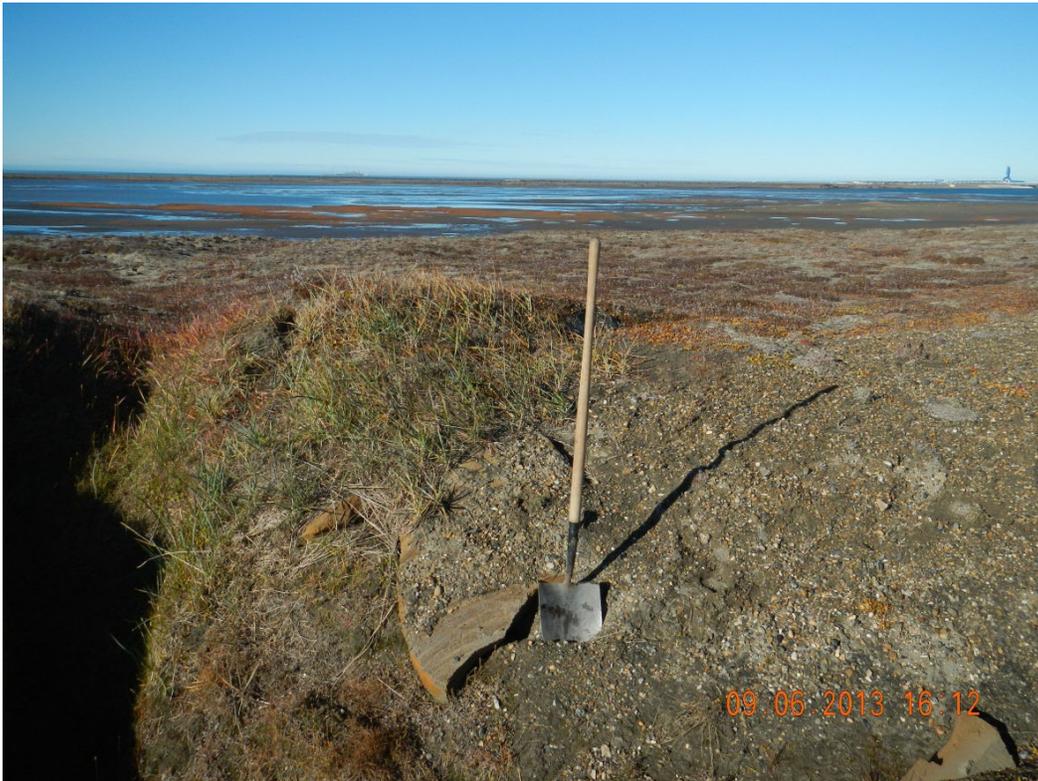
**PHOTOGRAPH 4: VEGETATION AND FOAM BOARD (STYROFOAM, APPROXIMATELY 5 INCHES THICK) OBSERVED NEAR NORTHEAST CORNER OF PAD, BY THERMOKARST TROUGH.**

A layer of foam board, believed to be approximately 6 inches thick at the time of installation, extends beneath the entire area of the gravel pad at a depth of approximately 1.4 feet below the present-day
