STATE OF ALASKA DEPARTMENT OF NATURAL RESOURCES
DIVISION OF MINING, LAND AND WATER
Statewide Abatement of Impaired Land Section

Requested Action

GRANT MINE TAILINGS IMPOUNDMENT
ESTER, ALASKA

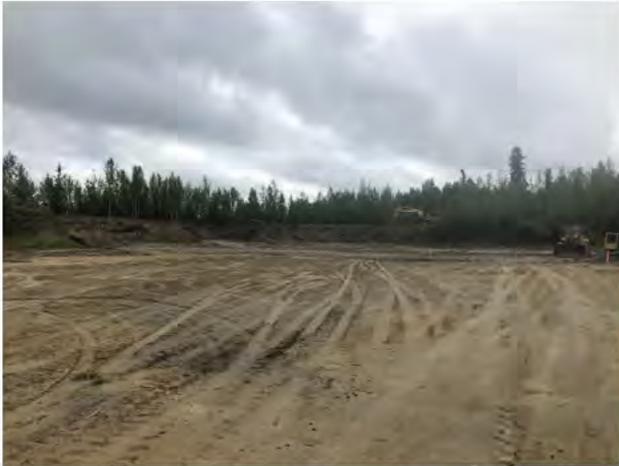
Photo 1: 20210728 Initial Lifts looking south

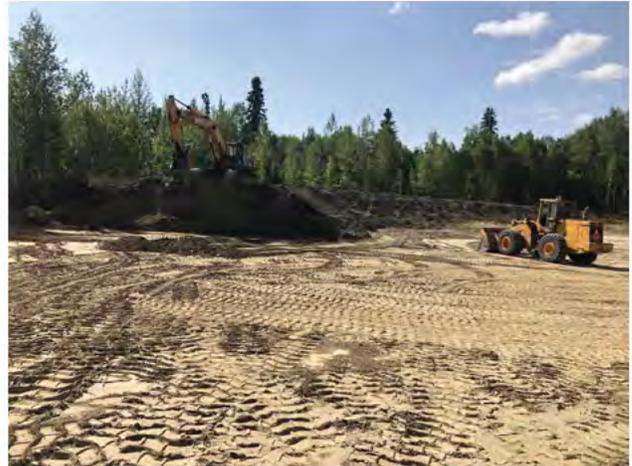
Photo 2: 20210804 Dismantling southern berm

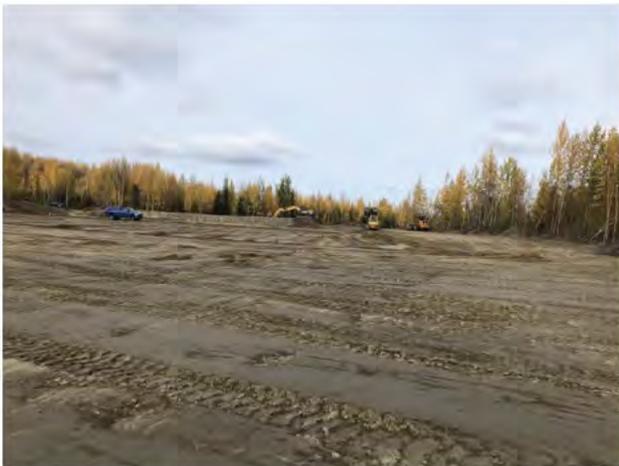
Photo 3: 20210921 Dismantling northern berm

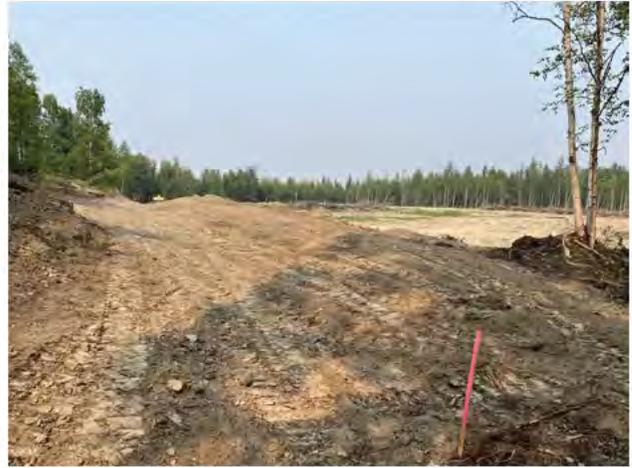
Photo 8: 20220630 Beginning of Diversion Ditch looking North

The drainage diversion channel was constructed in accordance with the specifications of the C&A Plan, with only the exception noted in Section 4.3.2. Photos of the closure construction are presented in Appendix A. Stutzmann surveyed the site on September 16, 2022 after the capping and diversion channel was completed and prepared the *Record Drawing As Built* presented in Appendix B. Based on Stutzmann's survey, the thickness of the cap is at least 24 inches.

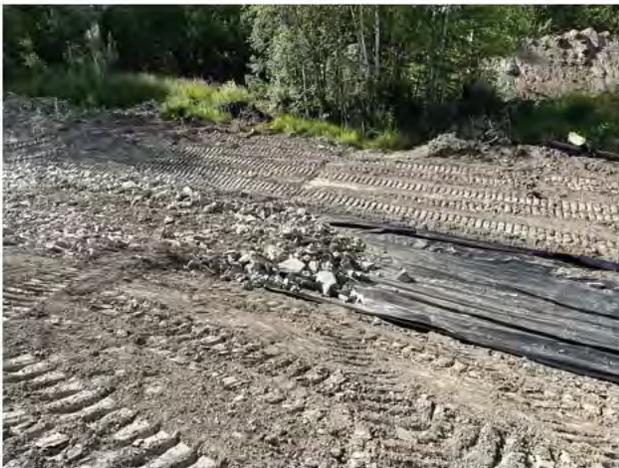
Photo 9: 20220723 Placing Riprap looking west

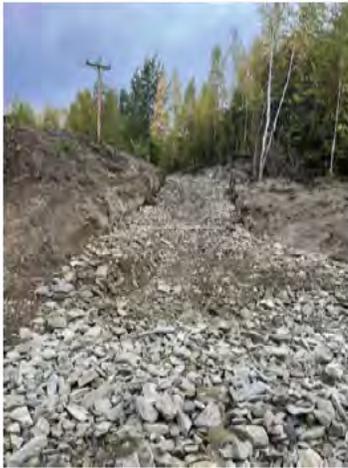
Photo 15: 20220916 lower portion of channel

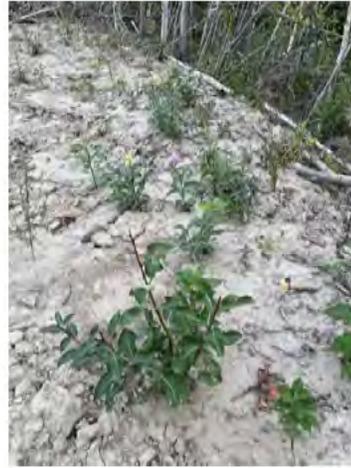
Photo 16: 20220916 Natural Revegetation

The monthly inspections will include monitoring for settlement and erosion of the impoundment cap and will also include photographing vegetative growth on berms and unlined ditches to document revegetation. The post-closure inspection form is presented in Appendix F. Mr. Burggraf proposes the monitoring period be between April and October due to the prevalence of snow cover and freezing conditions during the winter months.

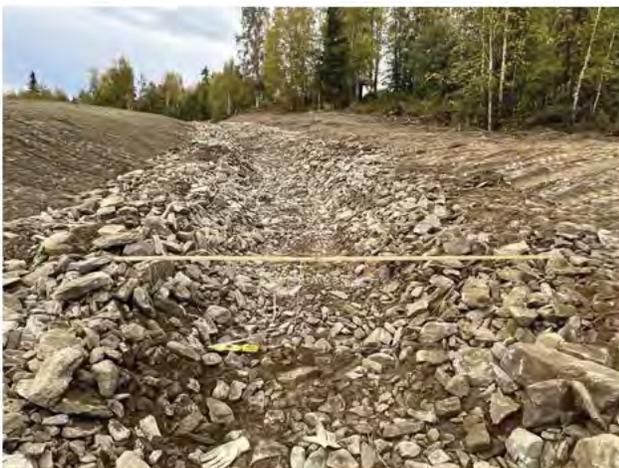
Photo 17: 20220916 upper portion of channel

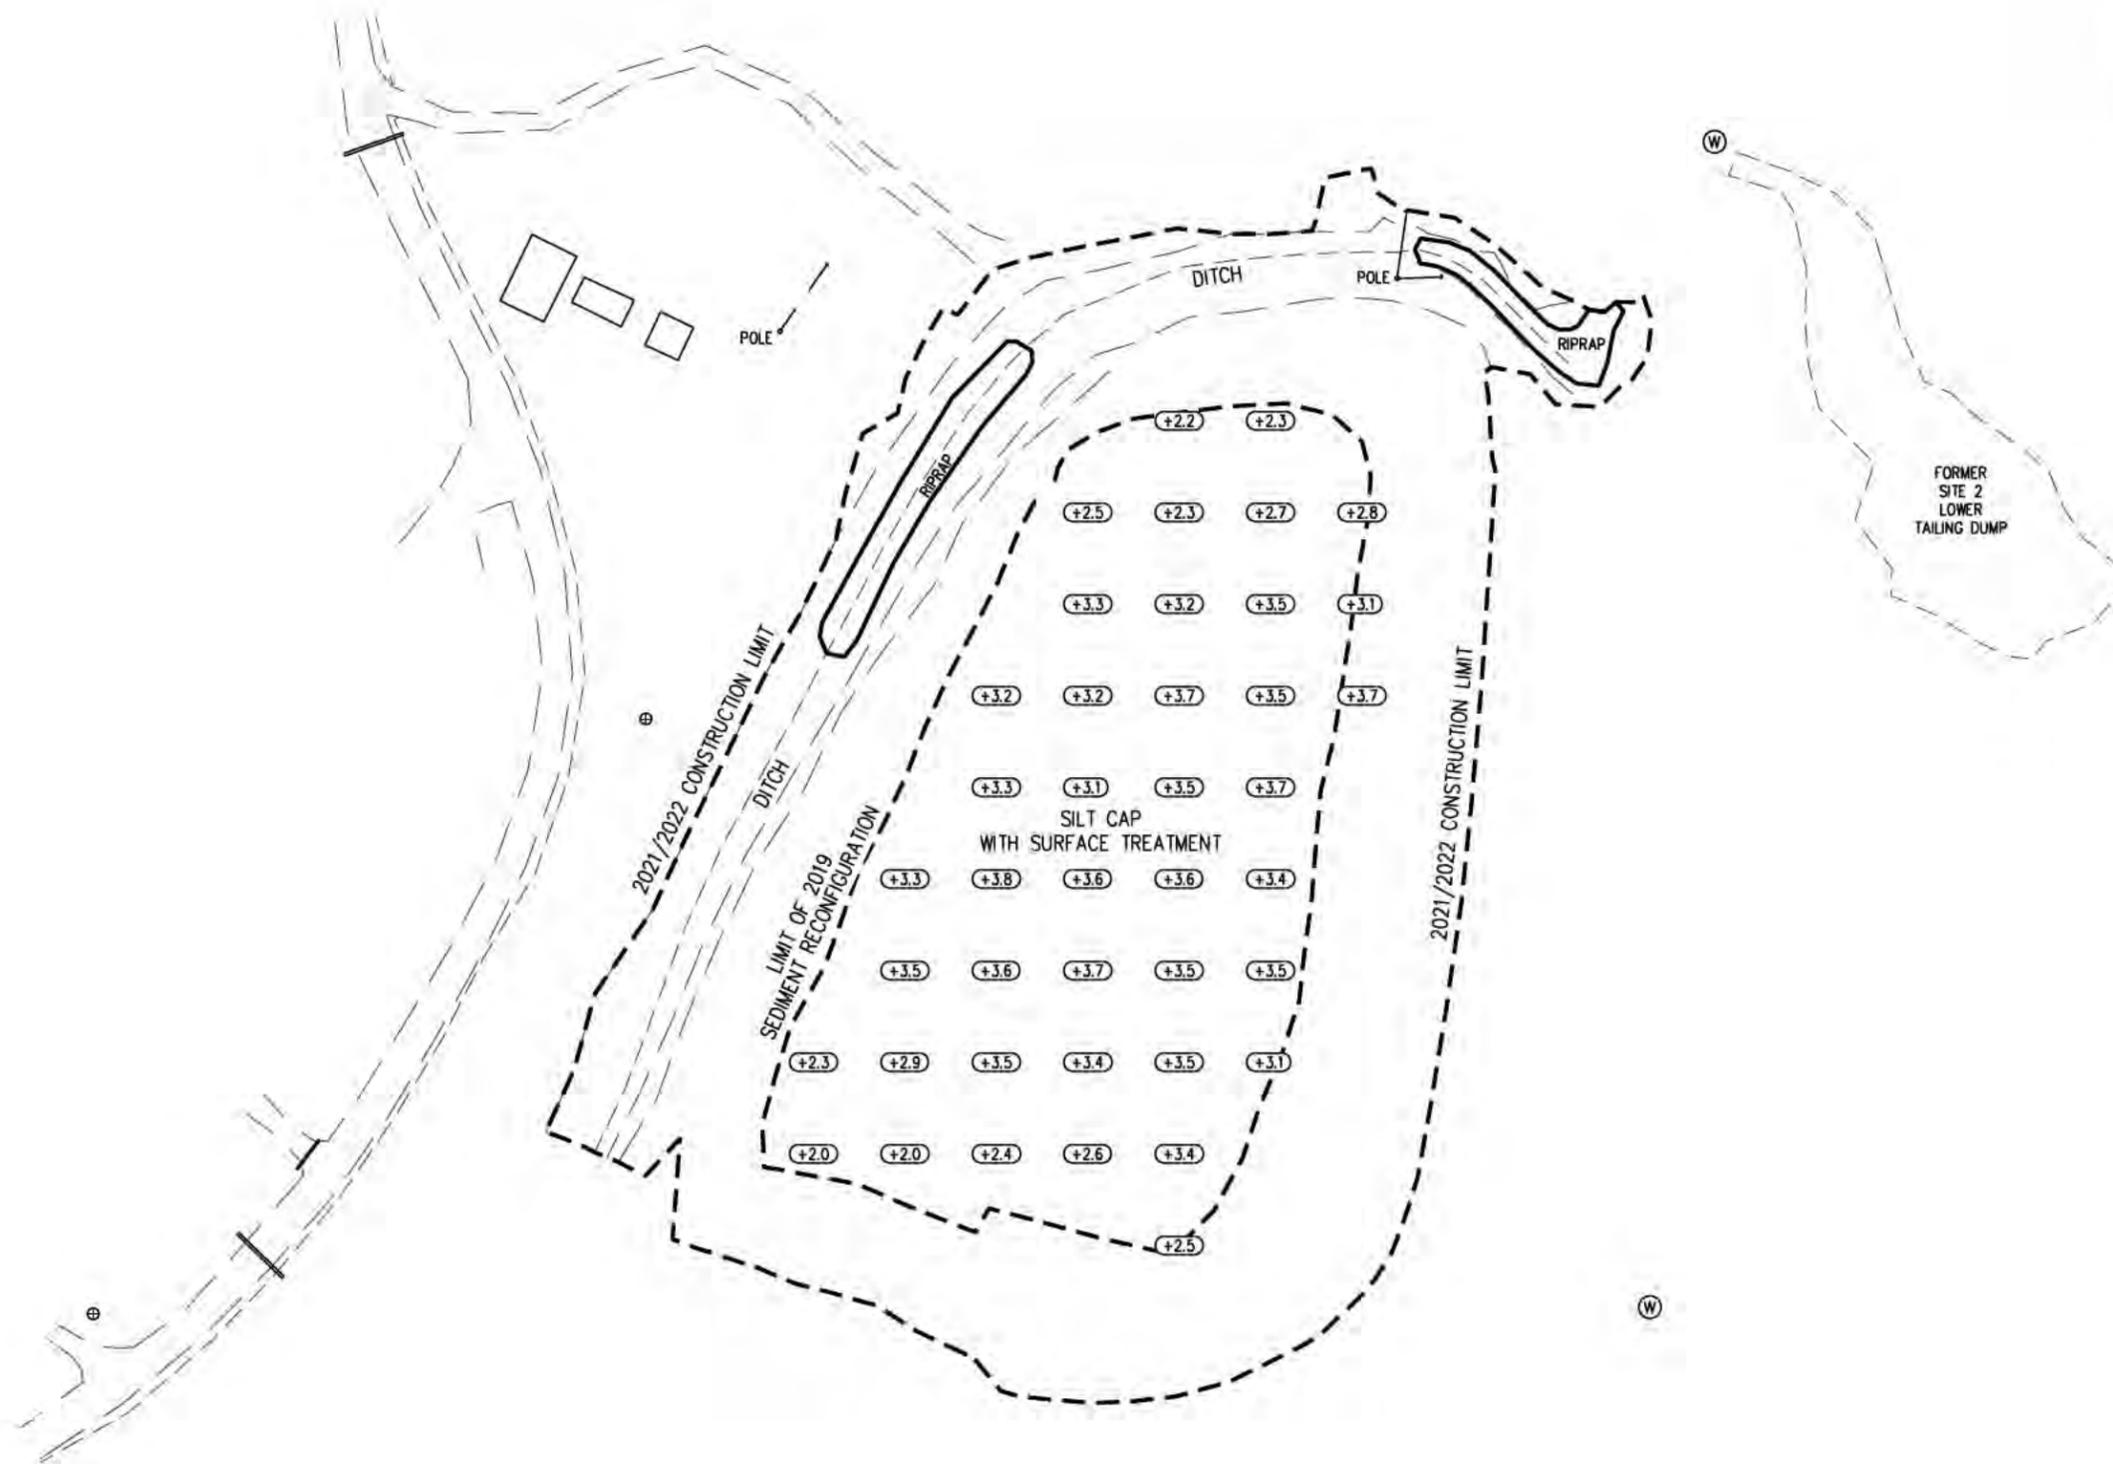
NOTES:
 1. This sheet shows cap thickness in feet comparing as-built survey September 16, 2022 to progress as-built survey November 11, 2019 of sediment reconfiguration.
