STATEWIDE MATERIAL SITE INVENTORY

MATERIAL SITE
INSPECTION REPORT

DALTON HIGHWAY

MS 65-9-029-2
Shooting Range

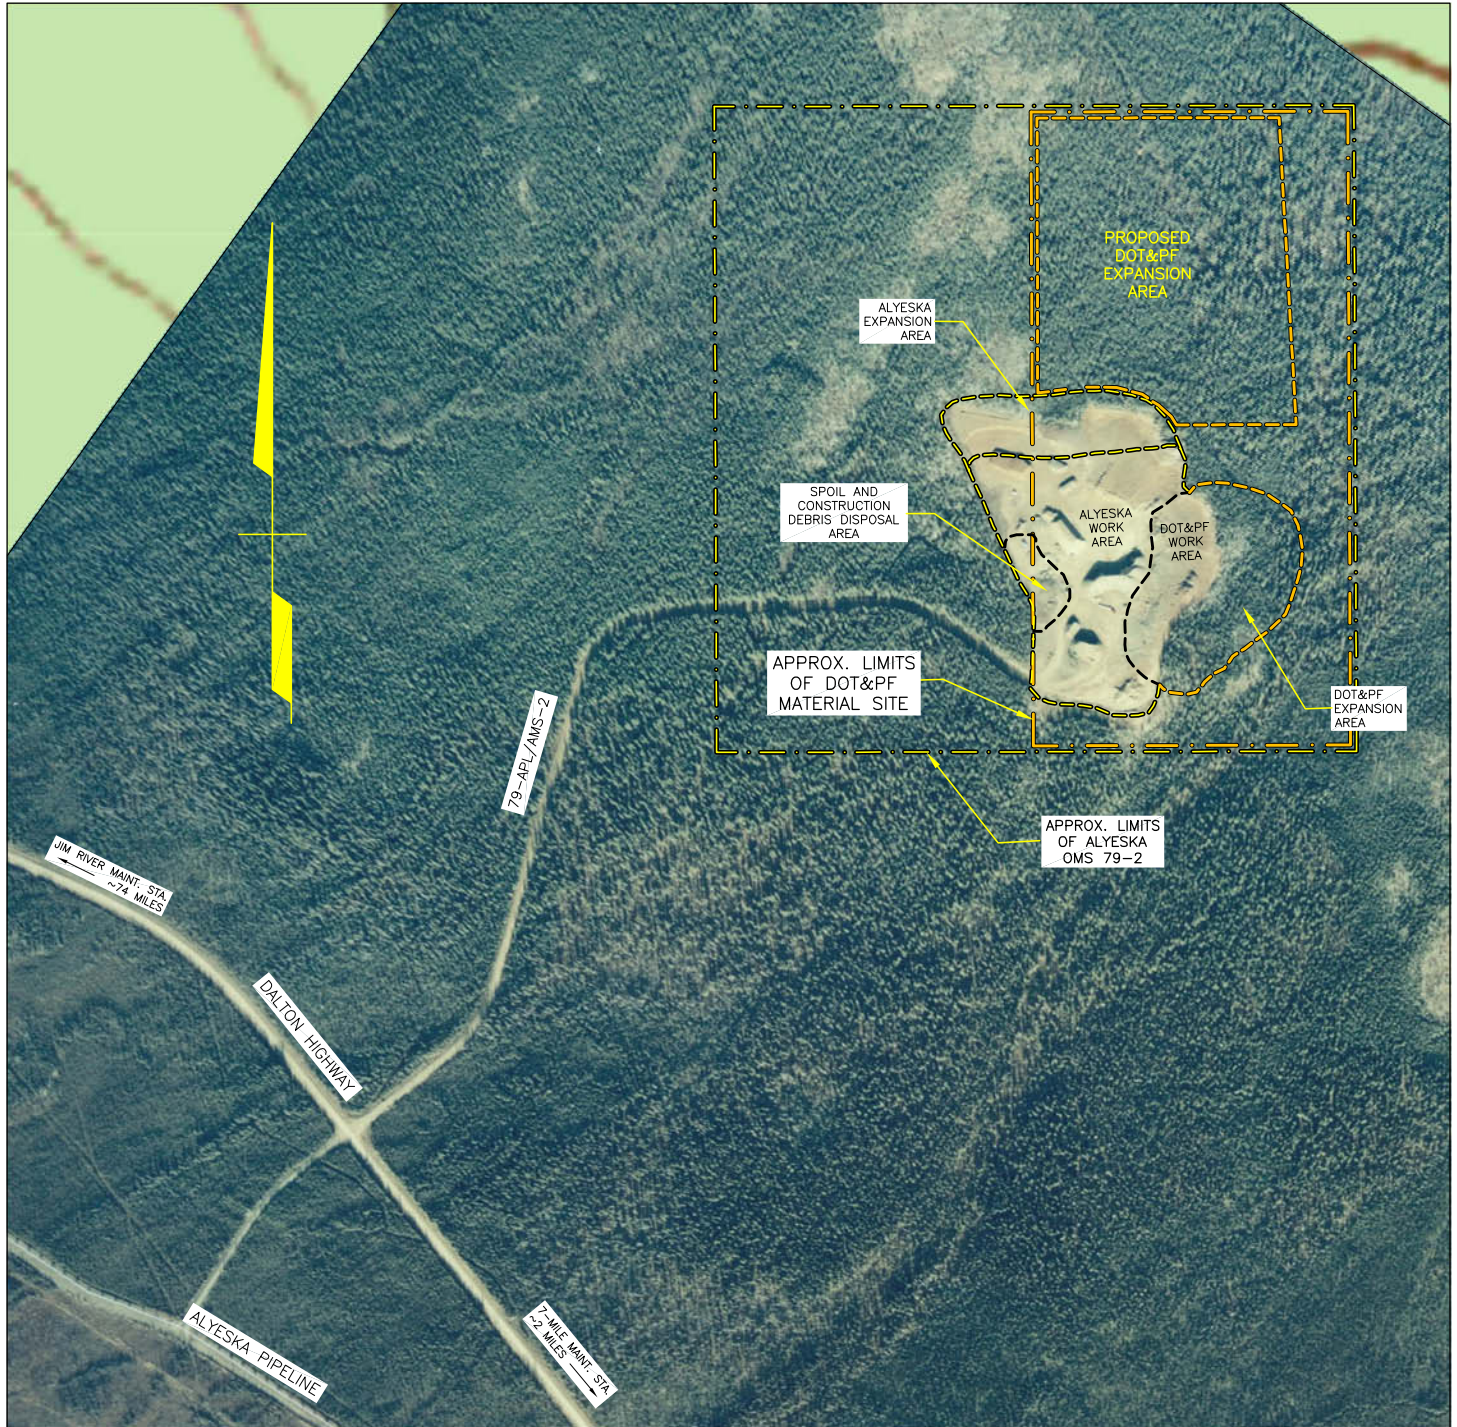
SITE MAP

BASE MAP IS 2008 AERIAL PHOTOGRAPHY. THIS IS A PLANNING DOCUMENT ONLY. THE MATERIAL SITE BOUNDARIES SHOWN ON THIS DRAWING ARE APPROXIMATE. OWNERSHIP OF THE LANDS ADJACENT TO THIS SITE ARE UNKNOWN. THE ACCESS ROW SHOULD BE VERIFIED.

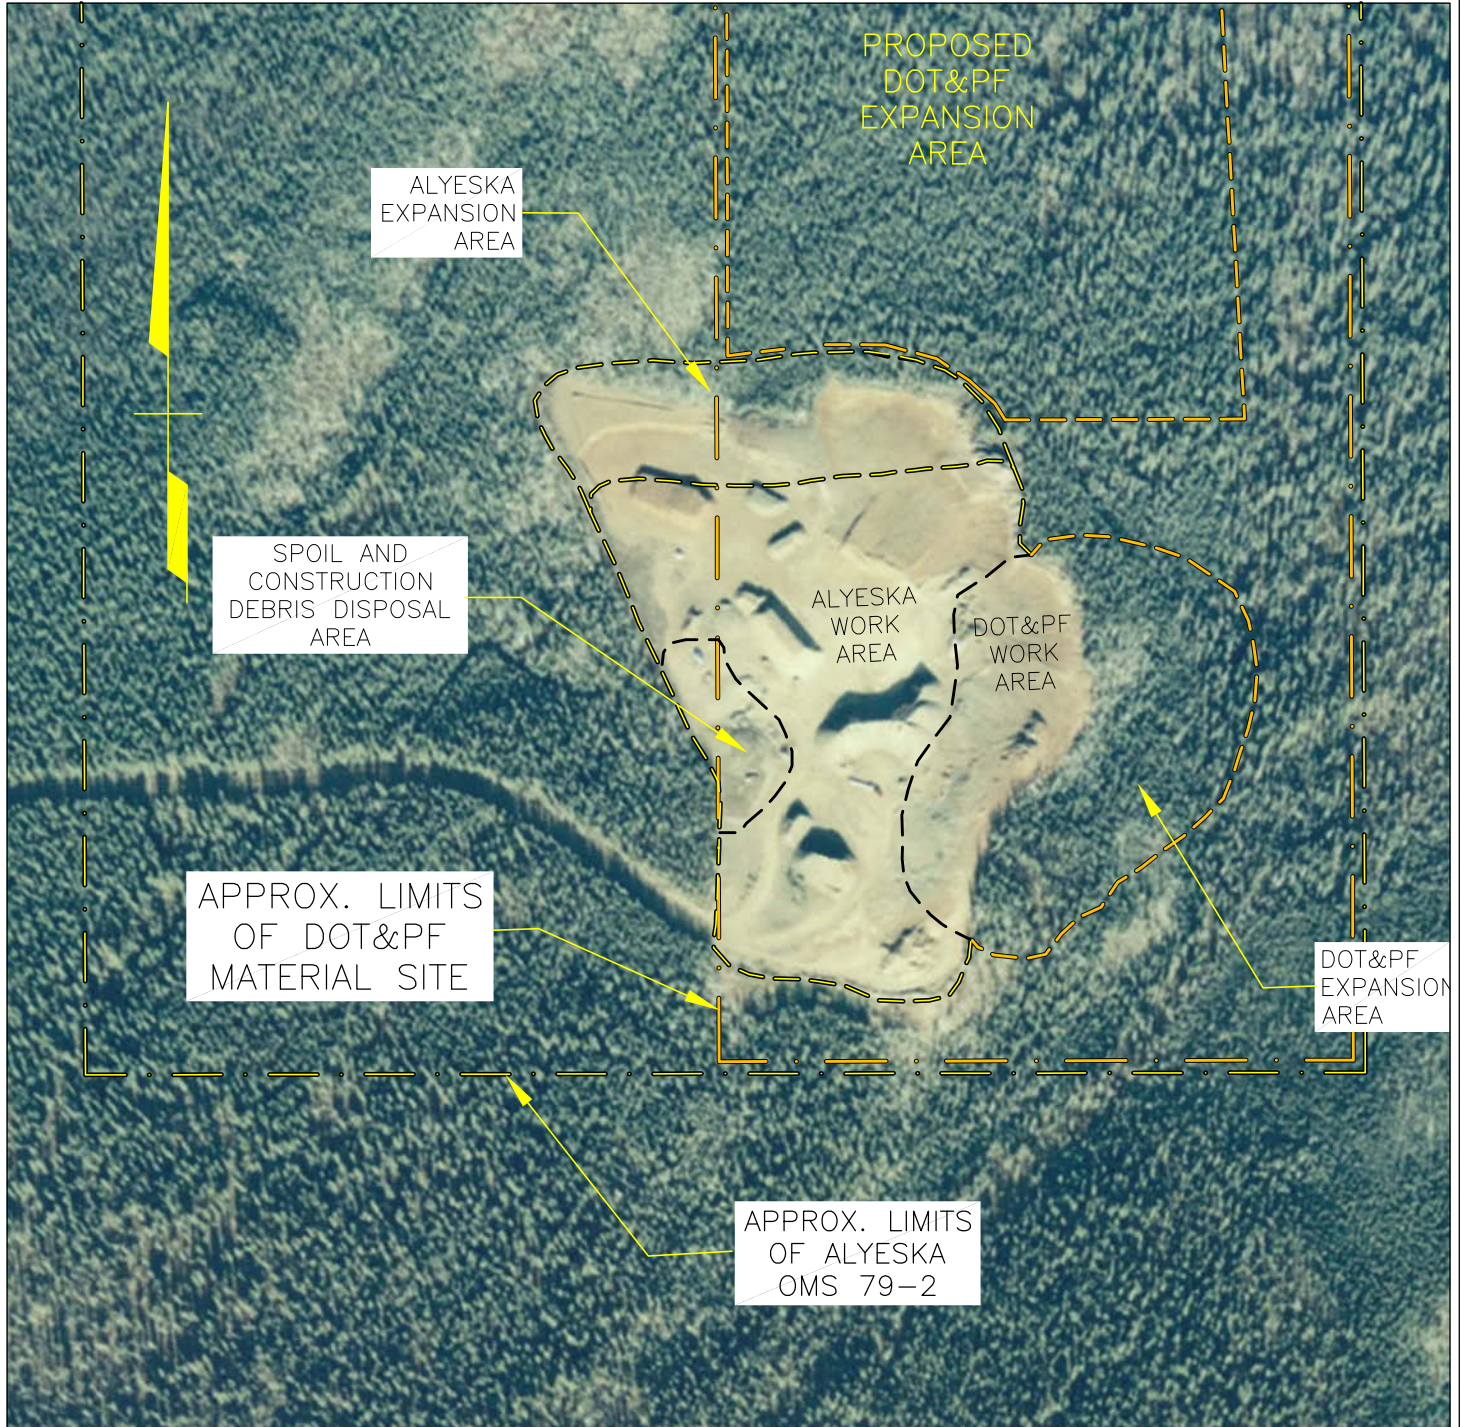
SITE MAP

BASE MAP IS 2008 AERIAL PHOTOGRAPHY. THIS IS A PLANNING DOCUMENT ONLY. THE MATERIAL SITE BOUNDARIES SHOWN ON THIS DRAWING ARE APPROXIMATE. OWNERSHIP OF THE LANDS ADJACENT TO THIS SITE ARE UNKNOWN. THE ACCESS ROW SHOULD BE VERIFIED.
