**STATEWIDE MATERIAL SITE INVENTORY**

**MATERIAL SITE**  
**INSPECTION REPORT**

**DALTON HIGHWAY**

**MS 65-9-102-2**

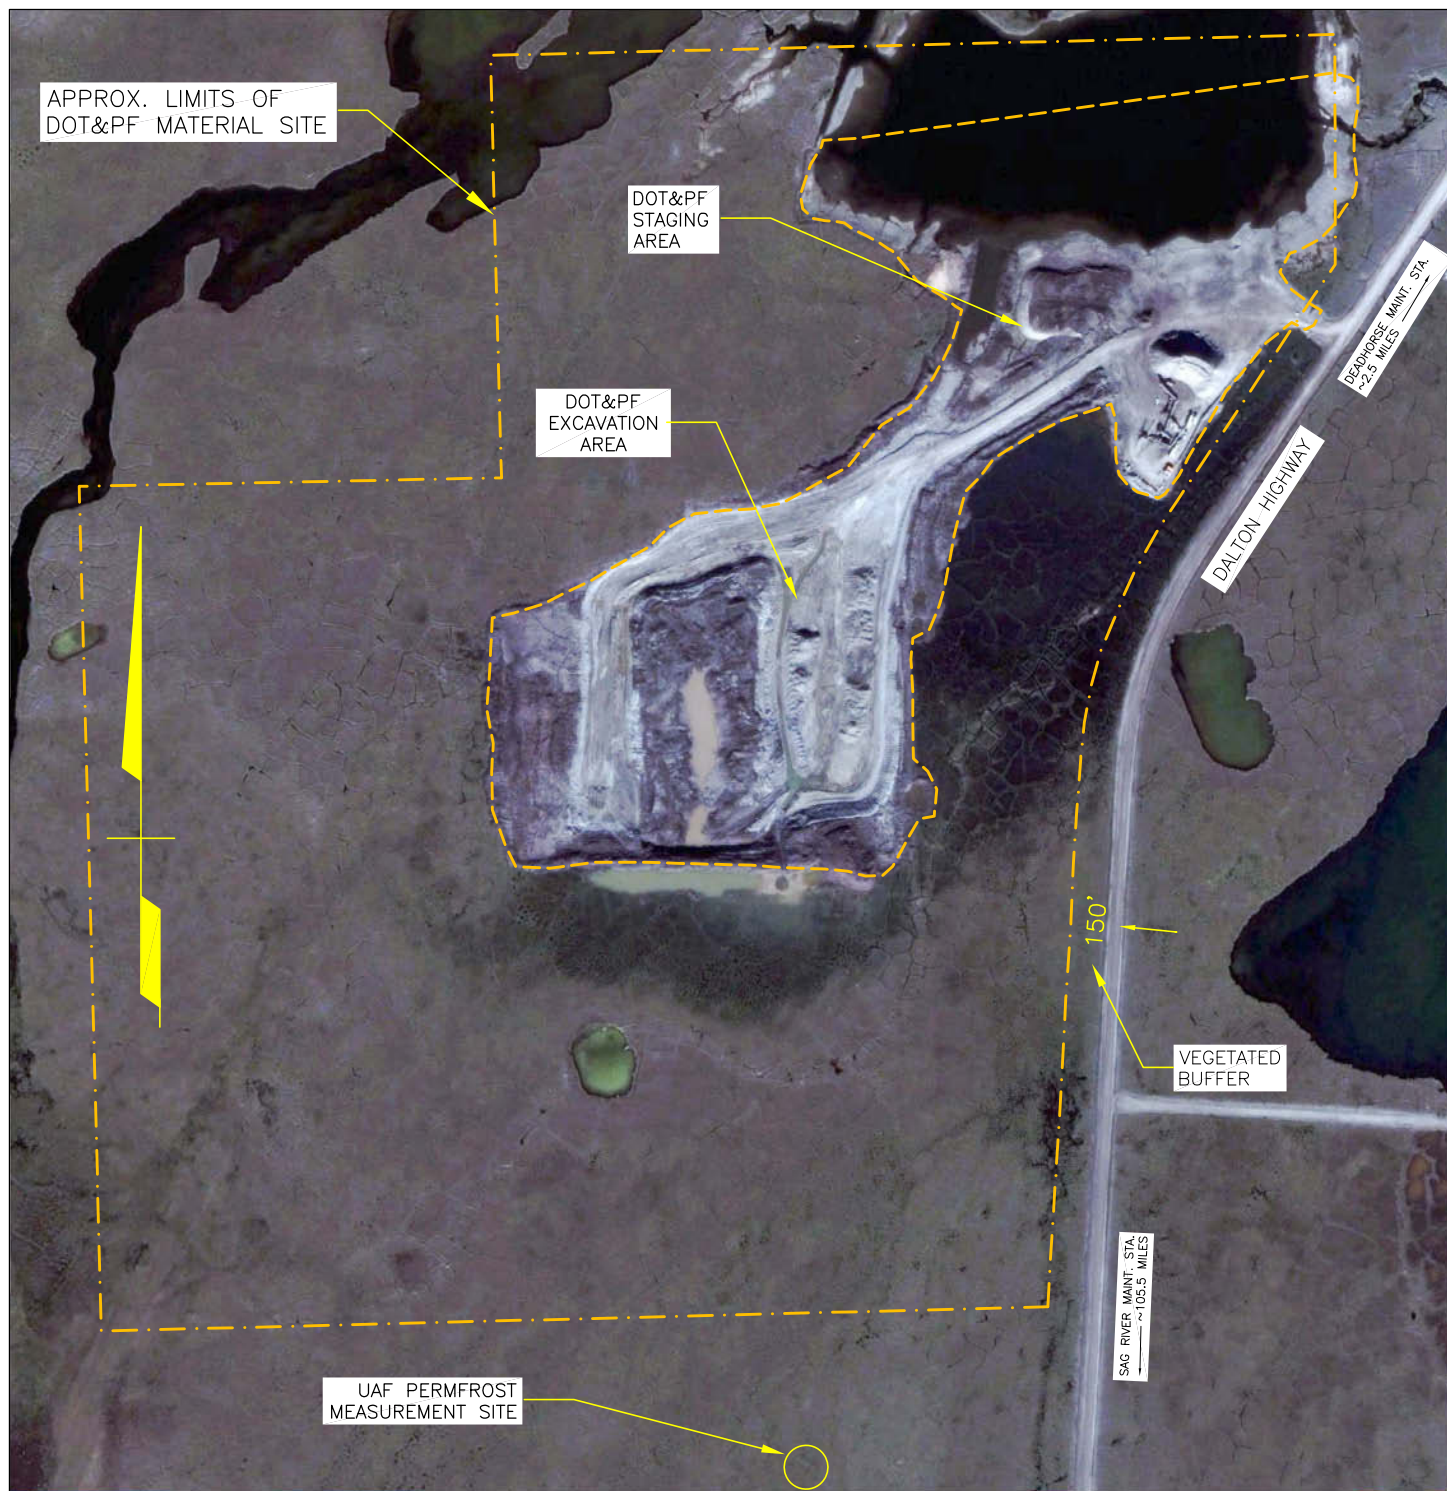
# SITE MAP

BASE MAP IS AUGUST 15, 2006 SATELLITE IMAGERY. THIS IS A PLANNING DOCUMENT ONLY. THE MATERIAL SITE BOUNDARIES SHOWN ON THIS DRAWING ARE APPROXIMATE. OWNERSHIP OF THE LANDS ADJACENT TO THIS SITE ARE UNKNOWN. THE ACCESS ROW SHOULD BE VERIFIED.

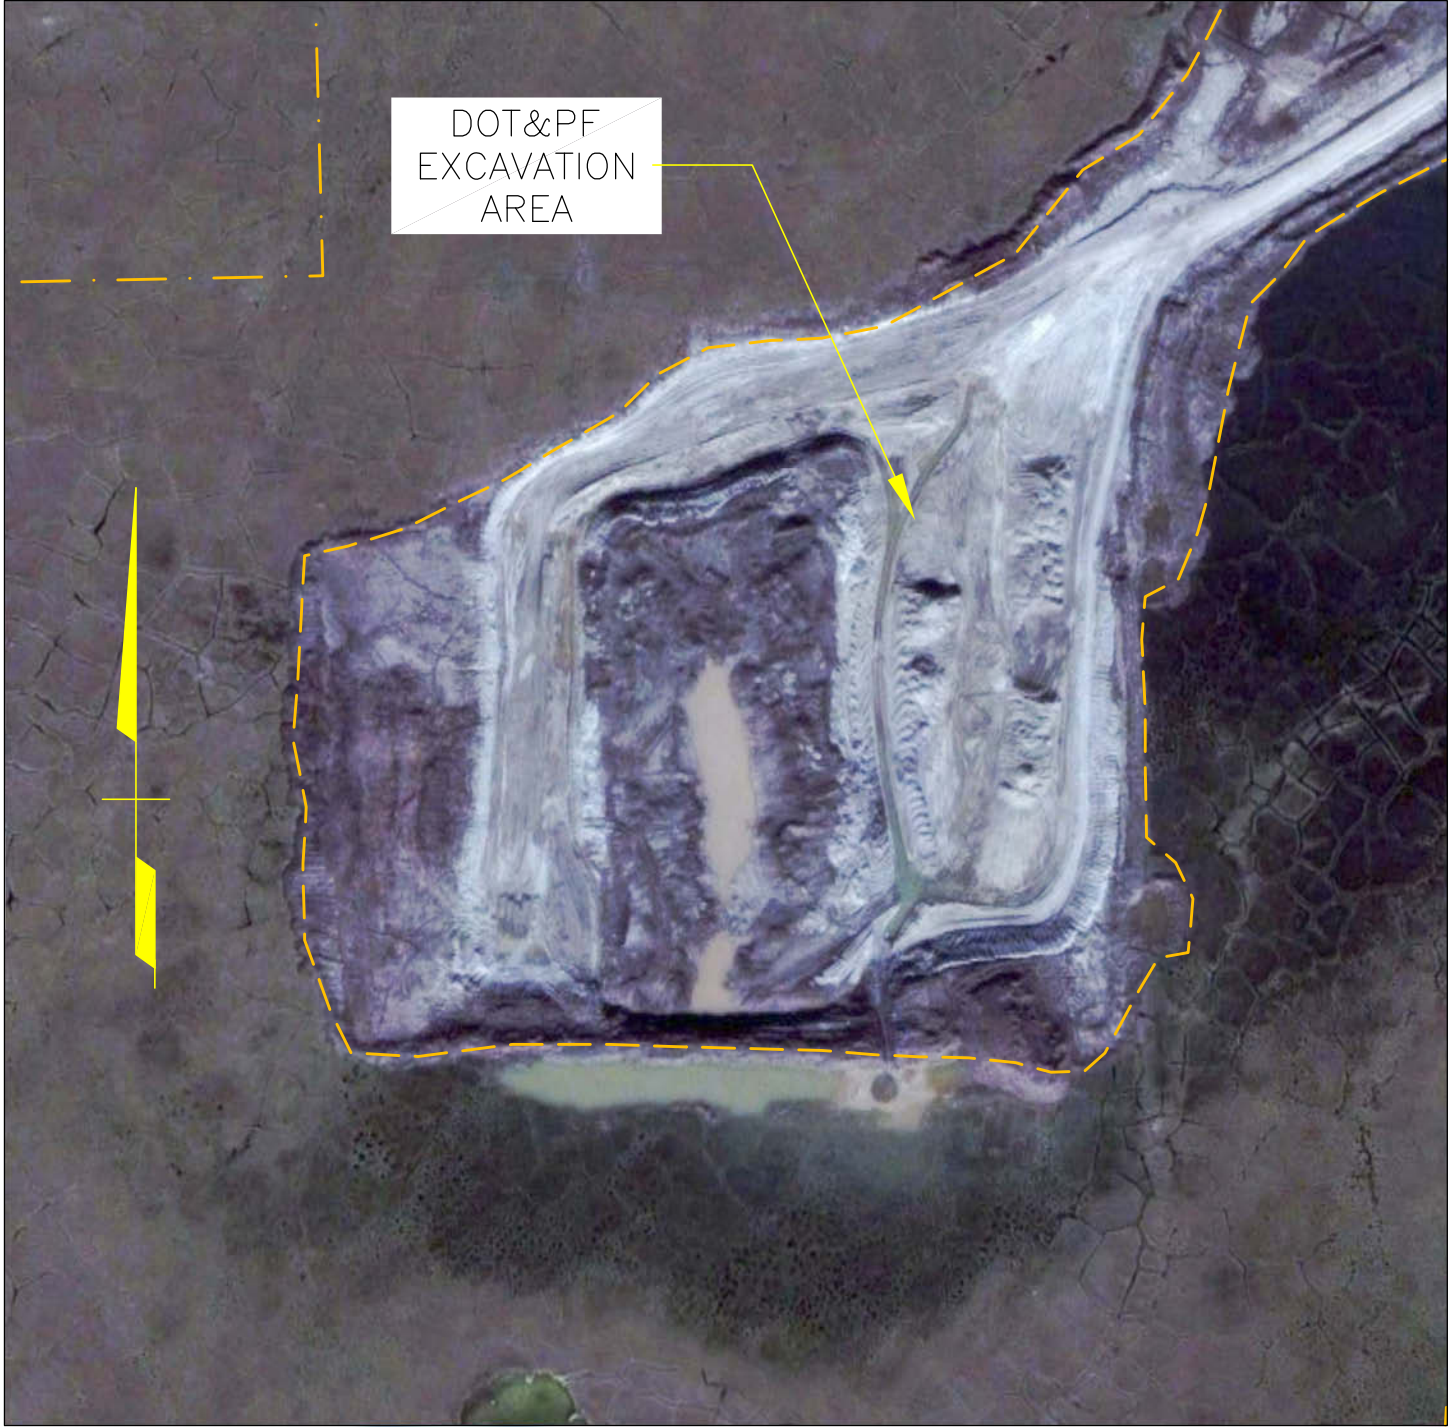
# SITE MAP

BASE MAP IS AUGUST 15, 2006 SATELLITE IMAGERY.  
 THIS IS A PLANNING DOCUMENT ONLY. THE MATERIAL SITE BOUNDARIES SHOWN ON THIS  
 DRAWING ARE APPROXIMATE. OWNERSHIP OF THE LANDS ADJACENT TO THIS SITE ARE  
 UNKNOWN. THE ACCESS ROW SHOULD BE VERIFIED.
