STATEWIDE MATERIAL SITE INVENTORY

MATERIAL SITE
INSPECTION REPORT

ELLIOTT HIGHWAY

MS 680-105-2
Rosebud Creek Pit

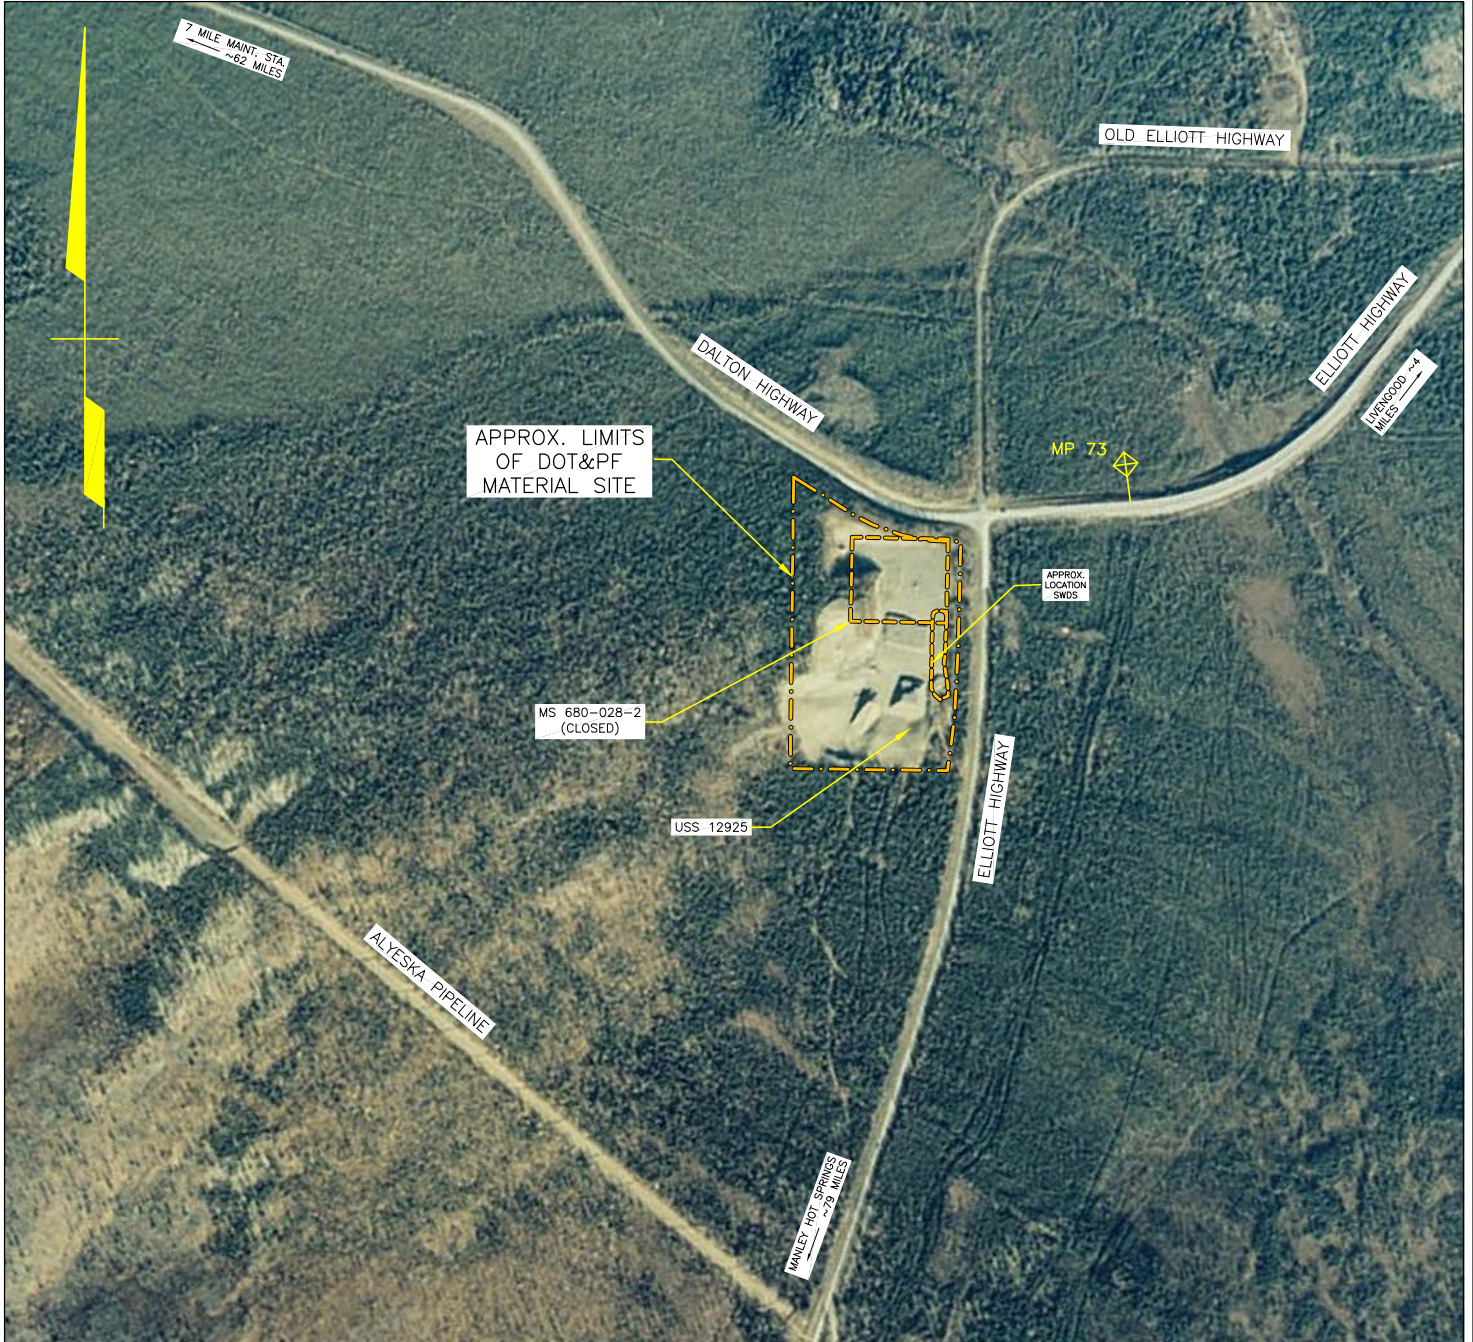
SITE MAP

BASE MAP IS 2008 AERIAL PHOTOGRAPHY. THIS IS A PLANNING DOCUMENT ONLY. THE MATERIAL SITE BOUNDARIES SHOWN ON THIS DRAWING ARE APPROXIMATE. OWNERSHIP OF THE LANDS ADJACENT TO THIS SITE ARE UNKNOWN. THE ACCESS ROW SHOULD BE VERIFIED.

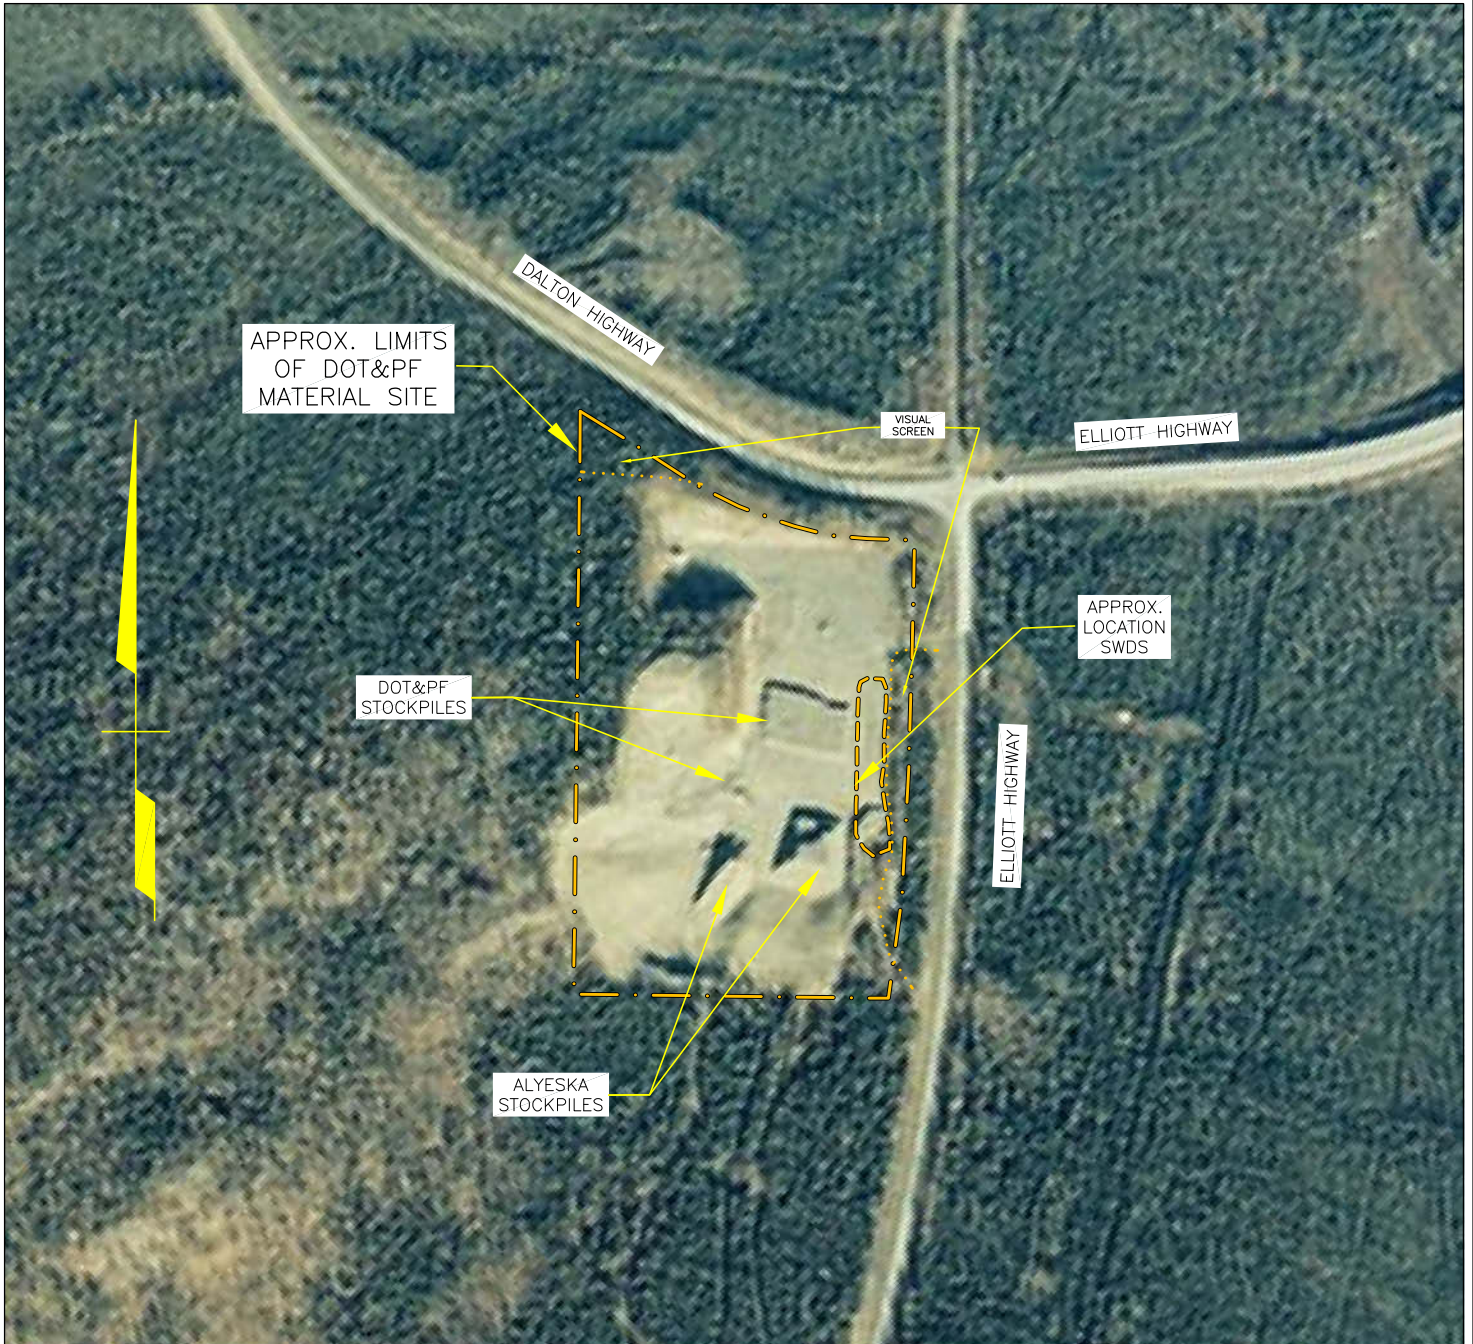
SITE MAP

BASE MAP IS 2008 AERIAL PHOTOGRAPHY. THIS IS A PLANNING DOCUMENT ONLY. THE MATERIAL SITE BOUNDARIES SHOWN ON THIS DRAWING ARE APPROXIMATE. OWNERSHIP OF THE LANDS ADJACENT TO THIS SITE ARE UNKNOWN. THE ACCESS ROW SHOULD BE VERIFIED.

28/30. Vegetated spoil berms were present along the north and southeast margins of the existing pit. Additionally, a portion of the existing pit near the eastern pit boundary was used to establish a solid waste disposal site (see site map, page 3B). Material was stockpiled over much of the designated solid waste disposal site as of August, 2009.
