**STATE OF ALASKA ITB NUMBER 2524N096
AMENDMENT NUMBER Three (3)**

ITB TITLE: Crushed Aggregate, Stockpiled, Dalton Highway- Federally Funded

MATERIAL SITE INSPECTION REPORT

MS 65-9-099-2

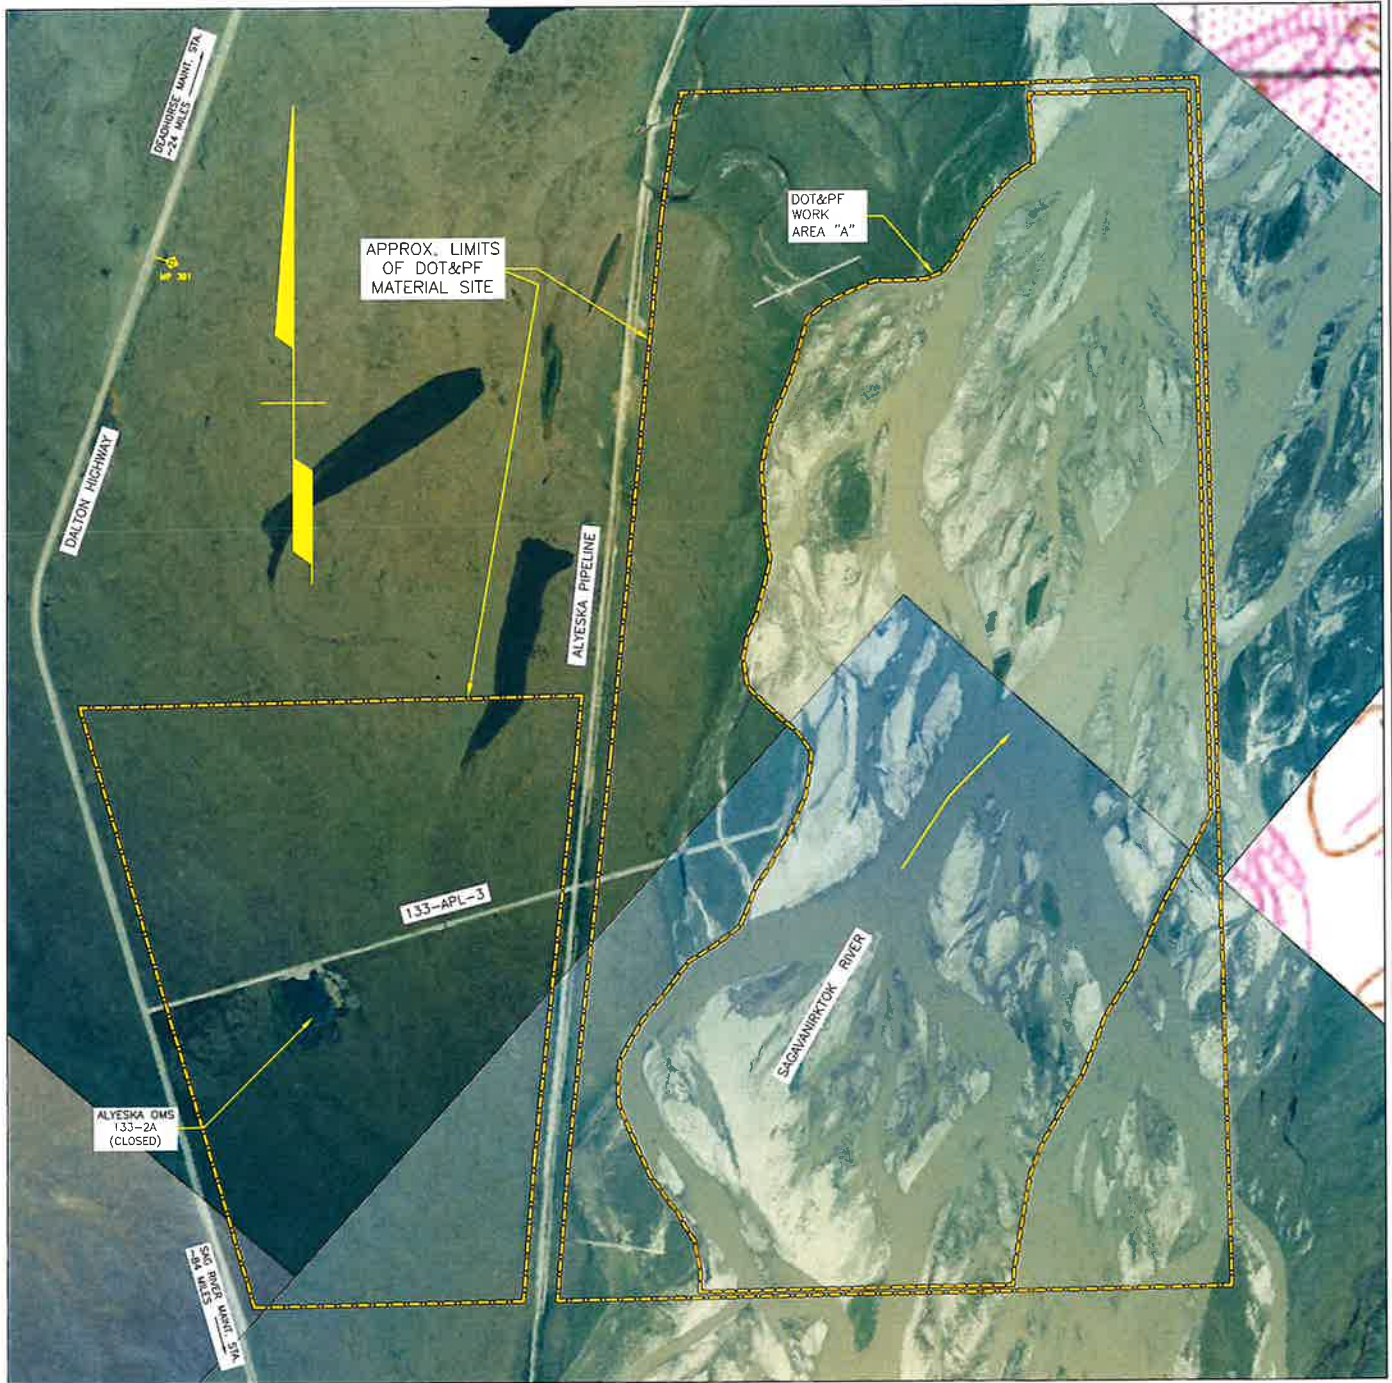
SITE MAP

BASE MAP IS 2006 AERIAL PHOTOGRAPHY. THIS IS A PLANNING DOCUMENT ONLY. THE MATERIAL SITE BOUNDARIES SHOWN ON THIS DRAWING ARE APPROXIMATE. OWNERSHIP OF THE LANDS ADJACENT TO THIS SITE ARE UNKNOWN. THE ACCESS ROW SHOULD BE VERIFIED.

BASE MAP FROM AERIAL PHOTOS DATED 7/25/06

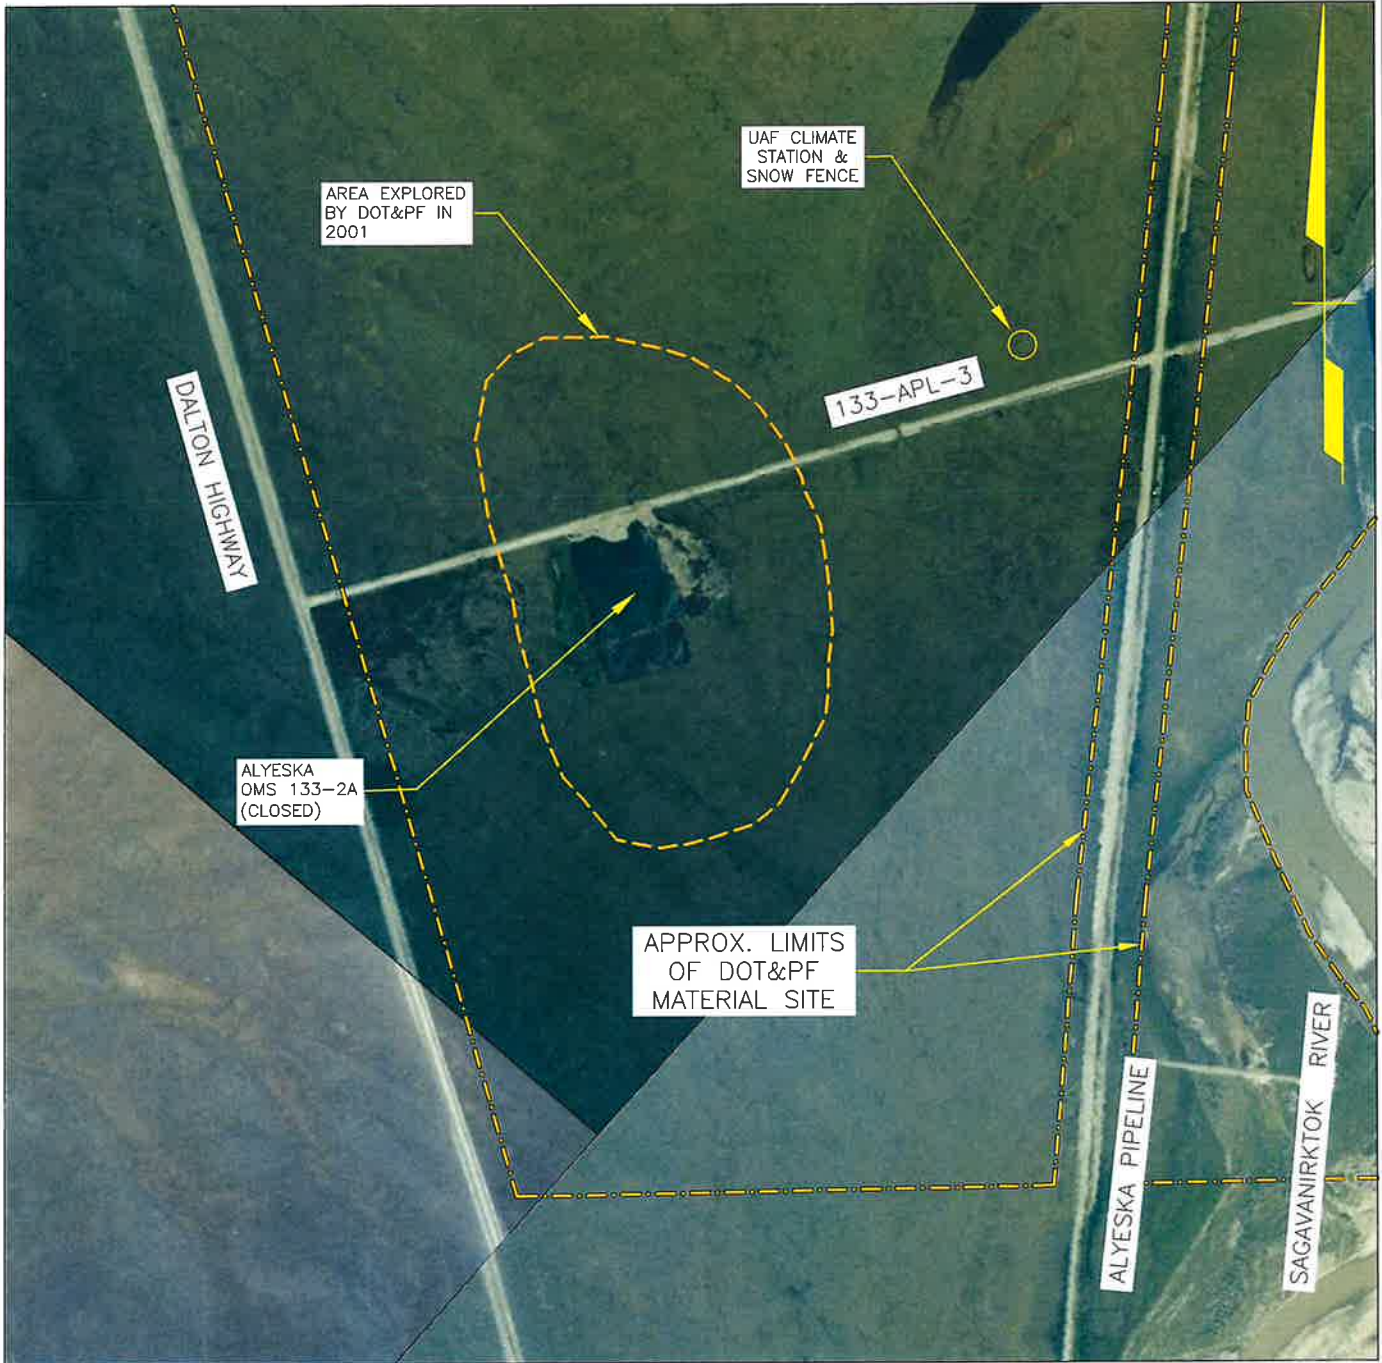
SITE MAP

BASE MAP IS 2006 AERIAL PHOTOGRAPHY. THIS IS A PLANNING DOCUMENT ONLY. THE MATERIAL SITE BOUNDARIES SHOWN ON THIS DRAWING ARE APPROXIMATE. OWNERSHIP OF THE LANDS ADJACENT TO THIS SITE ARE UNKNOWN. THE ACCESS ROW SHOULD BE VERIFIED.

BASE MAP FROM AERIAL PHOTOS DATED 7/25/06

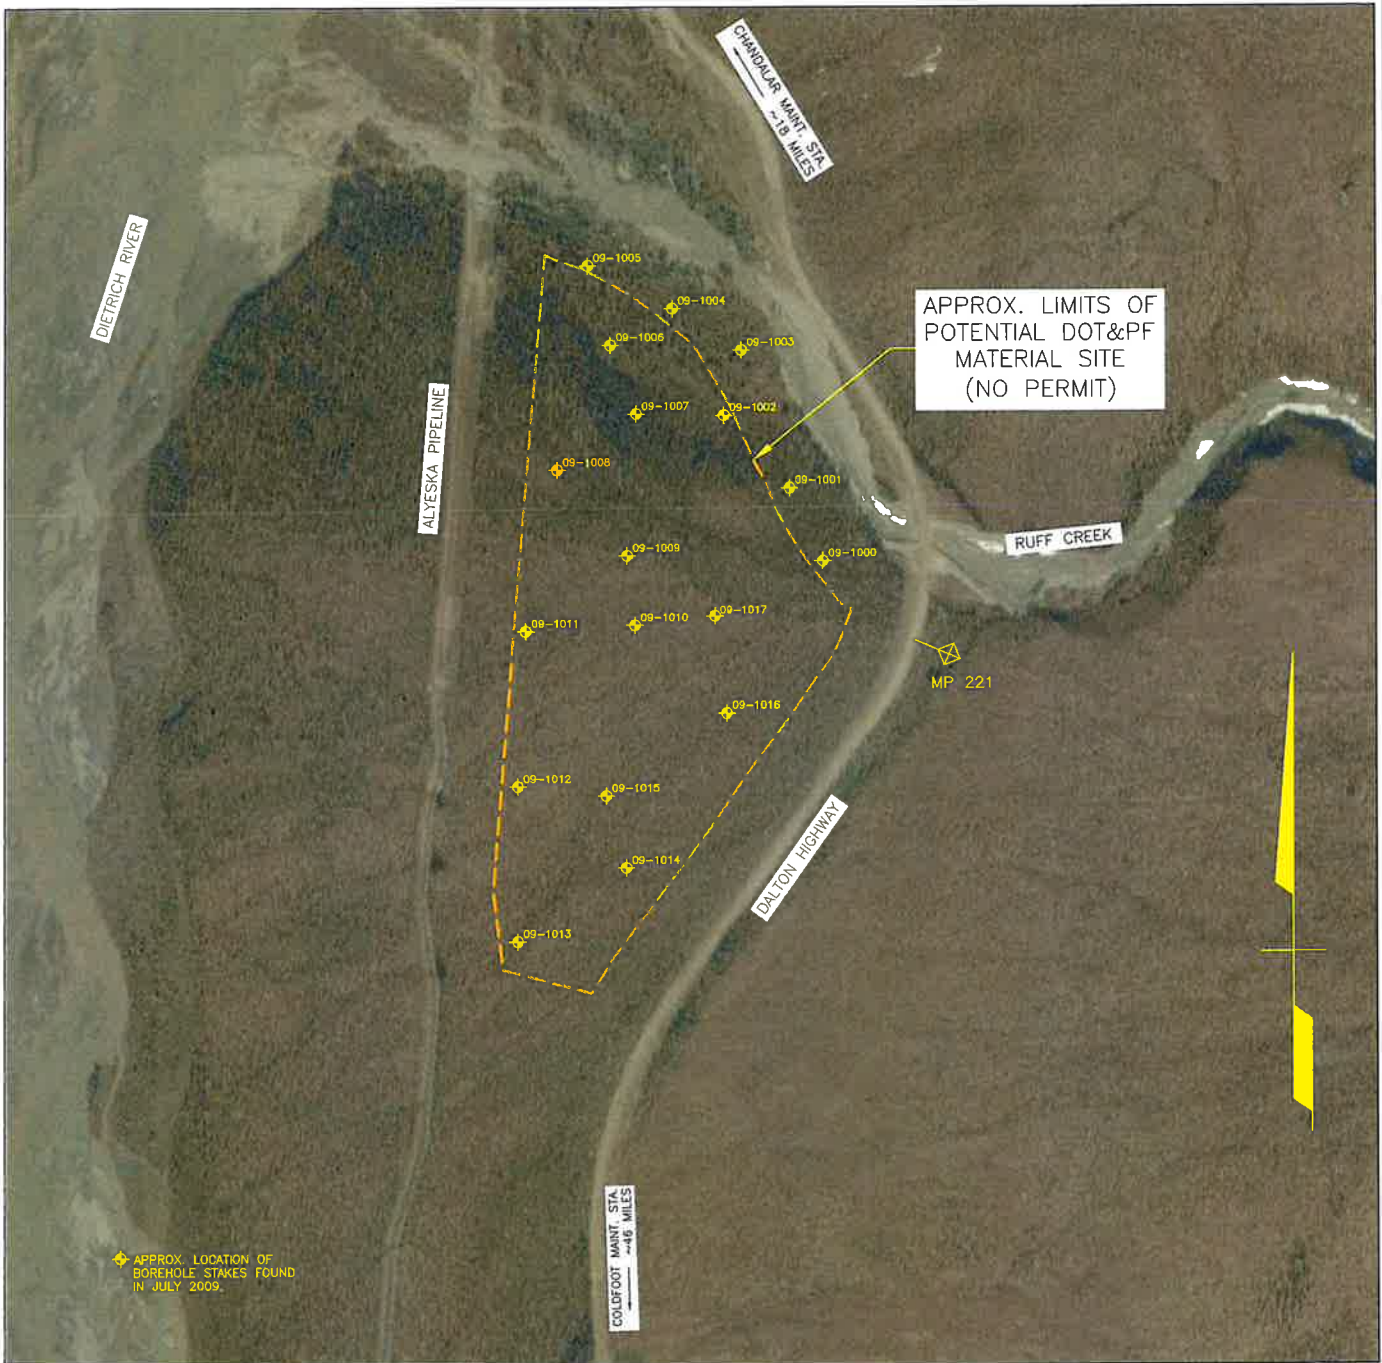
SITE MAP

APPROX. LIMITS OF
POTENTIAL DOT&PF
MATERIAL SITE
(NO PERMIT)

◆ APPROX. LOCATION OF
BOREHOLE STAKES FOUND
IN JULY 2009.

BASE MAP IS 2005 SATELLITE IMAGERY.
THIS IS A PLANNING DOCUMENT ONLY. THE MATERIAL SITE BOUNDARIES SHOWN ON THIS
DRAWING ARE APPROXIMATE. OWNERSHIP OF THE LANDS ADJACENT TO THIS SITE ARE
UNKNOWN. THE ACCESS ROW SHOULD BE VERIFIED.

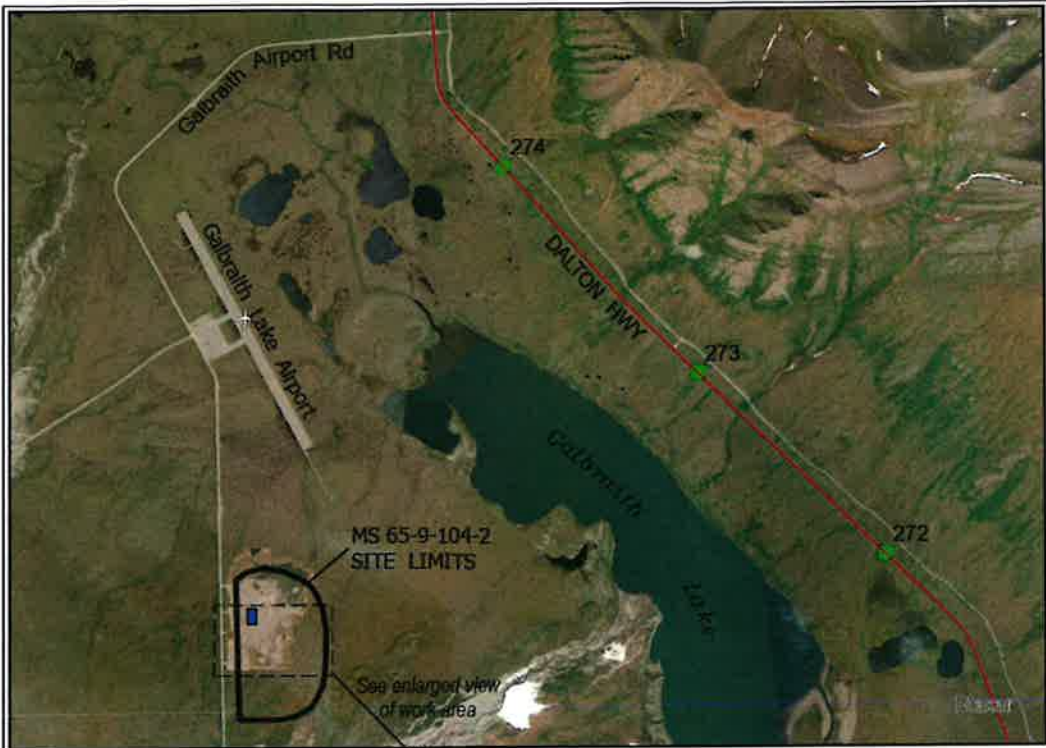
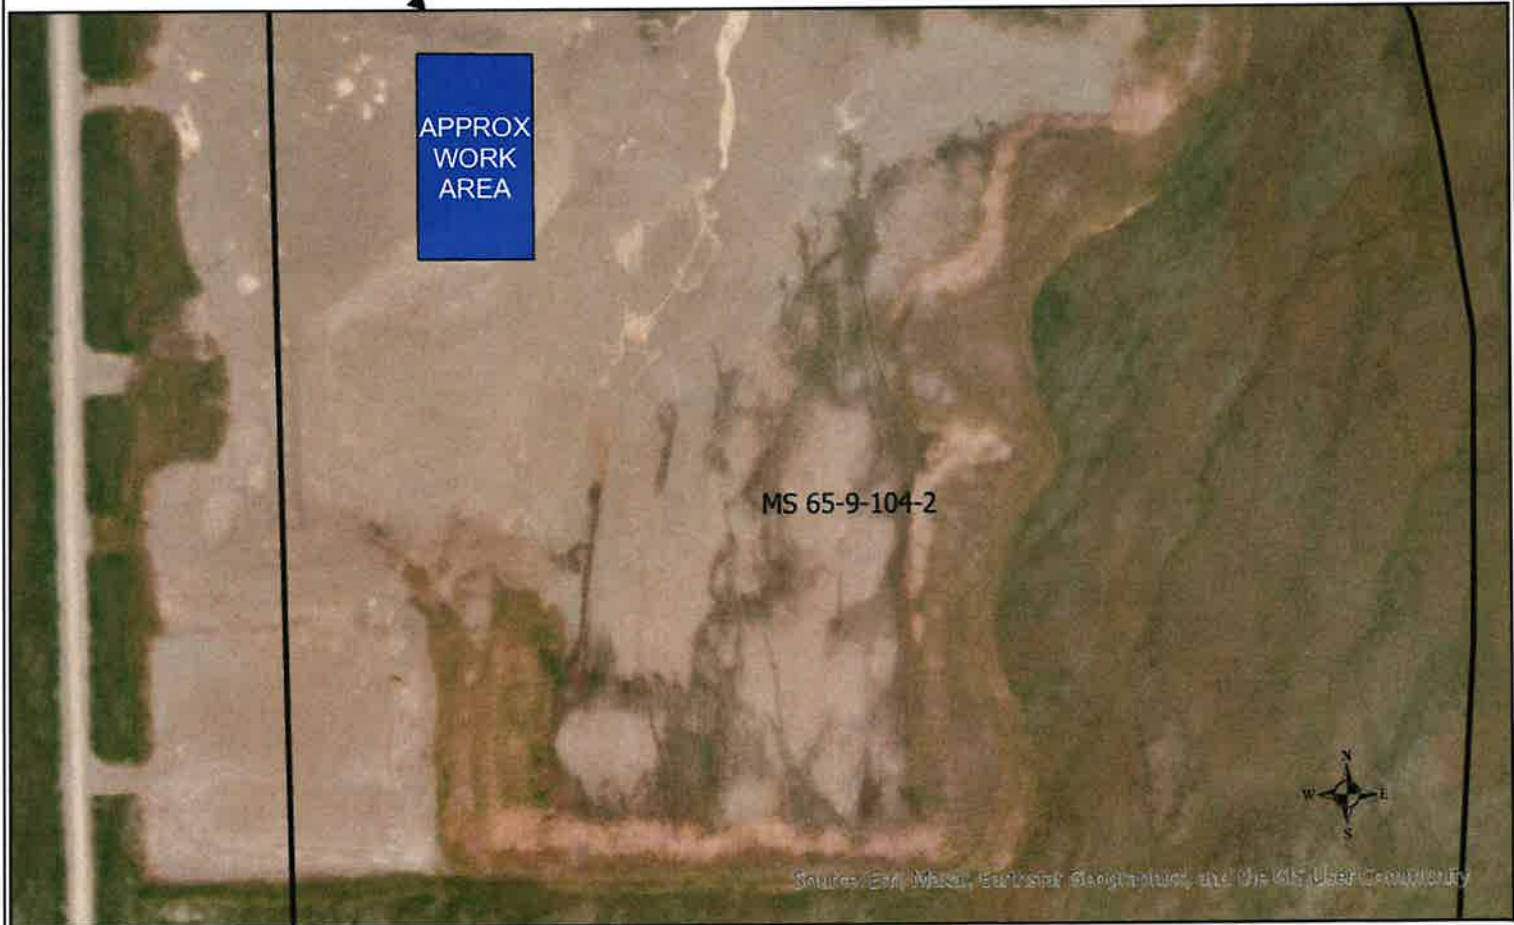
**NR AGGREGATE PROGRAM
DALTON DISTRICT
DALTON HWY MILE 221 65-9-105-2**

-   DOT&PF Road System
-   Site Limits
-   Planned Mining/Work Area
