National Guard Federal Scout Armory

Remedial Action Report

Savoonga, Alaska

June 2023

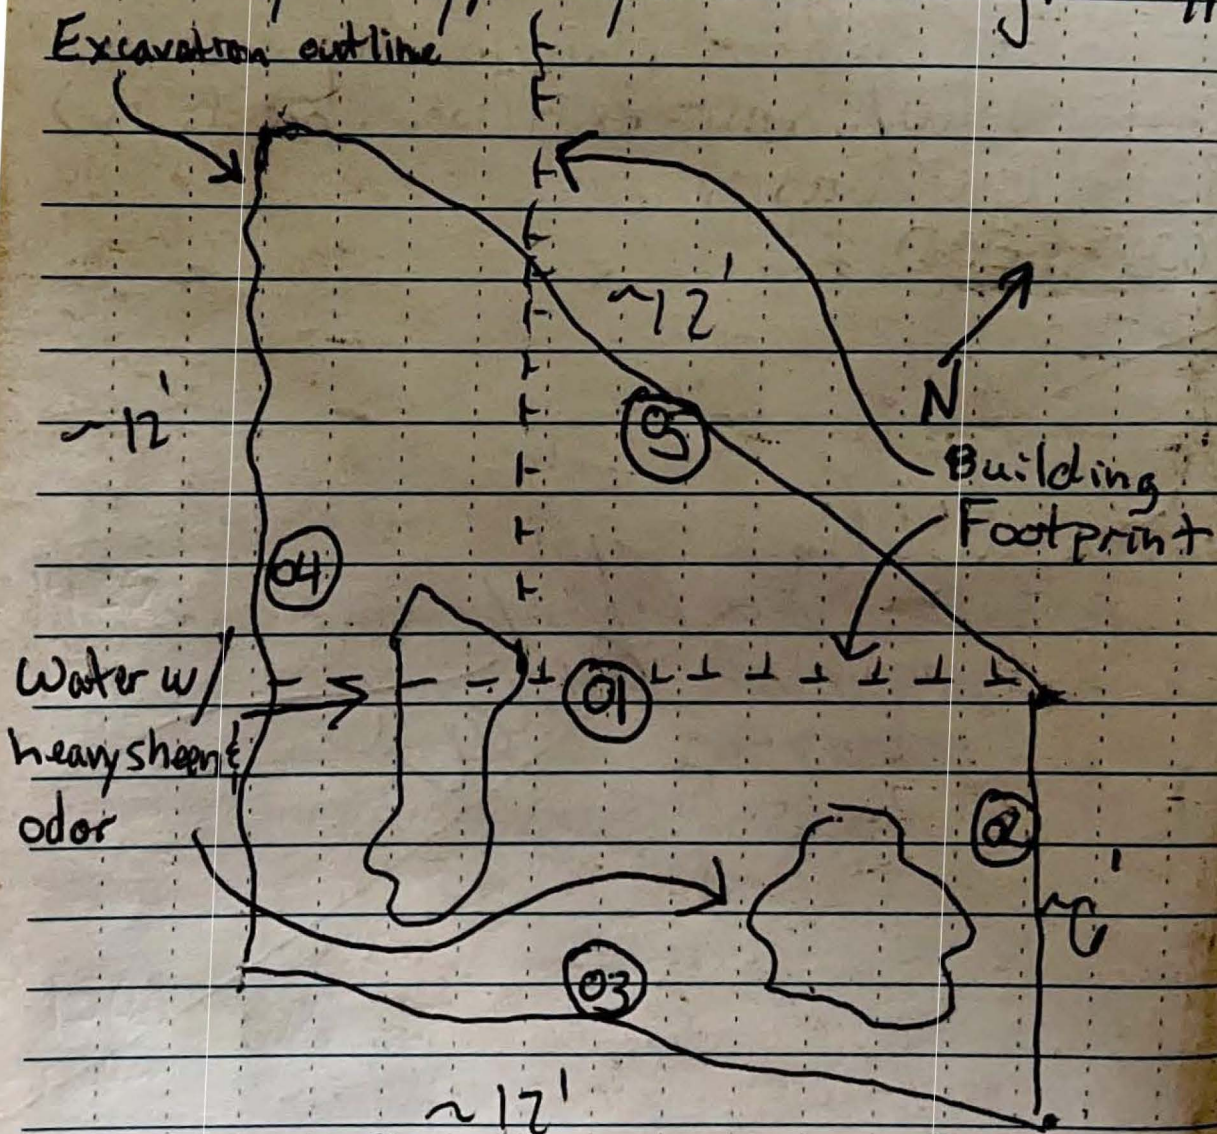
Excavation outline

~3 ft deep, ~2" of water in
south eastern end of excavation
w/ heavy sheen & odor.

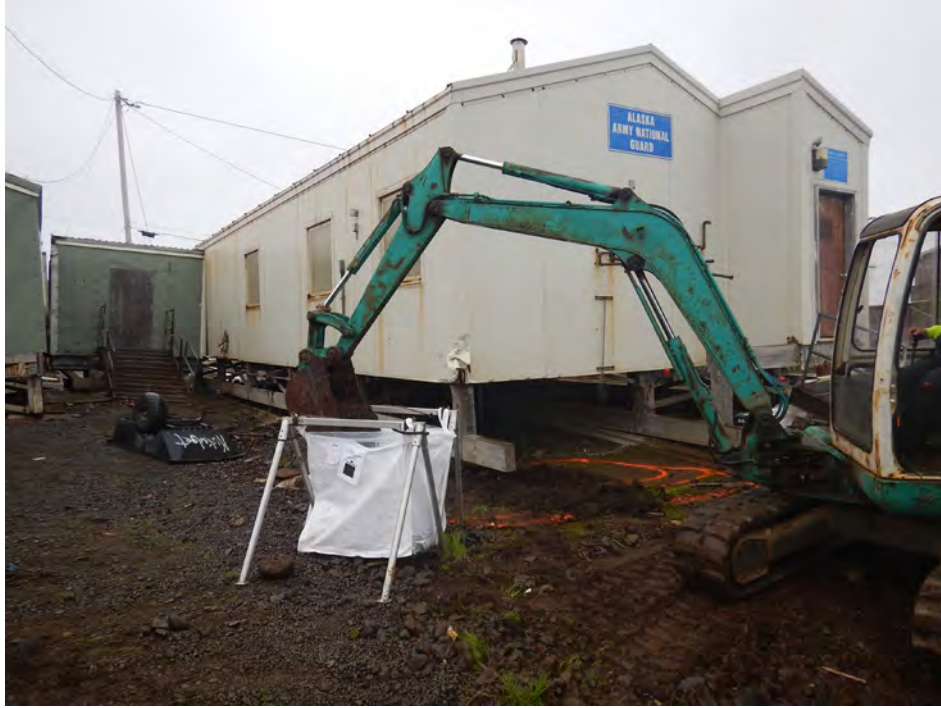
Photograph 3: Beginning excavation, view north.

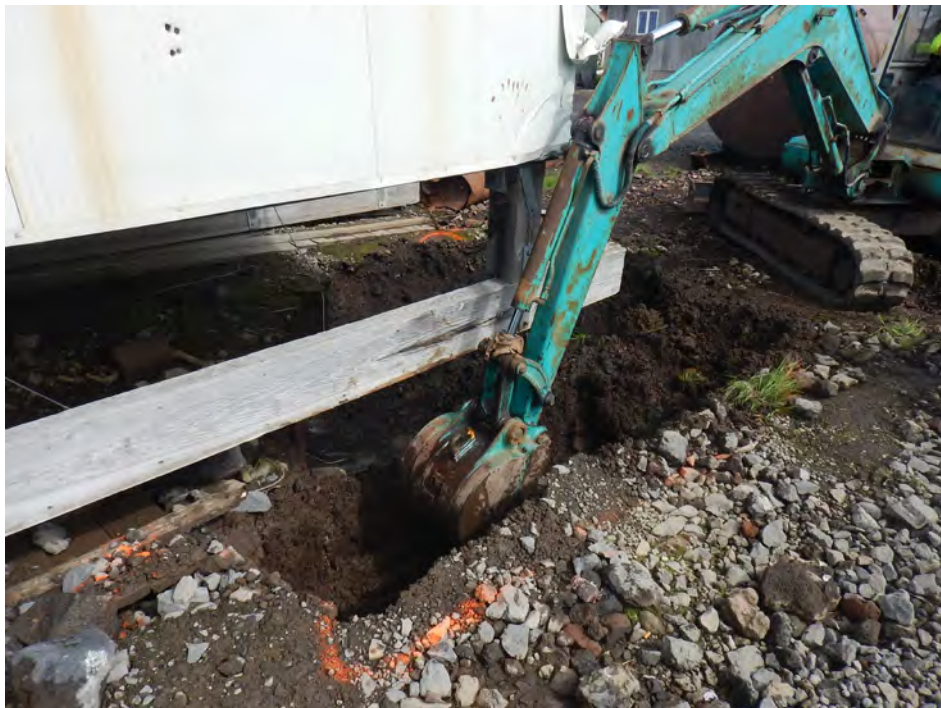
Photograph 4: Excavation at 10 cubic yards removed, view east.

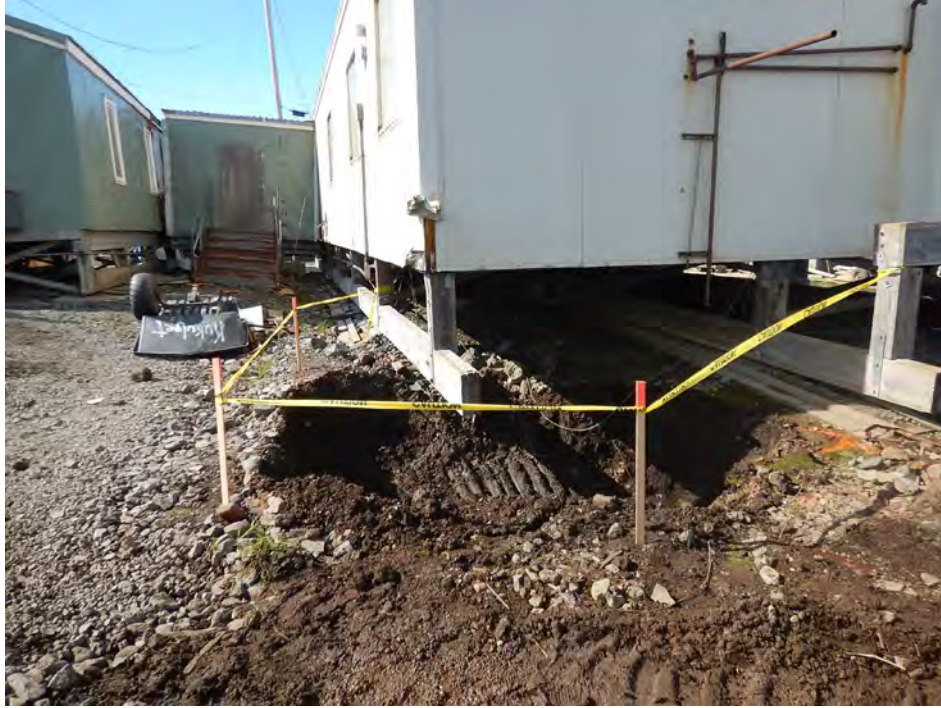
Photograph 5: Excavation at 12 cubic yards removed and 3 feet deep, view north.

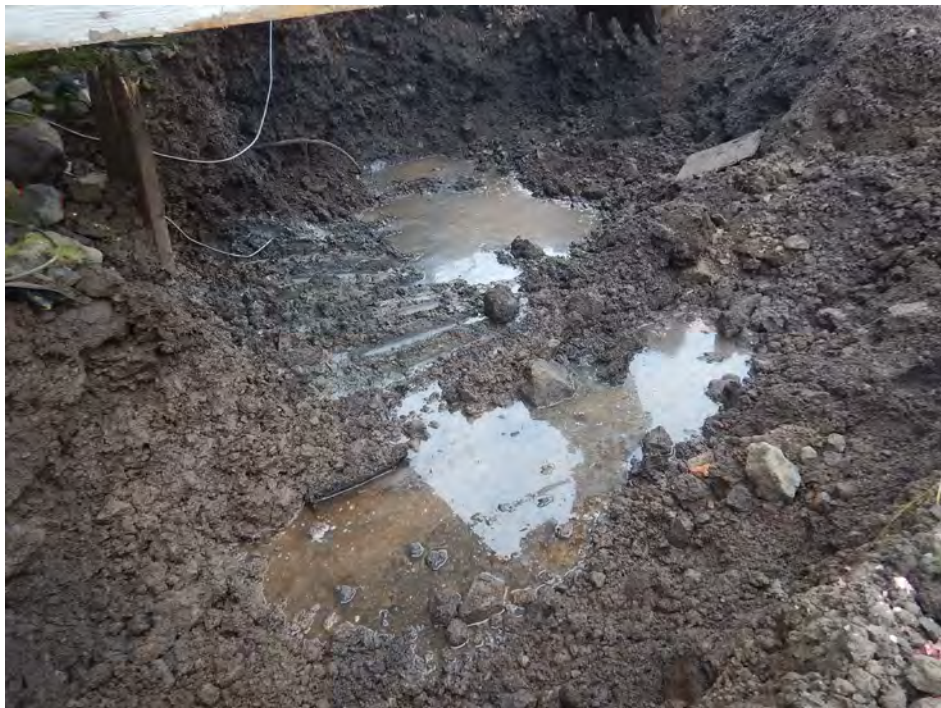
Photograph 6: Water in excavation with POL sheen, view east.

Data indicates that supra-permafrost porewater has been impacted by fuel releases. Also, sheen was observed on the supra-permafrost water inside the excavation. For purposes of this CSM, the supra-permafrost porewater is being evaluated relative to the “groundwater” exposure pathways referred to in the ADEC *Guidance on Developing Conceptual Site Models* (ADEC 2017).

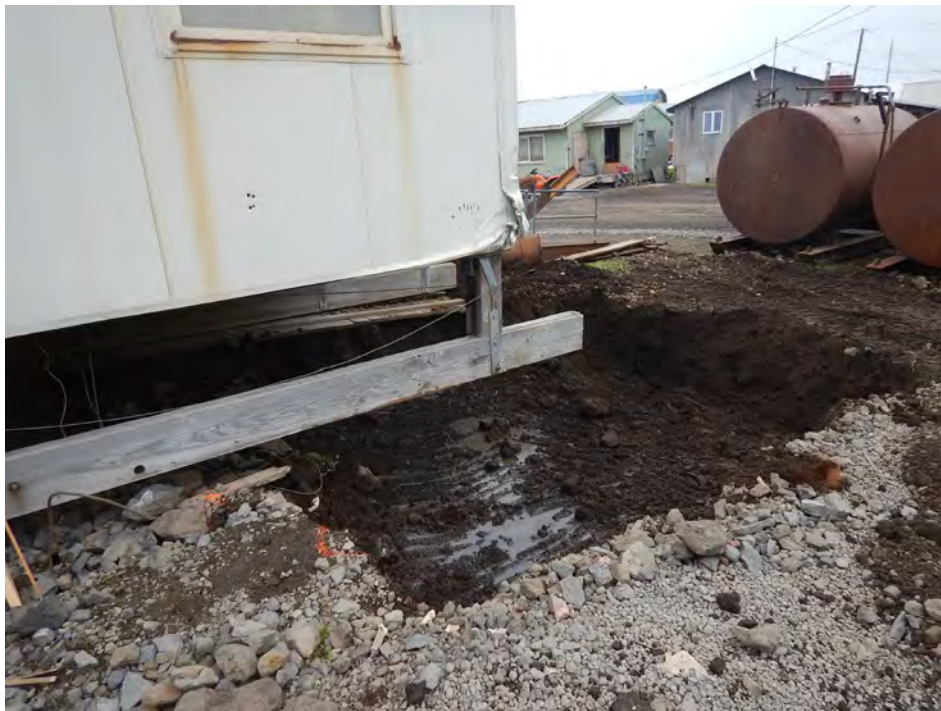
Photograph 8: Completed excavation at 30 cubic yards removed, view east.

A Komatsu PC40 mini excavator, with an arm reach of 18 feet, was used to remove approximately 30 cy of contaminated soil from the source area. Excavated soil was placed into 1 cy supersacks for transport and disposal. The excavation was advanced to the depth of frozen soil at approximately 3 feet bgs. During the soil removal supra-permafrost water with a sheen and POL odor was observed inside the excavation. Soil samples were collected from the base and sidewalls of the excavation using disposable or clean, decontaminated stainless steel tools, and submitted for the analysis of DRO, BTEX, and PAHs. Soil samples were collected at locations in the excavation that appeared to be the most contaminated based on field screening results, field observations including olfactory and visual indications of contamination, and previous analytical sample results. Samples were collected in laboratory-provided sample containers. To minimize volatilization during soil sampling for volatiles (BTEX), approximately 25 grams of soil was placed

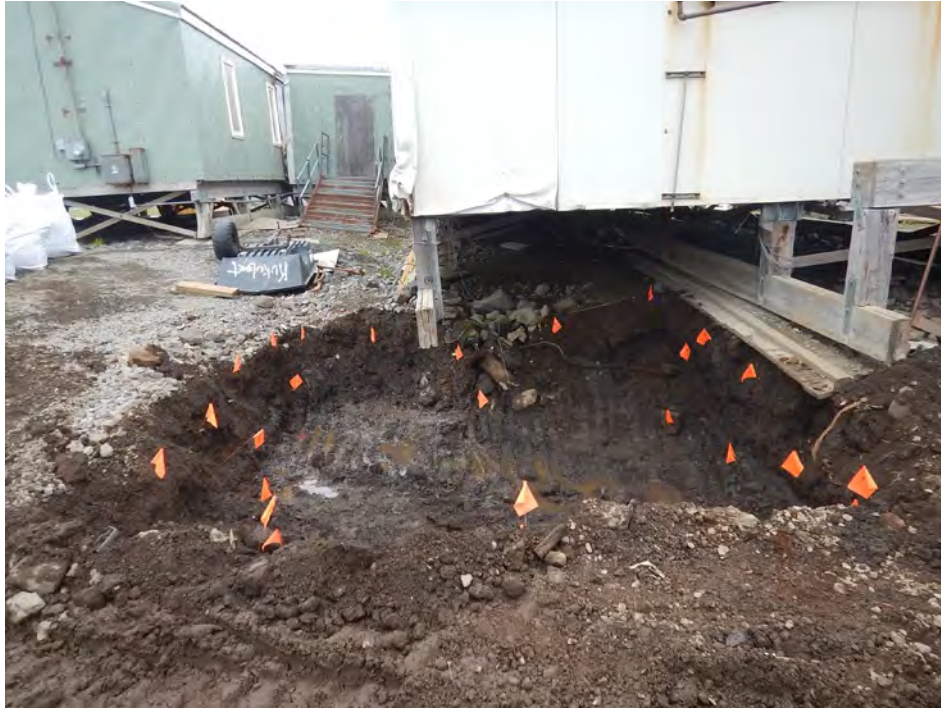
Photograph 9: Field screening pin flag grid in excavation, view northwest.

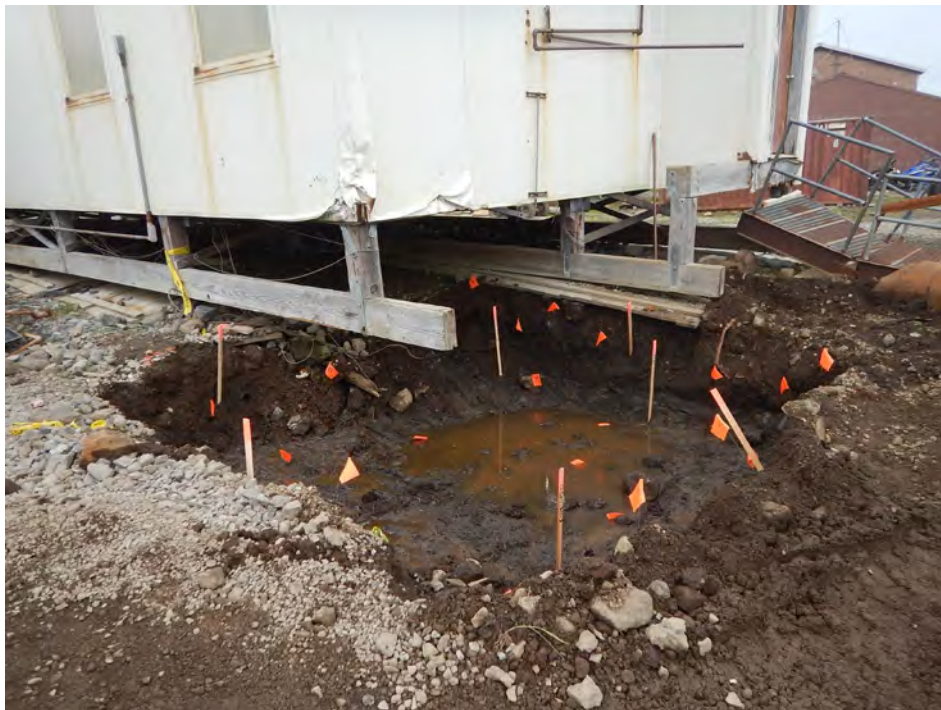
Photograph 10: Sample locations marked with stakes in excavation, view north.

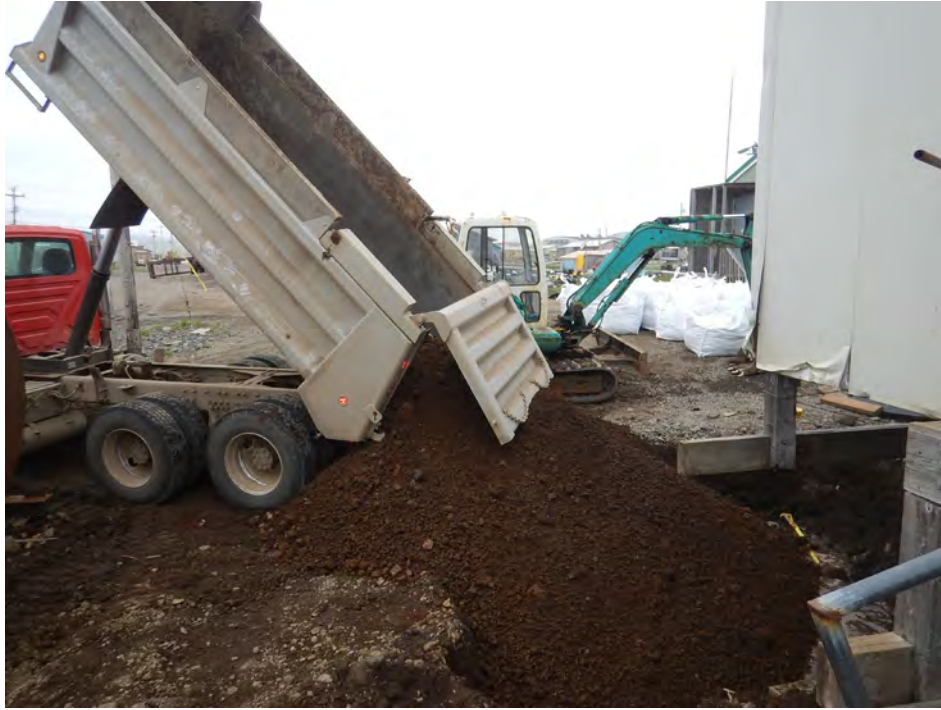
Photograph 11: Backfilling excavation, view south.

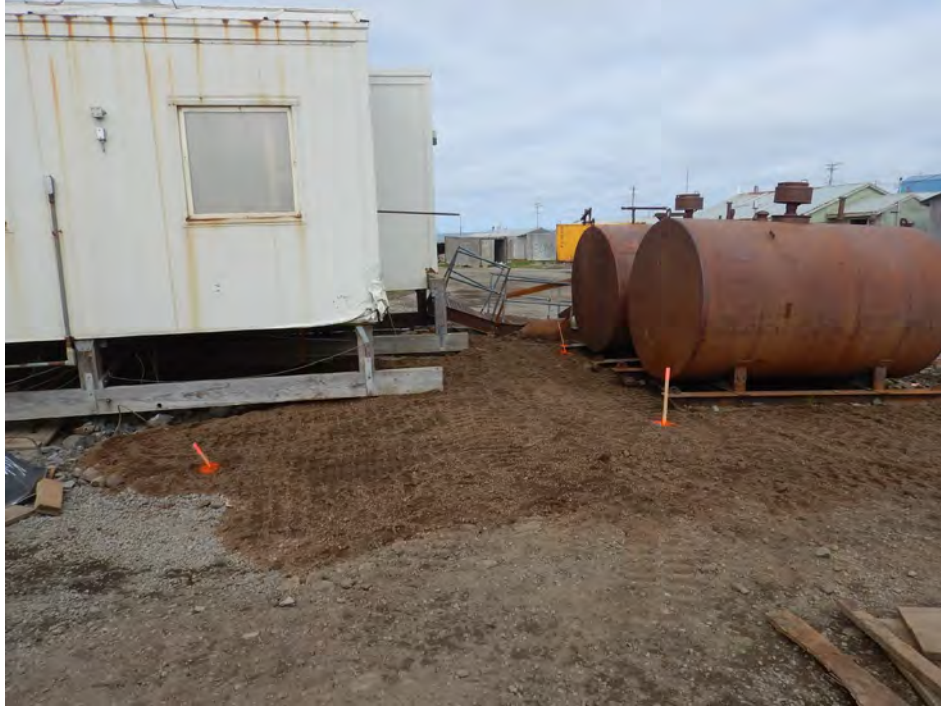
Photograph 13: Recontoured backfilled excavation, tanks moved southwest approximately 10 feet away from road, view northeast.

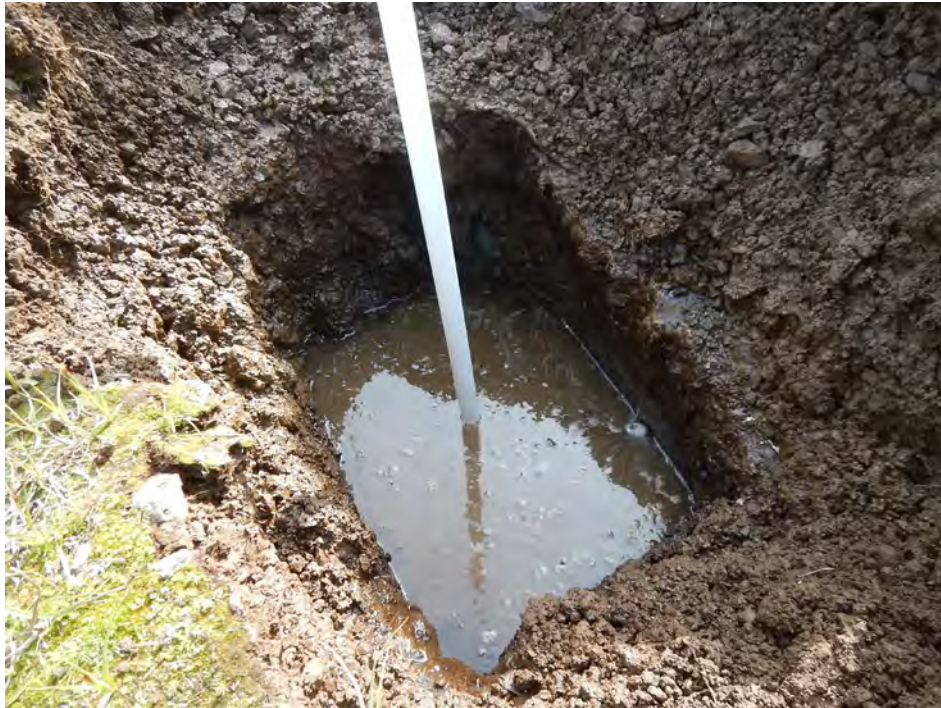
Photograph 14: WP-05 in approximately 1 foot of water in test pit with POL sheen, view east.

1130 WP-05/TP-10 Dug to 3' 8" BGS
ground water infiltration at
18" along 6" thick organic
mat from SE & NW filling
pit. Clay lense ~2' BGS, POL
sheen on water, moderate
hydrocarbon odor. 1" PVC
slotted TWP installed to 3' 8" BGS,
SU = 1' 4". PIT headspace
reading = 88.3 ppm, saturated w/H₂O
1 50lb bag sand used as filter pack
(10/20)

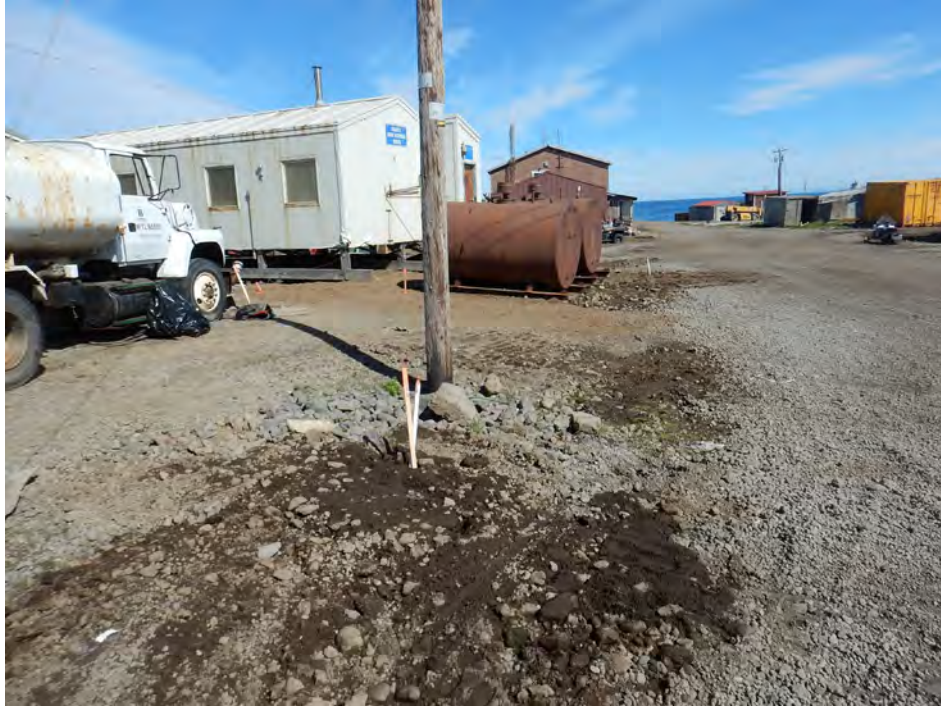
Photograph 15: WP-01 and WP-02 visible near road, view northeast.

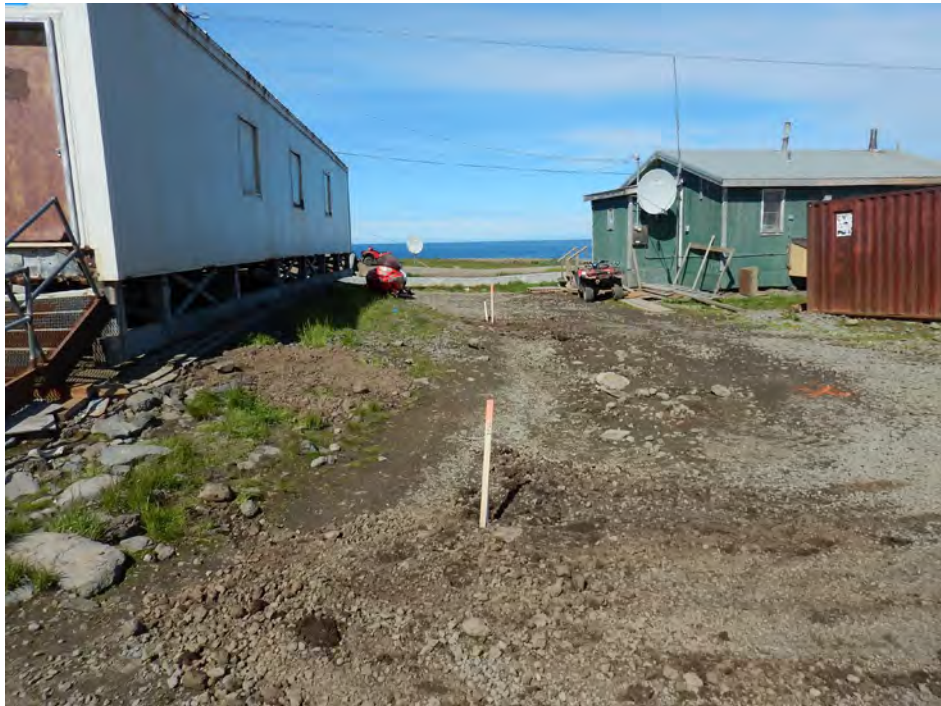
Photograph 16: WP-03 and WP-04 as seen from road on east side of FSA, view northeast.

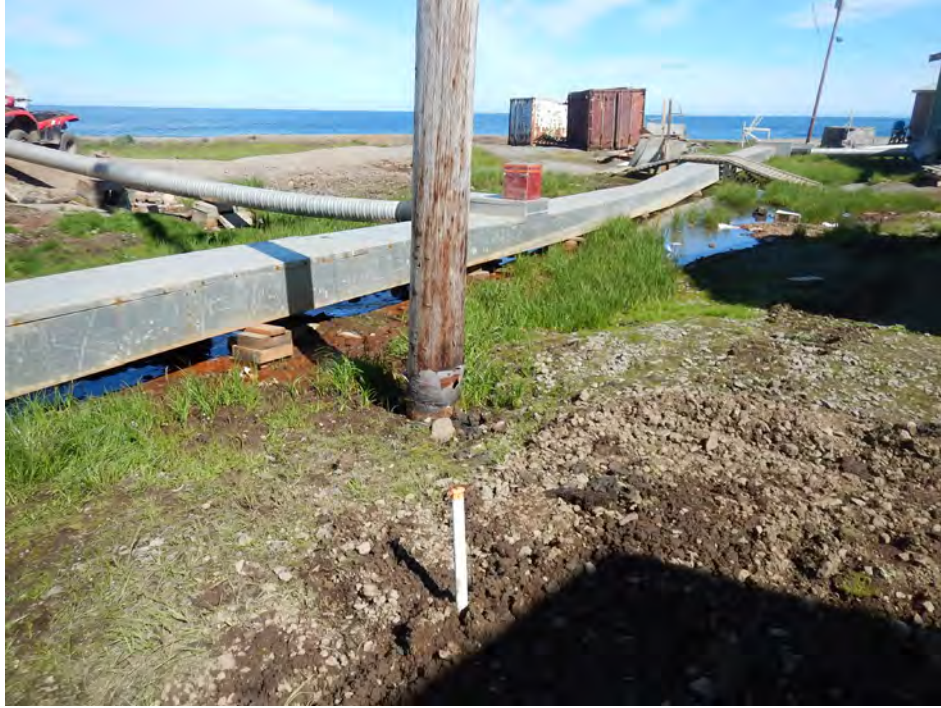
Photograph 17: WP-05 on north side of building, view northeast.

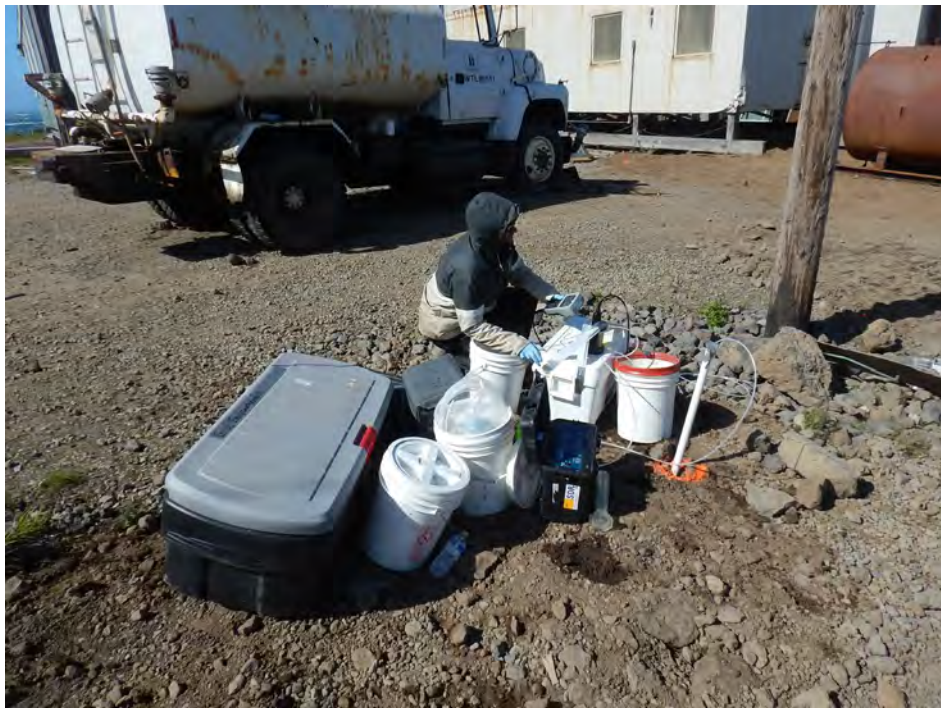
Photograph 18: Water sampling at WP-01, view north.
