State of Alaska
Department of Environmental Conservation
Village Safe Water Program

Re: Amendment 2
ITB 25-VSW-PBV-006
Saint George Water Storage Tank Replacement
ITB Due Date: October 2, 2024 @ 2:00 PM AST

286,000 GALLON BOLTED STEEL WATER STORAGE TANK (1998)

**GEOTECHNICAL RECONNAISSANCE OBSERVATIONS AND PRELIMINARY RECOMMENDATIONS,
REPLACEMENT WATER STORAGE TANK, ST GEORGE, ALASKA**

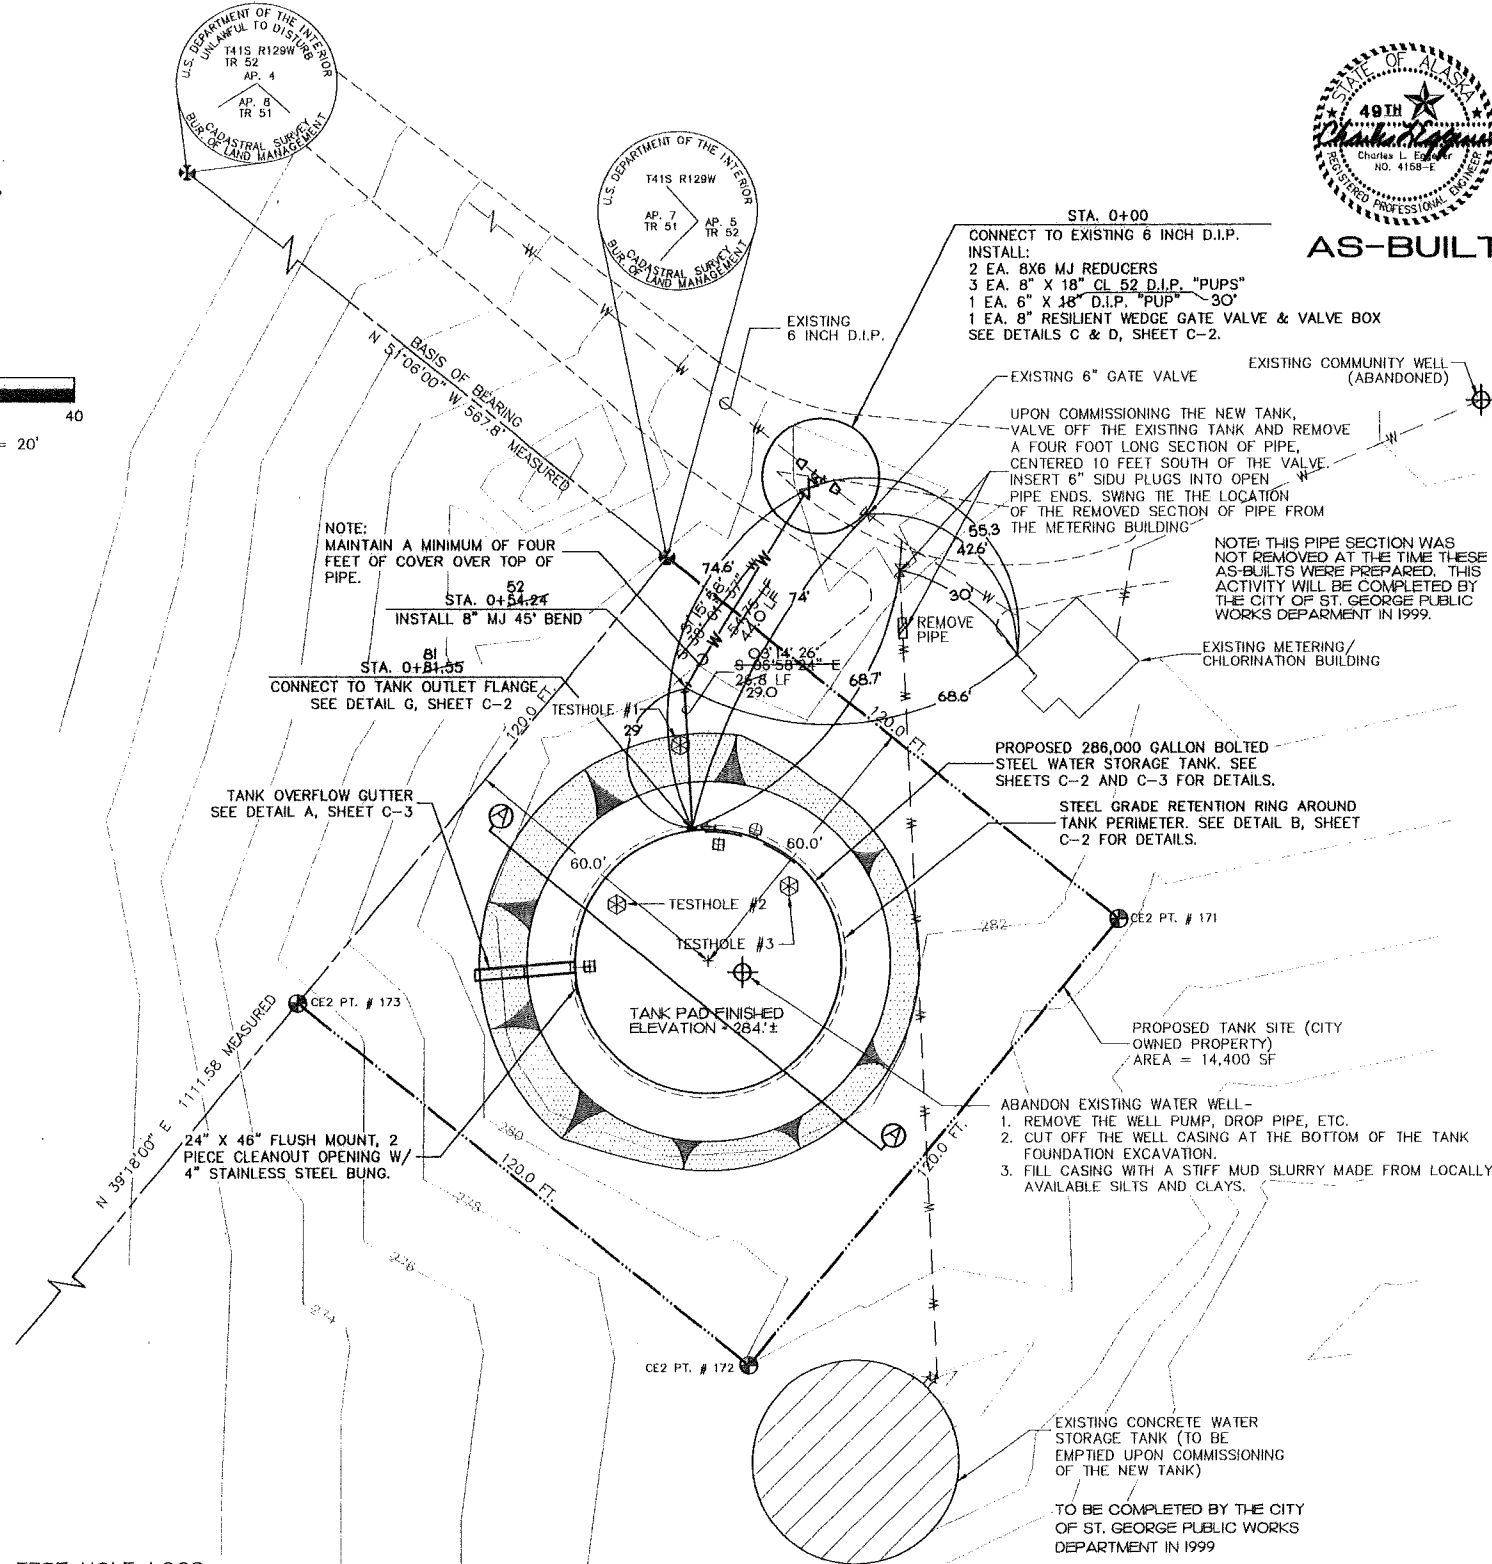
TANK SITE PLAN

TESTHOLE #1

0-2 FT. SCORIA FILL
2-4.5 FT. ORGANICS AND ORGANIC SILT
4.5 FT. WEATHERED BEDROCK

<u>TESTHOLE #2</u>	
0-2 FT.	ORGANICS AND ORGANIC SILT
2-4 FT.	SILT
4 FT.	WEATHERED BEDROCK

TESTHOLE #3

0-2 FT.	ORGANICS AND ORGANIC SILT
2-5 FT.	SILT
5 FT.	WEATHERED BEDROCK

TESTHOLES LOGGED ON MAY 14, 1998 BY
C. EGGNER, P.E.

Department: The attached record drawings of the existing tank include test hole logs (on Sheet C-1) for three test holes excavated prior to construction, and document construction of the existing tank pad. The attached report dated 3/17/2023 by WSP documents their reconnaissance and preliminary recommendations regarding the existing tank pad and construction of a new tank on the pad.

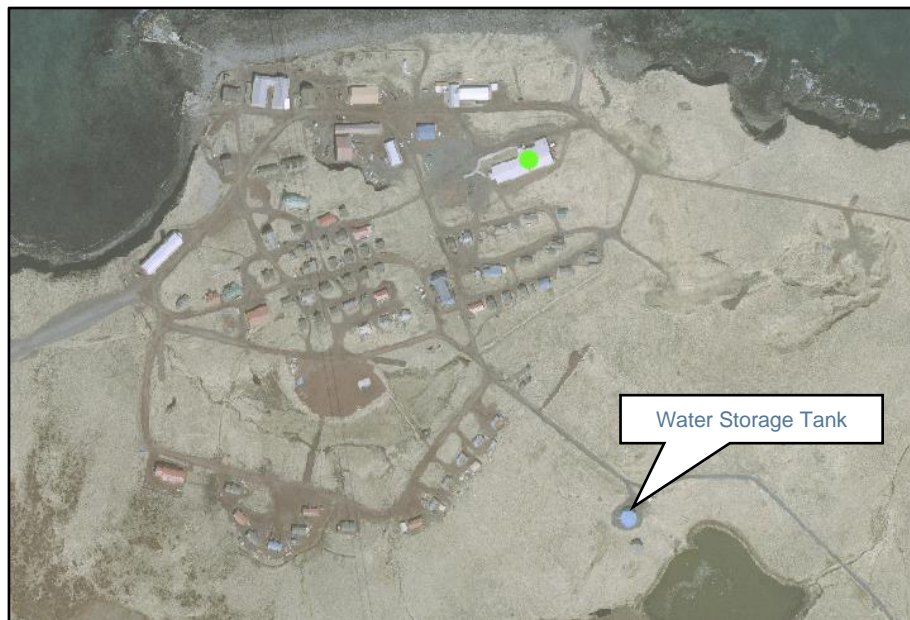
The WST is a bolted steel shell tank founded at-grade on a locally obtained granular fill. There were no obvious indications of settlements of the tank perimeter in excess of design or performance tolerances for a structure of its age and use. The existing WST is designated for replacement on the same pad of roughly the same general dimensions as part of a community-wide water and sewer upgrade. Raw water is provided through a series of water wells connected via buried pipelines to the WST.

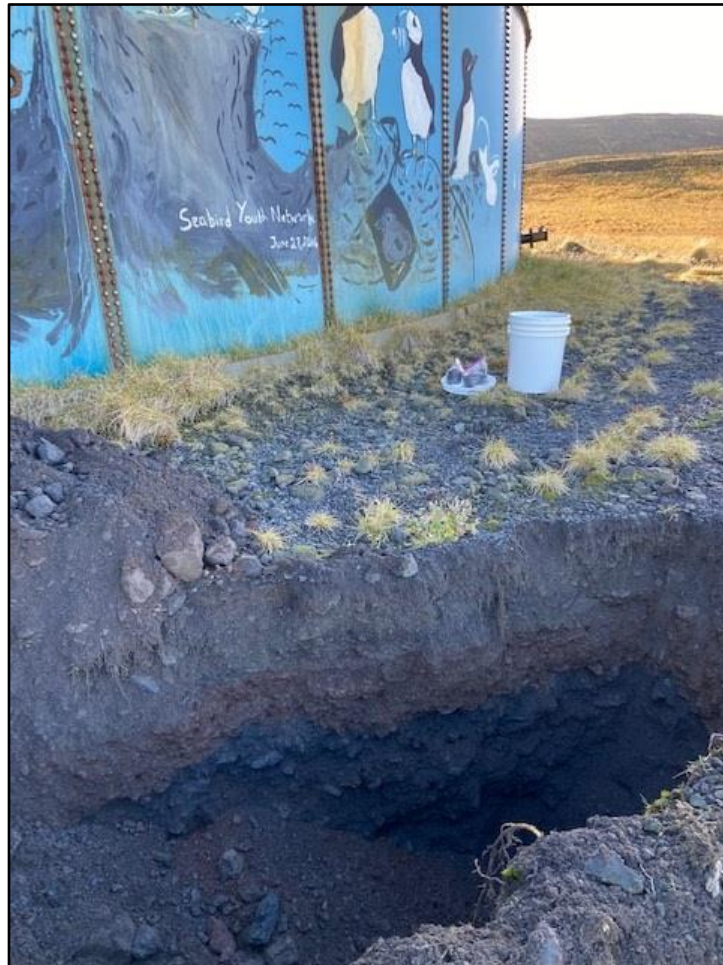
TP-1, WST North Side

Test pits TP-1 (north side) and TB-2 (southwest side) were advanced to approximately 4 feet below existing grade, considered the safe working limited for the equipment, operator, and proximity to the tank to avoid the risk of damage to the existing structure. Two soil samples were retained from TH-1 at 1-1.5 feet and 2.5 to 3.5 feet below ground surface. One sample was retained from TP-2 at 2.5 to 3.5 feet below existing grade. TP-3 was advanced to 3 feet below grade encountering relict materials, possibly an abandoned pipeline, at that depth. TP-3 was terminated at the initial exposure of the relict materials. One sample was retained from TP-3 at 1.5 to 2.5 feet below grade. All test pits were backfilled with excavated material and tamp compacted to adjacent grade prior to demobilization.

Subsurface materials encountered in all three test pits are considered similar. The site consisted of a locally source aggregate apparently mechanically processed to a 3/4-inch minus sand with gravel and some fines (material passing the US Number 200 standard sieve size). The processed fill appeared to be basalt with some

larger dimensions (3 to 4 inch nominal diameter) andesitic aggregate placed as a thin, random layer at the surface as an apparent erosion protection measure. TP-1 and TP-2 may have initially encountered in-place fractured in-place basalt near the base of their excavations as noted by larger dimensioned (12-inch) basalt or other volcanic material recovered in the backhoe bucket. The operator recommended not attempting to advance deeper into the zone over concerns to equipment damage or test pit trench sidewall sloughing resulting from increased excavation effort.

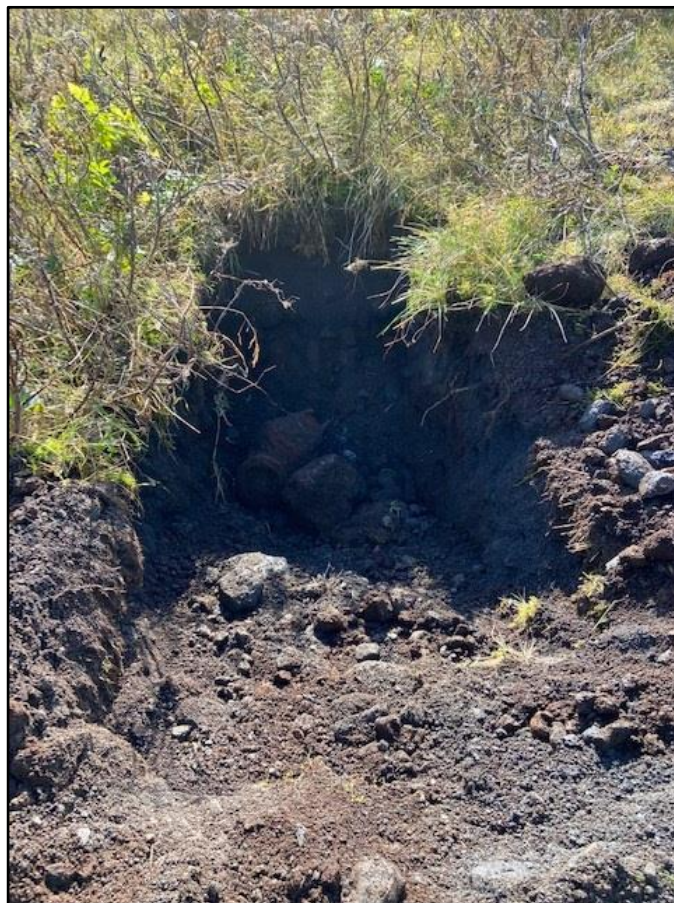
TP-3, WST Eastern Side

Based on our field findings and review of the geotechnical laboratory data, the soils encountered in the test pits are considered relatively consistent with approximately 40-percent by dry mass fine grained gravel and 4 to 7-percent fines in TP-1 and TP-2. A slightly elevated fines content was noted in TP-3 but this test pit encountered some relict materials which may have included material with a slightly elevated fines content.
