# Wetland Delineation Report

August 1, 2024

SKYLINE HEIGHTS ESTATES  
KACHEMAK LANDING AIRPARK

Homer, Alaska

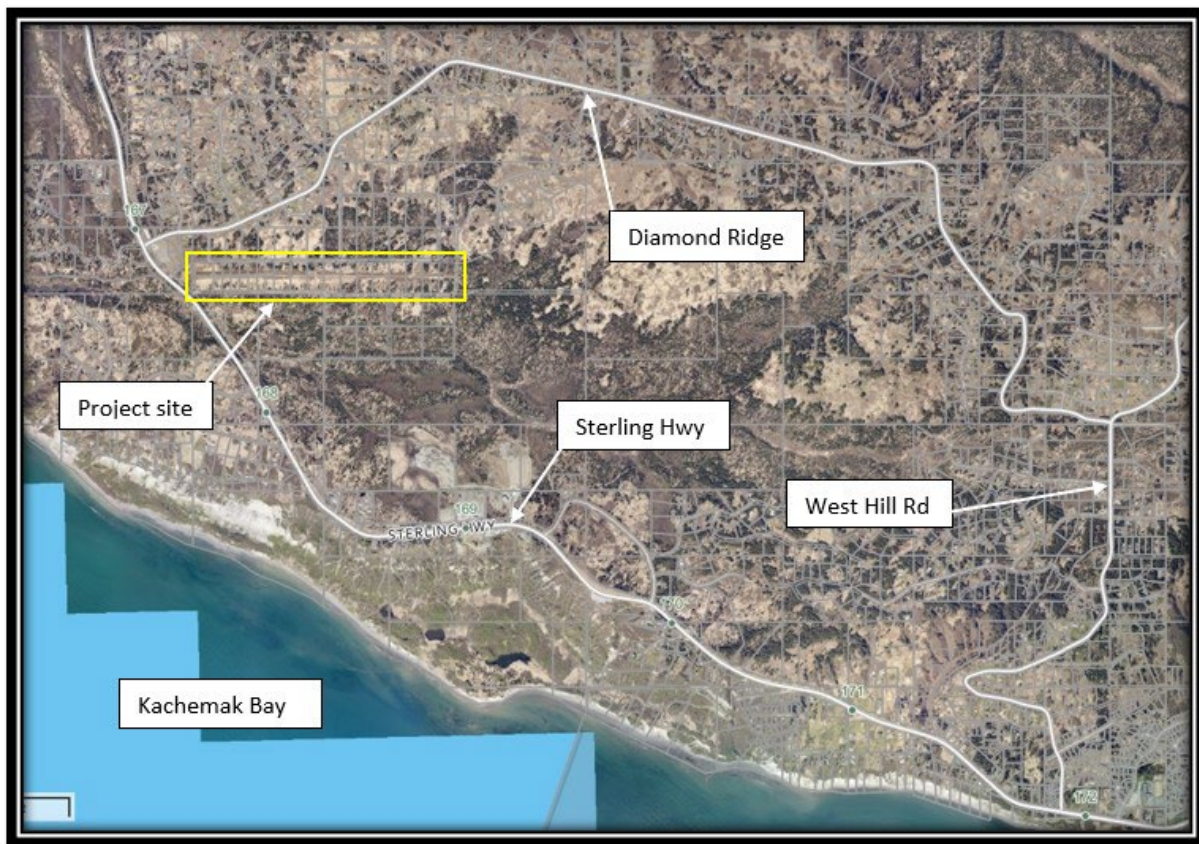
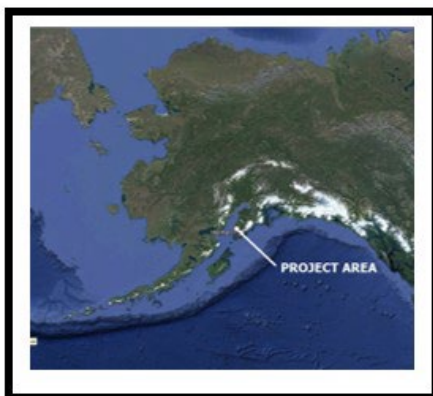
## FIGURE 1: VICINITY SITE MAP

The chosen lots are located on the south side of Diamond Ridge Rd, approximately 1,300 feet east of Sterling Hwy, accessible via Cirrus Rd and Stratus Rd, and directly south of Cirrostratus Ave. Roadway development and improvement is set to occur along parts of Cirrostratus Ave, Aviation Way, Barred Moore Ave, and Miss Lassie St. Airstrip improvement is set to occur along the existing runway, which runs east to west centered between Cirrostratus Ave and Barred Moore Ave and is being used as a temporary roadway while improvement plans are finalized. Existing lots shall be replatted and developed such that lots will line the runway on the north and south sides, with many of the lots being provided both runway access for small aircraft and roadway access for residential vehicles. Currently the lots are partially developed, with historical aerial imagery indicating development occurred when the runway was built between 2006 and 2011. At this time, multiple east to west ditches were installed across the lots both north and south of the runway, trees were cleared to either sides of the runway, culverts were placed crossing the runway, and multiple driveways were filled in to access various lots. Additionally, by 2015 beetle kill on the peninsula had cleared many more trees from the area, which was once densely forested. While previous development and beetle kill significantly altered hydrology and vegetation in the area, it has been several years since these changes have occurred and the land has acclimated to the new conditions. New vegetation has established itself and wetland communities have persisted.

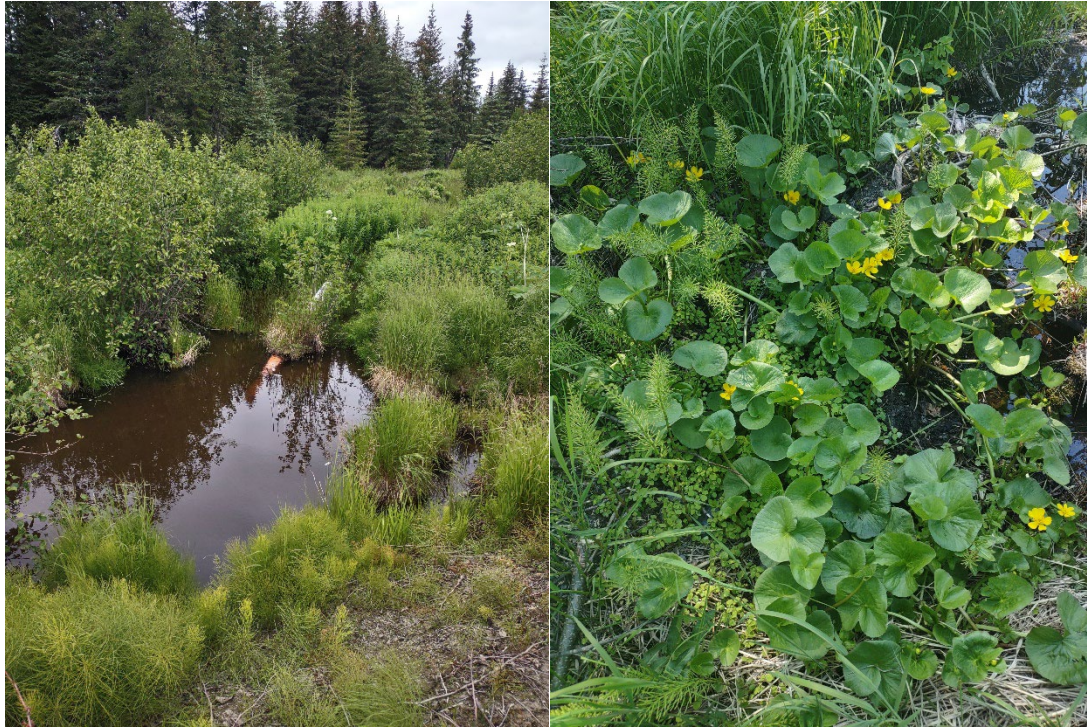
*Figure 8. Ponding water near data point "PND" where culvert has failed (left) Marsh marigolds lining creek in eastern RP system (right)*

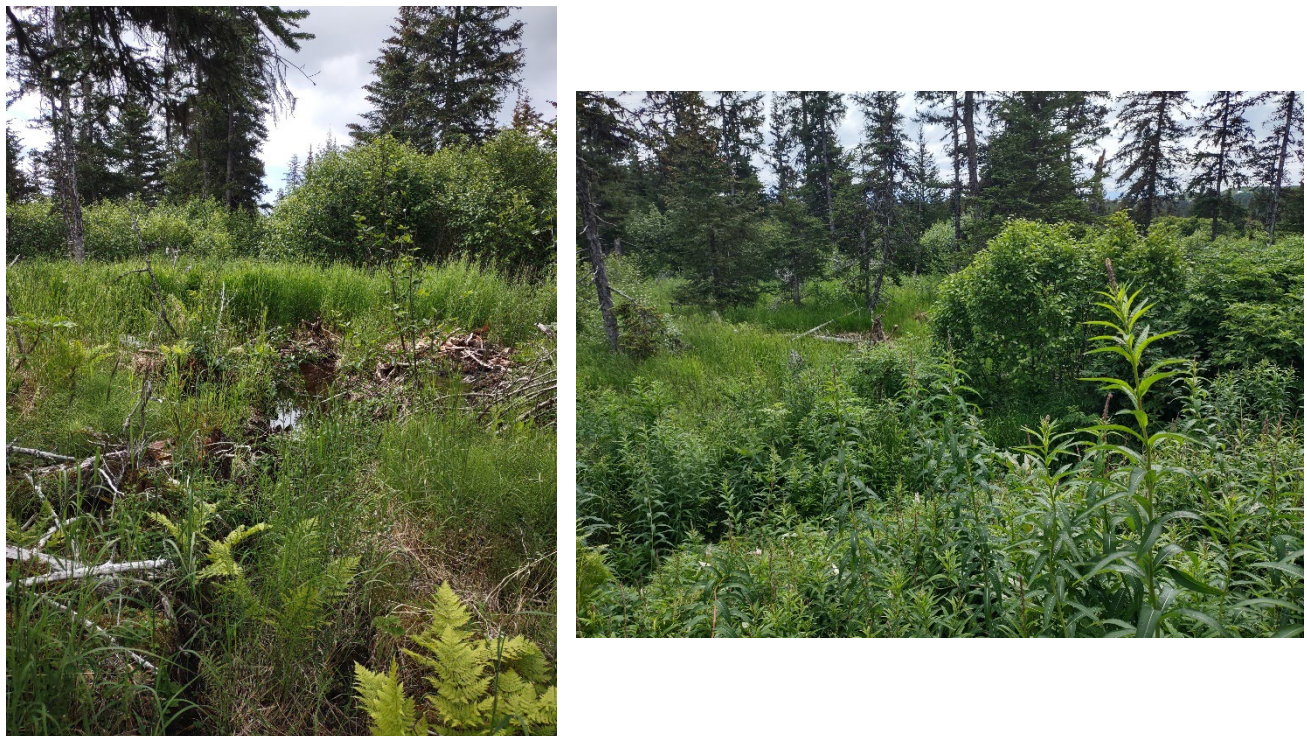
*Figure 9. Surface water, deadfall, and uneven terrain in southeastern PEM facing north (left) Uneven terrain visible from local high point on southeastern lot facing south (right)*

Overall, we found this site to contain a mix of wetland and upland communities, with land generally growing wetter as you move south and to the east. Hydrology on site is not entirely unmodified, and the current wetland conditions reflect changes to the land that were made years ago during the initial development of the airport. Extensive ditching was installed during the time of construction, including two sets of east-west ditches on the north side of the runway which collect and concentrate surface and most subsurface flows approaching the runway from the north and direct it into a series of culverts, which outlet on the south side of the runway. Over the years, wetland communities have formed around ditch banks and culvert outflows, and uplands have formed where water has been directed away. However, the ditches and culverts do not entirely block the natural flow of water, and large swaths of wetlands continue to act as discharge slopes, fed by water flowing through the soils underneath the runway.
