GEOTECHNICAL FINDINGS REPORT
Entrance Channel Dredging (KOD009)
St. Paul and St. Herman Harbor (10168 & 320418)
Kodiak, Alaska

SUBJECT: Geotechnical Findings Report for the Entrance Channel Dredging Project, Kodiak, Alaska (KOD009) (10168 & 320418)

GEOTECHNICAL FINDINGS REPORT
Entrance Channel Dredging (KOD009)
St. Paul and St. Herman Harbor (10168 & 320418), Kodiak, Alaska

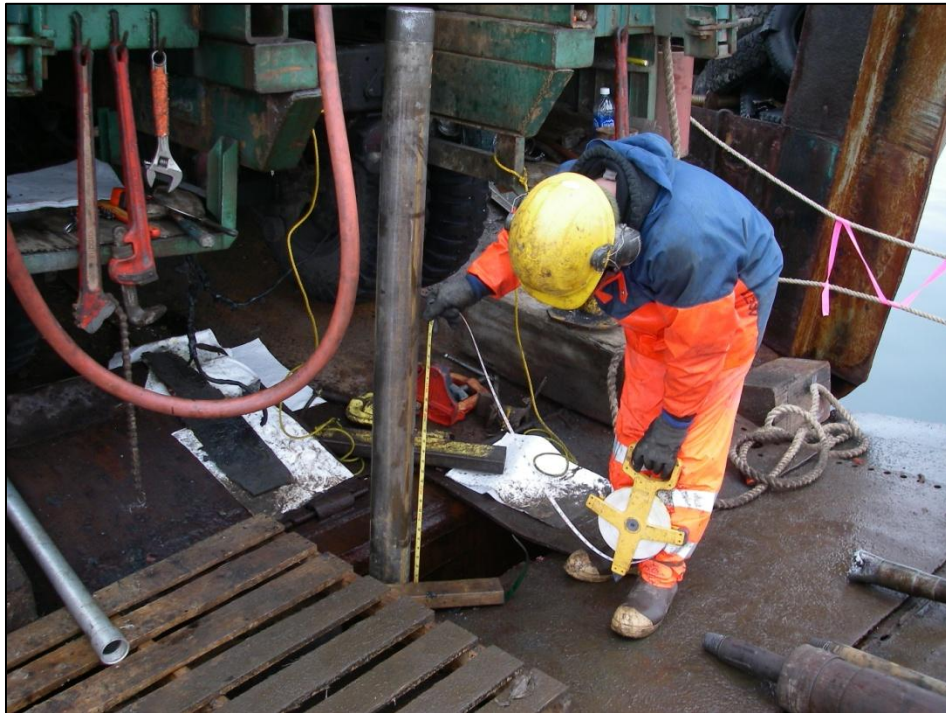
Photograph No.1: Drilling operations conducted on the LCM landing craft Cape Douglas.

Drilling operations were conducted on a 24 hour per day basis with a truck-mounted Mobile B-61 drill rig fitted with 4.0-inch inside diameter by 4.5-inch outside diameter HW casing and NQ-3 coring equipment. Drilling services were provided by Denali Drilling, Inc. and the LCM landing craft Cape Douglas, owned and operated by Doug Peterson, was used to access test boring locations. Photograph No.1 shows the placement of drill casing between the loading ramp and landing craft.

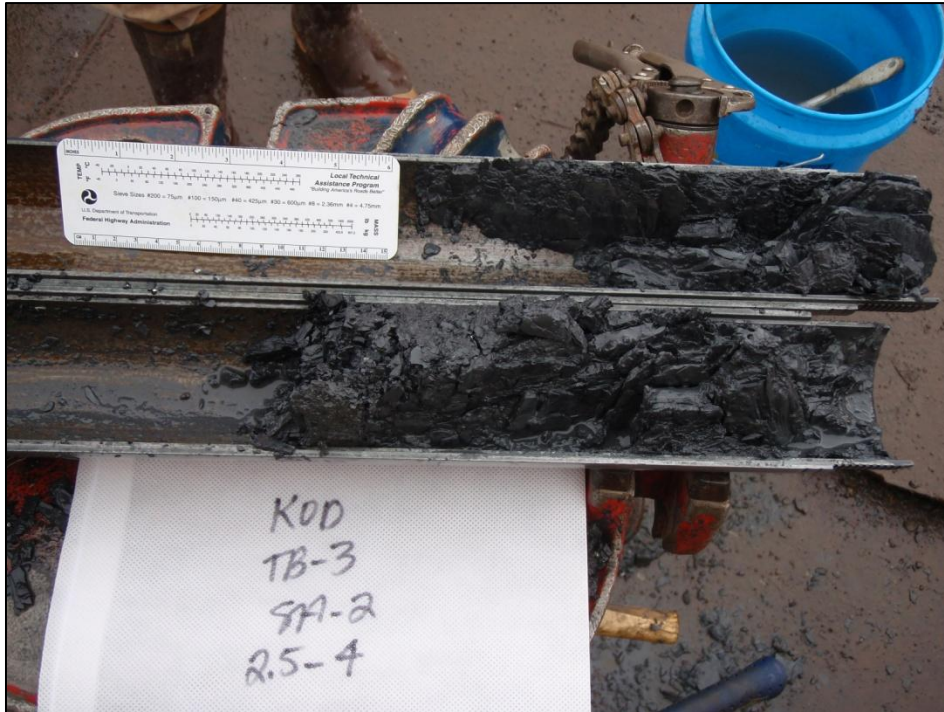
Photograph No.2: Sample of slightly weathered bedrock from test boring AP-149 taken between 2.5 and 4.0 feet below the mudline.

Photograph No.2 shows an example of slightly weathered bedrock that was sampled with a spilt spoon sampler. Samples of slightly weathered bedrock retrieved from the split spoon sampler consisted of fractured gravel and sand size rock fragments. These broken rock fragments were caused by the split spoon sampling operation and they do not represent the existing in situ bedrock condition. Mechanical excavation using large heavy excavation equipment, ripper teeth, and hydraulic rock breakers will be required to break the slightly weathered bedrock into rock fragments that can be dredged.

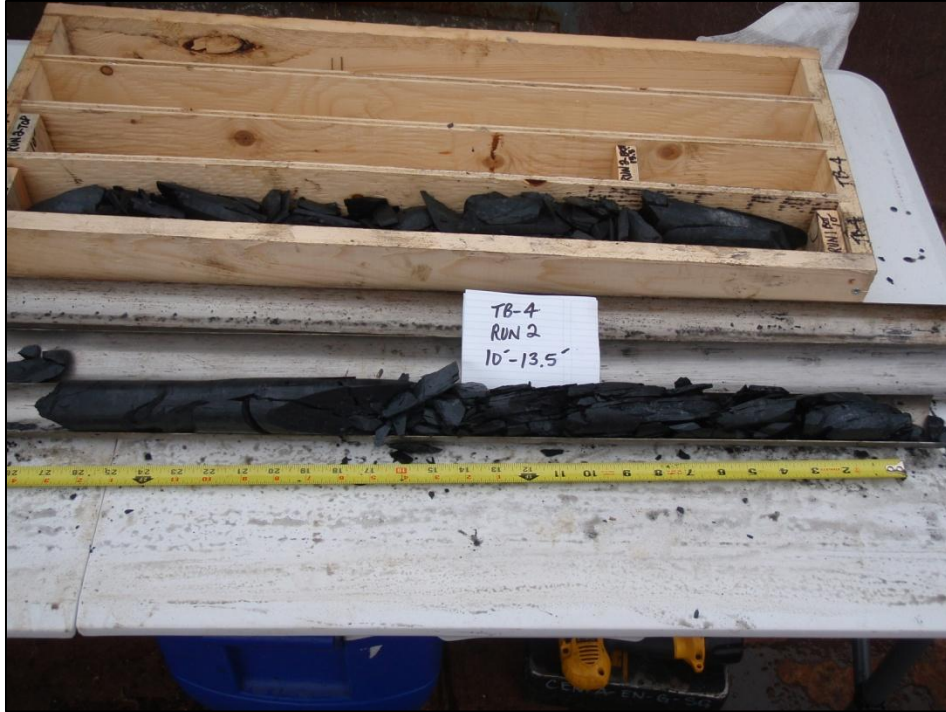
Photograph No.3: Sample of bedrock from test boring AP-150 taken between 10.0 to 13.5 feet below the mudline. Reported ASTM D 6032 Rock Quality Designation (RQD) = 0.

Laboratory test results indicate the rock has a bulk specific gravity of 2.709 and absorption of 1.025 percent. A petrographic examination of rock core sampled in AP-148 was conducted by the CTL Group to evaluate the general rock composition and characteristics. The results of this examination are presented in Appendix B. Photograph No.3 shows an example of core rock recovered from test boring AP-140.

Generally the bedrock hardness or relative strength was identified in the field as medium hard. According to Table 3 found in the USACE Technical Report GL-85-3, this range of rock hardness correlates to an estimated minimum uniaxial compressive strength range between 1,450 and 3,645 pounds per square inch. The bedrock's stratification thickness was laminated which had a general orientation dip between vertical and 60 degrees. The rock texture was foliated and the toughness or resistance to fracture was low. Rock samples readily fracture or split along foliation planes when hit with a geologic hammer. All rock recovered during core drill was described as having a rock quality designation (RQD) value of zero which indicates a classification of rock quality as very poor.
